# PRELIMINARY ARBORICULTURAL REPORT

8 Little Mead, Shalbourne, Marlborough SN8 3QB

PRI Ref: 344153

Survey Date: 03-12-2025

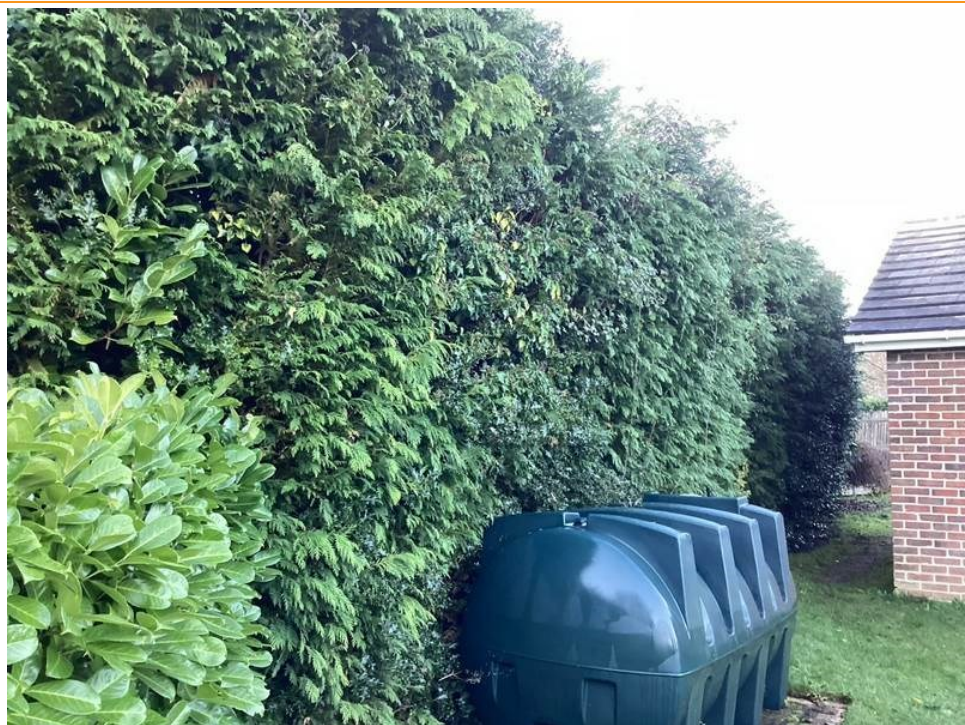
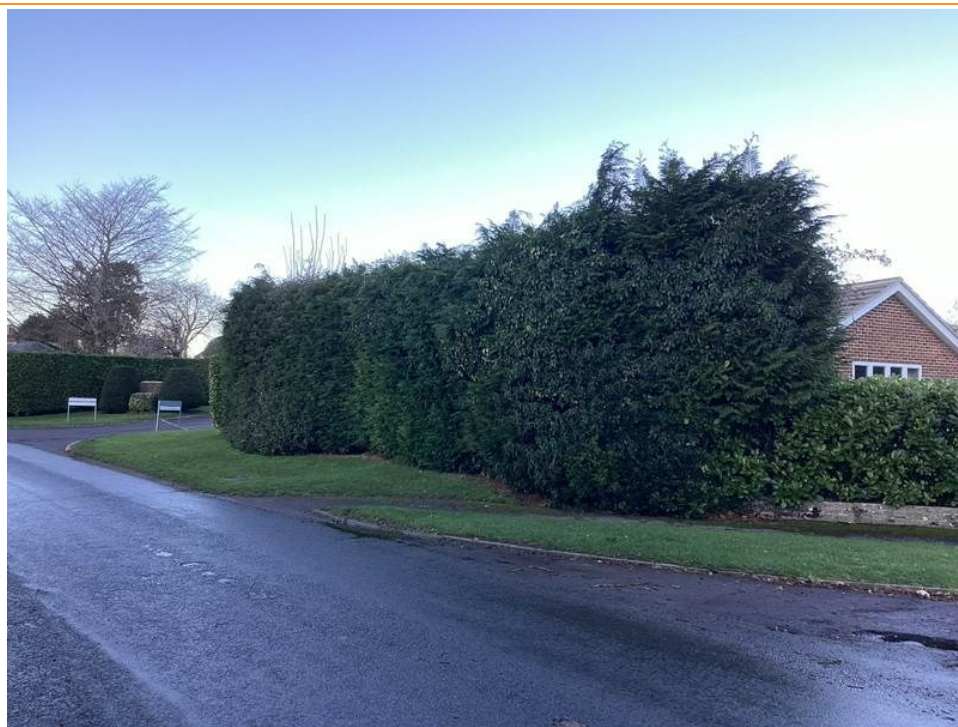
HG2 Mixed species hedge

| Tree No: | Common Name | Age Class | Condition | Height (m) | Crown Spread (m) | Stem diam. (mm) | No. of Stems | Dist to bldg. (m) | Roots Implicated | Pruning History | Recommendation | Tree Work Constraints | Notes | Owner address | Owner |
|---|---|---|---|---|---|---|---|---|---|---|---|---|---|---|---|
| HG2 | Mixed species hedge | Mature | Good | 3.00 | 2.25 | 150 | 10 | 1.50 | Unavailable | Managed by regular pruning. | Fell close to ground level (approx. 50mm) (conifer). | There are restrictions to the site or to the tree – contractor should quote. Oil tank adjacent. | Hedge is majority Thuja, with Holly dispersed within. Stem count and diameters estimated. Approximately 10m in length. | 8 Little Mead, Shalbourne, Marlborough, SN8 3QB | PH |

| Tree No: | Species | Works Required | CA | TPO | Ownership |
|---|---|---|---|---|---|
| HG2 | Mixed species hedge | Fell close to ground level (approx. 50mm) (conifer). | Yes | No | PH |

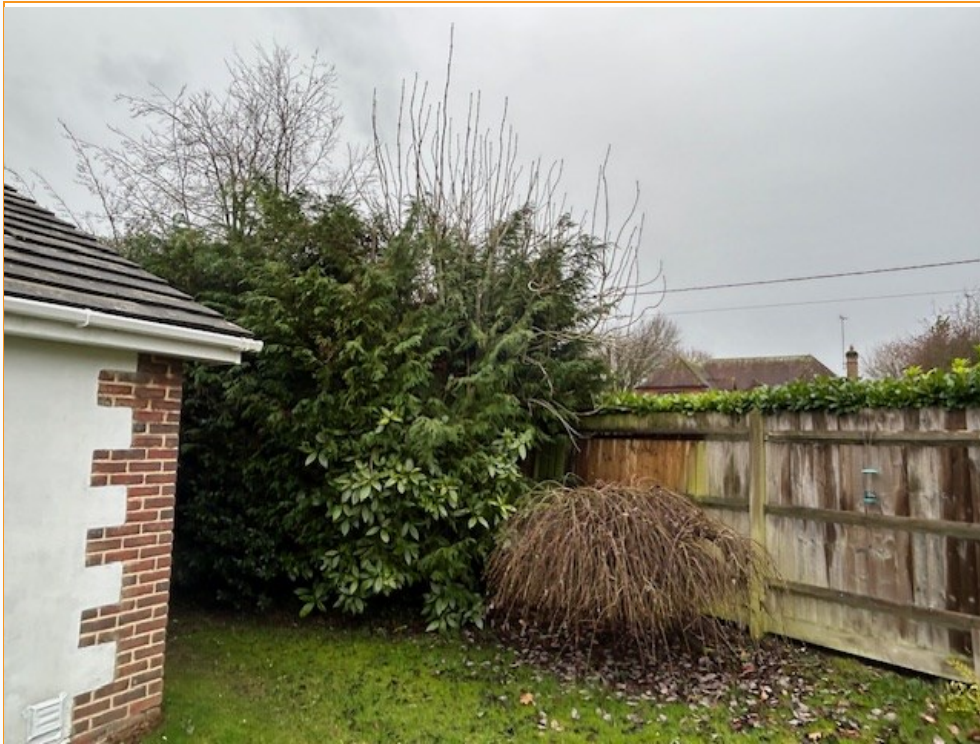
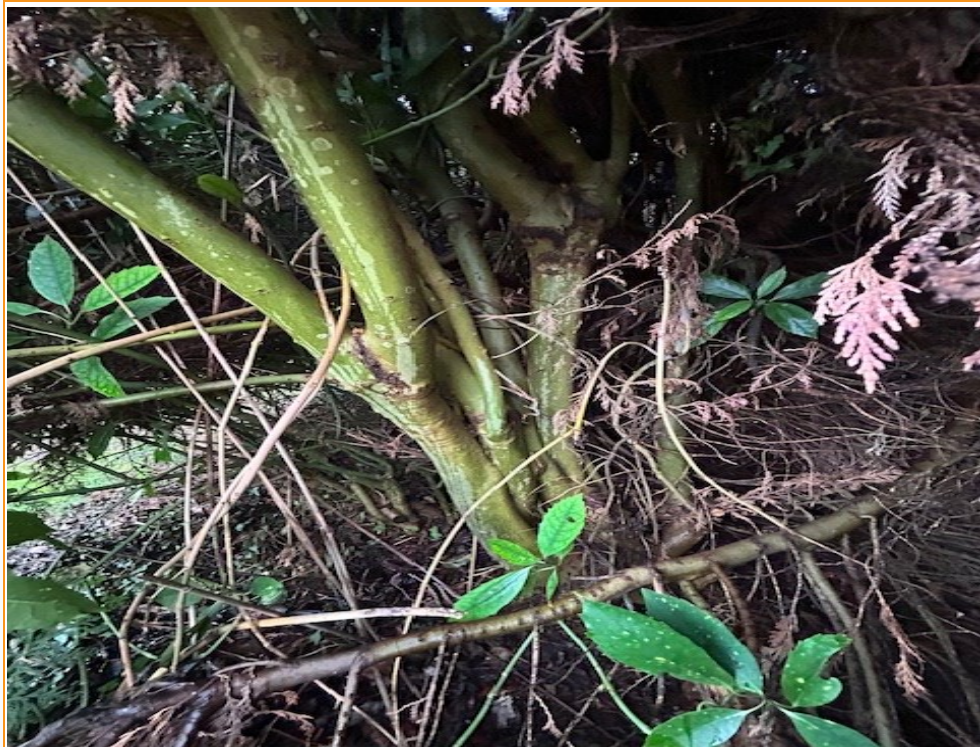
T4 - Ash

| Tree No: | Common Name | Age Class | Condition | Height (m) | Crown Spread (m) | Stem diam. (mm) | No. of Stems | Dist to bldg. (m) | Roots Implicated | Pruning History | Recommendation | Tree Work Constraints | Notes | Owner address | Owner |
|---|---|---|---|---|---|---|---|---|---|---|---|---|---|---|---|
| T4 | Ash | Early Mature | Good | 5.50 | 3.25 | 100 | 4 | 3.00 | Unavailable | Significant past works. | Fell and treat stump with eco plugs (broadleaved). | There are no restrictions to the site or to the tree - scheduled rates may apply. | Close proximity to AOD. | 8 Little Mead, Shalbourne, Marlborough, SN8 3QB | PH |

| Tree No: | Species | Works Required | CA | TPO | Ownership |
|---|---|---|---|---|---|
| T4 | Ash | Fell and treat stump with eco plugs (broadleaved). | Yes | No | PH |

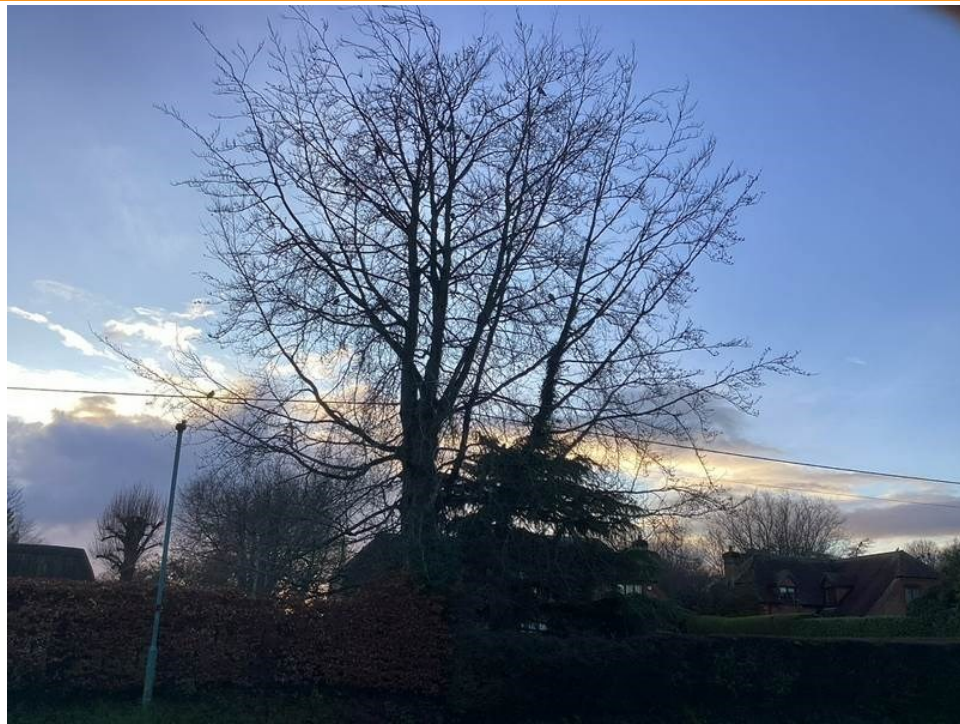
3rd party Alder outside expected influencing range

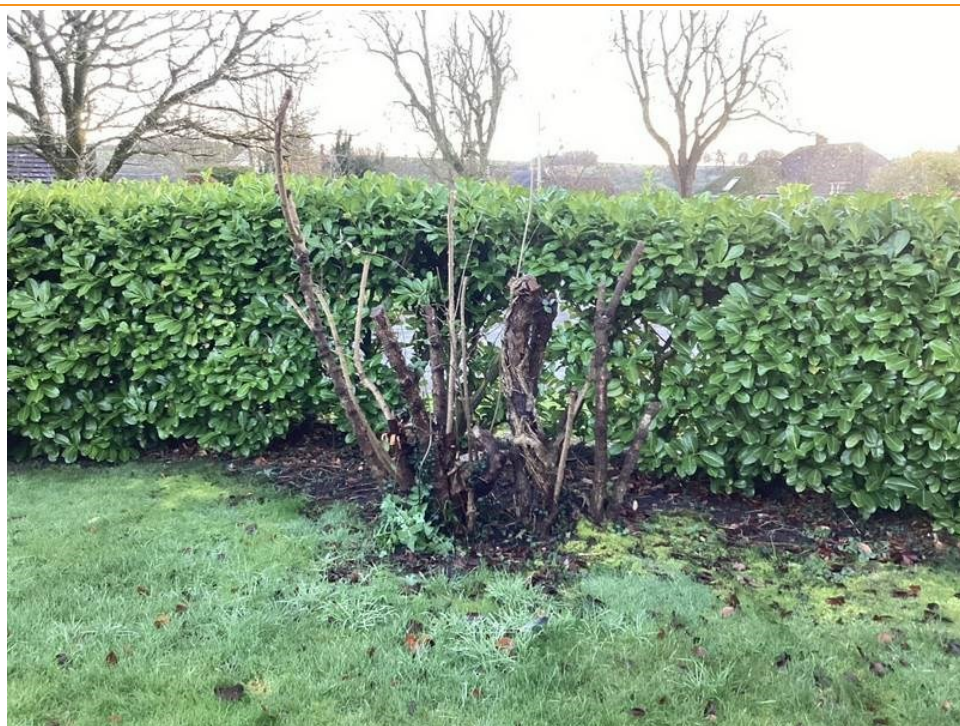
Dead/dying coppice
