# MAGPIES FARM MEYSEY HAMPTON

## **Structural Inspection Report**

**Document reference: 21.80-SR01**

**Barsby Structural Consultants Ltd**  
**Mike Barsby M.Eng (Hons), CEng, MStructE**

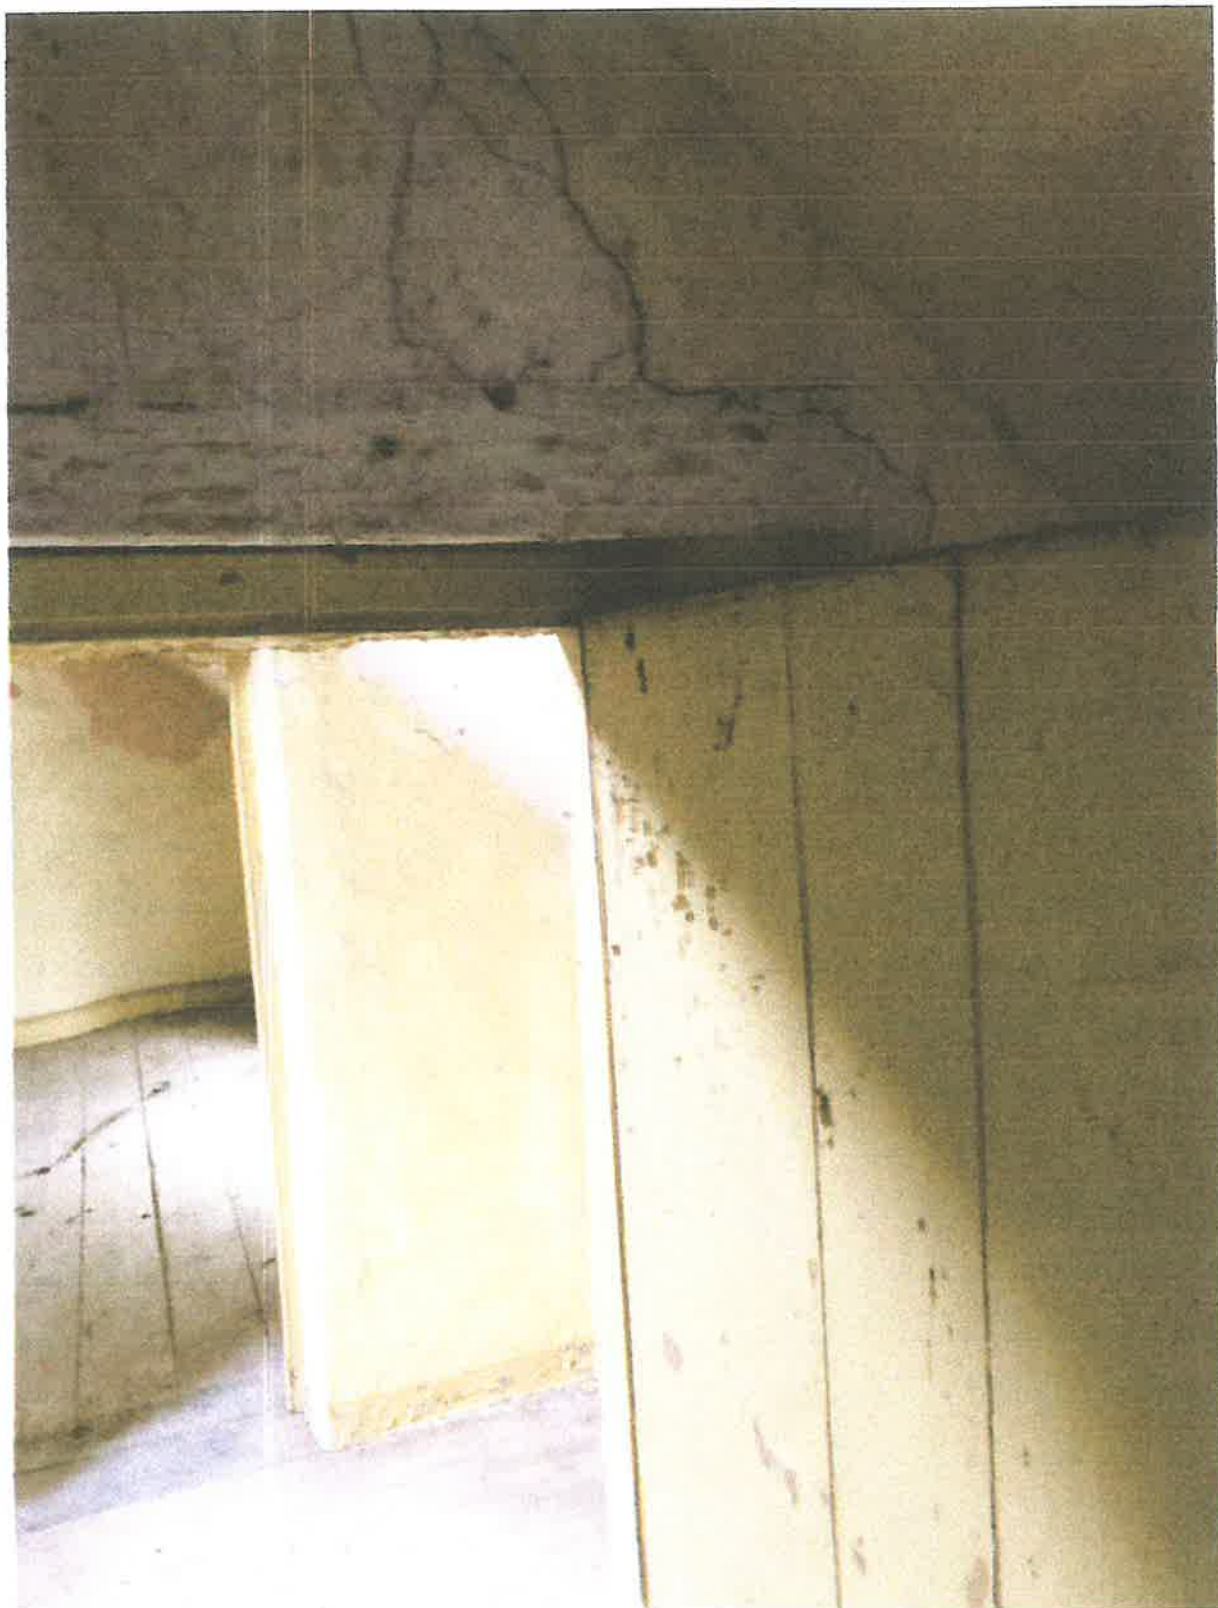
- It was noted that the eastern roof structure included collars between the common rafters forming a ceiling, yet the western half appeared to have these collars removed creating a fully vaulted roof structure. Cracking was noted to the spine wall on the western side of the stairwell, located at the junction between the roof and wall, along with some cracking above the small section of masonry over the door lintel.

The condition of the masonry to this part of the structure was in a sound condition, other than cracking observed to the second-floor spine wall, to the eastern side of the stairwell. This wall was directly adjacent the roof with missing ceiling collars and the cracking pattern appeared to be attributable to minor roof spread as a result of the missing tying restraint which would have been afforded by the ceiling collars. It is recommended that the collars to the eastern room be reinstated and the cracks over the door lintel be stitched with Helifix Helibars or similar to prevent cracking re-occurring at the weak junction. The cracking to the skirting to wall junction should be repaired as appropriate.

*Figure 1 - Cracking over internal door lintel at second floor spine wall of the original property*

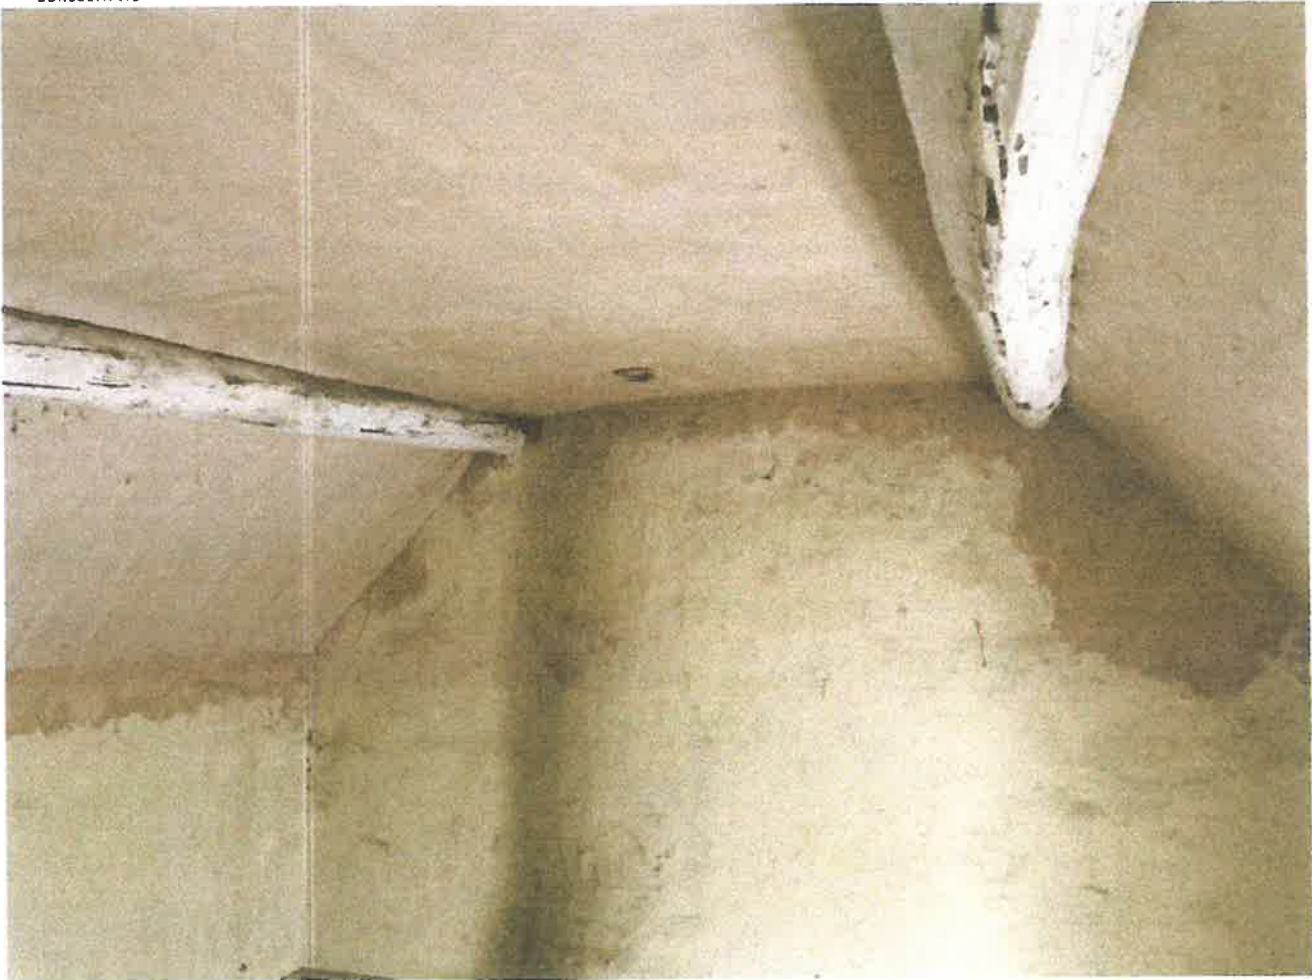
*Figure 2 - Ceiling present to western half of original roof*

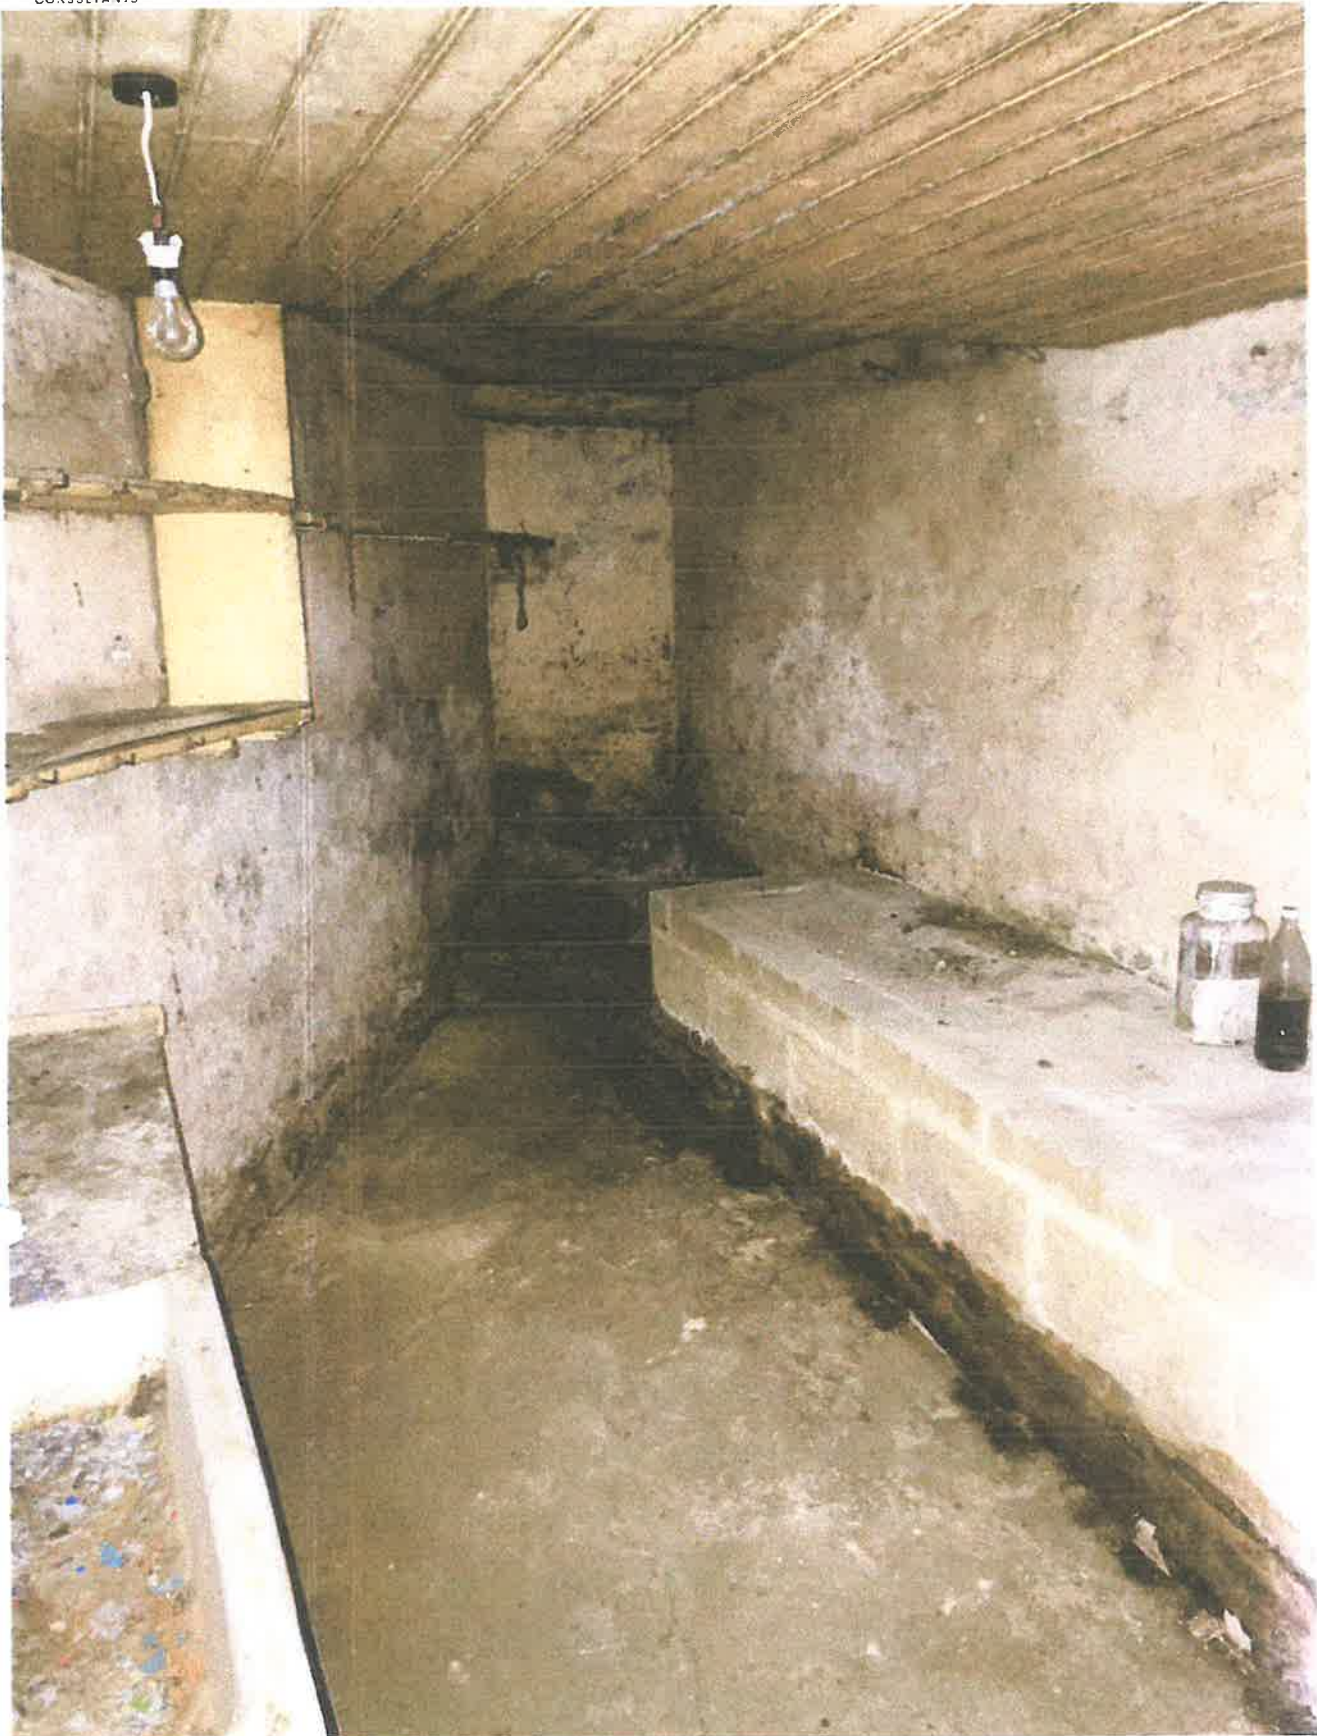
- There was an oak beam within the Utility Rooms western gable which appeared hollow when knocked. It was not clear what this beam was supporting.
- Extensive frost damage was noted to the brickwork feature reveals surrounding the windows. This had resulted in spalling of the brick face. Cracking was also noted over the ground floor window lintels suggestive lintel failure. The lintels here are splayed brick arches, which are common weak points.

**Figure 3 - Utility room showing barrel storage rack and oak lintel to room end in need of further inspection.**

The oak beam in the Utility should also be intrusively inspected during the renovation and replaced if it has deteriorated.

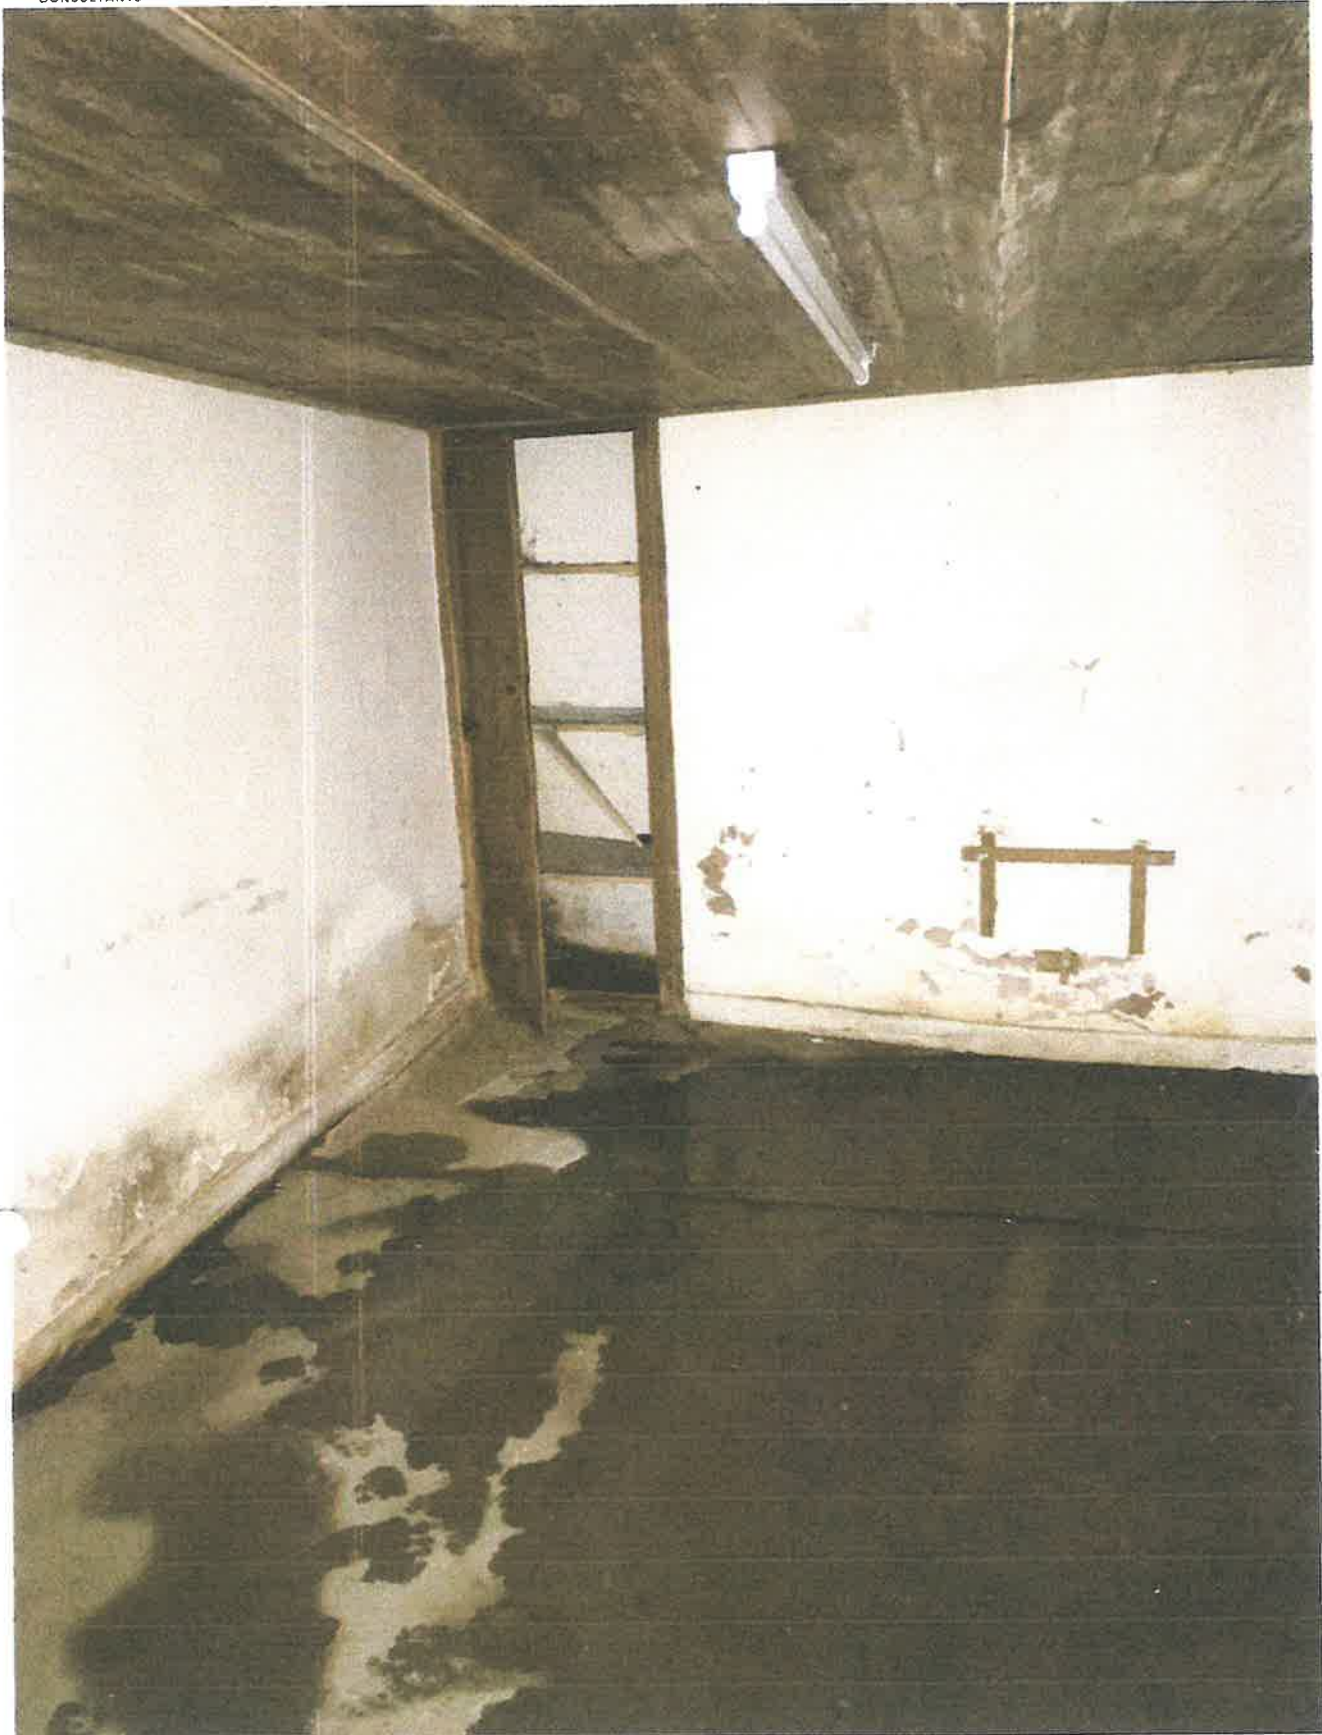
- An extensive section of roof tiles had been removed from the eastern end of this extension at eaves level of the roof. Water ingress was noted as a result through to ground floor level and as such it is possible some degradation of the first-floor structure and roof rafters may have occurred. Indeed, some damp staining was noted to the rafter feet over the bathroom.

- Significant dampness was noted at ground floor level under the missing roof tiles. This is likely to be attributable to extensive water ingress through the hole in the roof.

*Figure 4 - Damage to area under missing roof tiles.*

The missing roof tiles will clearly need to be addressed as part of the refurbishment. Inspection of the roof and floor structures immediately below the opening should also be made during the refurbishment and replacement joists and rafters installed where the originals have rotten. Indeed, some damp staining was noted to the rafter feet during the inspection which may have deteriorated these elements of the building. The floor structure appeared sound during the inspection.

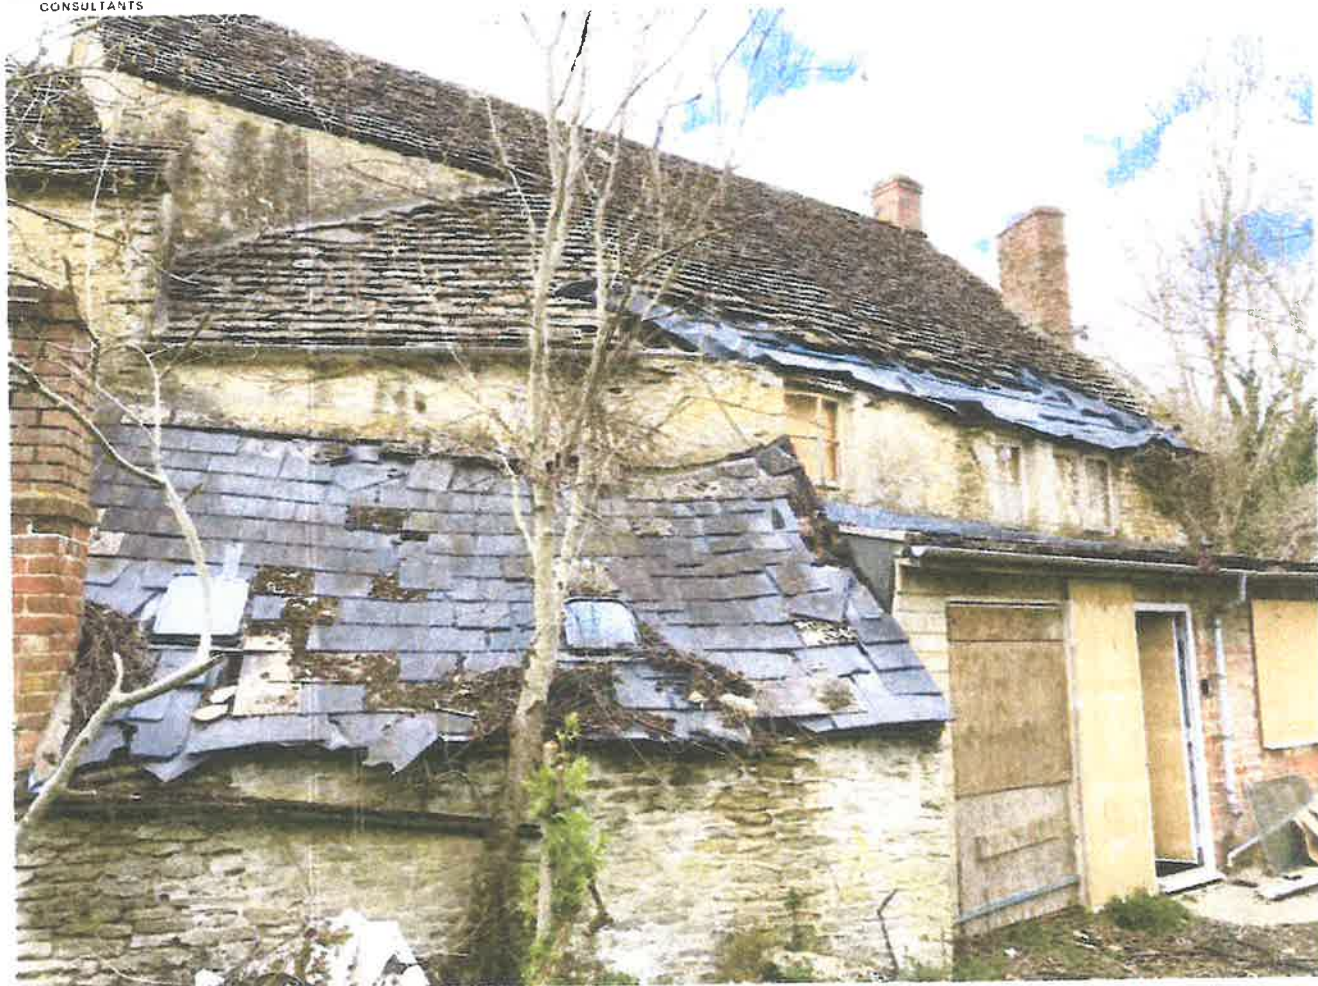
- These extensions to the property appeared to be of poor construction, with a mix of stone, brick and blockwork.
- The condition of this parts of the property was not recorded during the inspection as the client revealed plans to demolish these structures and replace with a modern extension backing onto the original two storey mono-pitched part of the property.

This part of the property is of poor construction and not in keeping with the original building fabric. The client has earmarked this part of the property for demolition and replacement with a suitable modern extension; this appears appropriate given the condition of this element of the building.

*Figure 5 - Rear elevation showing poorly constructed single storey extensions and missing roof tiles.*

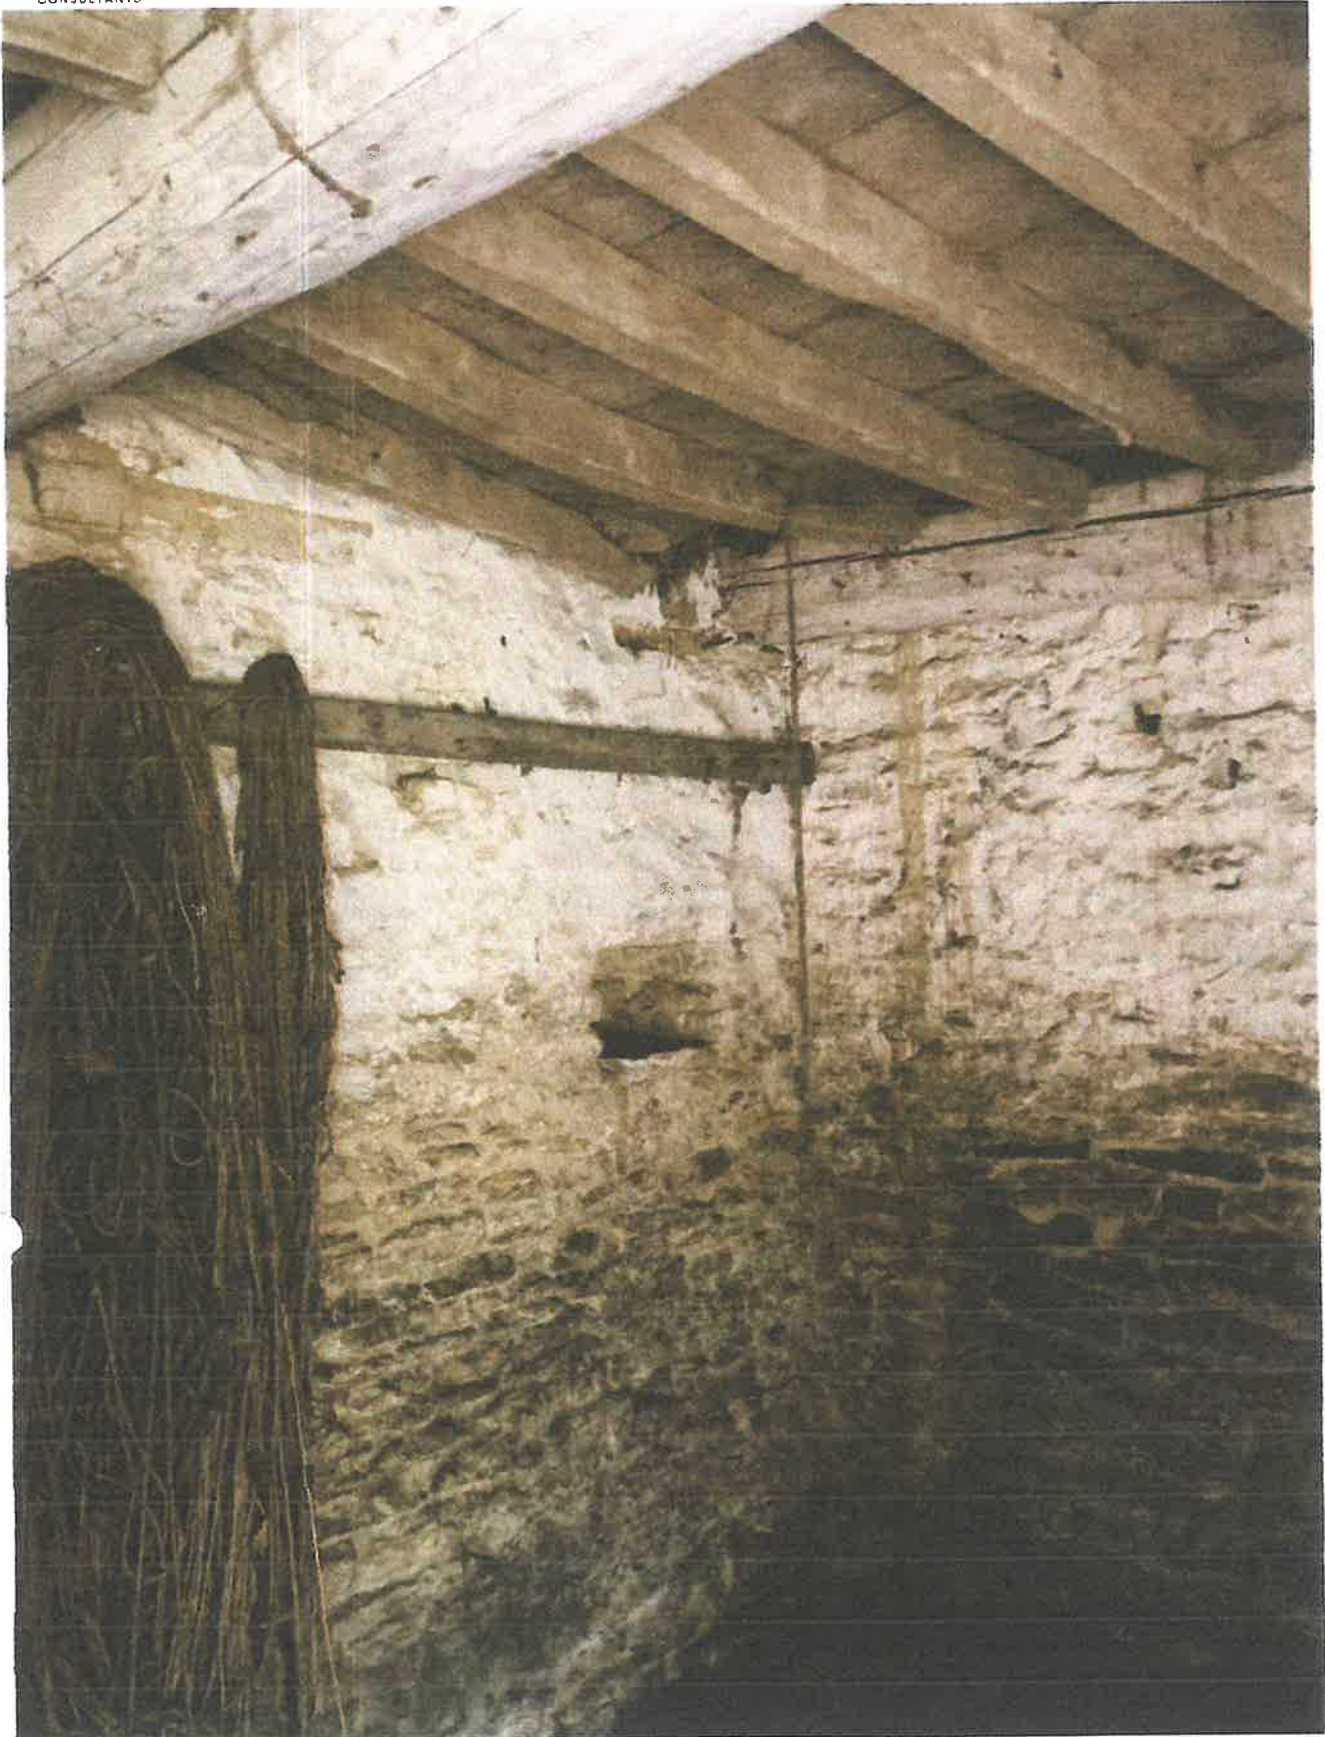
- The condition of the masonry to the farm store appeared in a sound condition, with no obvious signs of cracking or movement.
- The first-floor joists had deflected causing a significant bow in the first-floor structure. These joists were supported on a central hardwood chamber beam spanning from north to south through the centre of the ground floor and supported on the external walls. The condition of the chamber beam was good; however, the joists had some signs of rot, with a few of the joist's bearings completely rotten away.

*Figure 6 - Farm store showing chamber beam and sagging joists, noting rotten and split joists.*

This part of the property has masonry construction in a sound condition, however attention to the timber first floor will be required during the refurbishment, including replacement of rotten timbers with new wood. The chamber beam to the first floor appeared in a sound condition and should be retained as part of the works, to be sympathetic to the original construction.

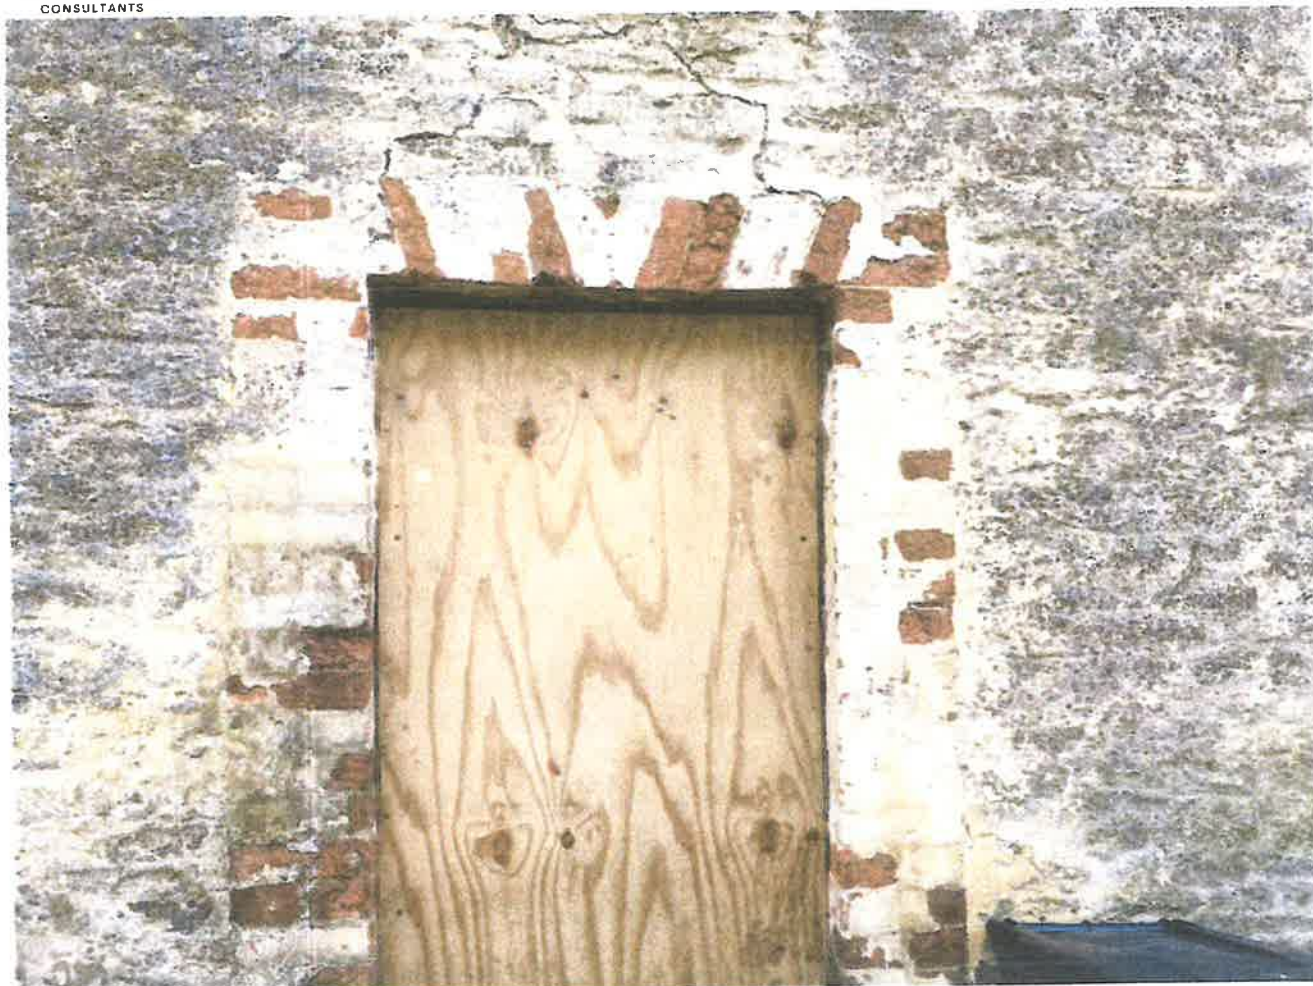
***Figure 7 - Frost damage to brickwork feature limb and revealed, along with cracking to stone above limb.***

Whilst the frost damage to the brick reveals and lintels is not of immediate concern, it does appear to have progressed sufficiently to allow the stone above to drop creating cracks. This is likely to deteriorate further if no intervention is made. Given the building is listed, any remedial measures should be sympathetic to the original construction and therefore the Listed Building Officer should be consulted on remedial measures. Painting of the brick arches with a suitable paint (as previously attempted) or hydrophobic coating will protect the bricks from further frost damage, however this may not resolve the cracked stone above due to the brick arch lintel failure. It would be more permanent to carefully prop and take down the brick arch, then re-build using reclaimed masonry units to form a new brick arch similar to the original construction. A relieving lintel could be installed to the stone above using either a single leaf lintel concealed in the wall or using Helibars.

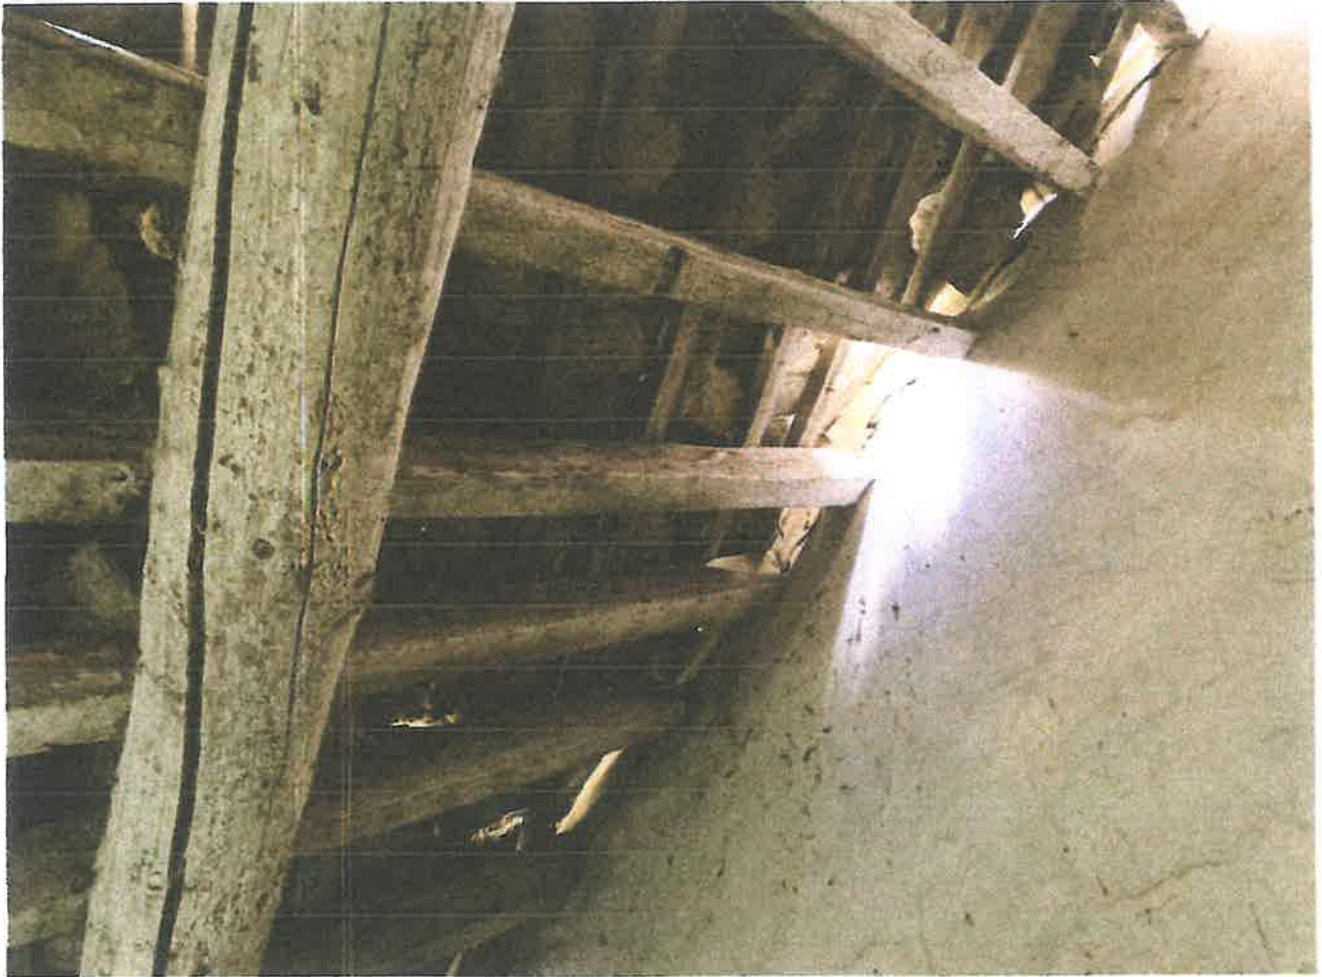
- No further masonry defects were noted as being visible during the inspection.
- Inspection of the mono-pitched roof revealed some movement of the upper rafters, where they abutted the original part of the 1830 property. This movement had allowed the rafters to drop down the face of the wall, with the worst movement at the western end corresponding to the location of hipped section of the roof structure.

1. The roof structure of the mono-pitched roof was not adequately support at ridge level back onto the original part of the property allowing the rafters to slide down the face of the wall, resulting in a lateral thrust at the lower eaves plate and thus tension on the joint between the extension and the original building masonry.
2. The extension has seen minor settlement, which has allowed the structure to overturn and pull away from the original part of the property. This has allowed the rafters of the mono-pitched roof to settle and top of the rafter to slide down the face of the original rear wall of the 1830 section of the building.

**Figure 8 - Rafter junction of two storey mono-pitched roof to original building showing vertical slip of rafters down the face of the wall.**

Once a trial hole has been completed, the cracking should be stitched using Helifix crack stitching details for rubble filled walls. The rafters should also be adequately supported at the higher end using a timber wall plate resin anchored to the original rear wall of the 1830's building to prevent the rafter slipping further.

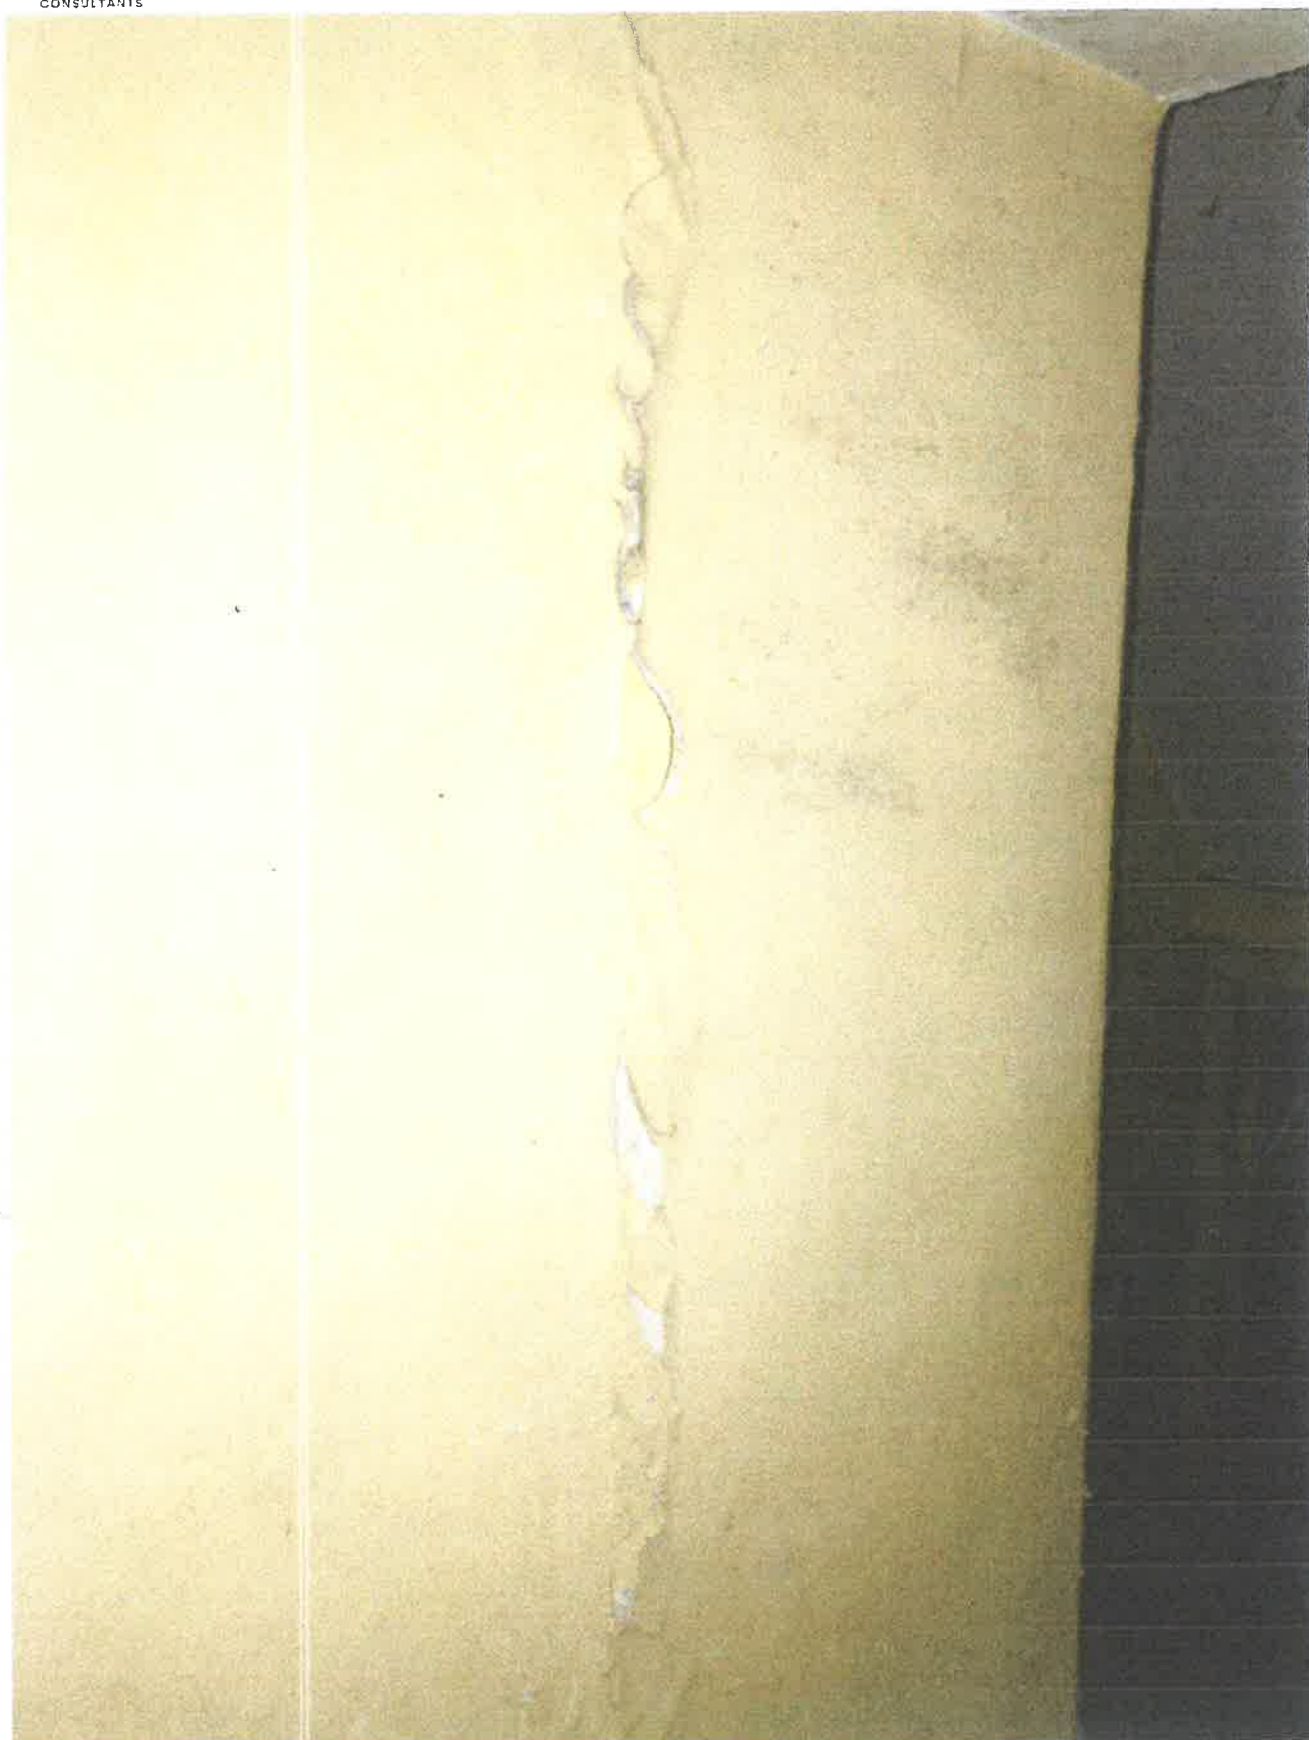
- An inspection of the two-storey extension immediately to the rear of the original property revealed some cracking up the junction between the original part of the building and that of the extension in the centre of the building. The cracking was only noted to the upper floor level and was marginally wider at the top of the wall.

The cracking to the joint between the original part of the building and this extension is characteristic of the eaves line of the extension moving laterally relative to the original 1830's building, creating a crack at the weak joint. This could be the result of one of two potential issues.

It should also be noted that no cracking was observed to the end walls of the extension, and therefore if settlement is an issue, it would be localised to the centre section of this two-storey extension. This also supports conclusion 1 above being more likely, whereby the lateral movement as a result of roof thrust would be worst at the centre of the extension, where restraint is weakest.

*Figure 9 – crack down junction between original and two storey extension.*

It was not possible to ascertain the cause during the inspection and further investigation would be required to rule out settlement of the extension. Given the aspect ratio of the extension height to depth, a minor settlement would have resulted in an amplified movement at the roof level laterally. Therefore, the amplitude of the cracking noted would suggest any settlement would not currently be considered extensive and in need of immediate attention. It would be prudent however to carry out a trial hole to the extension during the refurbishment to rule out poor foundation construction, prior to carrying out expensive re-decoration.

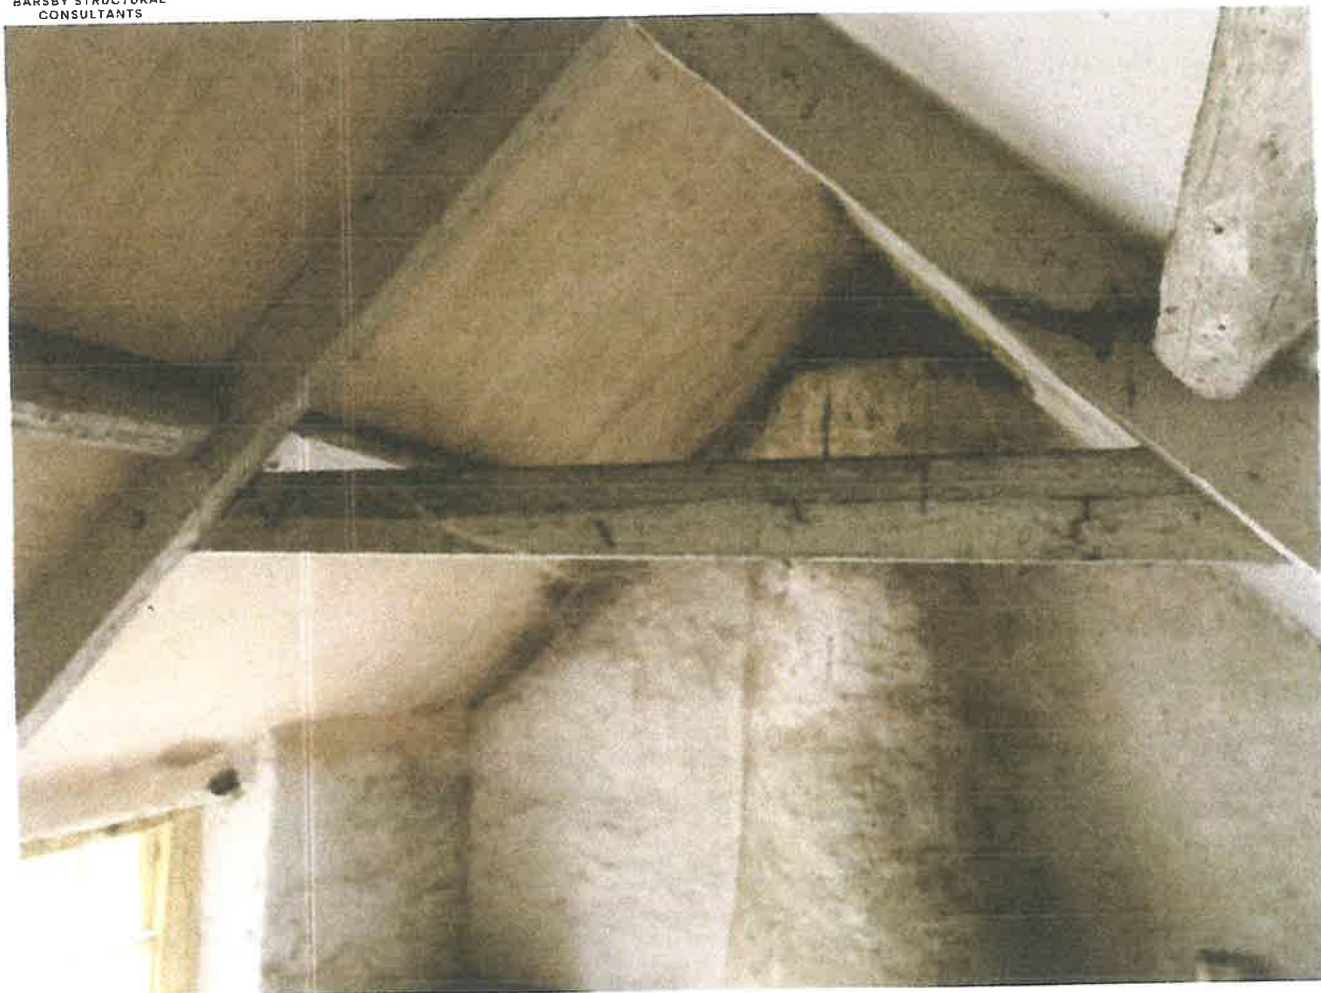
*Figure 10 - Eastern half of main roof showing truss and missing ceiling collars.*

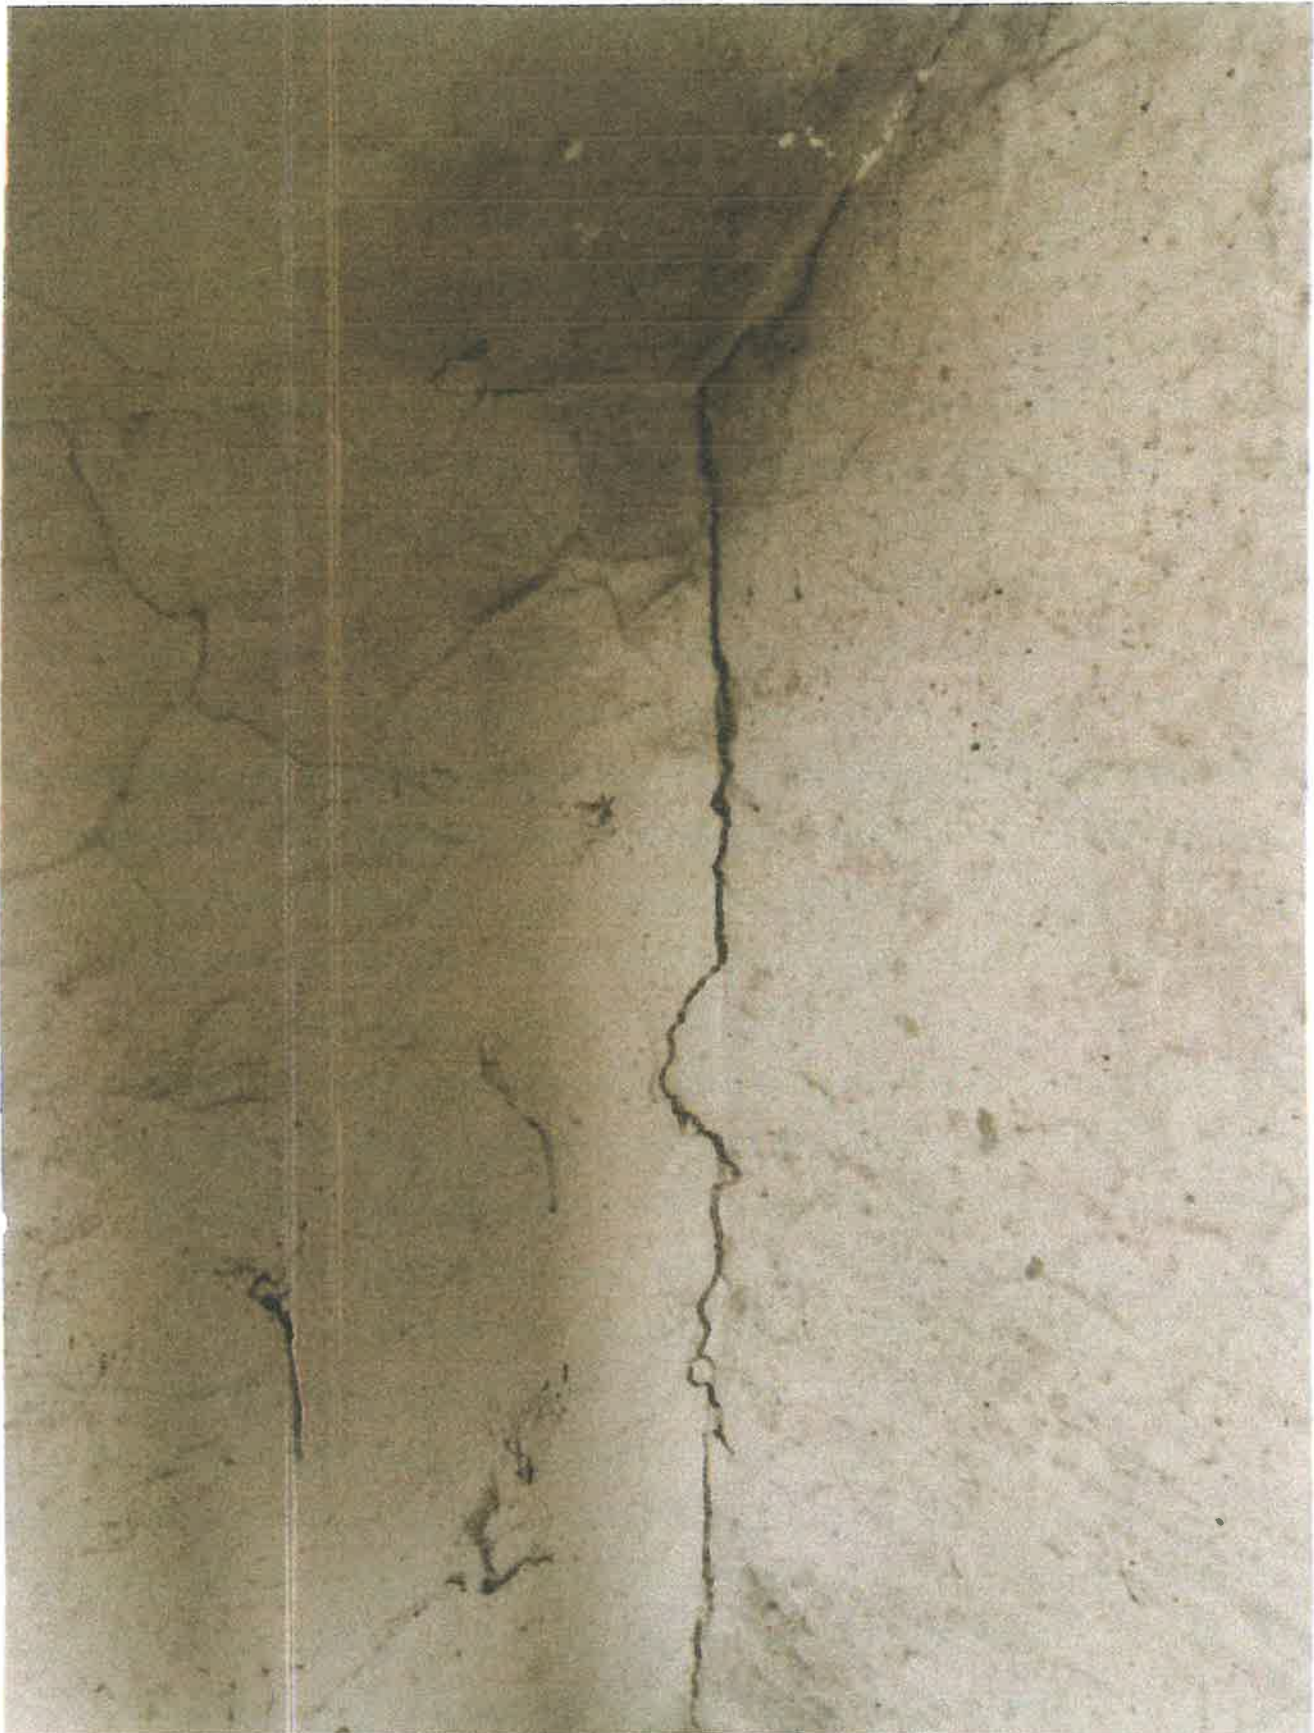
*Figure 11 - Cracking down junction of walls and skeling of second floor.*
