LBC & PLANNING

Stable 1 & Tractor Shed  
Manor Farmhouse [SN10 5UE]      **22-03.02-E41**

Existing Section AA

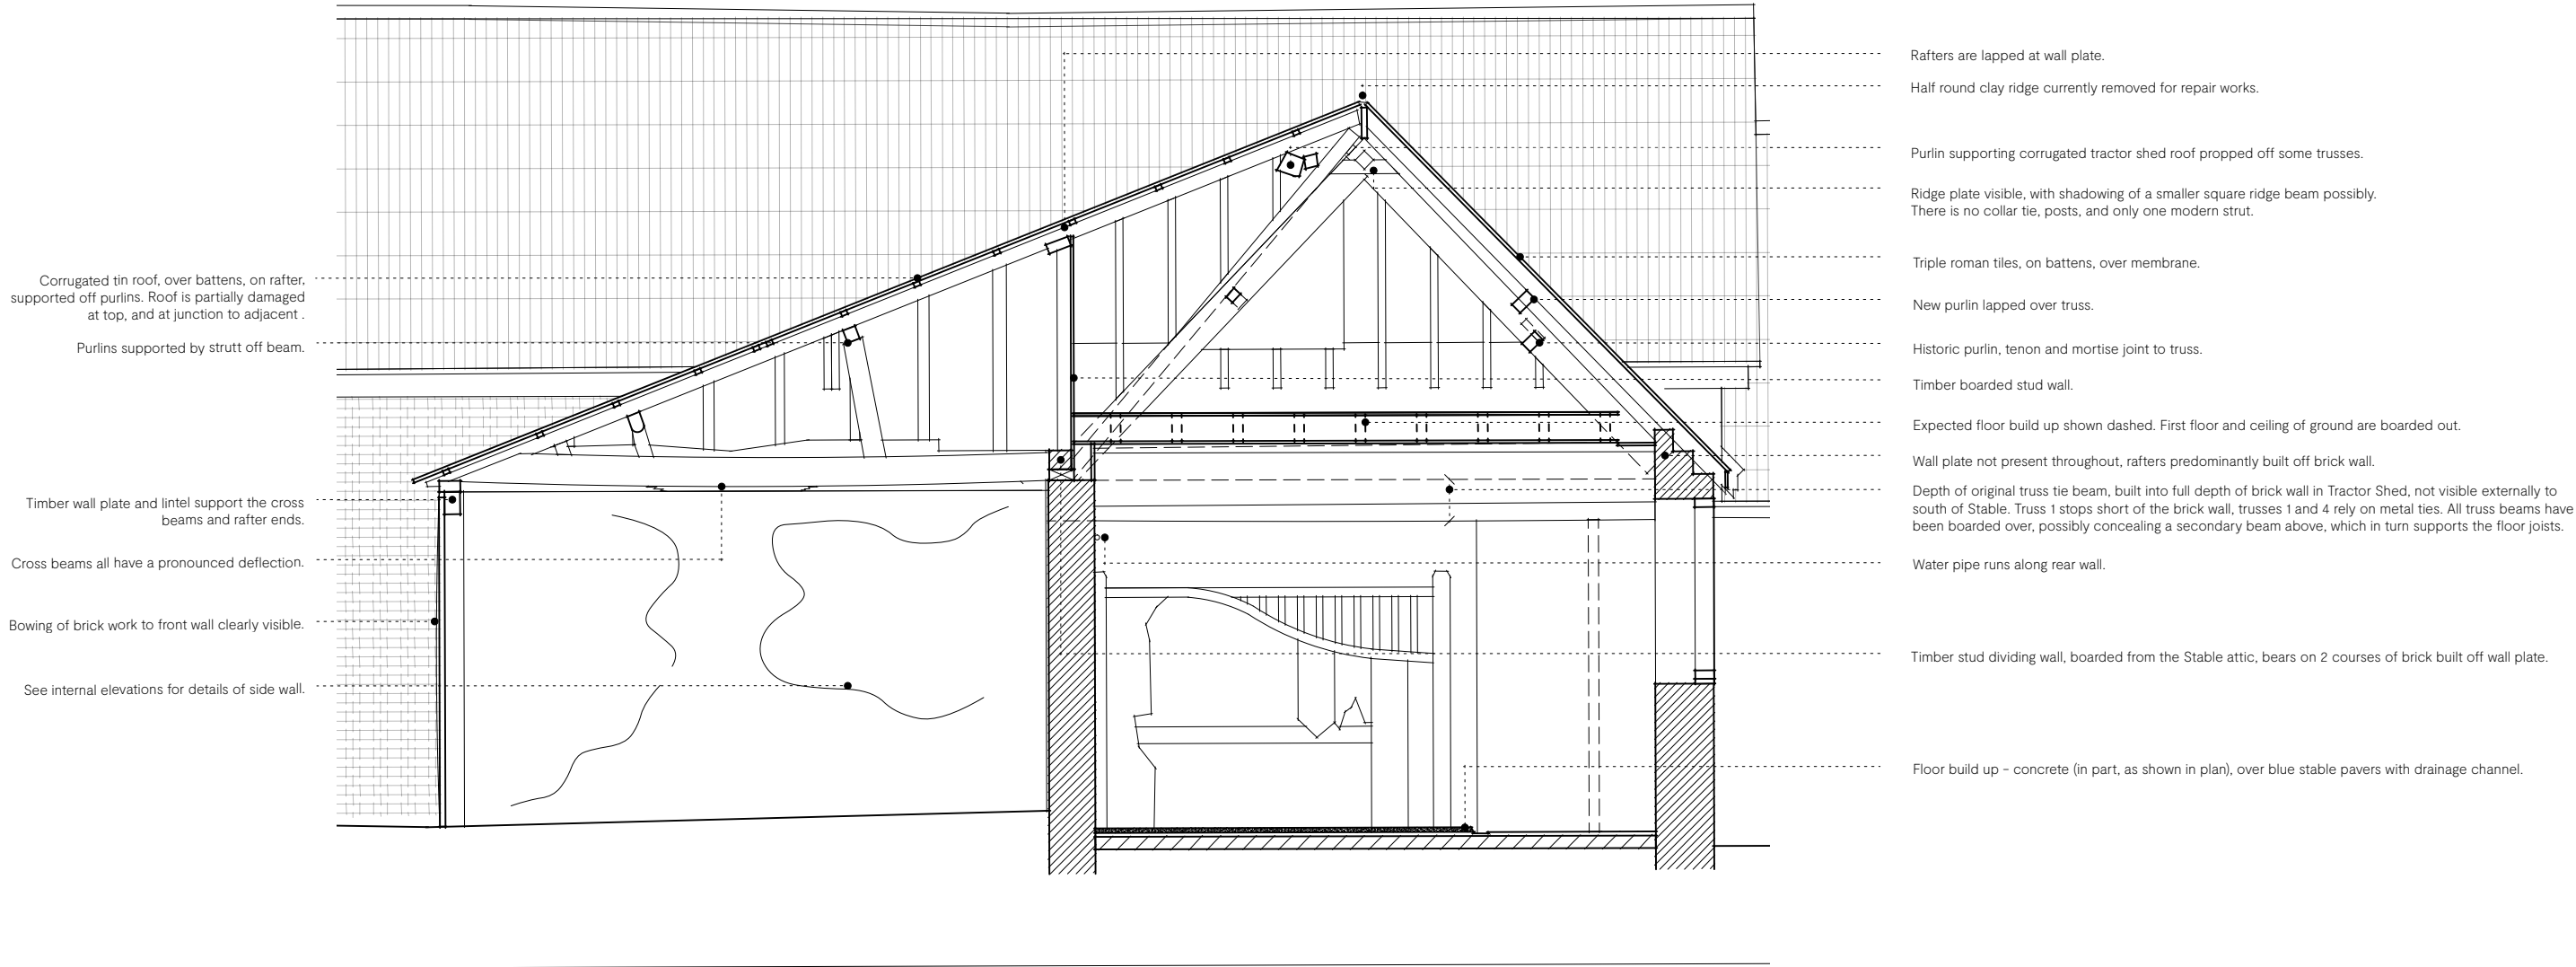
Corrugated tin roof, over battens, on rafter, supported off purlins. Roof is partially damaged at top, and at junction to adjacent.

Purlins supported by strutt off beam.

Timber wall plate and lintel support the cross beams and rafter ends.

Cross beams all have a pronounced deflection.

Bowing of brick work to front wall clearly visible.

Rafters are lapped at wall plate.

Half round clay ridge currently removed for repair works.

Purlin supporting corrugated tractor shed roof propped off some trusses.

Ridge plate visible, with shadowing of a smaller square ridge beam possibly. There is no collar tie, posts, and only one modern strut.

Triple roman tiles, on battens, over membrane.

New purlin lapped over truss.

Historic purlin, tenon and mortise joint to truss.

Timber boarded stud wall.

Expected floor build up shown dashed. First floor and ceiling of ground are boarded out.

Wall plate not present throughout, rafters predominantly built off brick wall.

Depth of original truss tie beam, built into full depth of brick wall in Tractor Shed, not visible externally to south of Stable. Truss 1 stops short of the brick wall, trusses 1 and 4 rely on metal ties. All truss beams have been boarded over, possibly concealing a secondary beam above, which in turn supports the floor joists.

Water pipe runs along rear wall.

Timber stud dividing wall, boarded from the Stable attic, bears on 2 courses of brick built off wall plate.

Floor build up - concrete (in part, as shown in plan), over blue stable pavers with drainage channel.
