**WILDING ARB**

## Sonic Tomography Survey

**Site Location:** 6, Maur Close,  
Chippenham, Wiltshire,  
SN15 2NJ

**Date:** 02/12/2025

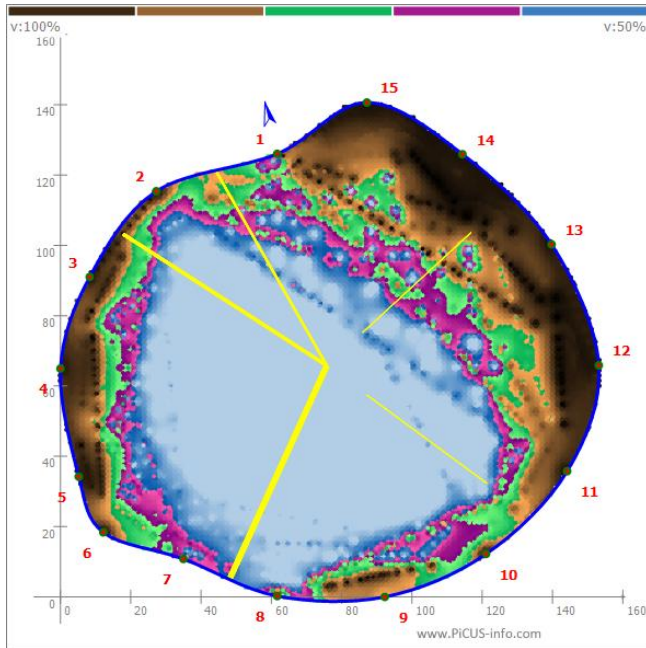
**FIG 1**

Upon reviewing the imagery from the picus sonic tomogram (See Fig1.) It would appear that this oak has succumbed to the effects of the *Ganoderma*. Displayed by the very large blue colouring on the image which indicates potentially compromised timber via slower sound wave detections. The yellow lines on the imagery would suggest a sound barrier i.e. a potential cavity of which the sound has been unable to travel through and thus not detected by other sensors.

In conclusion to the observations and tests made it would appear that this mature oak is in a state of decline. The heavy handed management and fast acting fungi may have attributed to this. The apex of this apparent decline is centred in the wellbeing of the buttresses and large supporting stem.

Having reviewed the information obtained and taking into account the size of this tree and its proximity to targets and neighbouring properties the recommendation is to have this tree removed within 6 months. This timeframe should allow for it to be worked on before becoming too compromised to do so.

Another option to retain ecological and sentimental value would be to leave a monolith at no higher than 3 metres.

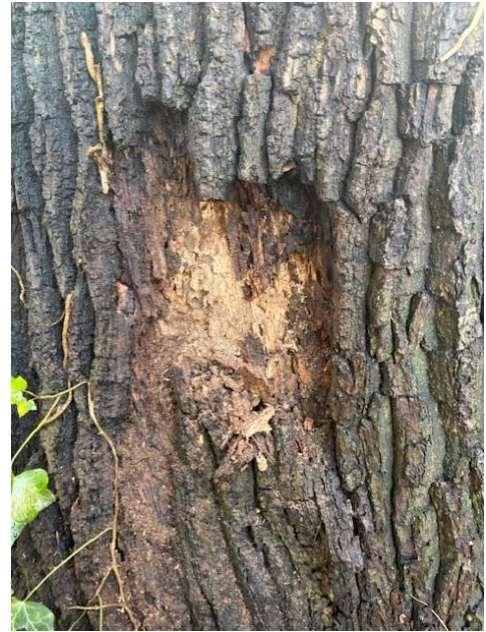
**FIG 2**

Towards the lower stem and base of this tree a multitude of defects become apparent. It seems there is significant bark flaking on the N side of the stem underpinned by a softening cambium layer. Accompanied by a multitude of small holes this is very likely to be the work of a species of boring beetle. (See Fig 2.)

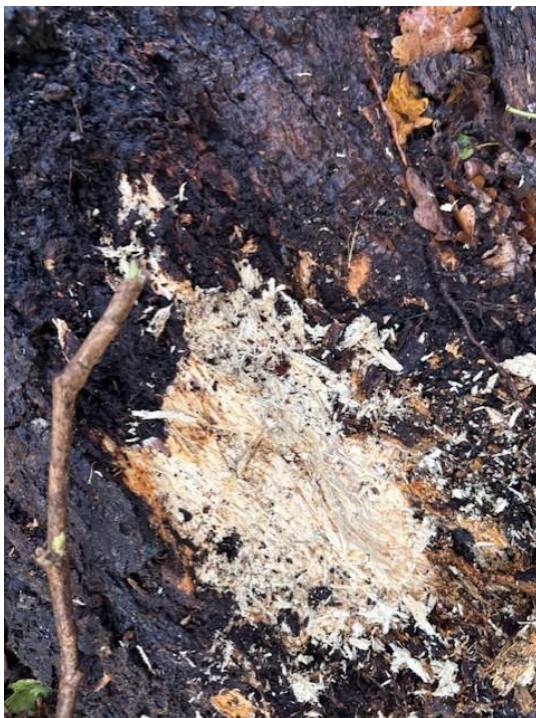
**FIG 3**

Upon further inspection there is also evidence of isolated white rot on 2-3 of the flared buttresses on N side of the tree. (See Fig 3.) The sole cause of this is unclear but it is potentially damning for the future of the tree.

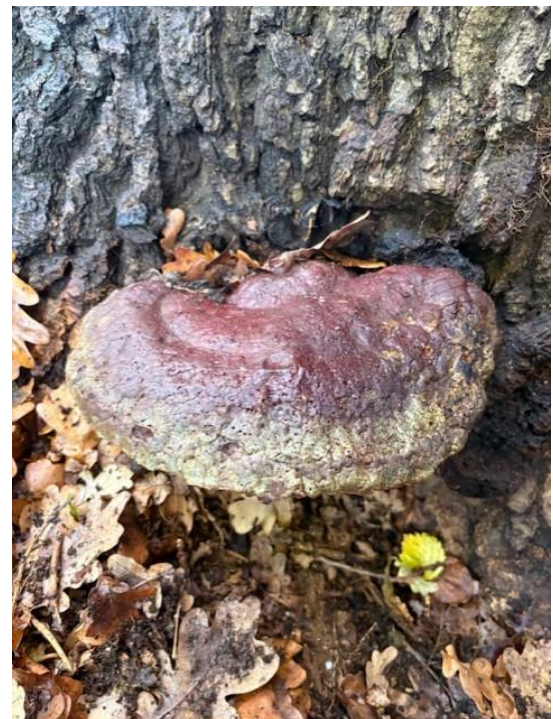
**FIG 4**

One of the most striking features that occupies the base of this tree is the presence of a multitude of old and new bracket fungi. (*Ganoderma Resinaceum*). With a particularly large bracket found between measuring points 7 & 8 (See Fig 4.)

*Ganoderma Resinaceum*: A parasitic, white rot fungi. This fungus has the potential to cause basal cavities. It strips the lignin from the timber leaving a structurally compromised makeup of the internal wood.
