CA7317.02

14 August 2025

## **The Barns, Pound Farm, Wiltshire, SN15 3RG.**

### **Purpose of the Report**

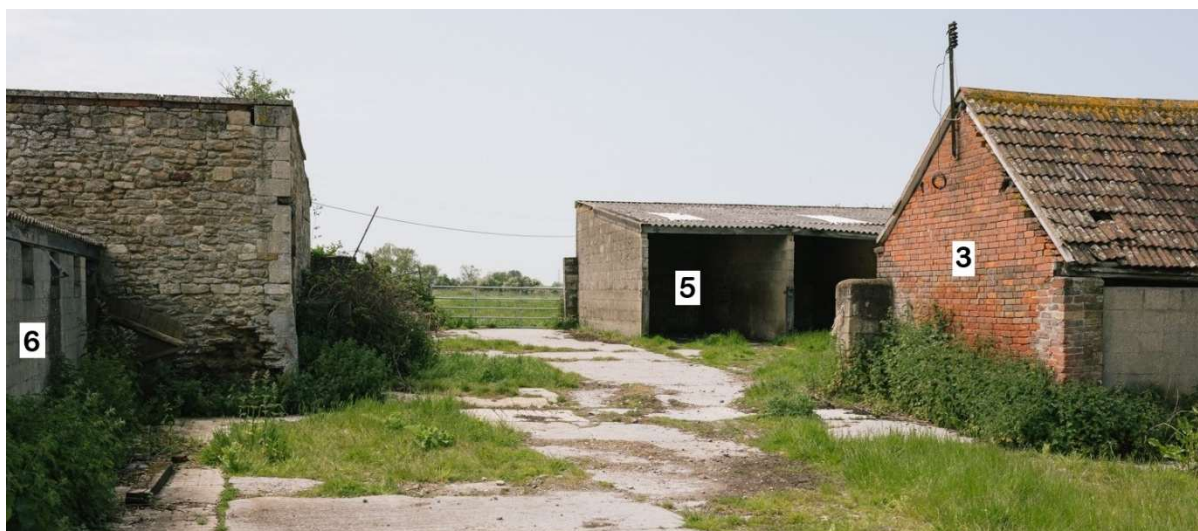
Photo 1: View into the courtyard

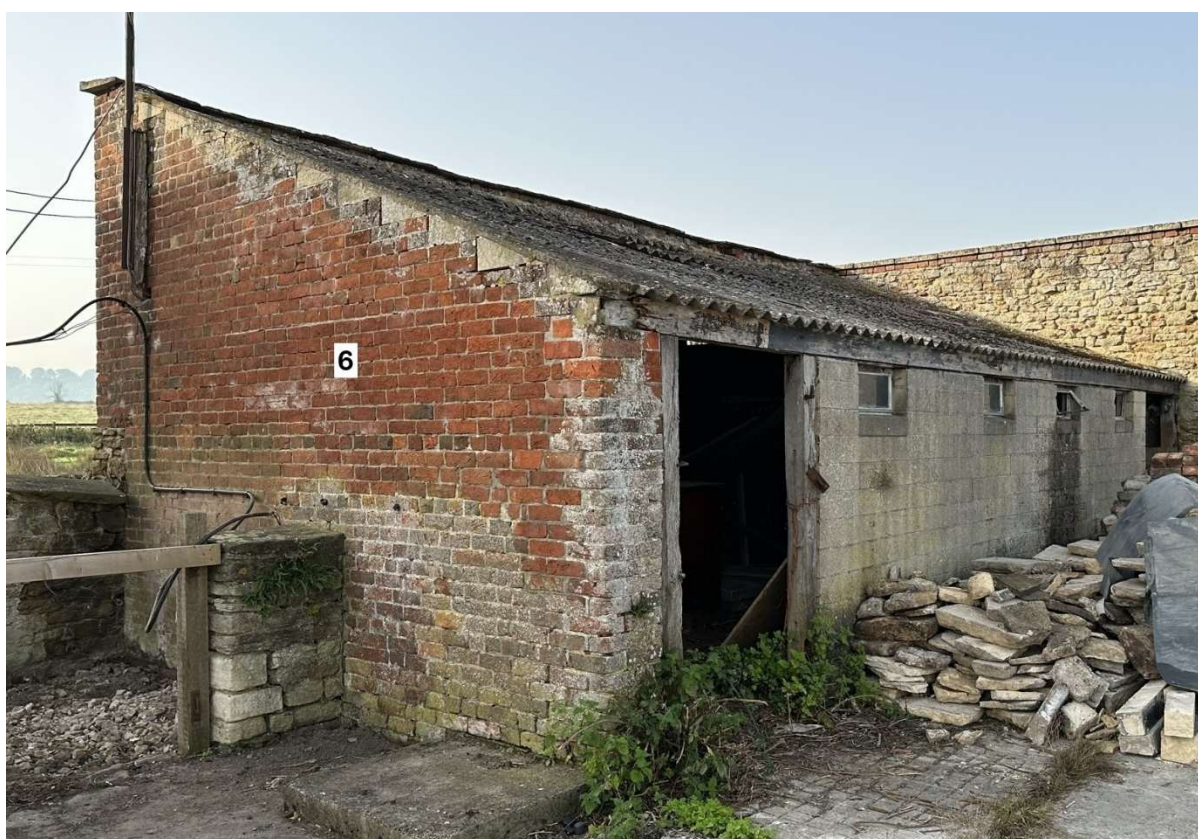
Photo 2: Barn 6

Check the quality of the existing concrete floor – by trial holes and retain or replace as agreed with the Structural Engineer.

Any new concrete floor to be 150 mesh reinforced concrete on DPM on 150 sand blinded granular hardcore. Install DPM and insulate over.

Retain wall structures. Allow to upgrade 100 thick walls to an acceptable grade for a external wall – cladding as required.

Rake out and repoint brickwork walls with deep lime mortar. Inspect blockwork for any necessary repairs and allow to lime render the retained existing blockwork where appropriate.

Construct new blockwork walls internally and tie to existing masonry.

Take down the existing single pitched roof structure and replace with an insulated roof to the same fall.

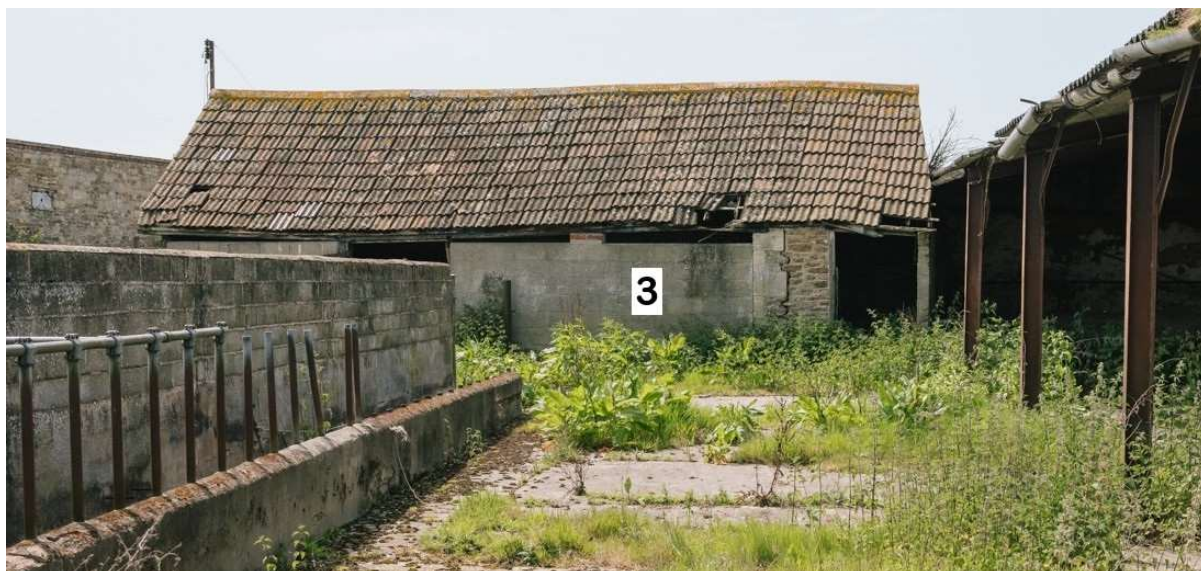
The roof areas comprise corrugated sheets supported by timber purlins and in barn 4, these are supported by large timber roof trusses. The exception is barn 3 which has clay roof tiles. Some of the roof areas have partly collapsed although this mainly applies to the heavier clay tiled roof.

A structural survey of the roof to barn 3 will be required to see if the roof structure can be retained without strengthening. As it carries heavier roof tiles, it's possible that it can be retained with hopefully only limited local strengthening.

Photo 3: Barn 3 (view from the top of the page)

Check the quality of the existing concrete floor – by trial holes and retain or replace as agreed with the Structural Engineer.

Any new concrete floor to be 150 mesh reinforced concrete on DPM on 150 sand blinded granular hardcore. Install further DPM and insulate over.

Retain wall structures. Rake out and repoint brickwork walls with deep lime mortar. Inspect blockwork for any necessary repairs and allow to lime render the retained existing blockwork.

Construct new blockwork walls internally and tie to existing masonry.

Retain roof frame structure.

Replace damaged rafters and make good any displaced supporting structure. Inspection to confirm quantity on site.

Install new roof insulation and roof coverings including replacing the existing roof tiles and sarking felt.

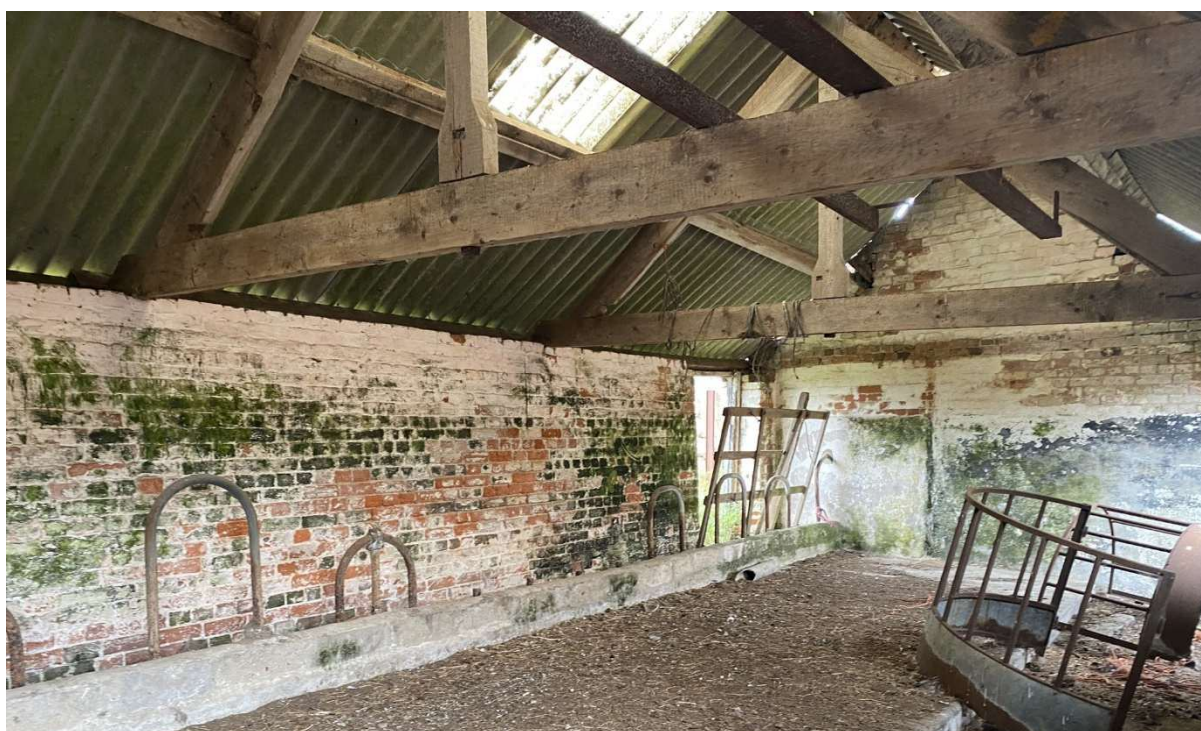
Barn 4 has a central ridge with parallel purlins all of which are supported on existing timber trusses. We will need to analyse the construction to see if the existing timber trusses have the capacity to support a modern roof construction. It's very unlikely that these trusses originally supported just the existing corrugated roofing and so it is possible that the trusses can be retained without strengthening..

Photo 4: Barn 4 looking toward 3

Retain roof truss structure but strip away the corrugated roof covering (check for asbestos).

Allow for the timber trusses to be checked by structural engineer if the new roof covering is any heavier.

Strengthen trusses if required and add new insulated roof decking.

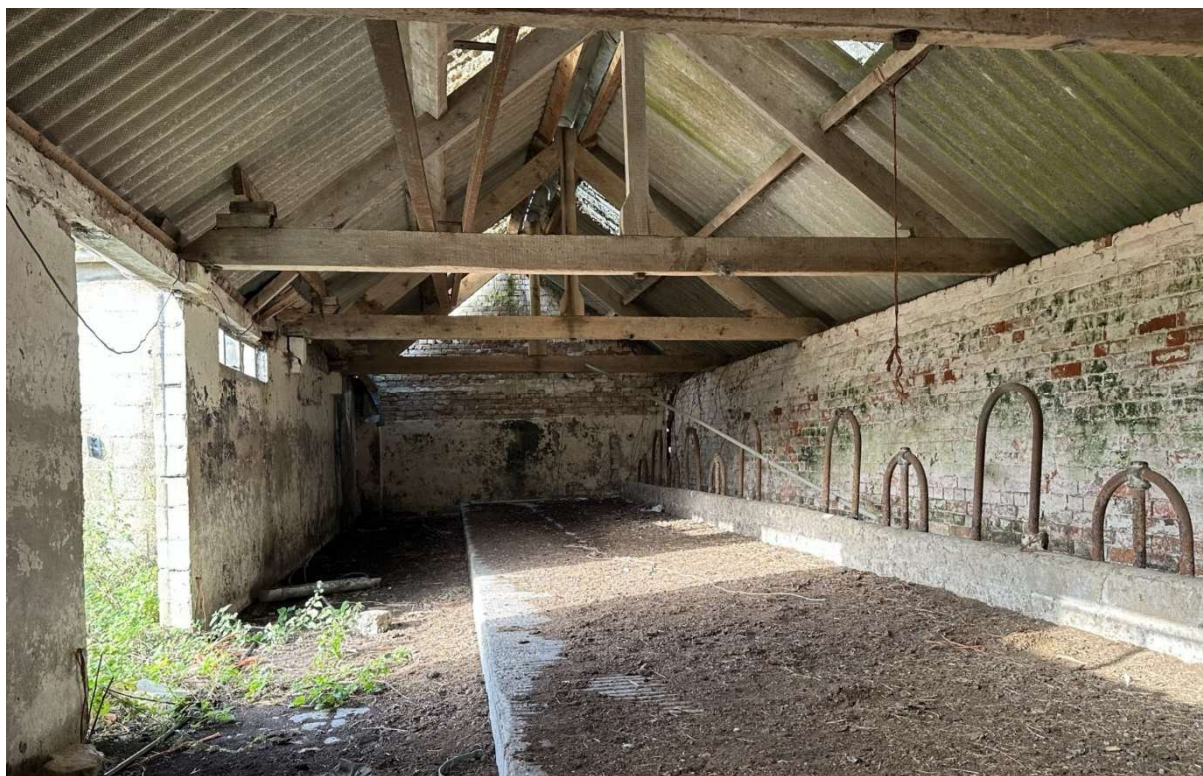
Photo 5: Barn 4 looking towards 3

Retain concrete floor but extend it as necessary (see LH photo 5), install DPM and insulate over.

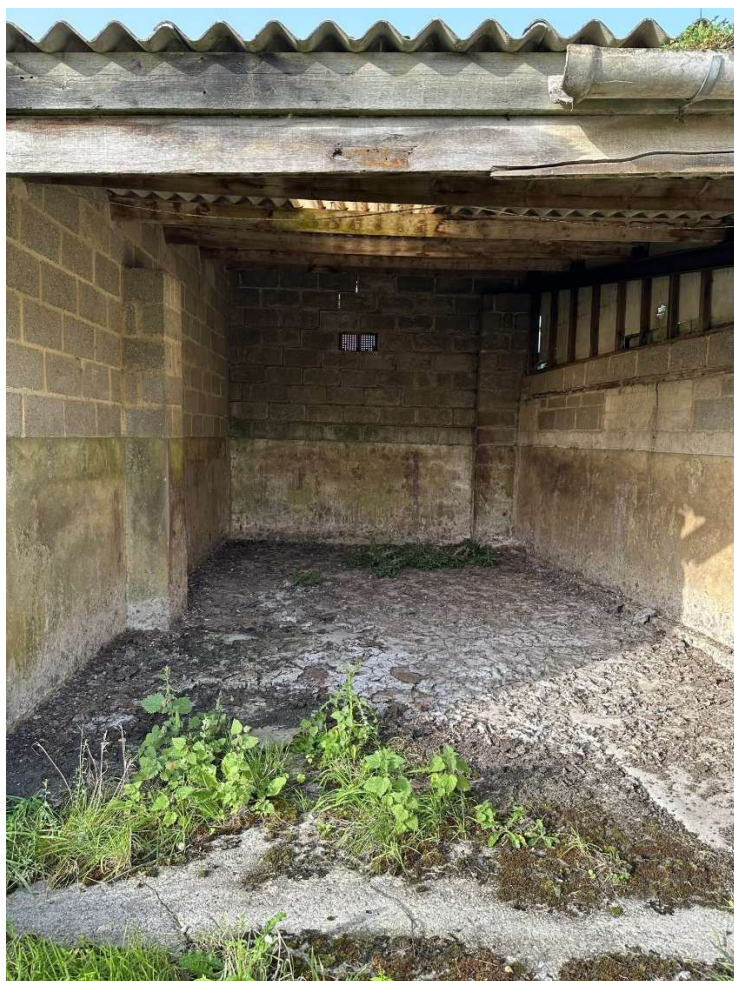
The single properties surround a small courtyard and are constructed with brickwork walls of varying quality. They have been made good in the past with patch brickwork repairs or using a more modern blockwork infill. The blockwork infill to barn 3 (photo 6) forms separating walls which support the roof purlins. These blockwork loadbearing walls indicates that this unit is more recent or that it has been substantially rebuilt. The condition of the brickwork suggests that these repairs have been carried out at different times.

Photo 6:  
Looking into  
barn 5

Check the quality of the existing concrete floor – by trial holes and retain or replace as agreed with the Structural Engineer.

Any new concrete floor to be 150 mesh reinforced concrete on DPM on 150 sand blinded granular hardcore. Install DPM and insulate over.

Retain external wall structures. Allow to upgrade 100 thick walls to an acceptable grade for a external wall – cladding as required.

Rake out and repoint brickwork walls with deep lime mortar. Inspect blockwork for any necessary repairs and allow to lime render the retained existing blockwork where appropriate.

Take down the existing shallow pitched roof structure and replace with an insulated roof to the same fall.

Construct new blockwork walls internally and tie to existing masonry.
