CA7317.01

02 April 2025

## **The Granary, Pound Farm, Wiltshire, SN15 3RG.**

### **Purpose of the Report**

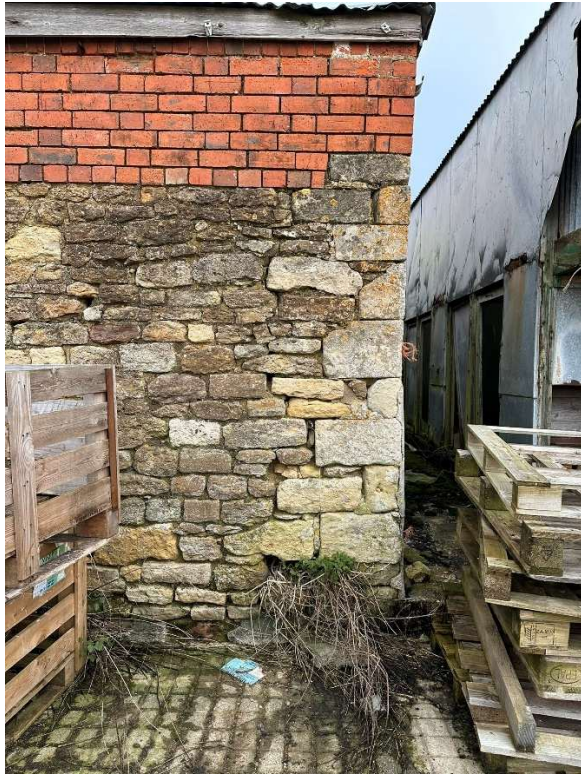
1 Return wall to the gable

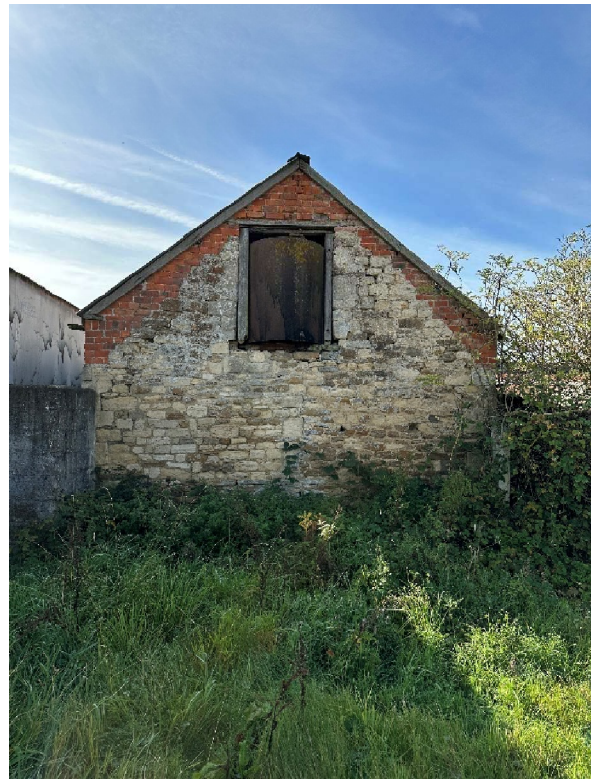
2 Gable end – the short leg of the L

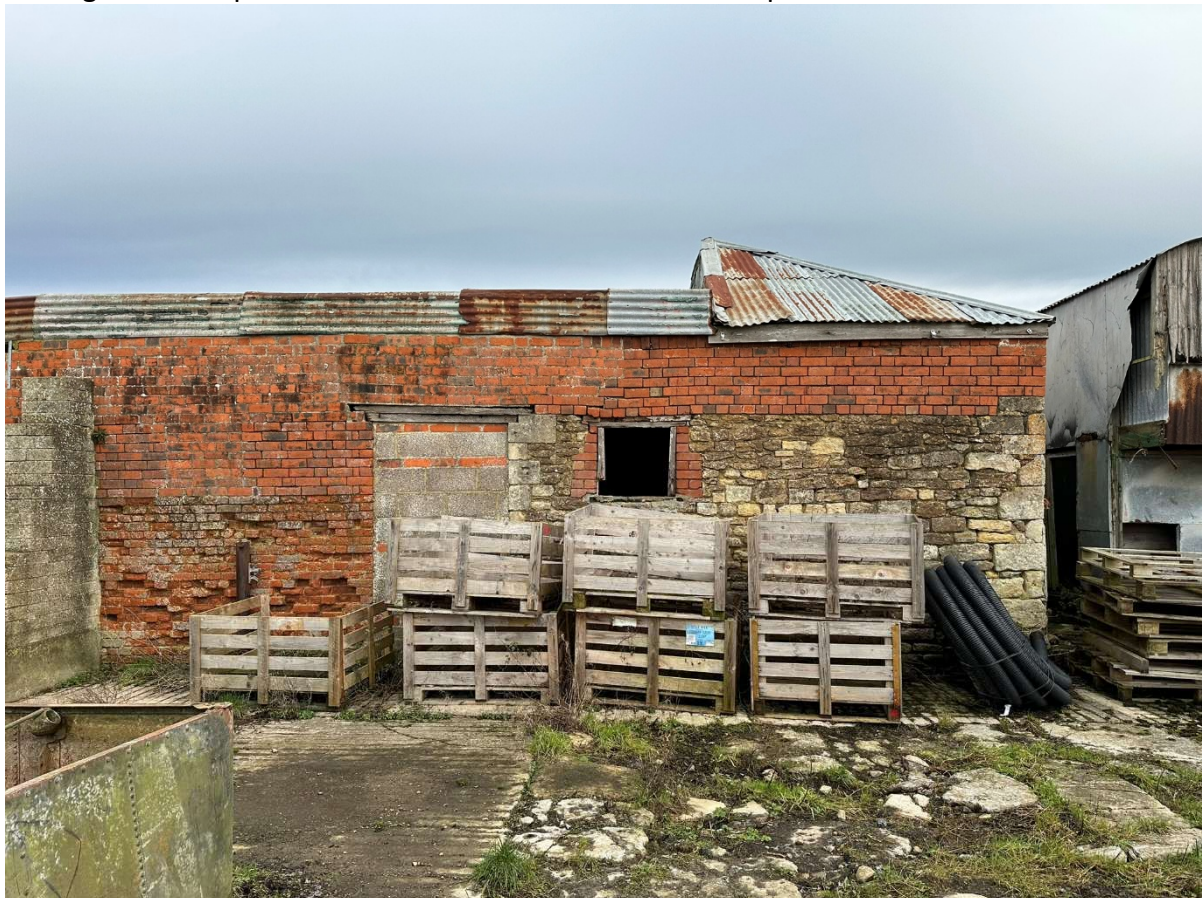
The walls are largely vertical although some areas of brickwork have fallen away. The remaining areas of stonework appear to be in a fair condition. Deep repointing in a lime mortar will be required over most of the surfaces together with the stitching in of brickwork where bricks are missing. In some areas the extent of spalled brickwork is so excessive that it suggests that the area of brickwork might be unusually porous and would be difficult to make watertight. See left of photo 3, bottom half of the wall.

3 Longer view of photo 1 with the defective roof and the spalled low-level brickwork

Given this specific area of damaged brickwork we recommend propping the more stable upper section of wall and replacing the defective brickwork below with dressed stone or similar brickwork on a foundation with a similar depth as the adjacent retained foundations.

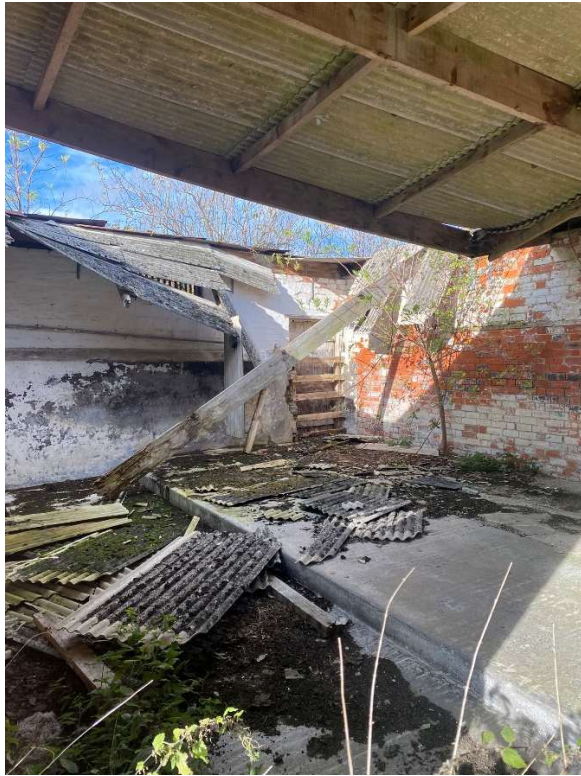
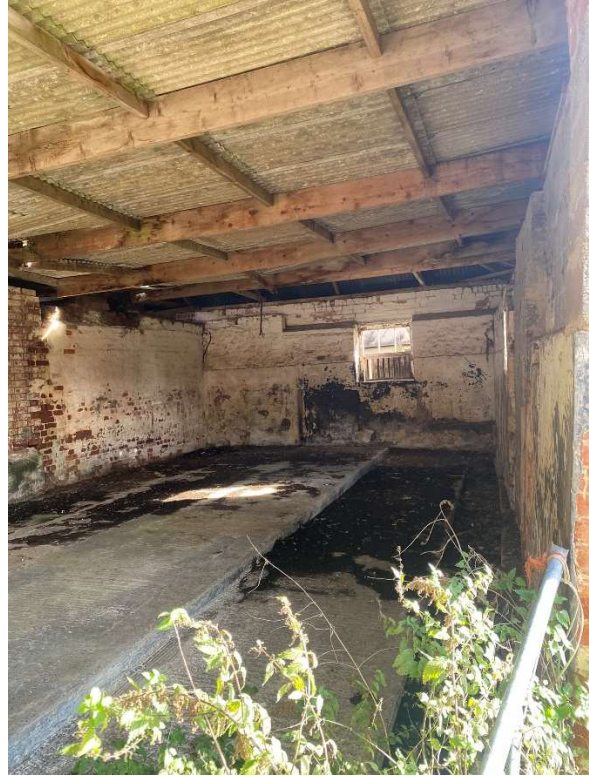
The existing modern concrete floor (photos 4 & 5) appears to be in a relatively good condition; however, a damp proof membrane and insulation will need to be introduced into the construction finishes assuming that the floor levels work for the new refurbishment.

The modern roof to the main barn area and the modern concrete ground slab.
