**BS: 5837 REPORT, TREES AT 101 PICKWICK ROAD CORSHAM WILTS SN13  
9DA**

**Clients: Cliffe Property Investments Limited. James Routledge BSc MRICS**

**Issue Date: 7 November 2025**

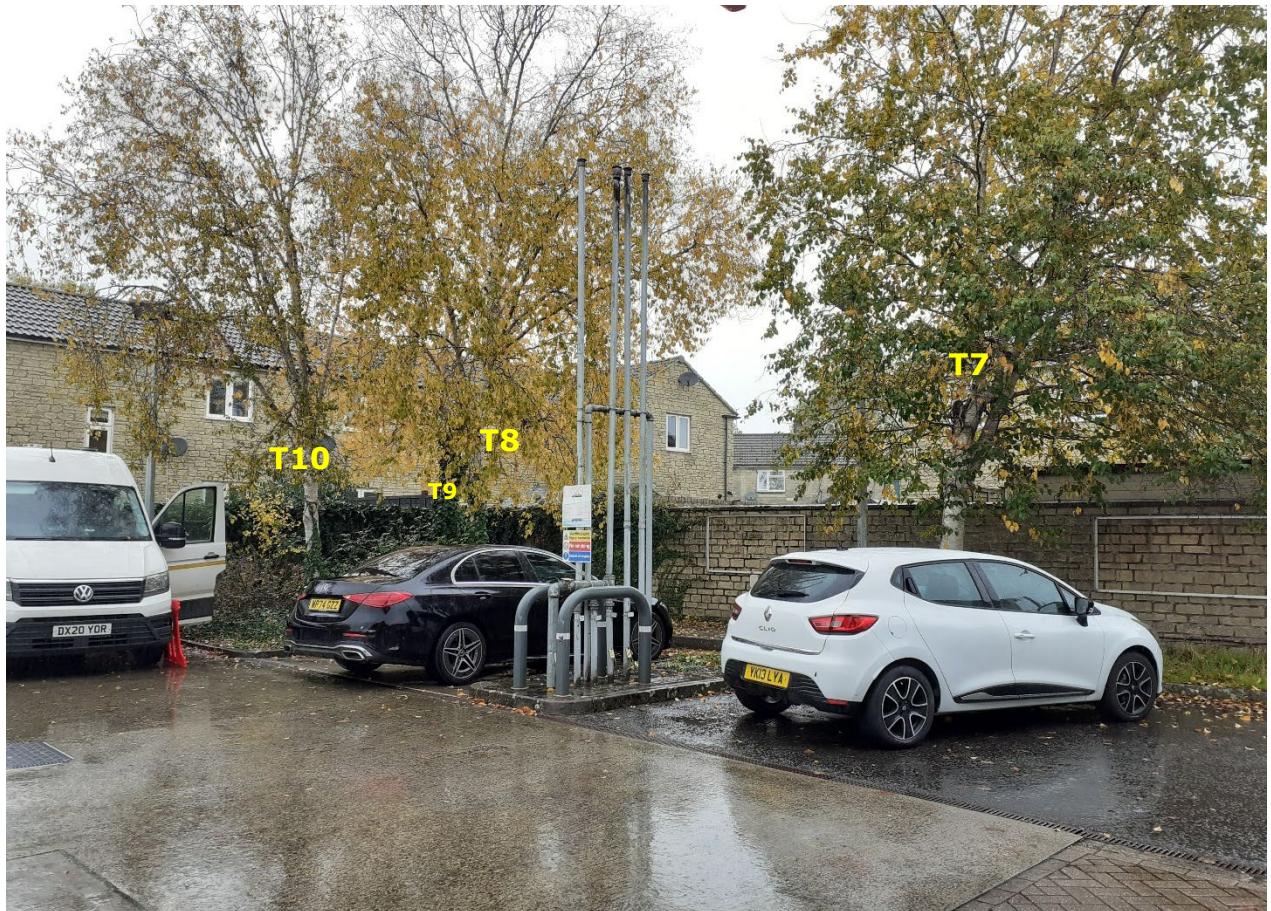
Viewed facing northwest, note T7, T8 and T9 are to be retained, their tops are prominent when approaching the forecourt and seen from the dwellings of Dickens Avenue behind the wall. T10 is shown as removed on the proposed plan, the mitigation new planting will be x5 shade and drip tolerant native Yew trees planted closely around the bases of T8 and T9, and x3 Field Maple planted beneath T7 as a 'nod' to BNG Council's Policies and providing sustainable continuity of tree cover. The species and precise planting positions should be with the agreement of the clients and Council.
