**Avon House, Langley Park**

**Visual Condition Assessment**

**Northland PM**

Project No: 13918

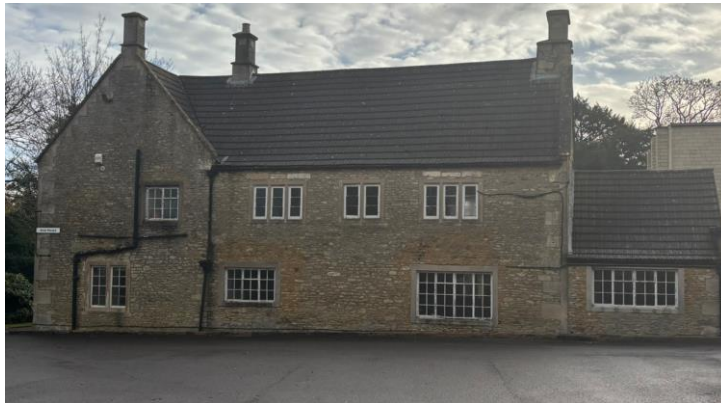
5.1.1 The main two storey section of the property appears to be in a good condition bearing in mind the age of the property and the clear lack of recent use.

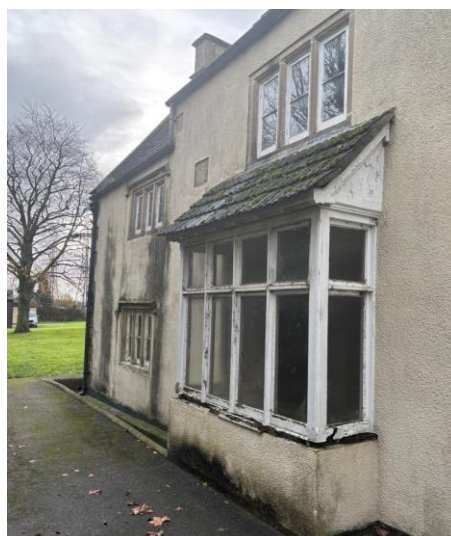
5.1.2 The render on the front elevation, facing Cocklebury Lane is average condition and not believed to be original.

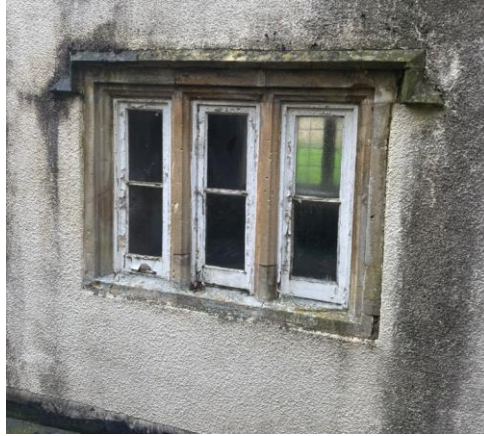
- 5.1.3 Within the rendered elevation, the window stone lintels, cills and reveals appear to be in below average condition with remedial repairs required.

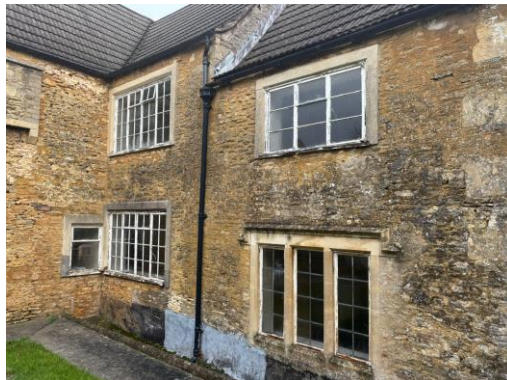
- 5.1.4 To the rear of the property, various remedial repairs to the stonework above and below damp proof level have been completed to a poor standard.

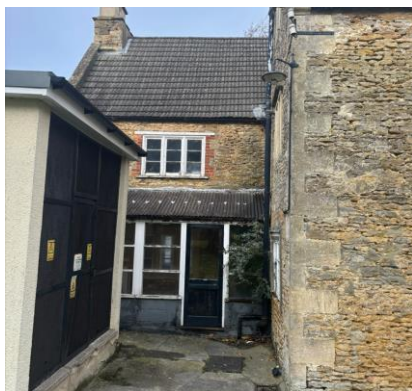
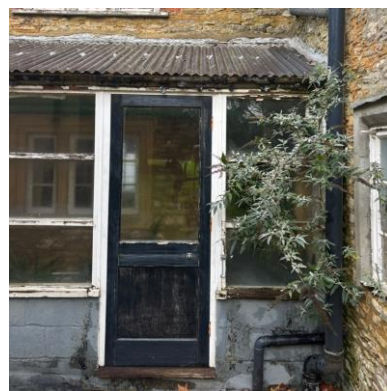
- 5.1.5 Again, to the rear of the property a timber / blockwork lean-to has been constructed. The lean-to links the original building to the more recent single storey extension to the rear. The lean to is considered to be in poor condition with significant damp issues and vegetation impacting the structural integrity of the build.

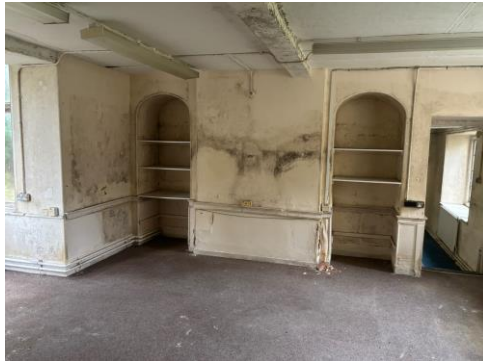
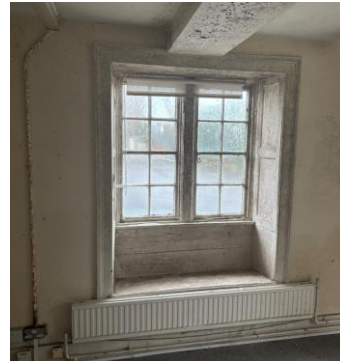
- 5.1.6 Internally, the two-storey structure appears to be in below average condition, with a lack of adequate heating and ventilation causing significant areas of damp to occur.

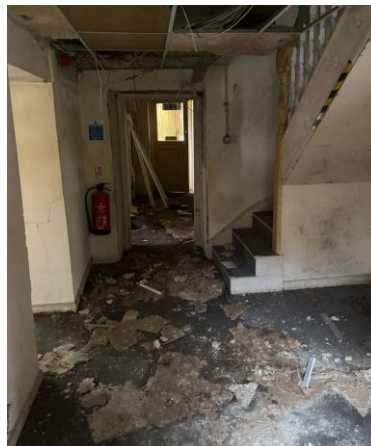
- 5.1.7 Previous issues with roof coverings, now repaired, have resulted in the central corridor area being impacted by moisture ingress.

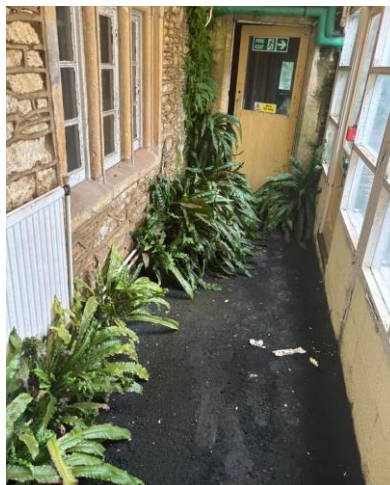
- 5.1.8 As noted externally, significant vegetation occupies the internal area of the recently installed timber / blockwork lean-to.

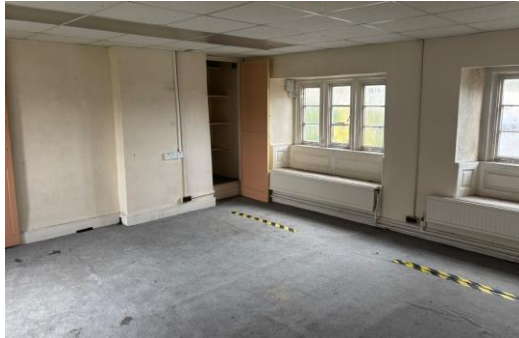
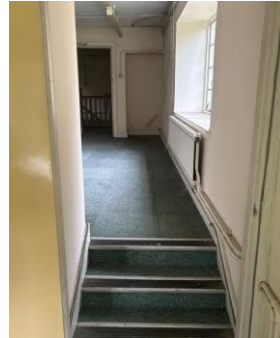
- 5.1.9 At first floor, the internal condition of the main two storey structure was generally considered to be in average condition. Again, lacking adequate heating and ventilation, however the impact on the structure is considerably less when compared to the ground floor.

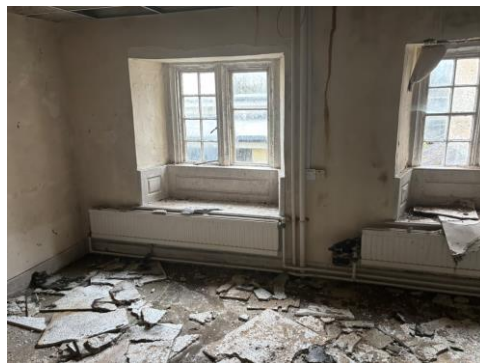
- 5.1.10 To the rear of the property the first-floor ceiling has collapsed, most probably due to previous moisture ingress / failed roof coverings.

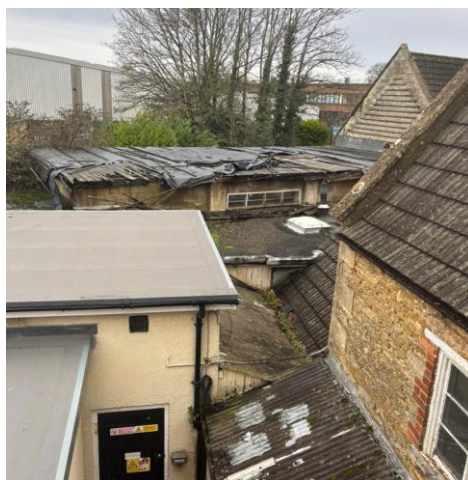
- 5.1.11 When viewed from the upper floors, significant failure of the roof coverings over the single storey structures to the rear is evident.

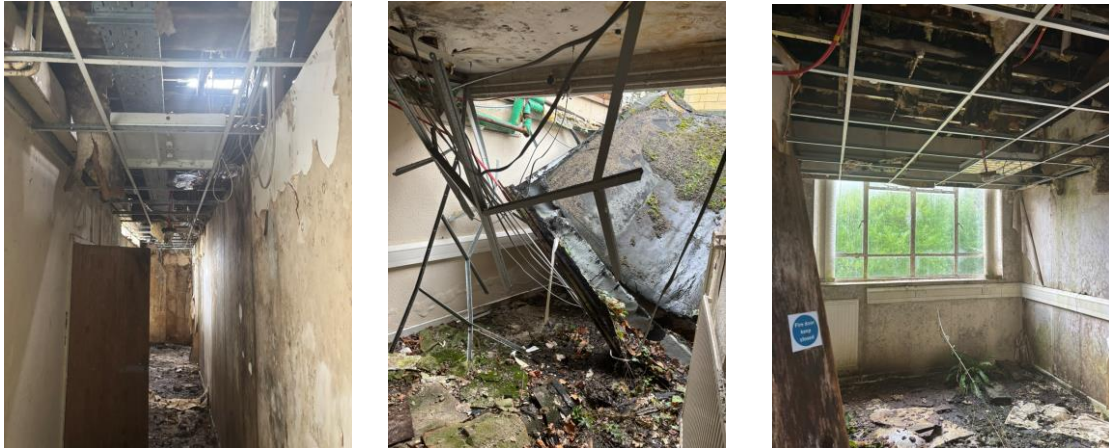
- 5.1.12 Upon closer inspection of the single storey structures to the rear of the property, collapse and structural failure of the roof coverings is clear. The roof collapse has clearly had a significant detrimental effect on the integrity of the structure.

- 6.1.1 Generally, the main two storey structure appears to be in average to poor condition. A lack of heating and ventilation in the property has resulted in extensive damp and mould occupying much of the property.
- 6.1.2 The two-storey section of the property is considered to be in structurally sound condition with no significant signs of structural failure / collapse.
- 6.1.3 Unfortunately, the single storey sections to the rear of the property are showing significant signs of structural failure with the failed roof coverings and moisture significantly impacting the integrity of the structure.
- 6.1.4 Due to the condition of the single storey elements, it is recommended they are demolished to avoid any further catastrophic failure of the structure.
