## DEVIZES CASTLE – DESIGN AND ACCESS STATEMENT: BELOW-GROUND DRAINAGE

### Statement to accompany the Listed Building Consent Application for Devizes Castle below-ground drainage proposals

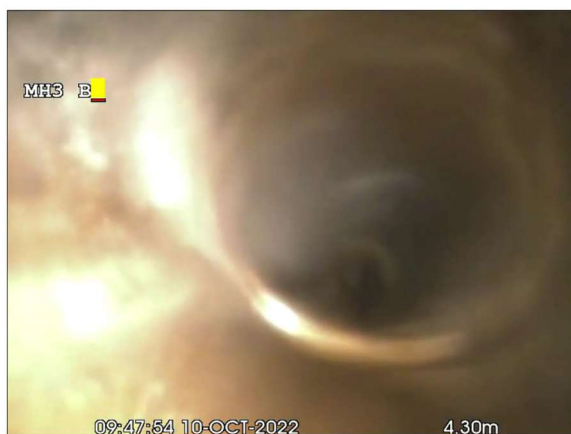
Photo: 10\_3a, 00:00:00  
4.77m, Joint displaced. Medium

*Figure 1 - CCTV Report showing existing foul water pipes with joint displacements.*

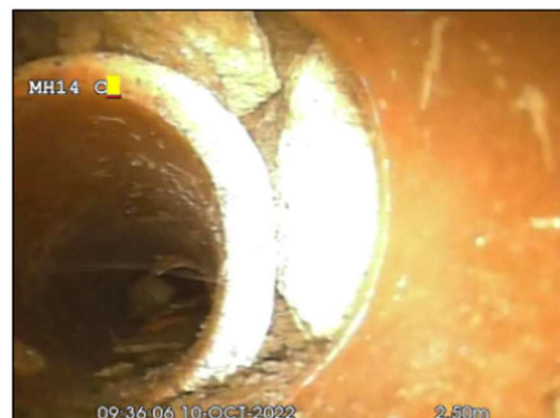
Photo: 15\_4a, 00:00:00  
2.55m, Joint displaced. Large

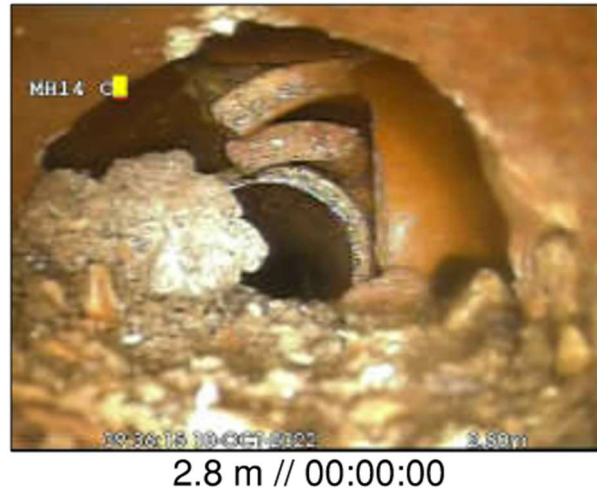
The CCTV survey also revealed significant debris, reducing the effective cross-sectional area of the pipe to 50% in some incidences, as illustrated in Figure 2. Due to the extent of the blockages, it is unlikely that the affected pipes can be cleared by jet cleaning alone, so require replacing.

*Figure 2 - CCTV Report showing existing foul water pipe junction with large joint displacement and excessive debris.*

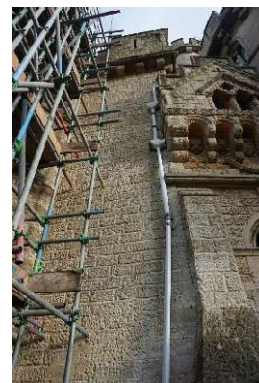
(f)

ABA also conducted a high-level photo survey of the existing drainage system in 2024 (Drawing 1969/020/101). A review of the two surveys to the drainage system revealed parts of the system have been added on an ad-hoc basis, with incidences of unsightly uPVC pipes running across roofs and terraces (Figure 3f), and some pipes discharging directly onto the property grounds (Figure 3e). Therefore, the existing system is ultimately not fit for purpose in most incidences so should be upgraded. It is recommended that proposed runs are in cast iron, connecting directly into the below-ground drainage system to improve the coherence, resilience and longevity of the system, as well as to help improve the visual appearance and the historic aesthetic of the building.
