## **STRUCTURAL REPORT**

**Moat Bridge  
Devizes Castle  
Castle Road,  
Devizes,  
Wiltshire  
SN10 1HL**

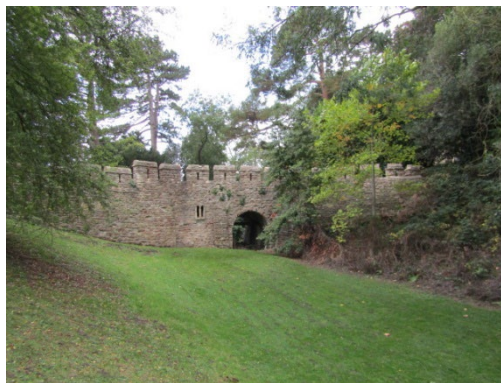
Photograph No. 1

The Consultants were appointed by Kayne Howes of Gardiner and Theobald, 10 South Crescent, London, WC1E 7BD, on behalf of the owner Kazuhiko Akao, to carry out a structural survey and prepare a report on the bridge which crosses the moat at Devizes Castle, Castle Road, Devizes, Wiltshire, SN10 1HL,. The purpose of this report is to comment on the current structural condition and recommend any repair works which may be required. The moat bridge is located on the southern driveway of the castle and a general view of the east elevation of the moat bridge is shown on photograph No. 1.

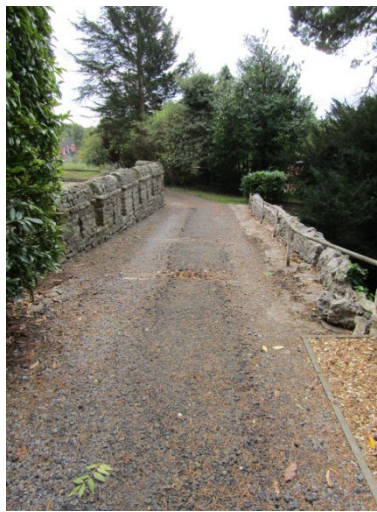
Photograph No. 2

A general view is shown on photograph No. 2, and this consists of tarmac which has drainage channels running in the east to west direction across the bridge deck to dissipate water to the edges of the bridge.

The deck is in a poor condition with different and uneven surfaces which include depressions where vehicles have tracked over the bridge. The existing deck requires removing and relaying on a solid, compacted infill. Drainage channels should be introduced to discharge rainwater off the bridge. There is a relatively large thickness between the surface of the deck and the top of the masonry arches and therefore the loads from vehicles should be well distributed over the arches.

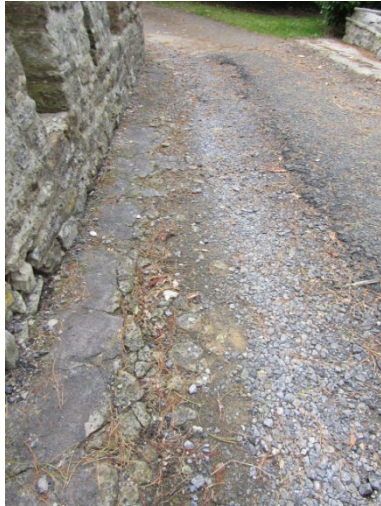
Photograph No. 3

The eastern side of the bridge has a parapet and flank walls but the western only has a small parapet and the outer eastern elevation is constructed from what appears to be tufa stonework. The deck has track marks and the tarmac is in a poor condition. There is concrete to the sides, and this is damaged, as can be seen on photographs No. 3 and 4 which show the eastern side of the bridge deck and the area to the western side of the southern flank wall where water pools and there is loose stonework and debris.

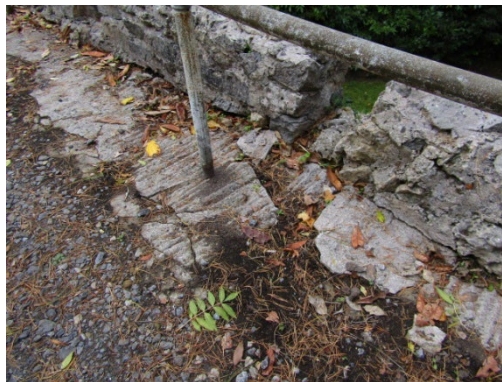
Photograph No. 5

On the western side of the bridge deck, there is a concrete area which is damaged and a metal guardrail to which the fixings are in a poor condition and sometimes are not fixed into the concrete as can be seen on photograph No. 5.

The parapet on the western side is minimal in height and the metal rail is loose and is only partly fixed into the concrete surface. It is considered that this is too low and there is a notable risk to persons using the bridge. Following a risk assessment it would be envisaged that the parapet is rebuilt and raised in height or an appropriate railing introduced.

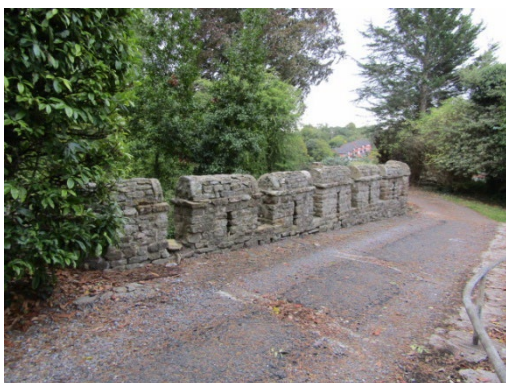
Photograph No. 6

A general view of the eastern parapet is shown on photograph No. 6 and this has flank walls on either side, the north of which is recorded on photograph No. 7.

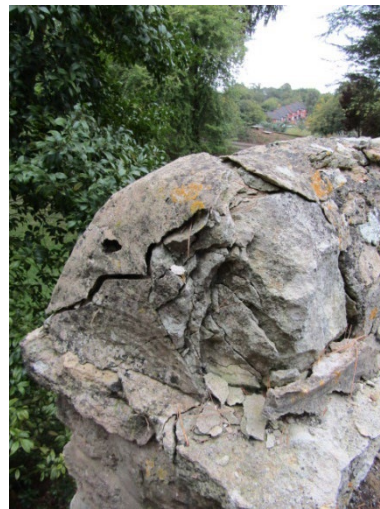
Photograph No. 9

There are examples where these have occasionally shattered, as can be seen on photograph No. 8, and a further example of this is recorded on photograph No. 9.

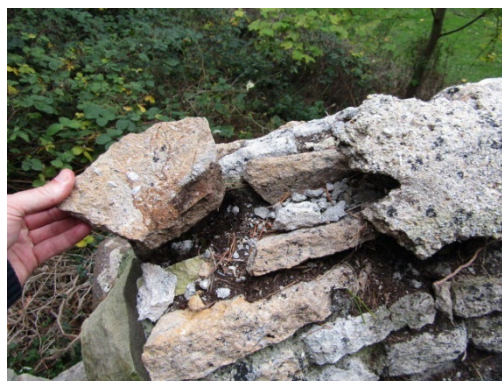
Photograph No. 10

The capping to the merlons are constructed from stonework, which is bedded firstly on the horizontal, then turns to vertical on the crown. This opens the capping up to the elements and there is a large degree of damage on the top surface where water settles and will be subjected to freeze thaw action. Consequently, there is a large amount of loose and damaged stonework on top of the capping and a typical example of this is shown on photograph No. 10.

The cappings on the merlons are generally in a poor condition as they are constructed from stones embedded in a semi-circular fashion which means that the central stones are vertically bedded. This allows moisture to settle on the top surface and, through freeze-thaw action, break down the stonework and mortar. This detail is commonly used for cappings throughout the walls and is prone to this failure. It is recommended that the damaged cappings are dismantled and reconstructed, the end stones pinned into position and replaced where they are damaged. The southernmost merlon on the eastern elevation requires resetting since it has likely suffered impact damage which has caused a displacement to occur.

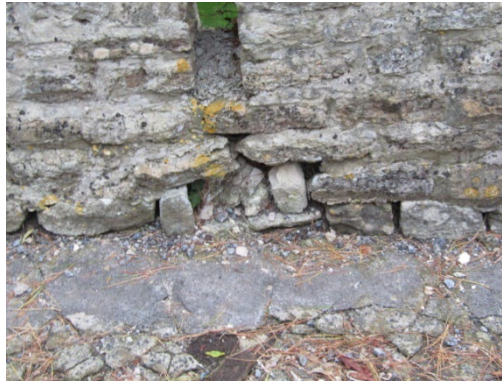
Photograph No. 11

Cementitious mortar has been applied in places and along the base are open joints caused by the spray back from puddles on the bridge deck, an example of this can be seen on photograph No. 11.

Hard cementitious mortar has been historically used, mostly on the eastern elevation including the parapets. The cementitious mortar should be removed as it does not allow the stonework to breathe and traps moisture within the stonework which will cause damage. On walls there should also be an allowance for grouting as the trapped moisture can create voids. There are open joints throughout the bridge which require raking out and repointing in a lime mortar. There are multiple bricks, mostly on the arches, which are damaged and spalled and these should be cut out and replaced with ones that match the existing bricks. Furthermore, there is also damaged, shattered, and spalled stonework on the walls and chamber structures, and these require removing and replacing. Where the masonry is missing, or there has been localised collapses, the masonry above should be propped and then the area rebuilt with the brickwork rebonded into the surrounding structure. The vegetation growth, which is mostly ivy, should be fully removed and the joints raked out and repointed where required. Where the ivy is well embedded into the masonry, it may be required to locally remove the surrounding stonework to access the root growth and then the stones reinstated once the vegetation root has been removed.

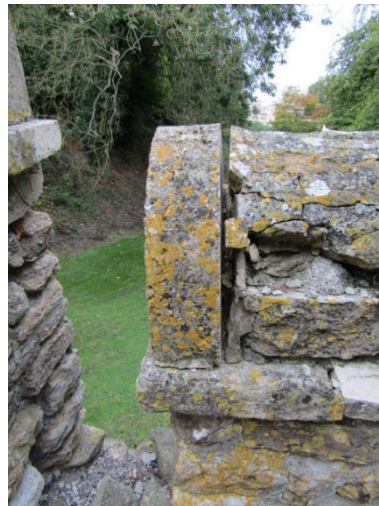
Photograph No. 12

There is minor vegetation growth in the capping and occasionally the end stones to the capping are loose and have become detached from the main section. An example of this is shown on photograph No. 12.

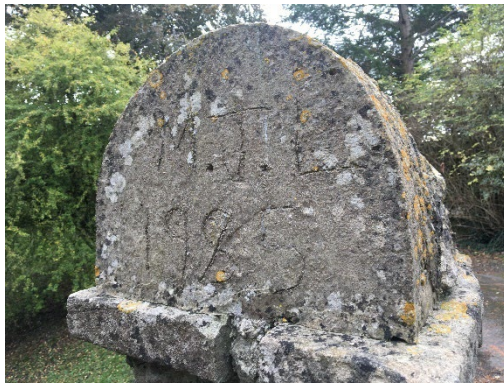
Photograph No. 13

On the northern face of one of the end capping stones is the initials M.J.L. and a date stamp of 1985. This is shown on photograph No. 13 and indicates that it is most likely that a major phase of repair work to the merlons was carried out 38 years ago. Photograph No. 14 shows cracking to the southernmost merlon and it is likely that this may be a localised impact damage.

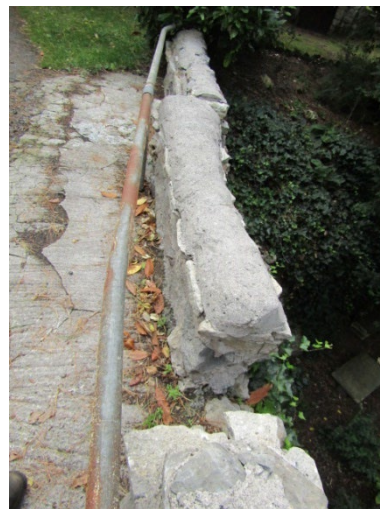
Photograph No. 16

A general view of the western parapet is recorded on photograph No. 15 and this consists of seven fairly crudely built merlons which are at low level. It can be seen that the southern two are not built in alignment but may not have displaced away from the bridge as the concrete on the western side of the deck is laid to their current position. The southern two merlons are shown on photograph No. 16 and, if they have displaced, it is thought to be historic movement.

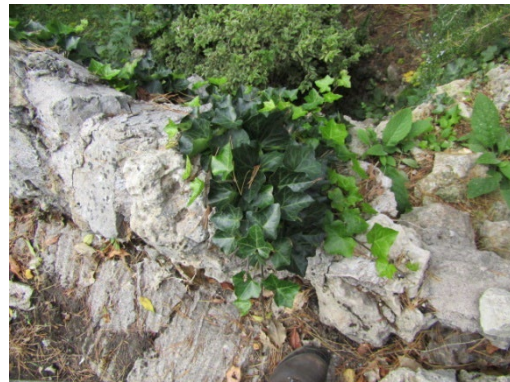
Photograph No. 19

There is ivy growth from the western elevation, as can be seen on photograph No. 18, and this is most evident on the northern end as can be seen on photograph No. 19.

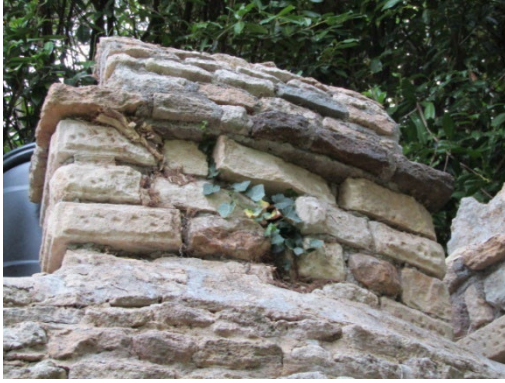
Photograph No. 21

A general view of the eastern elevation is recorded on photograph No. 20 and there is ivy growth rooted into the joints in the masonry both on the crenelations and the main face of the stonework as recorded on photographs No. 21 and 22.

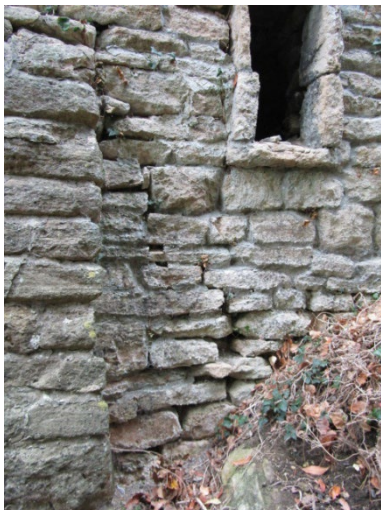
Photograph No. 23

On the northern side of the main opening, there is a series of open joints as can be seen on photograph No. 23. The majority of the elevation is pointed in a hard cementitious mortar and an example of this is recorded on photograph No. 24.

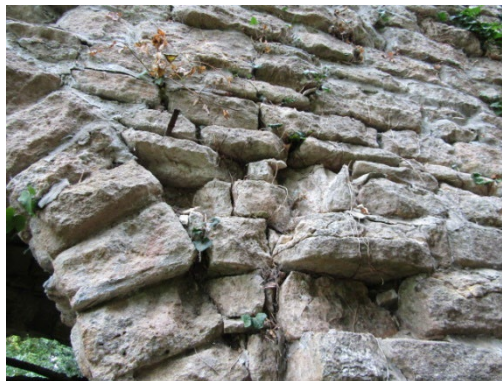
Photograph No. 25

There are localised areas of damaged stonework, as recorded on photograph No. 25, which is to the top of the northern side of the arch and at this position there is also ivy growth, and the damaged stones will require cutting out and replacing.

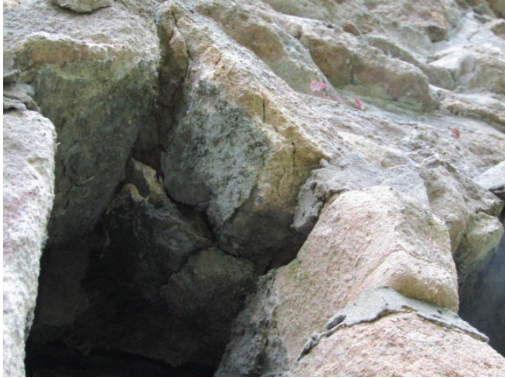
Photograph No. 26

On the southern side, there is slight de-bonding around the window and the stone on the southern side of the central mullion has fractured as recorded on photograph No. 26. There are other localised areas where hard cement mortar has been patched over the stonework in a crude manner and on the remainder of the flank wall there is a slight bulge and a general view is shown on photograph No. 27

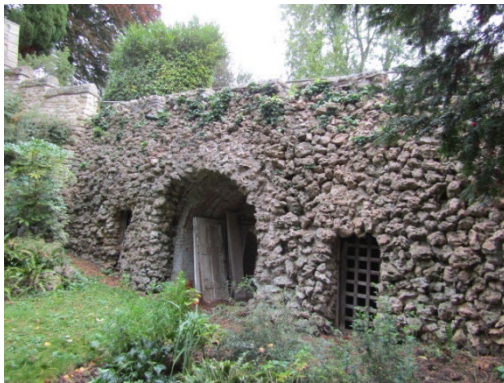
Photograph No. 28

A general view of this is shown on photograph No. 28 and there is slight vertical cracking on the southern side as can be seen on photograph No. 29.

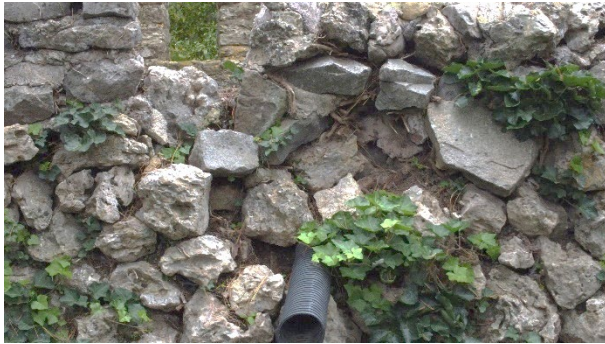
Photograph No. 30

Towards the northern side, there are missing blocks, and it is unknown how the blocks are fixed to the bridge and furthermore, there is ivy growth which is rooted deep into the wall, and these are both shown on photographs No. 30 and 31. There is further ivy growth on the southern side of the bridge as recorded on photograph No. 32.

The western elevation requires the ivy and vegetation, which is deep rooted into the structure, to be removed and the connection between the outer tufa stone wall and the brickwork behind should be investigated. The likelihood is that the cracking through the stonework on the southern side of this wall will require pinning with stainless steel pins, however, this will depend on the findings of the investigations.

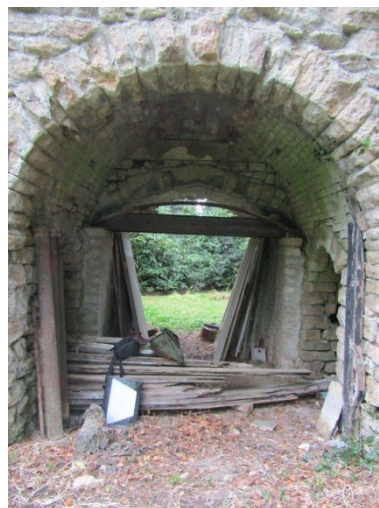
Photograph No. 33

A general view of the underside of the bridge is recorded on photograph No. 33 and this is taken from the eastern side.

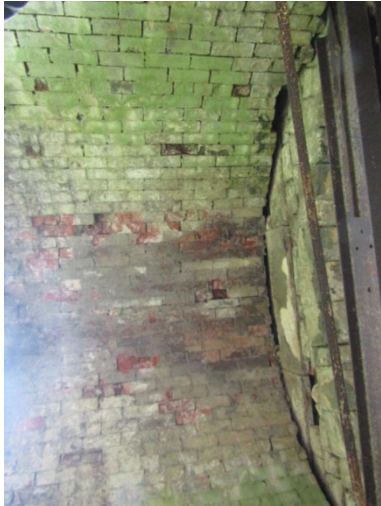
Photograph No. 34 shows the underside of the eastern arch and there are spalled bricks and open joints as recorded respectively on photographs No. 35 and 36. Furthermore, on the southern side, there are damaged and spalled bricks at the springing position as recorded on photograph No. 37.

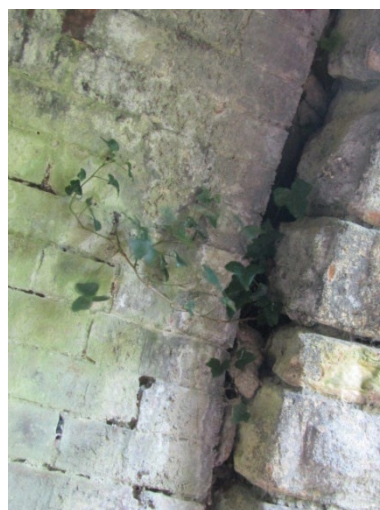
Photograph No. 38

The outer stonework arch is of a different span to that of the main brickwork barrel vault and there is a gap between the two materials which has ivy growth as can be seen on photograph No. 38.

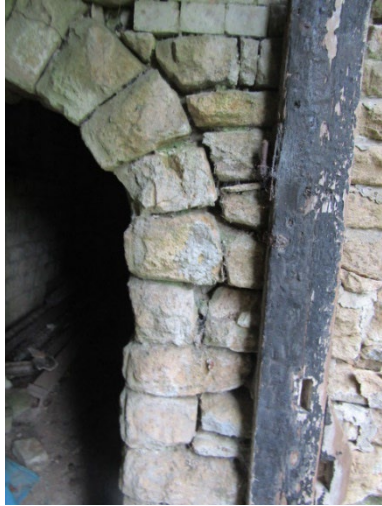
Photograph No. 39

On the northern side, to the east of the opening into the north-eastern chamber, there are open joints in the masonry as can be seen on photograph No. 39 and at the base of this is damaged stonework and the remnants of hard cementitious mortar pointing as recorded on photograph No. 40.

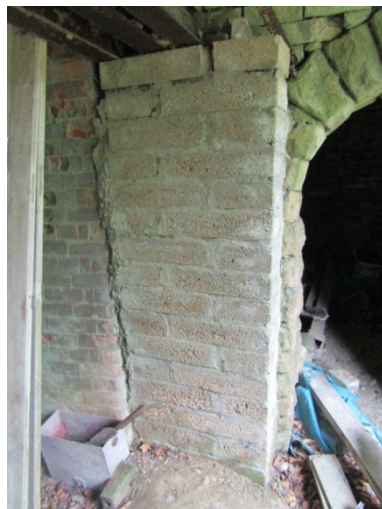
Photograph No. 41

In the centre of the space on the underside of the bridge, there are two modern blockwork piers which are shown on photographs No. 41 and 42 and these have been built to the line of the earlier masonry.

Modern blockwork piers have been introduced on either side of the underside of the bridge and these support three corroding steel beams. It is likely that the piers were installed to protect/mask damaged masonry behind and provide further support to the central wall. To fully repair the bridge, the steel beams and the blockwork piers require removing to expose the masonry behind which can then be repaired where necessary.

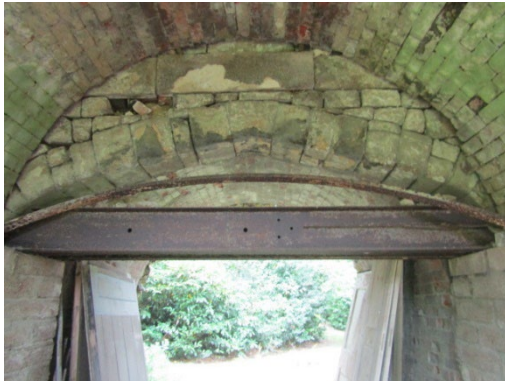
Photograph No. 43 shows a view of the central stonework arch which it is likely was once an external wall but the bridge has subsequently been adapted and widened. There are three steel beams spanning between the modern blockwork piers and the beams are corroding on the surface, and this is shown on photograph No. 44.

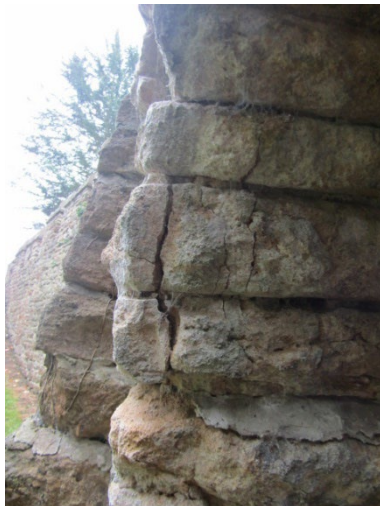
Photograph No. 45

On the southern side of the underside, there are stones on the eastern corner which have fractured as can be seen on photograph No. 45. There is damage and missing stonework on the top southern side of the central wall, as shown on photograph No. 46, and it is visible that there is brickwork behind so the stonework on show may be a façade on a brick structure.

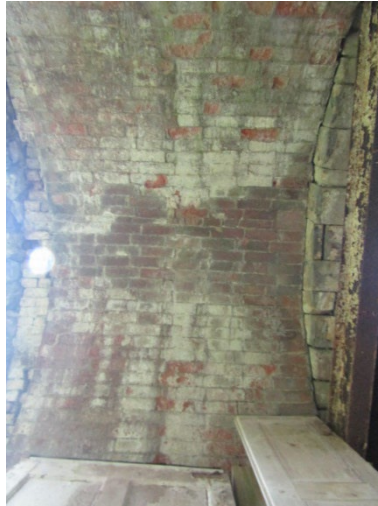
Photograph No. 47

A general view of the underside of the western barrel vault is recorded on photograph No. 47 and there is slight damage to the brickwork. This is thought to be a later arch which has been inserted beneath the older arch most likely to provide it with strengthening. On the western side, there is cracking in the earlier arch as recorded on photographs No. 48 and 49. The cracking indicates that the western elevation has displaced away from the bridge. This displacement is mainly on the northern side of this western section but the southern side indicates that the outer stonework façade of the western elevation has displaced away from the earlier brickwork structure as recorded on photograph No. 50. On the northern side, the junction can be seen between the newer brickwork and earlier masonry wall.

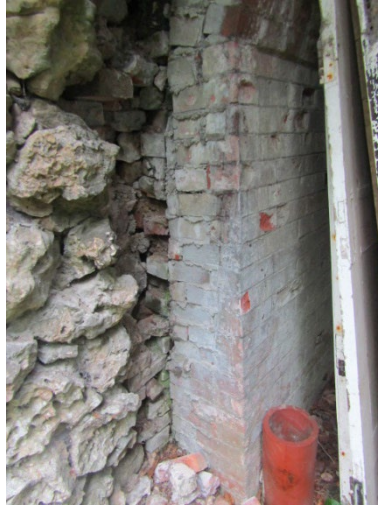
Photograph No. 51 shows the western corner of the earlier brickwork on the northern side of the wall and the brickwork here is in a poor condition with an amount of loose bricks and a pile of bricks on the floor indicating that a collapse has occurred at some time on the south-western corner.

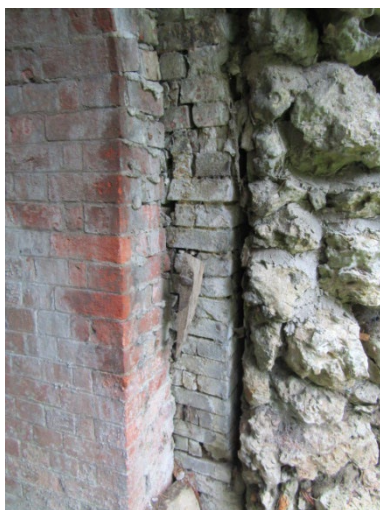
Photograph No. 52

The later brickwork masks the majority of the earlier bricks, however, the earlier bricks can be seen on the western edge on photograph No. 52 and there is a slight gap between this western edge and the tufa stonework which makes up the western elevation. There is slight cracking on the springing position in the brickwork as can be seen on photograph No. 53 and this has been caused by a slight movement of the inner brickwork to the south which has caused a compression crack to occur in the brickwork at the springing position. The movement which has occurred does not appear to be of major structural concern and the inner arch is buttressed so cannot move southwards. As the cracking is not of great concern, the joint below the springing position should be raked out and repointed.

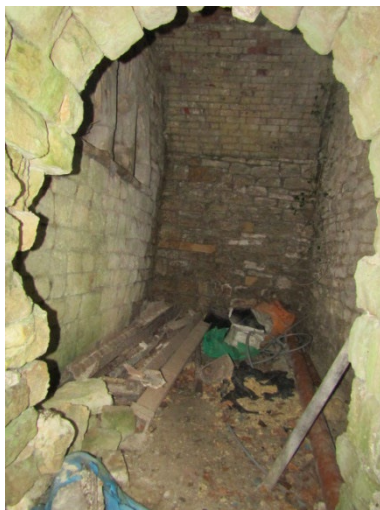
Photograph No. 56

A general view of this is shown on photograph No. 56 and the underside of the brickwork barrel vault is recorded on photograph No. 57.

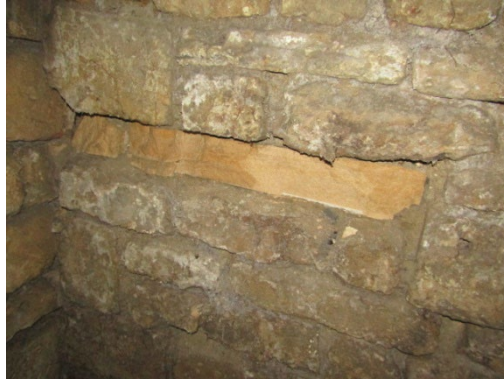
Photograph No. 58

On the northern wall, which is stonework, there is occasional damage to the stones, as recorded on photograph No. 58, and on the eastern wall there is a gap between the brickwork barrel vault and the stonework wall which is the inside face of the eastern elevation. This is shown on photograph No. 59. In this gap, there is ivy growth which should be removed, and this is recorded on photograph No. 60.

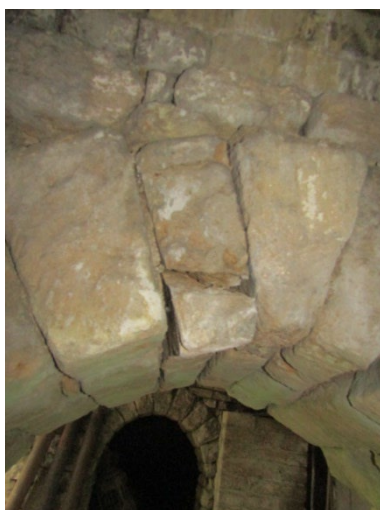
Photograph No. 61

Above the entrance doorway into this chamber, there is a stonework arch and damage to the voussoirs as recorded on photograph No. 61. Furthermore, the arch is very open jointed as can be seen on photograph No. 62.

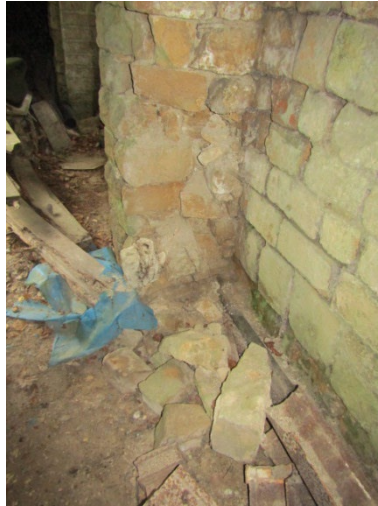
Photograph No. 63

The western reveal to this opening has a large degree of damaged stonework as indicated on photograph No. 63.

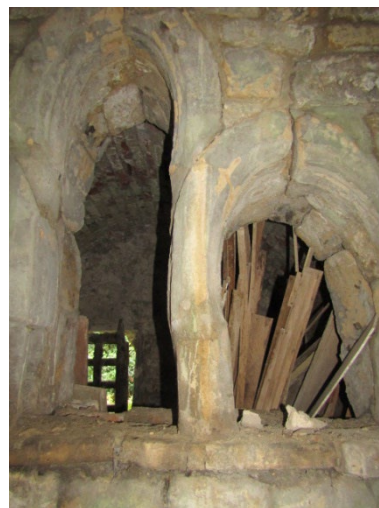
Photograph No. 66

There is an opening in this division wall which is shown on photograph No. 65 and the northern mullion has displaced to the south as there is a lack of buttressing against these stone arches as can be seen on photograph No. 66.

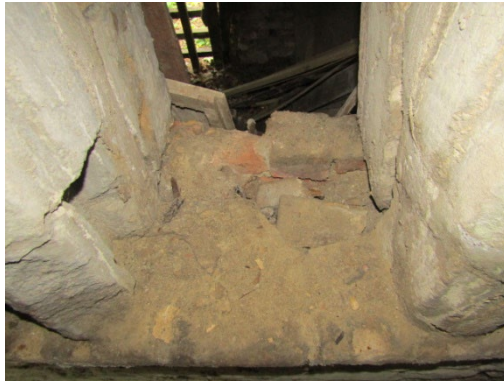
Photograph No. 67

The wall to which this window is supported is quite open on the surface and requires an allowance for grouting and this is shown on photograph No. 67. There is also cracking in the stonework above the northern tracery as recorded on photograph No. 68.

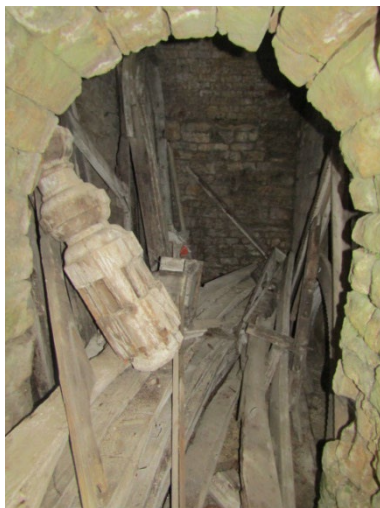
Photograph No. 69

A general view of the chamber is shown on photograph No. 69 and this consists of a brickwork masonry barrel vault which spans in the north to south direction and there is occasional spalling and damage to the bricks as indicated on photograph No. 70.

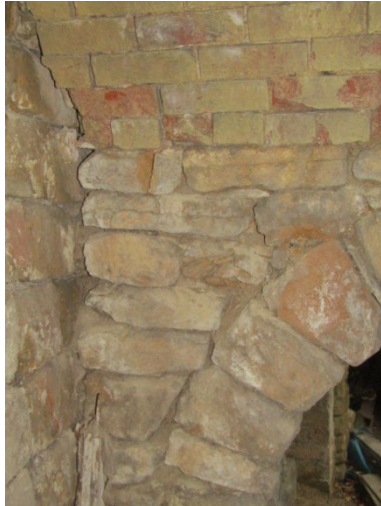
Photograph No. 71

The archway through to the northern wall is generally reasonable, although there is damage to the stonework surrounding the arch and open joints that require raking out and repointing. These two items can be seen on photograph No. 71 and 72.

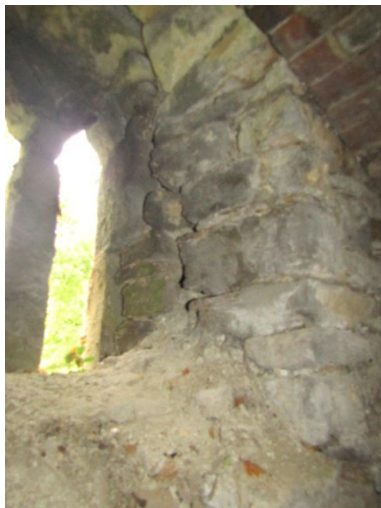
Photograph No. 73

Photographs No. 73 and 74 show that on the window of the eastern wall, the reveals are quite open and voided on either side and the stonework may require locally resetting.

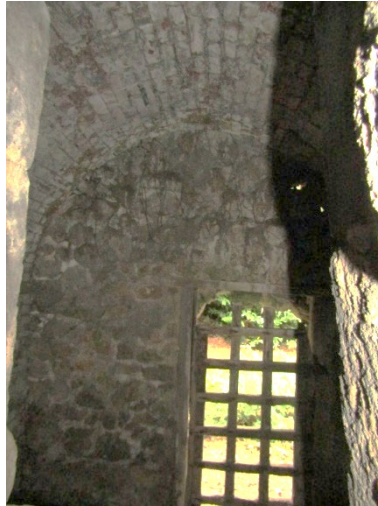
Photograph No. 79

A general view is recorded on photograph No. 79. The roof structure consists of a brickwork barrel vault, and this has cracking through the masonry as shown on photographs No. 80 and 81.

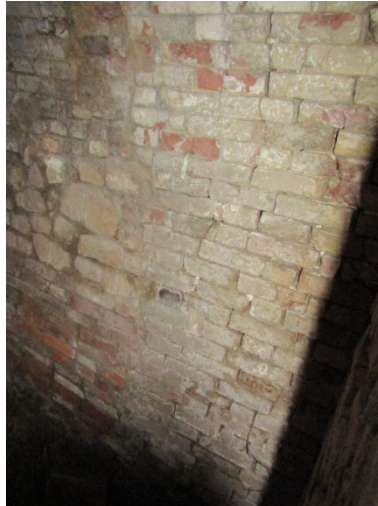
Photograph No. 82 shows the cracking on the northern wall adjacent to where the former doorway was infilled. The masonry around this point is quite open jointed and requires raking out and repointing.

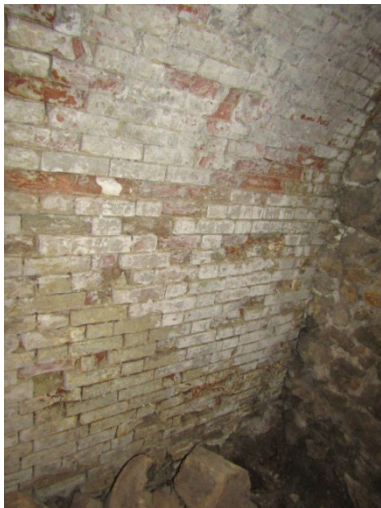
Photograph No. 83

The southern wall of the chamber is generally shown on photograph No. 83 and there are large amounts of spalled and damaged brickwork and the joints are open. This is all shown on photograph No. 84.

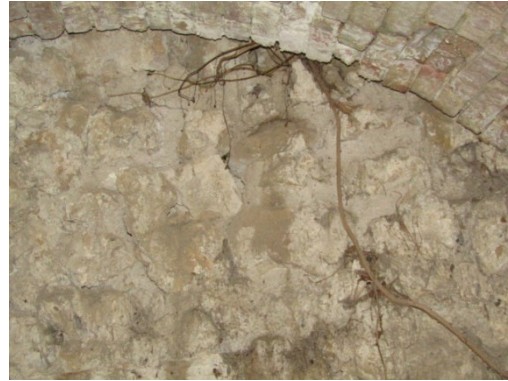
Photograph No. 87

A general view of the chamber is shown on photograph No. 86 and there is evidence of vegetation trapped in the gap between the brickwork barrel arch and the stonework wall to the rear of the chamber as can be seen on photograph No. 87.

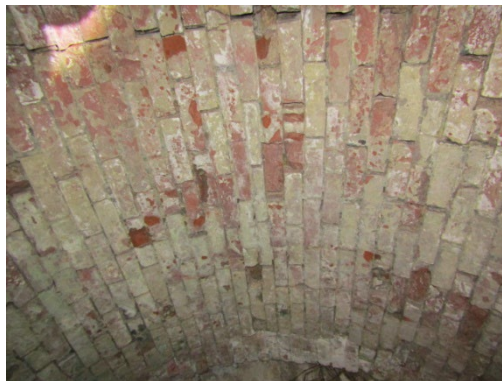
Photograph No. 88

A general view of the brickwork barrel vault is shown on photograph No. 88 and there are localised damaged and spalled bricks as well as slight cracking on the western wall.

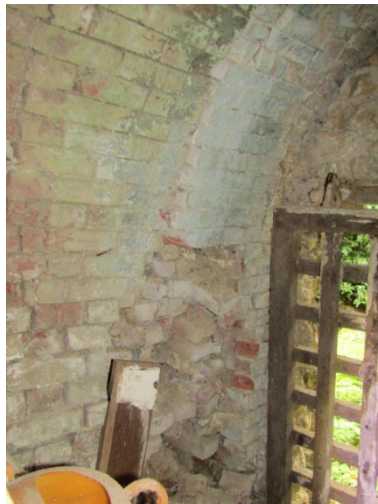
Photograph No. 89 shows there is a large amount of collapsed masonry on the southern wall where the brickwork above has cracked and displaced, and this area will require localised rebuilding.

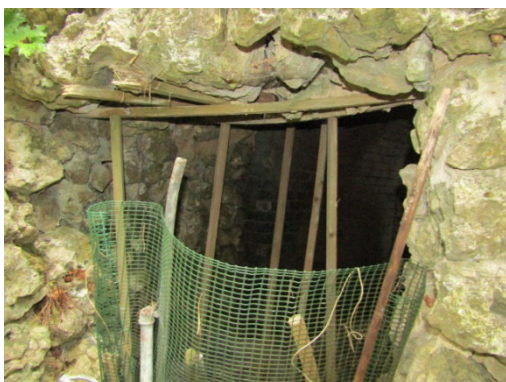
Photograph No. 90

This chamber is located to the north of the main north-western chamber and a view of the entranceway is shown on photograph No. 90. No access was gained into this chamber for safety reasons as there was a plastic fence over the entranceway. Photograph No. 91 shows that there is no evidence of structural lintols to support the stonework above and that small timbers have been introduced which will be providing negligible support to the stonework. It is therefore assumed that the stonework above here acts as an interlocking mass pinned together to prevent it from collapsing in front of the entrance of the chamber.

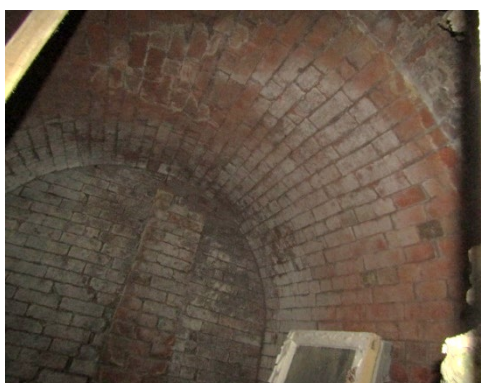
Photograph No. 92

General views of the chamber are shown on photographs No. 92 and 93 and there is a brickwork barrel vault spanning in the north to south direction with a brickwork rear wall and buttress. There is cracking in the rear wall, as can be seen on photograph No. 93, but this is not of major concern, and it is recommended that it is raked out and repointed in a lime mortar. There is evidence of slight opening in the joints on the masonry barrel vault and an indication of water ingress staining on the underside of the roof.
