# Tree Condition Survey and Management Work Recommendations

Date: 27<sup>th</sup> October 2025

(Full Report V1)

Prepared By: Trevor Osborne BSc (Hons) Dip Arb L4 (ABC)

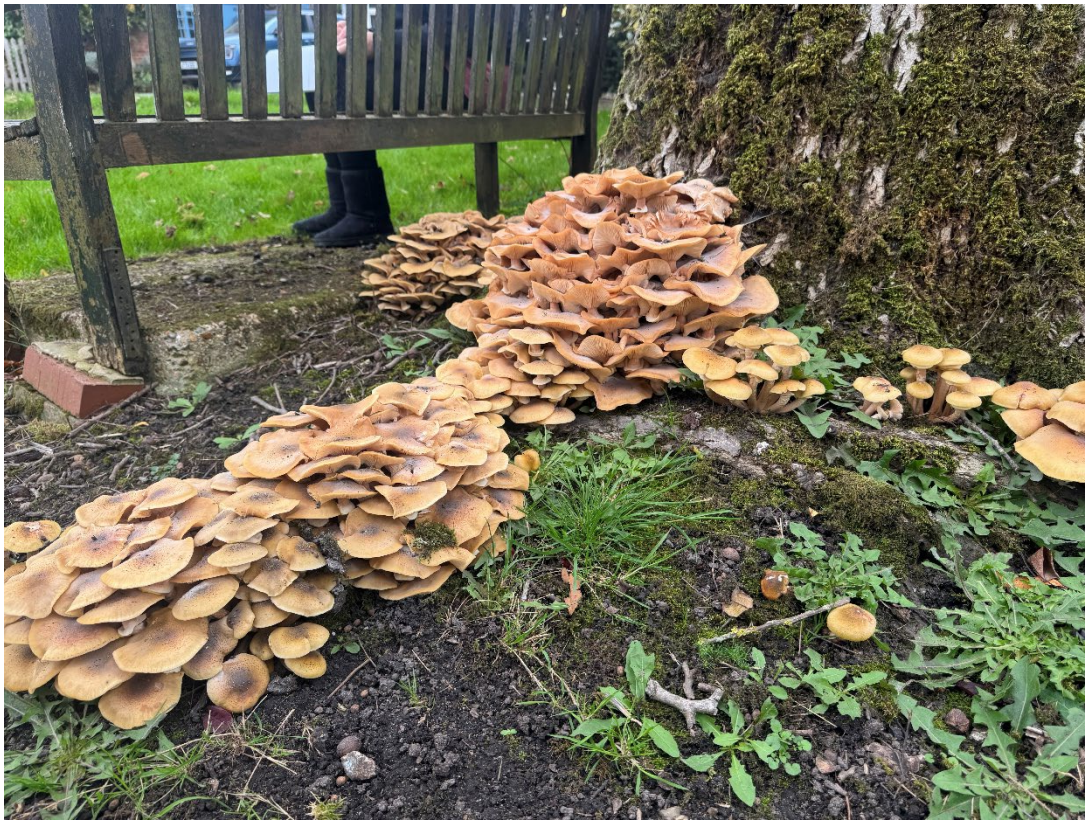
T1 - Walnut tree is exhibiting advanced stages of *Armillaria* (Honey Fungus), a destructive root disease caused by several species of the *Armillaria* fungus. This pathogen spreads through the soil via black, root-like structures known as rhizomorphs, which invade and colonize the roots of susceptible hosts. Infection results in progressive root decay, leading to canopy dieback and eventual tree death.

Unfortunately, the walnut shows advanced symptoms of infection, severely compromising both the physiological and structural health of the tree.

| TREE ID | TREE SPEICES | AGE | HEIGHT Metres | PHYSIOLOGICAL CONDITION | STRUCTURAL CONDITION | COMMENTS | MANAGEMENT/WORK RECOMMENDATIONS | TARGET OCCUPATION | WORK TYPE | WORK PRIORITY | LOCATION W3W |
|---|---|---|---|---|---|---|---|---|---|---|---|
| T1 | Walnut ( <i>Juglans regia</i> ) | Mature | 15 | Poor | Poor | Evidence of honey fungus around base and rooting area. Tree vitality poor | Fell, evidence of significant Honey Fungus, tree in decline ( <i>Armillaria</i> spp)<br><br>See Photo 1 | High | Hazard | B | ///slick.stags.campus |

Photo 1: T1 Walnut *Armillaria* fungus.

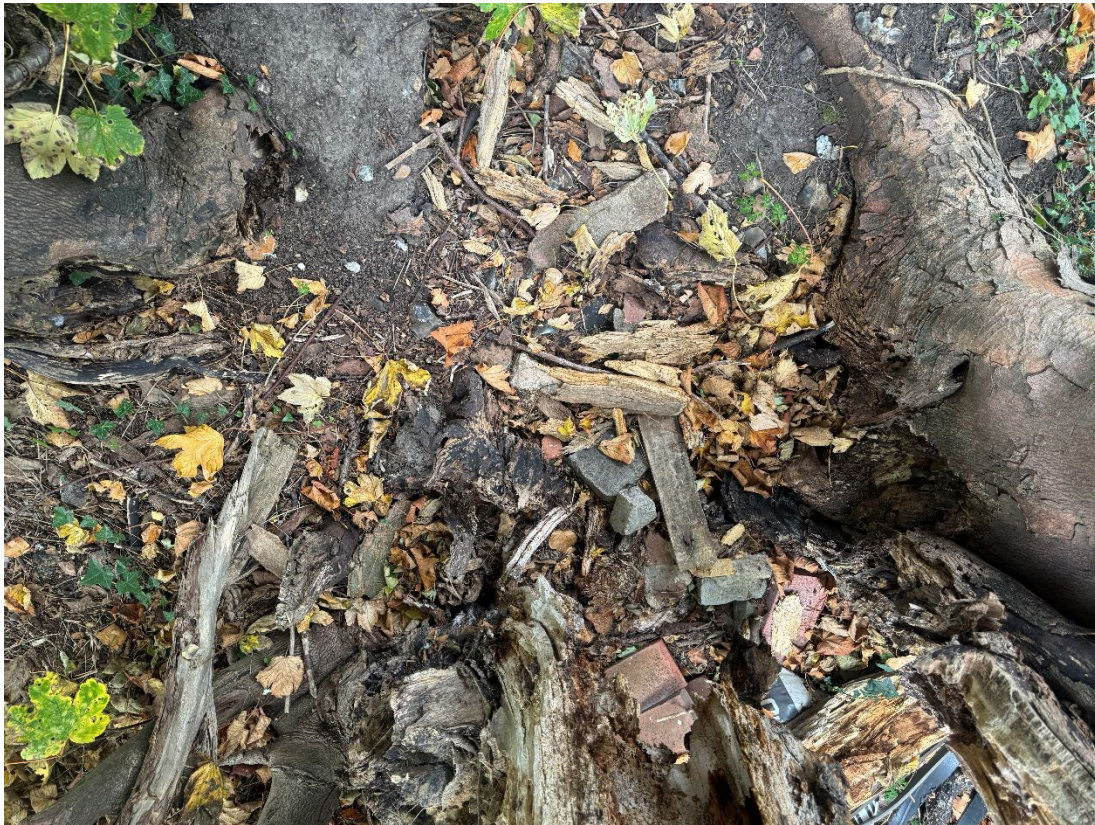
T10 – Sycamore (*Acer pseudoplatanus*) Evidence of extensive historic basal failure associated with wood decay fungi (*Dryad's Saddle* – *Cerioporus squamosus*). Remaining stems show significant structural compromise; one stem is leaning over the highway and the other over a shipping container, both in proximity to a primary school.

| TREE ID | TREE SPEICES | AGE | HEIGHT<br>Metres | PHYSIOLOGICAL<br>CONDITION | STRUCTURAL<br>CONDITION | COMMENTS | MANAGEMENT/WORK<br>RECOMMENDATIONS | TARGET<br>OCCUPATION | WORK<br>TYPE | WORK<br>PRIORITY | LOCATION W3W |
|---|---|---|---|---|---|---|---|---|---|---|---|
| T10 | Sycamore ( <i>Acer pseudoplatanus</i> ) | Mature | 18 | Fair | Very Poor | Multi stemmed specimen from base. Historic failure present. Decay present at base on 2 x leaning stems. 1 over highway, the other over shipping container and carpark. (Decay fungus Dryad Saddle <i>Cerioporos squamosus</i> ) | Fell due to structural defect and evidence and significant decay.<br><br>See Photo 2 | High | Hazard | B | ///conductor.executive.worker |

Photo 2: T10 Sycamore decay at base

Due to the extent of decay and structural instability, dismantle to ground level for safety reasons.
