# Design and Access Statement

**Property:** Kitchener's Court, Hill Street, Trowbridge, Wiltshire, BA14 8LA

**Date of Inspection:** 1<sup>st</sup> December 2025

**Listing Status:** Grade II\* Listed Building

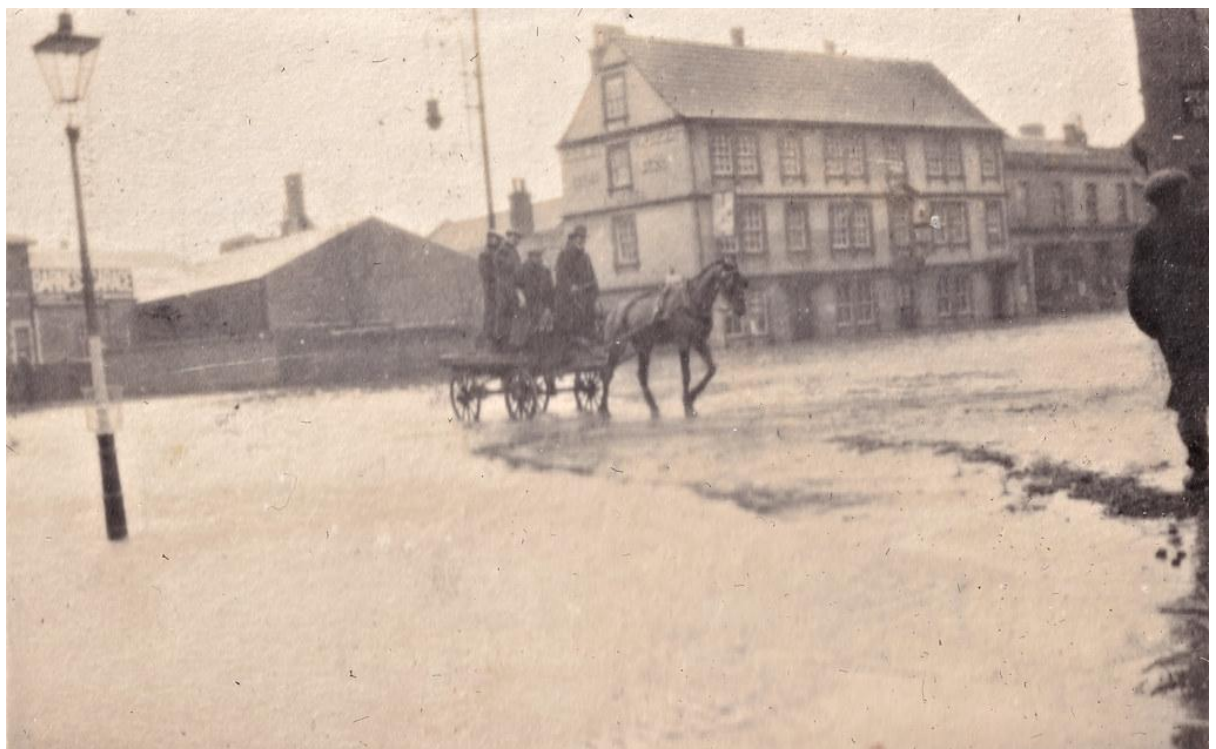
1916 Photograph showing flooding at Kitchener's Court – note there was once a window in the roof space.

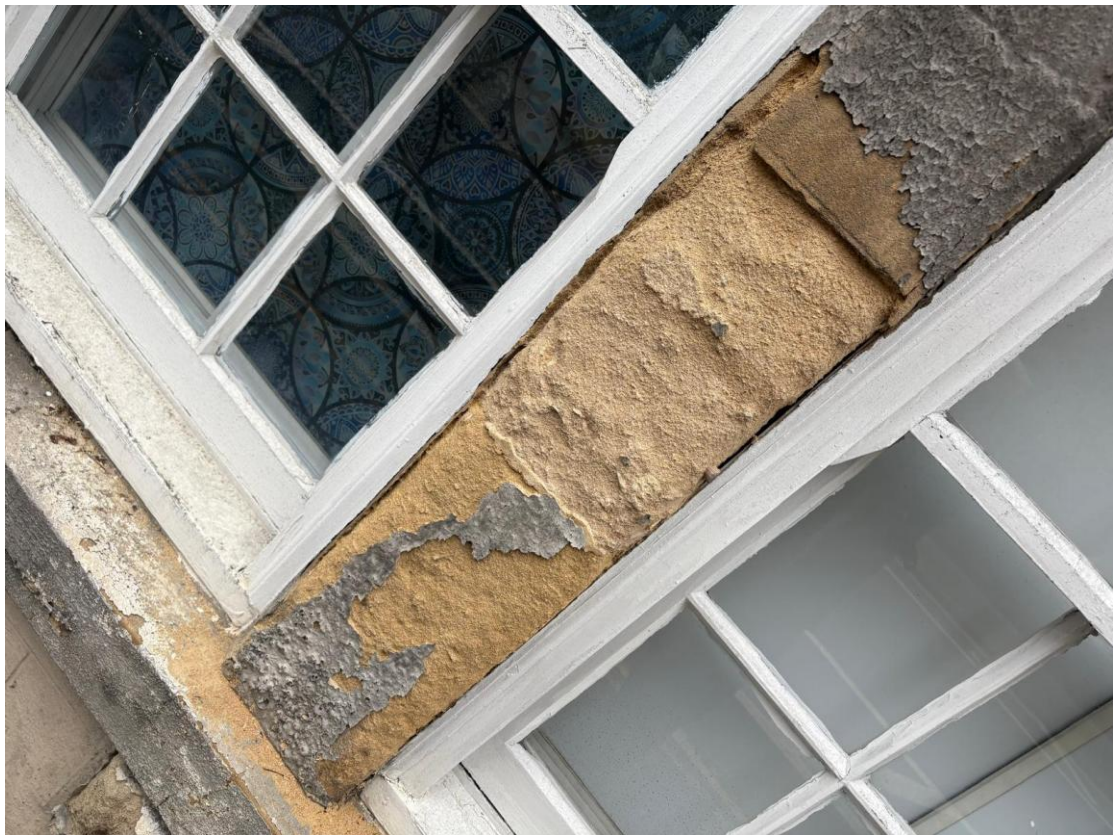
- **Ground Floor Stone Mullions:**
  - Exhibiting advanced deterioration, with visible cracking, spalling, and loss of profile.
  - Likely compromised structurally and aesthetically, requiring **extensive repair or full replacement.**
- **Ground Floor Window Cills:**
  - Exhibiting advanced deterioration, with visible spalling erosion, and loss of profile.

6. Significant erosion to stone window mullion – front ground floor.

- **Specialist Stone Repair:**
    - Engage conservation-grade stonemasons to assess and replace mullions using compatible stone and lime mortar.
    - Consider salvaging any sound sections where feasible.
  - **Pollution Mitigation:**
    - Introduce low-level planting or permeable barriers to reduce splashback and particulate accumulation.
    - Explore protective coatings only if breathable and conservation-approved.
  - **Moisture Management:**
    - Strip inappropriate paint layers carefully.
    - Allow stone to dry fully before any remedial works.
    - Repaint only with breathable mineral-based paints if necessary.
-

- **Engage stonemason** to assess deterioration of ground floor mullions.
- **Repair or replace** mullions using compatible stone and lime mortar.
- **Remove inappropriate paint layers** carefully; allow stone to dry fully before re-treatment.
- **Repaint with breathable mineral-based paints** if required.
- **Introduce pollution mitigation measures** (e.g. low-level planting or permeable barriers).

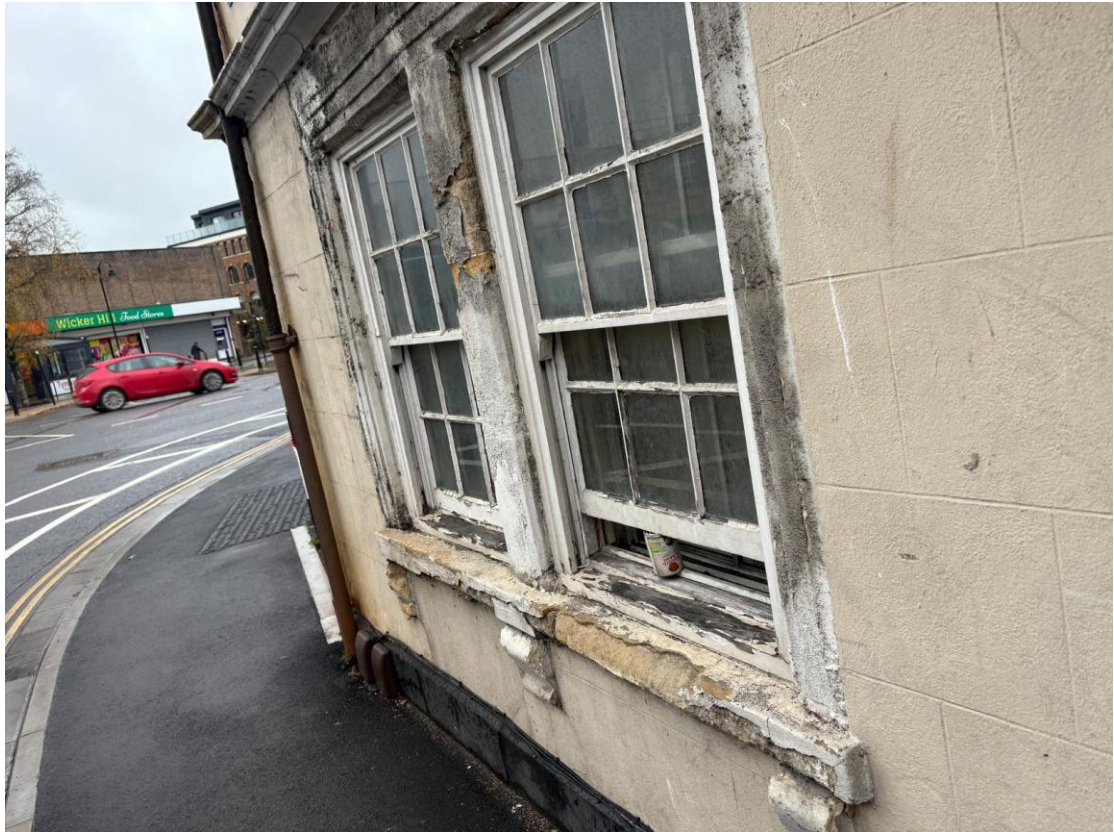
- Left hand side ground floor double stone window cill will require **full replacement** to match like for like to existing.
- **Environmental Stressors:**
  - **Road Traffic Pollution:** Continuous exposure to airborne particulates and exhaust fumes accelerating surface decay and discoloration.
  - **Water Erosion:** Rainwater runoff and splashback from adjacent hardstanding contributing to stone erosion and mortar washout.
  - **Inappropriate Paint Application:** Non-breathable coatings have trapped moisture within the stone, exacerbating freeze-thaw cycles and internal delamination.

7. Significant erosion to window cill – front left hand side.

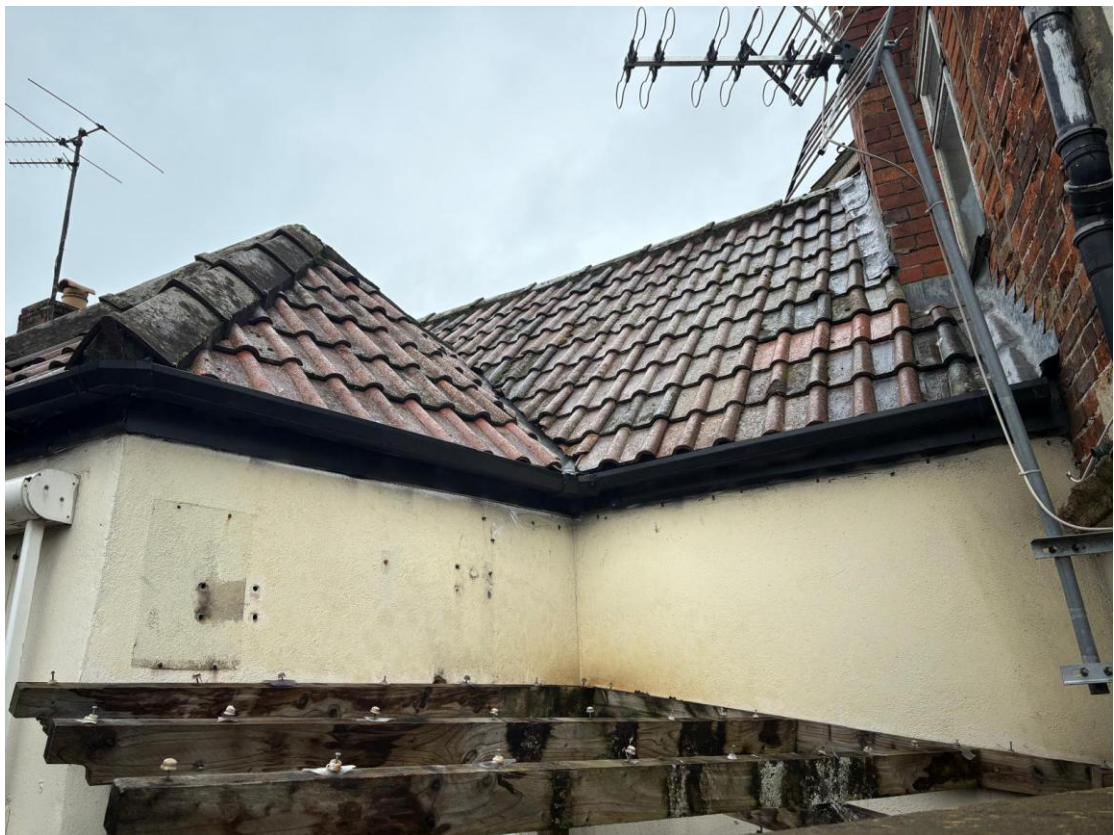
8. Decaying modern timber window requires replacement.

## 6. Replace rotten rear window.

- **Remove the existing decaying window as shown.**
- **Replace with purpose made hardwood opening casement window**
  - Double glazed for thermal efficiency.
  - To the approval of the Conservation Officer.

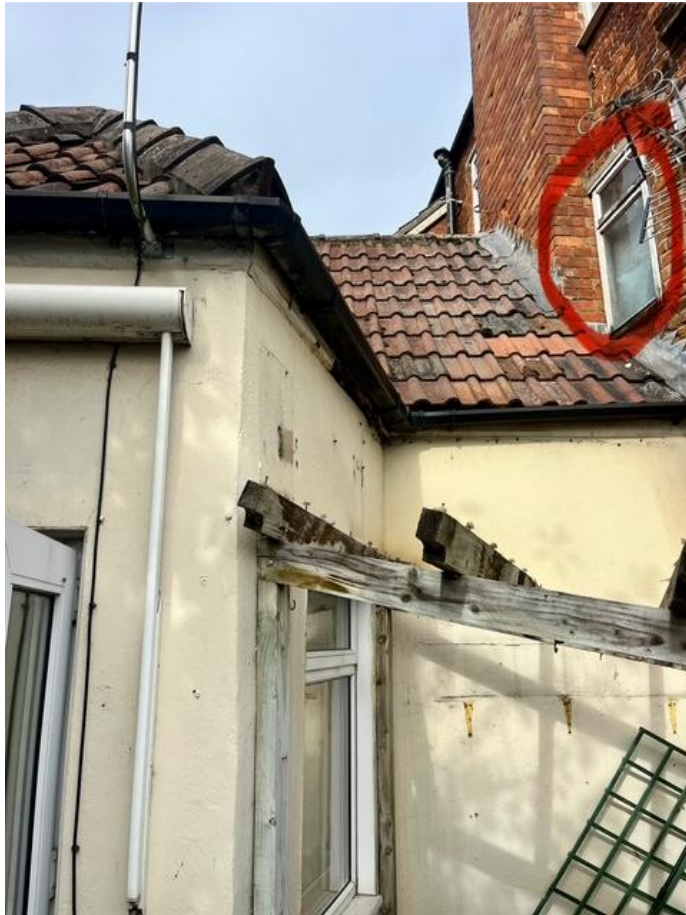
9. As above window to be replaced.
