Ref: 15337/EO/RPT/02

**STRUCTURAL ENGINEER'S INSPECTION REPORT**

**EXISTING BUILDINGS**

**7 AND 9 FISH ROW**  
**SALISBURY**  
**SP1 1EX**

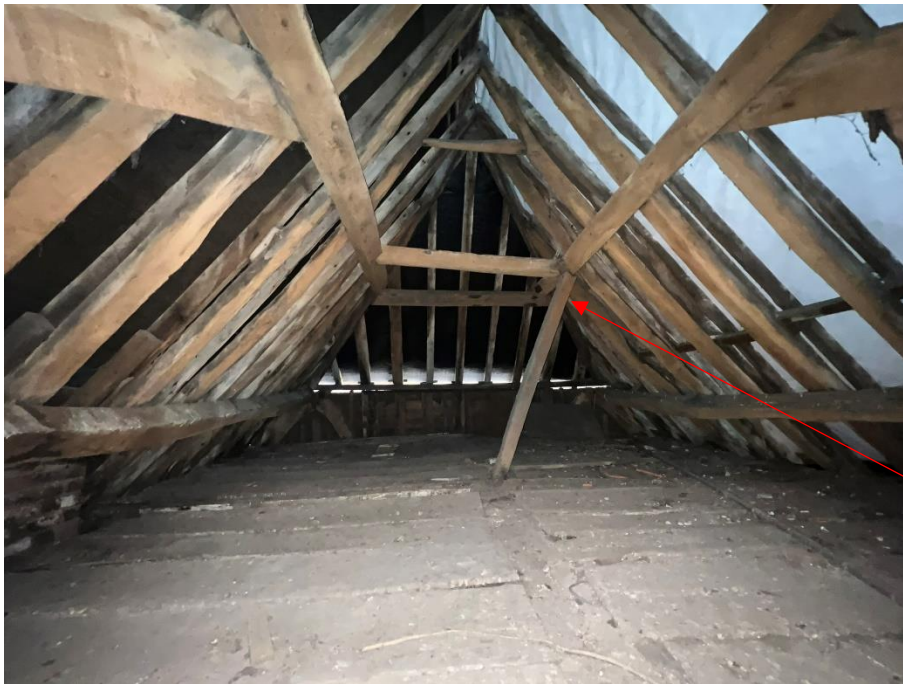
- 5.1 Room 11 – a timber prop has been introduced to support a partly fractured timber purlin on the West roof pitch (refer to Photograph 01 in Appendix A). The prop is supported on the ceiling beam beneath (effectively changing the original load path for which the roof and floor structures would have originally been designed for).

Photograph 01      7 and 9 Fish Row, Salisbury SP1 1EX  
Room 11 – Facing South – Showing propped fractured purlin

- A. Room 11 – the fractured timber purlin should be repaired or replaced. The prop can then be removed. It would be a prudent approach to allow for laying new floor also.

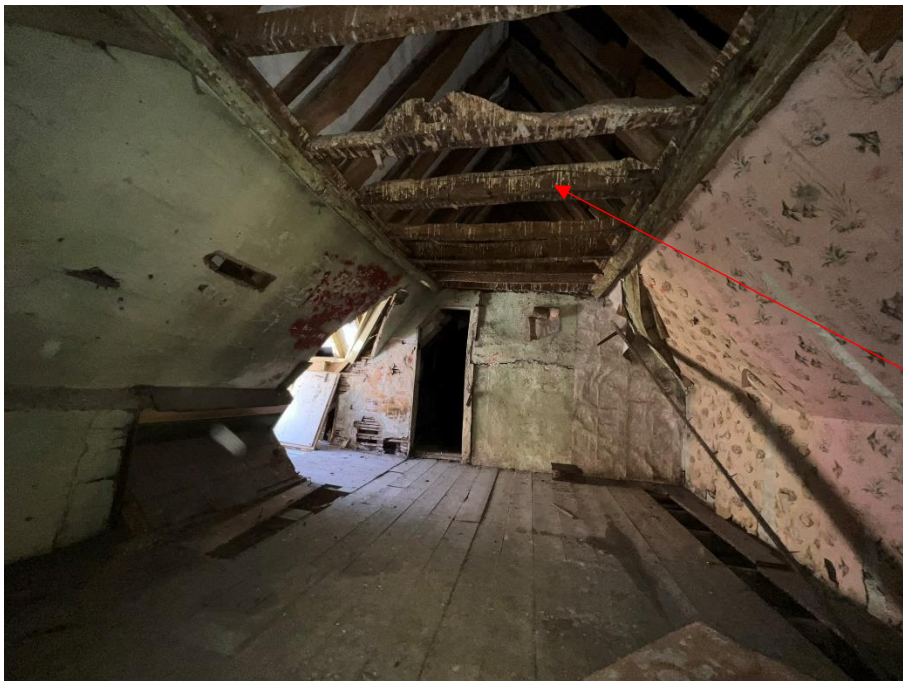
- 5.2 Room 10 – the ceiling ties appear to have deteriorated (refer to Photographs 02 and 03 in Appendix A). The ceiling ties are connected to and provide lateral restraint to the purlins.

Photograph 02      7 and 9 Fish Row, Salisbury SP1 1EX  
Room 10 – Facing North – Showing deteriorated ceiling ties

- B. Room 10 – the ceiling ties should be replaced; these should be nailed or screwed into the existing purlins.
- C. Room 9 – the fractured timber purlin should be repaired or replaced. The prop can then be removed. It would be a prudent approach to allow for laying new floor also.

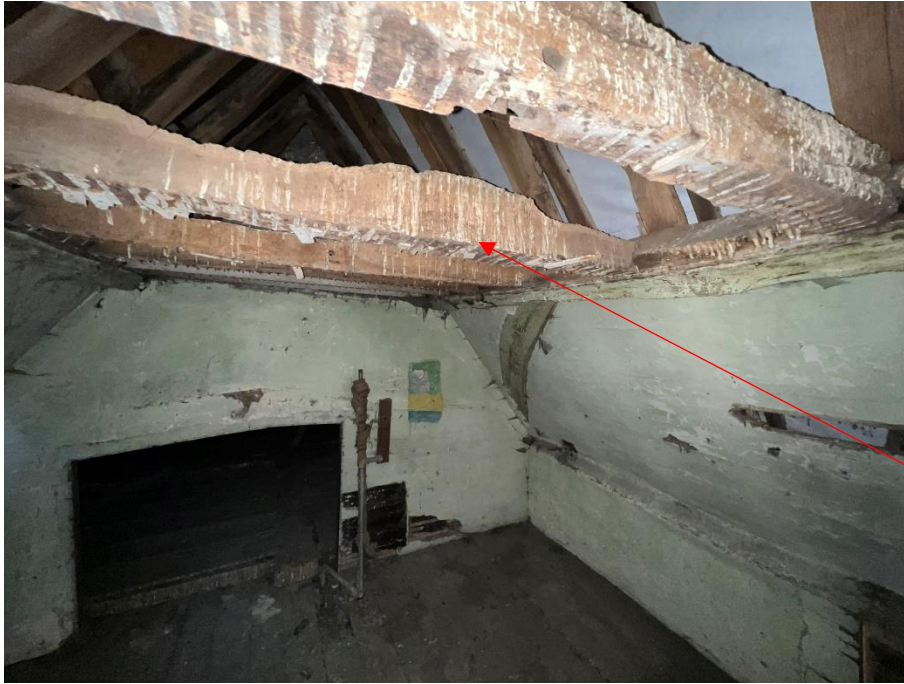
Photograph 03      7 and 9 Fish Row, Salisbury SP1 1EX  
Room 10 – Facing South – Showing deteriorated ceiling ties

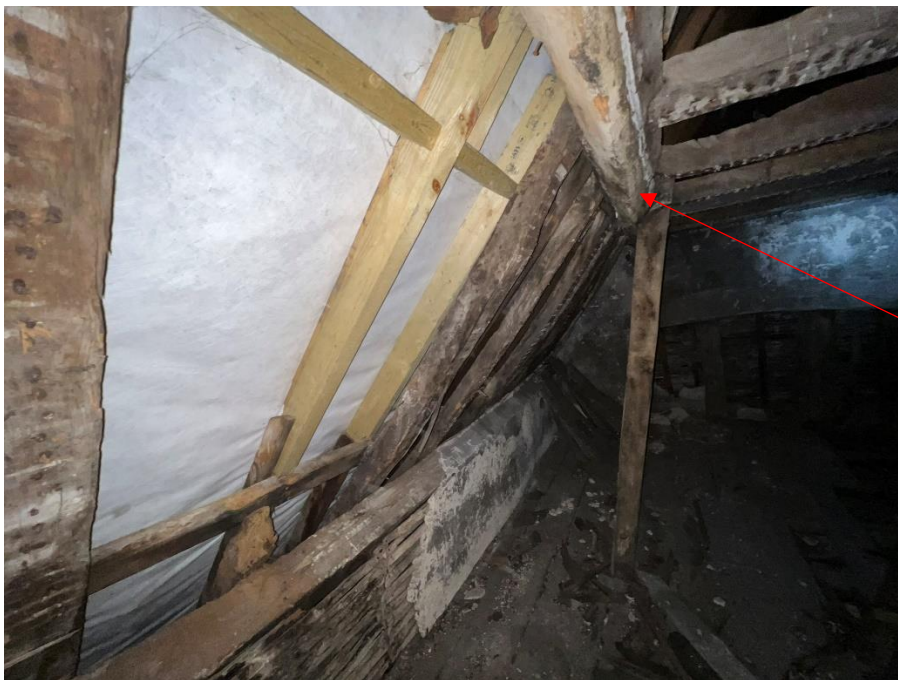
- 5.3 Room 9 – a timber prop has been introduced to support a partly fractured timber purlin on the West roof pitch (refer to Photograph 04 in Appendix A). The prop is supported on the ceiling beam beneath (effectively changing the original load path for which the roof and floor structures would have originally been designed for).

Photograph 04      7 and 9 Fish Row, Salisbury SP1 1EX  
Room 9 – Facing North – Showing propped fractured purlin

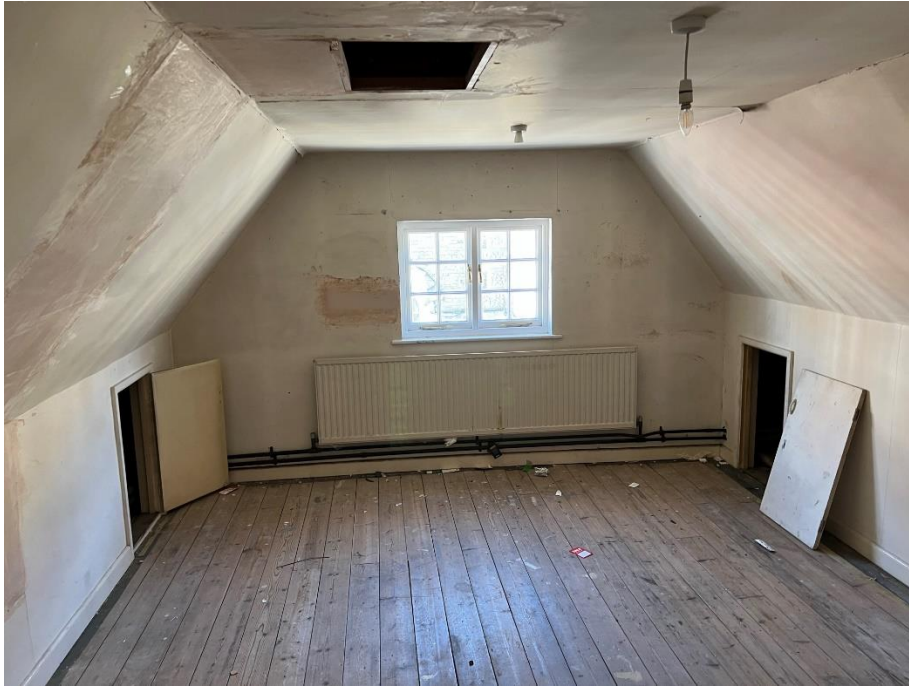
- 5.4 Room 1 – the walls and roof structure are in good condition, with no structural defects of note (refer to Photographs 05, 06 and 07 in Appendix A).

Photograph 05      7 and 9 Fish Row, Salisbury SP1 1EX  
Room 1 – Facing North – in good condition

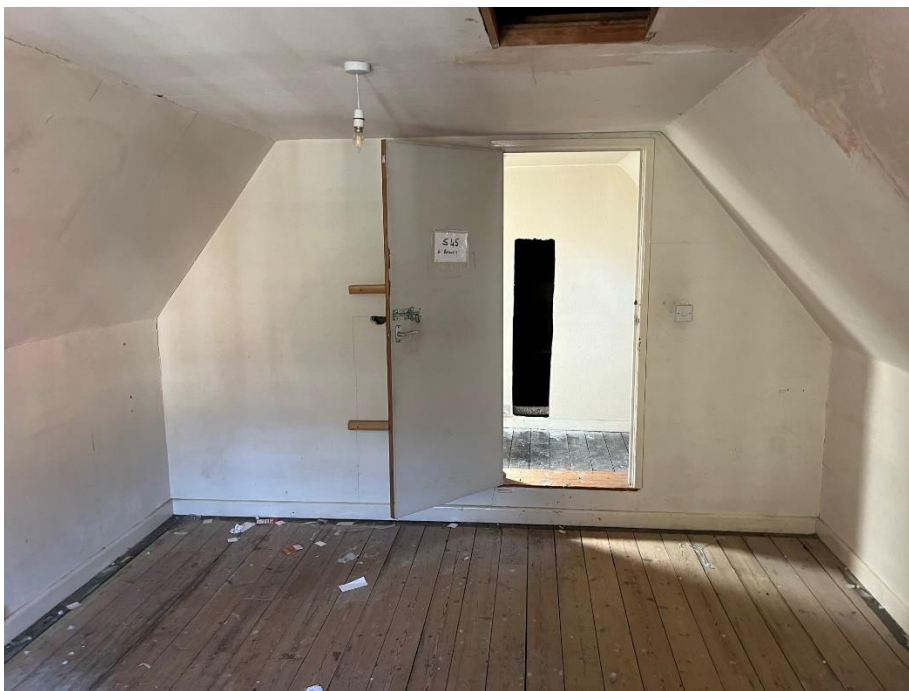
Photograph 06      7 and 9 Fish Row, Salisbury SP1 1EX  
Room 1 – Facing South – in good condition

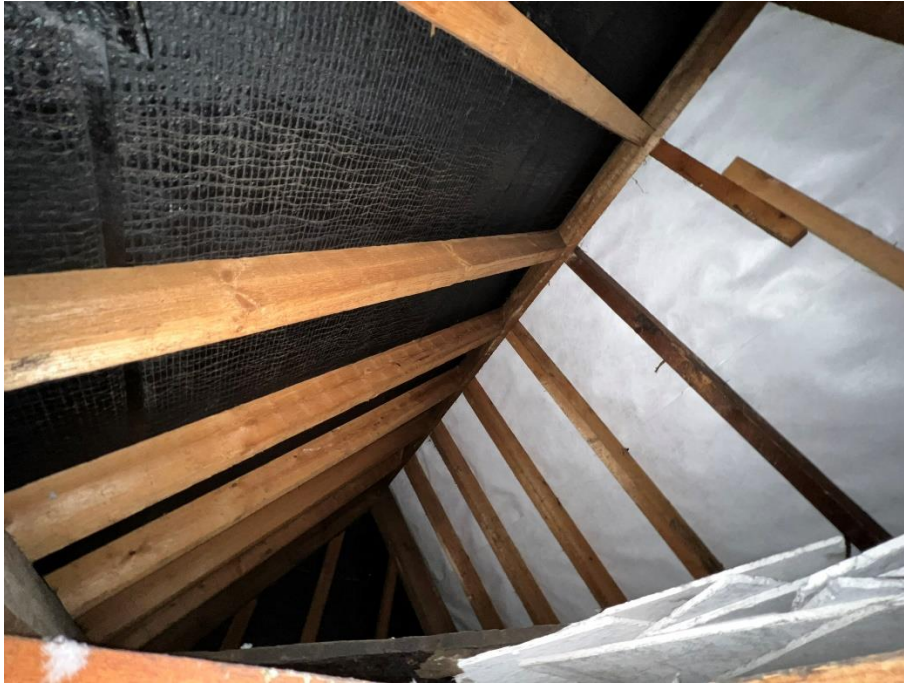
Photograph 07

7 and 9 Fish Row, Salisbury SP1 1EX  
Room 1 – Roof structure over – in good condition

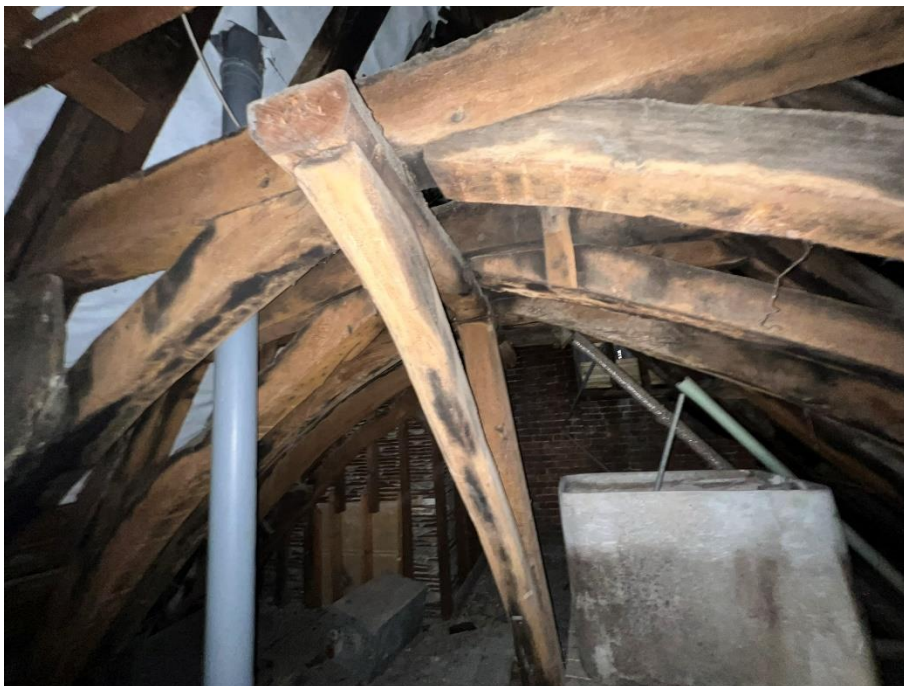
- 5.5 Room 8 – the historic roof timbers are in reasonably good condition, with no sign of any significant deterioration (refer to Photograph 08 in Appendix A).

7 and 9 Fish Row, Salisbury SP1 1EX  
Room 8 – Facing South – Historic timber framing – in reasonably good condition

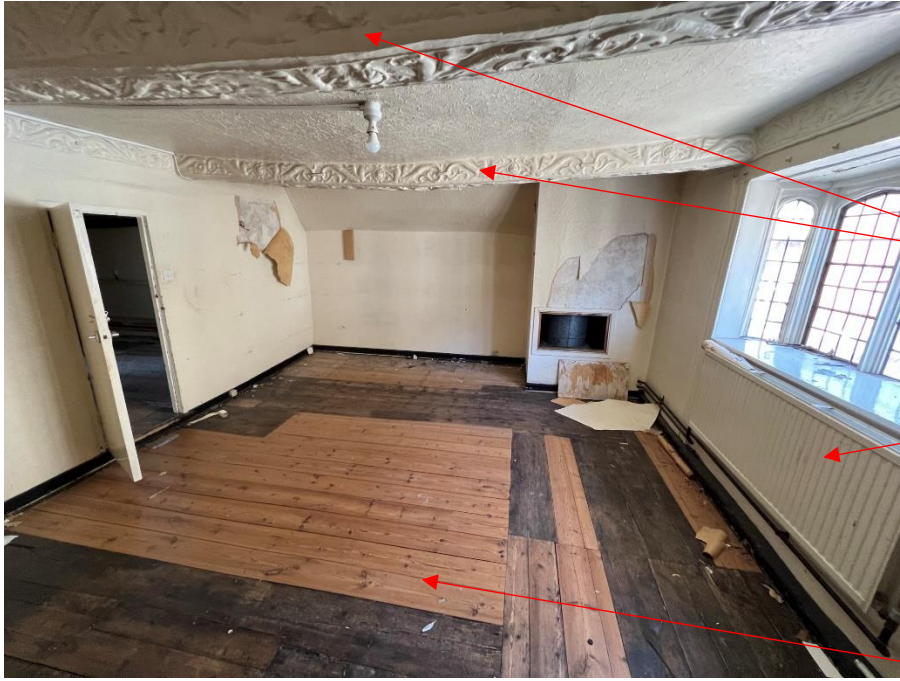
Photograph 09

- 5.6 Room 2 – the ceiling beams (one of which supports to the timber prop alluded to in Section 5.1 above) could be seen to be sagging excessively; the floors were somewhat uneven and sagging excessively also. The north elevation wall could be seen to be leaning outward slightly (refer to Photographs 09, 10 and 11). Given the age of the building, this type of movement is to be expected and the building should continue to be assessed on an ongoing basis. Some remedial measures are recommended in the short term to stiffen up the ceiling and floors.

7 and 9 Fish Row, Salisbury SP1 1EX  
Room 2 – Facing west – Sagging ceiling beams, sagging floor and leaning wall elevation

- D. Room 2 – The ceiling beams should be stiffened up to prevent further sagging or creep occurring over time. This can be achieved by introducing threaded metal bars in the internal body of the beams, bedded in epoxy resin; this can be done from above the ceiling, whilst preserving the historic cornices and other ceiling finishes to the underside. It would be a prudent approach to allow for laying new joists also.

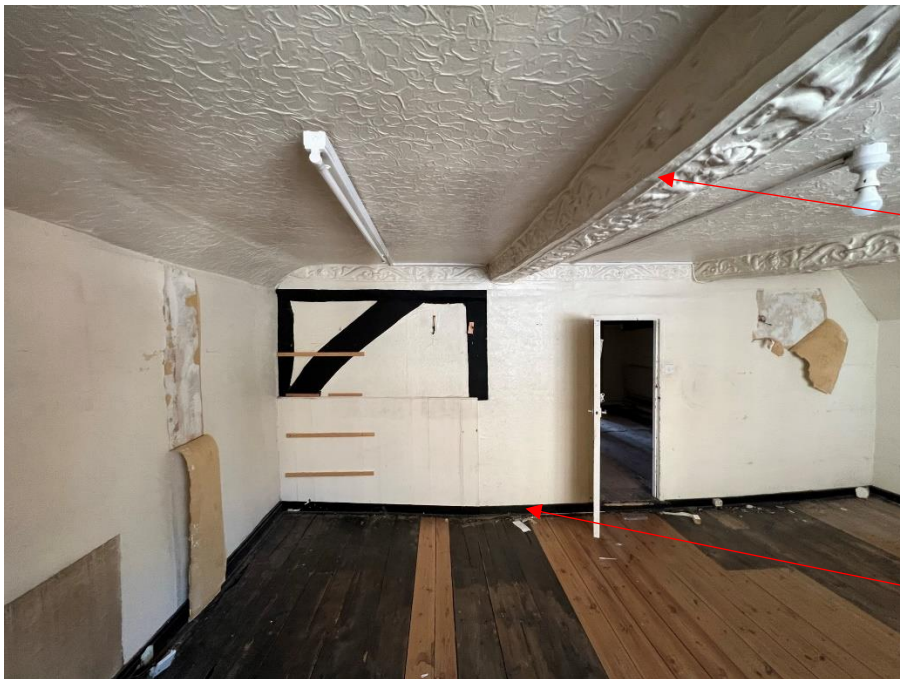
Photograph 10

7 and 9 Fish Row, Salisbury SP1 1EX  
Room 2 – Facing South – Sagging ceiling beam and sagging floor

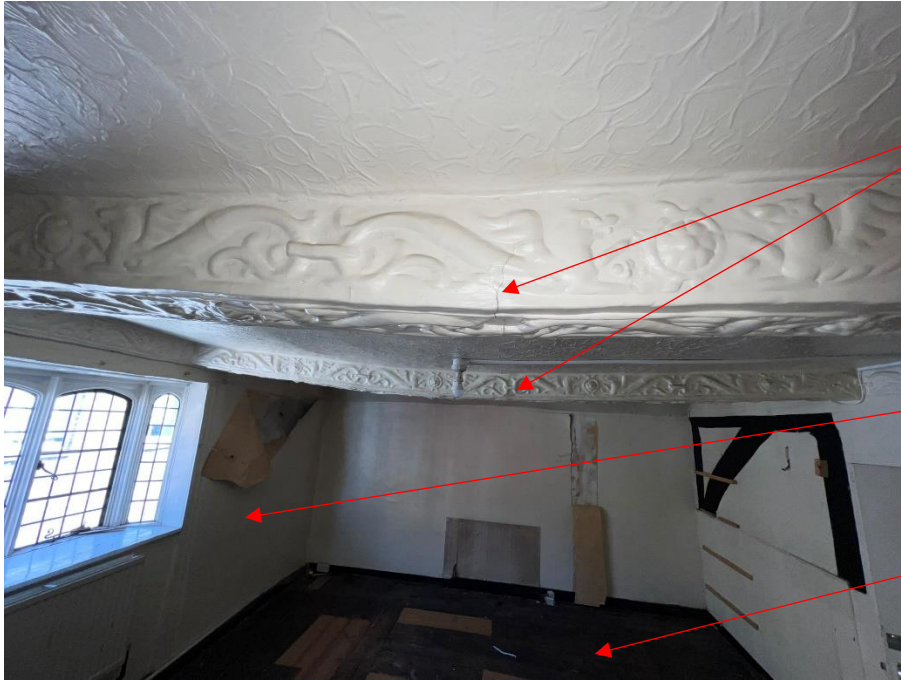
Photograph 11

7 and 9 Fish Row, Salisbury SP1 1EX  
Room 2 – Facing East – Sagging ceiling beams, sagging floor and leaning wall elevation

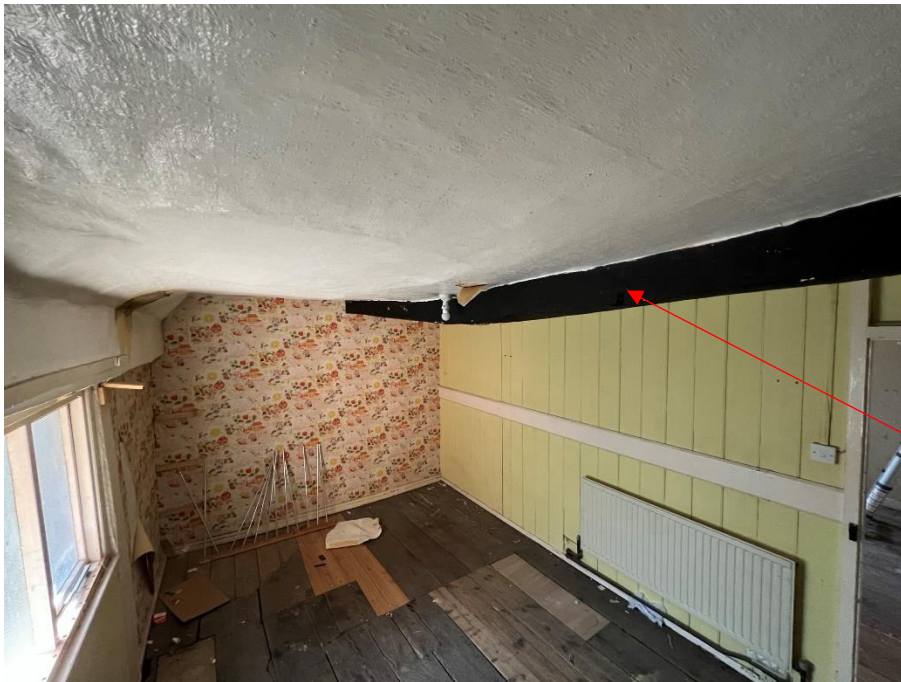
- 5.7 Room 3 – a ceiling beam could be seen to be sagging excessively (refer to Photograph 12 in Appendix A). Some remedial work is recommended to stiffen up the ceiling beam.

7 and 9 Fish Row, Salisbury SP1 1EX  
Room 3 – Facing South – Sagging ceiling beam

- E. Room 3 – The ceiling beam should be stiffened up to prevent further sagging or creep occurring over time. This can be achieved by introducing threaded metal bars in the internal body of the beams, bedded in epoxy resin; this can be done from above the ceiling, whilst preserving the historic cornices and other ceiling finishes to the underside.

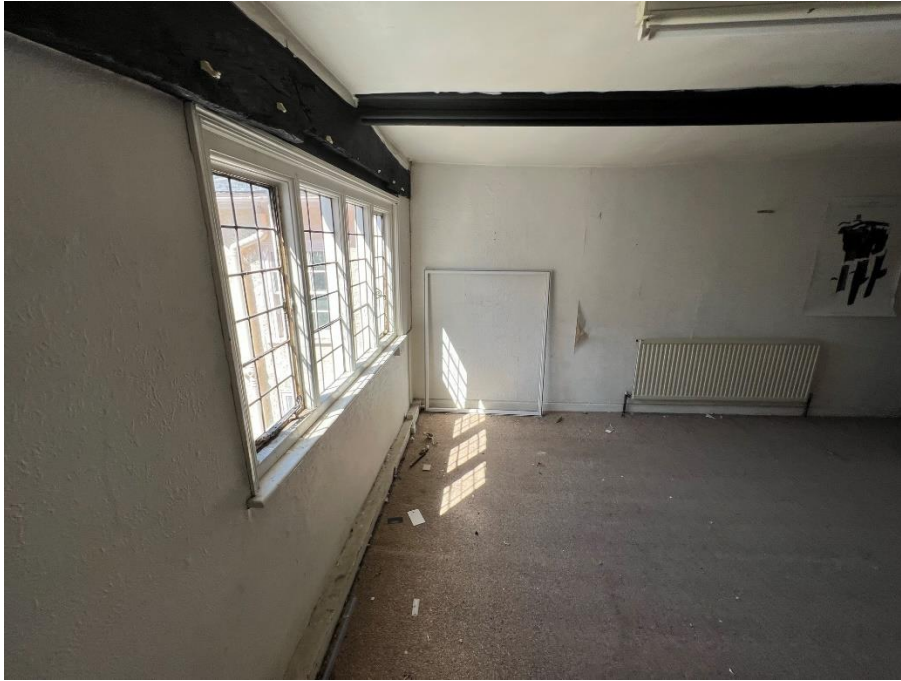
- 5.8 Room 4 – the walls and ceiling are in reasonably good condition, with no structural defects (refer to Photographs 13 and 14 in Appendix A).
- 5.9 Communal Area – the walls, floor and ceiling are in reasonably good condition, with no structural defects (refer to Photographs 15, 16 and 17 in Appendix A).

Photograph 13      7 and 9 Fish Row, Salisbury SP1 1EX  
Room 4 – Facing West – in reasonably good condition

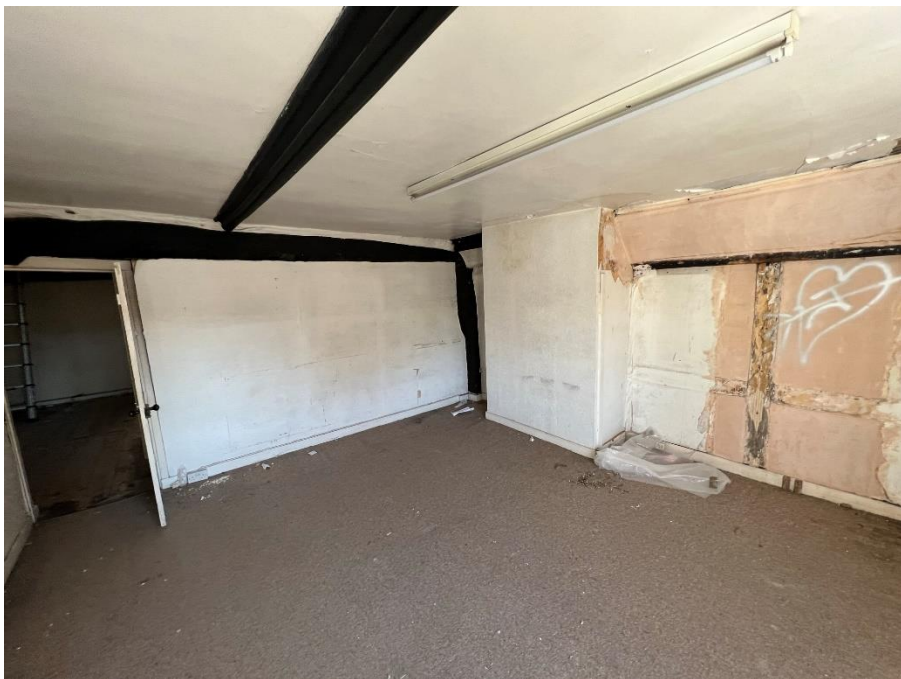
Photograph 14      7 and 9 Fish Row, Salisbury SP1 1EX  
Room 4 – Facing North – in reasonably good condition

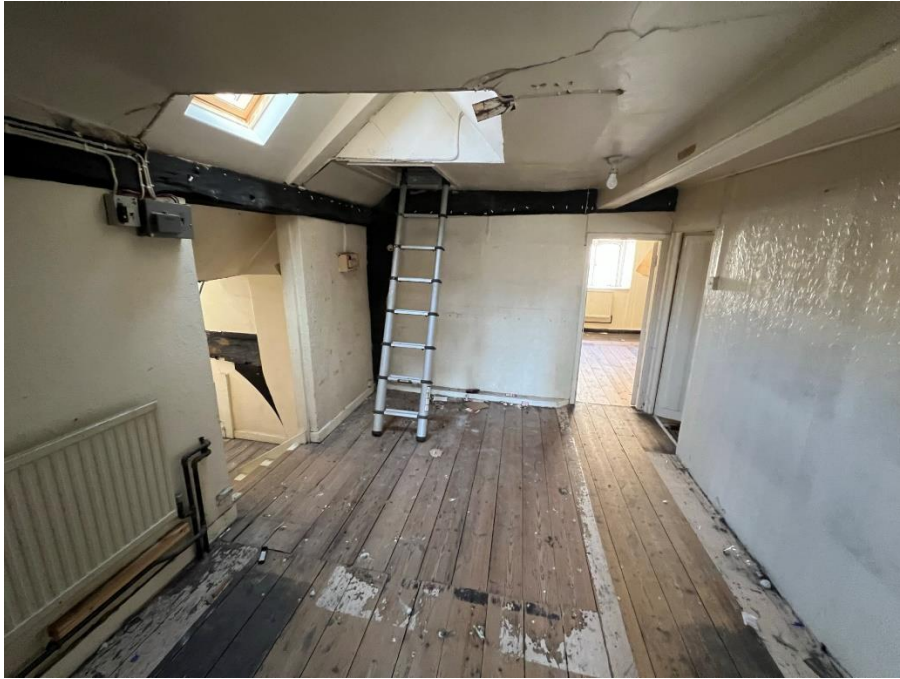
Photograph 15      7 and 9 Fish Row, Salisbury SP1 1EX  
Communal Area – Facing North – in reasonably good condition

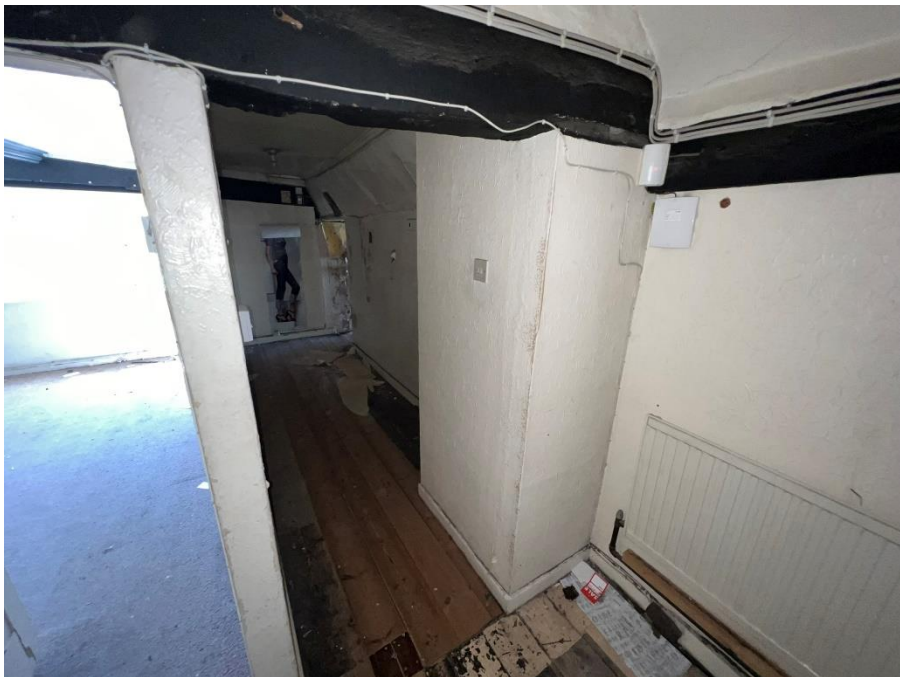
Photograph 16      7 and 9 Fish Row, Salisbury SP1 1EX  
Communal Area – Facing South – in reasonably good condition

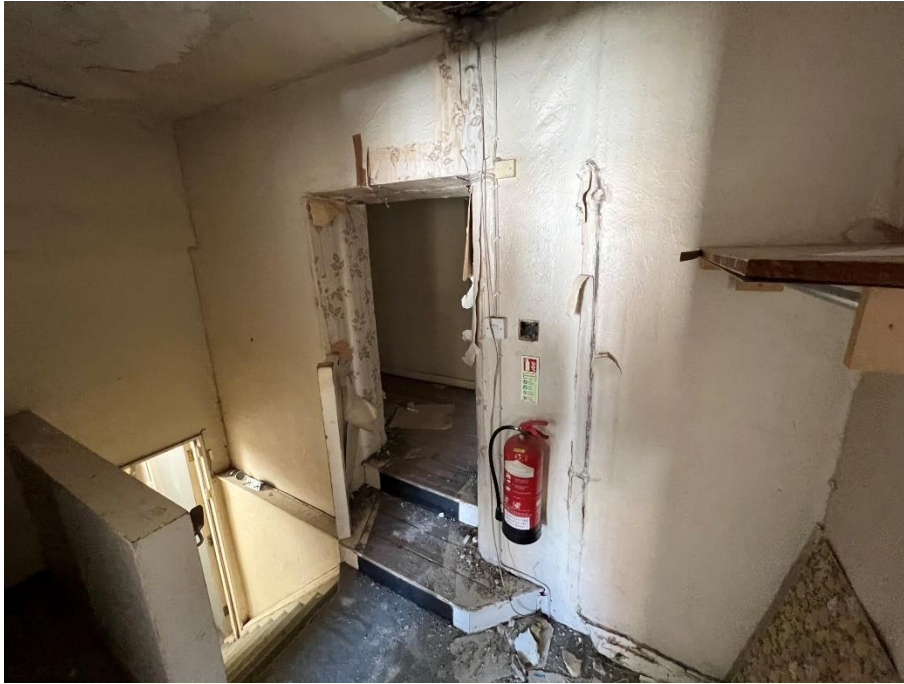
Photograph 17      7 and 9 Fish Row, Salisbury SP1 1EX  
Communal Area – Facing East – in reasonably good condition

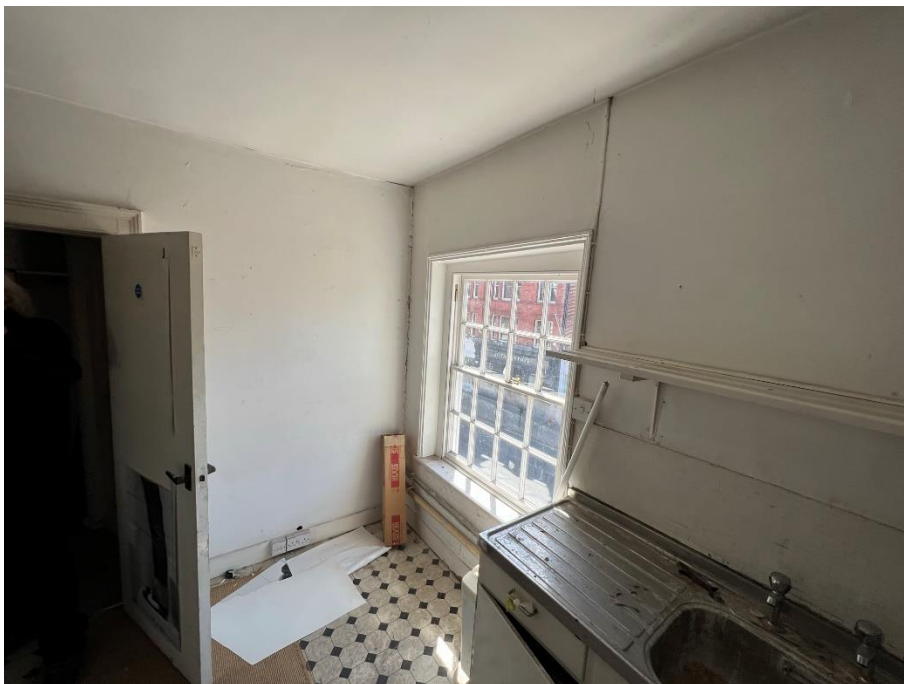
- 5.10 Room 5 – the walls, floor and ceiling are in reasonably good condition, with no structural defects (refer to Photographs 18 and 19 in Appendix A).
- 5.11 Room 6 – a crack could be seen in the ceiling; some signs of past water ingress could be seen also (refer to Photographs 20 and 21 in Appendix A). The cracking is not thought to be structurally significant, and is thought to be related to the water ingress issues which were evident. The roof timbers which were exposed at the time of the inspection did not appear to be affected by any water ingress issues. Measures should be taken to address any water ingress issues, if these have not already been taken care of.

Photograph 18      7 and 9 Fish Row, Salisbury SP1 1EX  
Room 5 – Facing East – in reasonably good condition

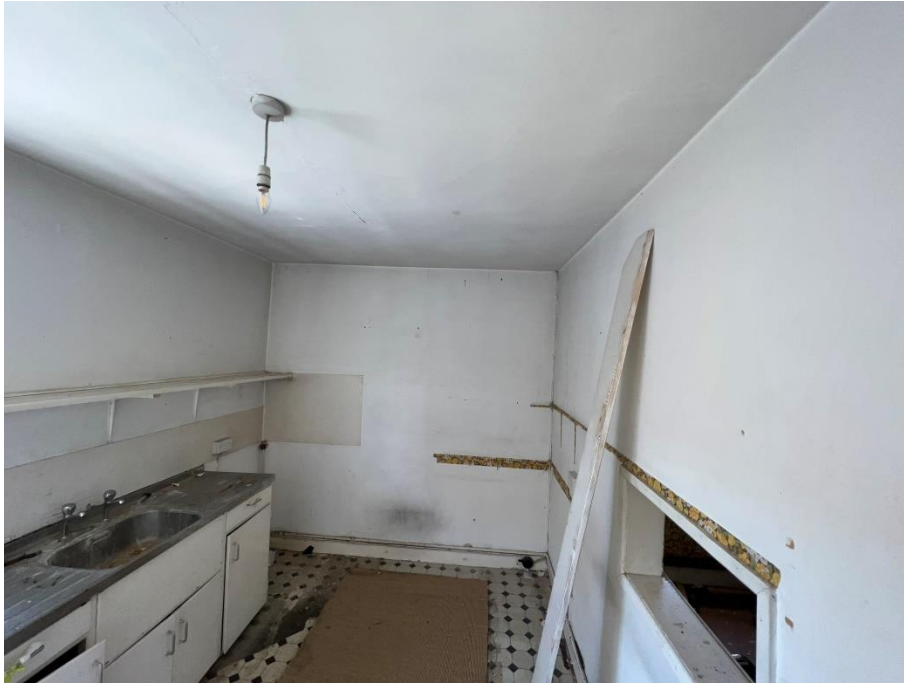
Photograph 19

7 and 9 Fish Row, Salisbury SP1 1EX  
Room 5 – Facing West – in reasonably good condition

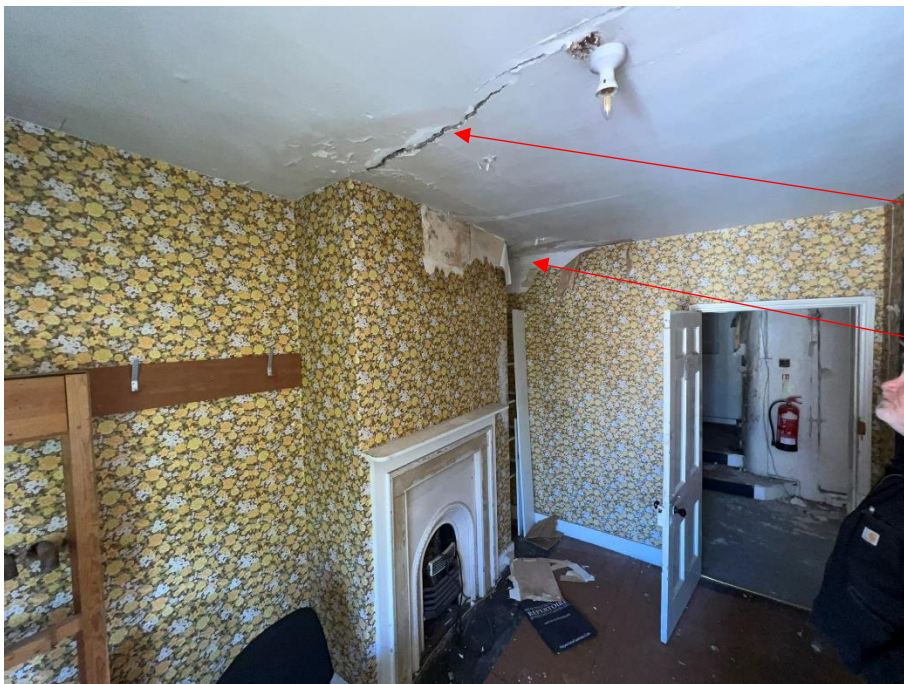
Photograph 20

7 and 9 Fish Row, Salisbury SP1 1EX  
Room 6 – Facing East – Showing crack in ceiling and some water penetration issues in ceiling, but otherwise in reasonably good condition

- F. Room 6 – the water ingress issues should be addressed in the short term, if not already done so.  
The crack should be suitably filled and covered over with an appropriate ceiling finish.

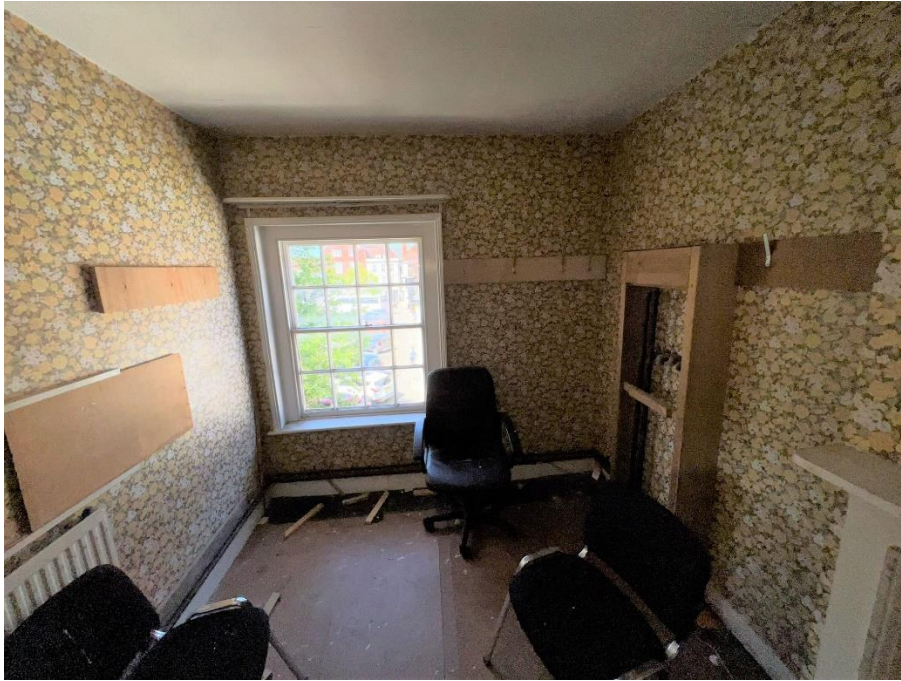
Photograph 21

7 and 9 Fish Row, Salisbury SP1 1EX  
Room 6 – Facing West – in reasonably good condition
