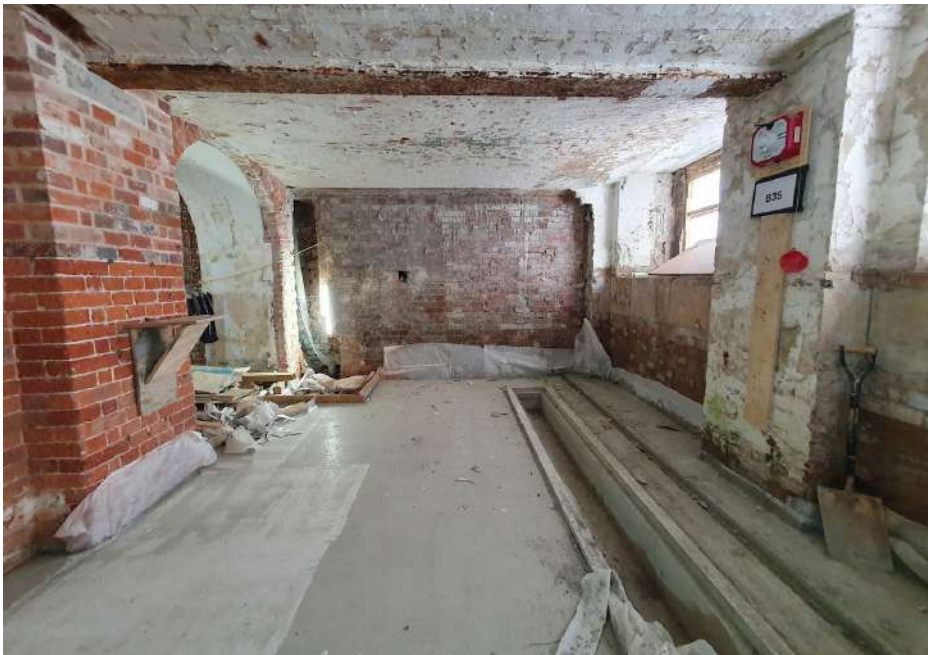
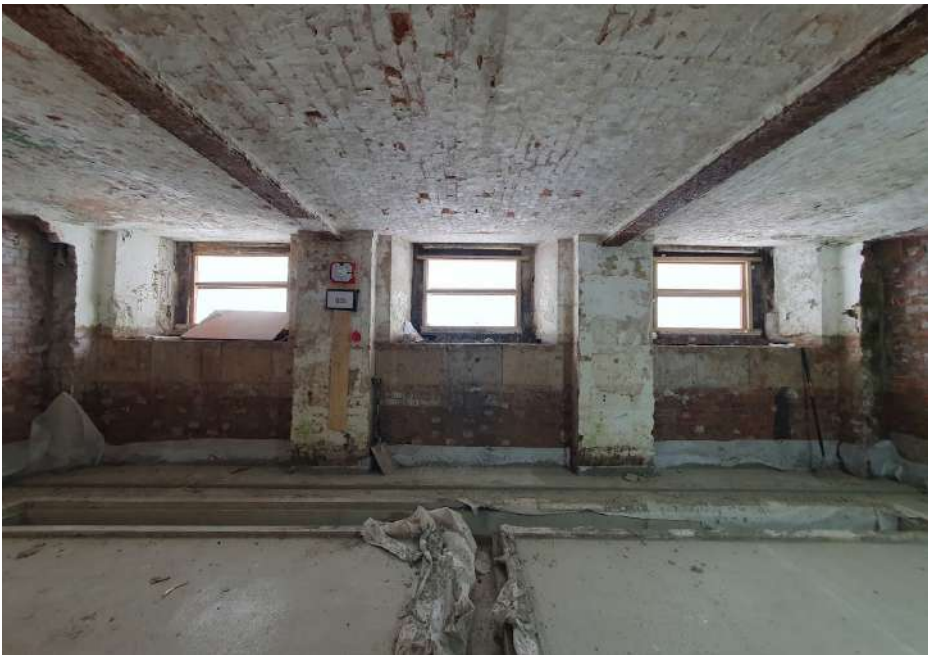
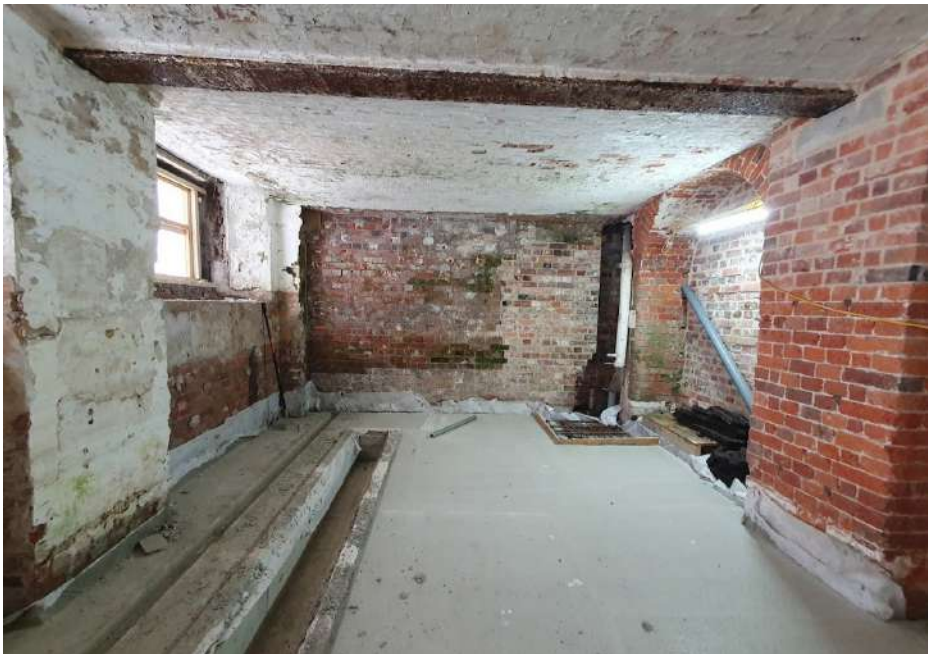
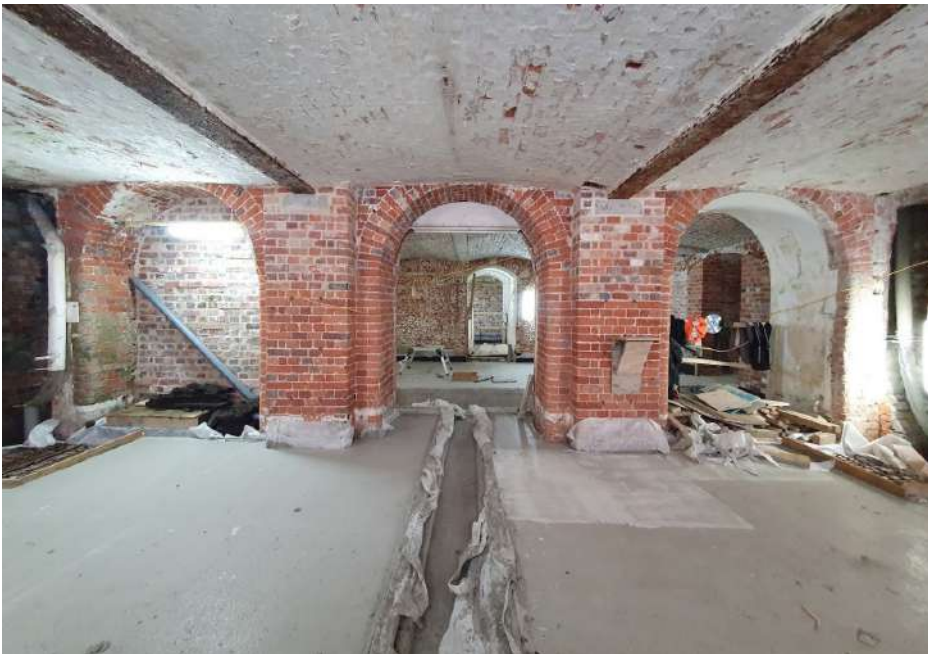
**Walls** –finishes not present. Traditional lime plaster to masonry reinstated with embedded waterproofing membrane as consented.

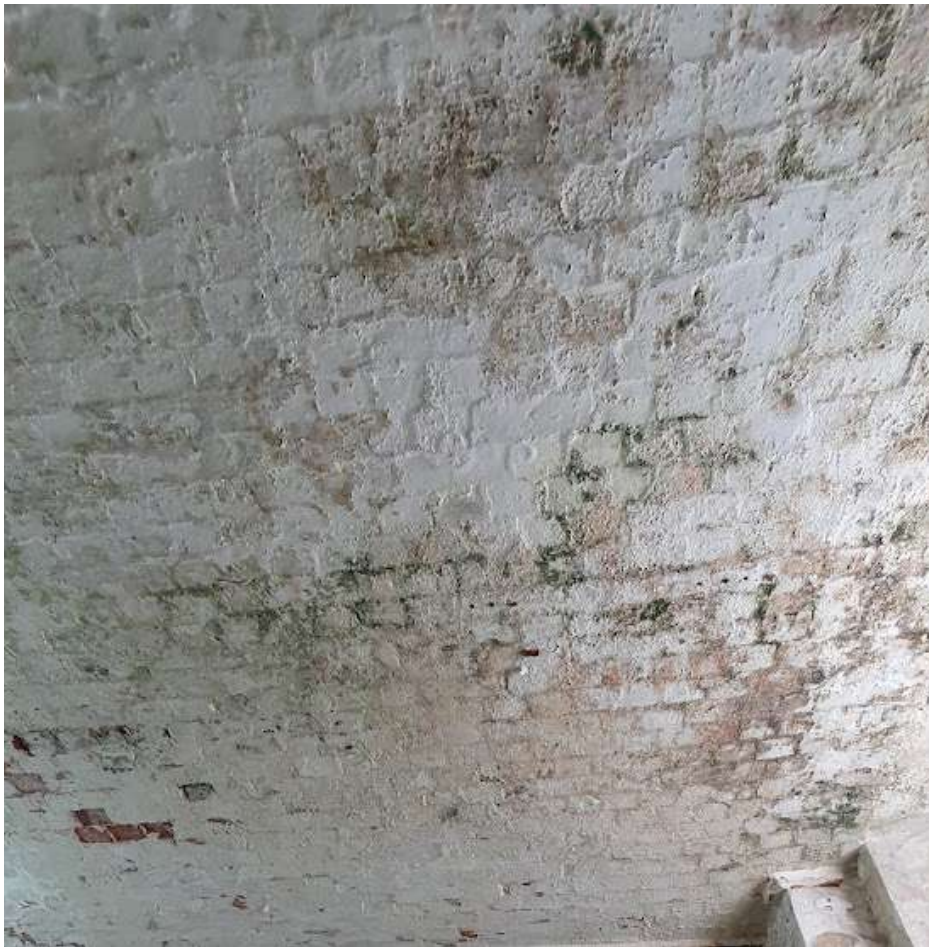
CEILING

**Ceiling** – brickwork to be cleaned and allowed to dry out. Repairworks to above terrace should resolve all damp ingress. Traditional lime plaster to masonry introduced. Plastered finish preferred as the space is used as a food storage area.

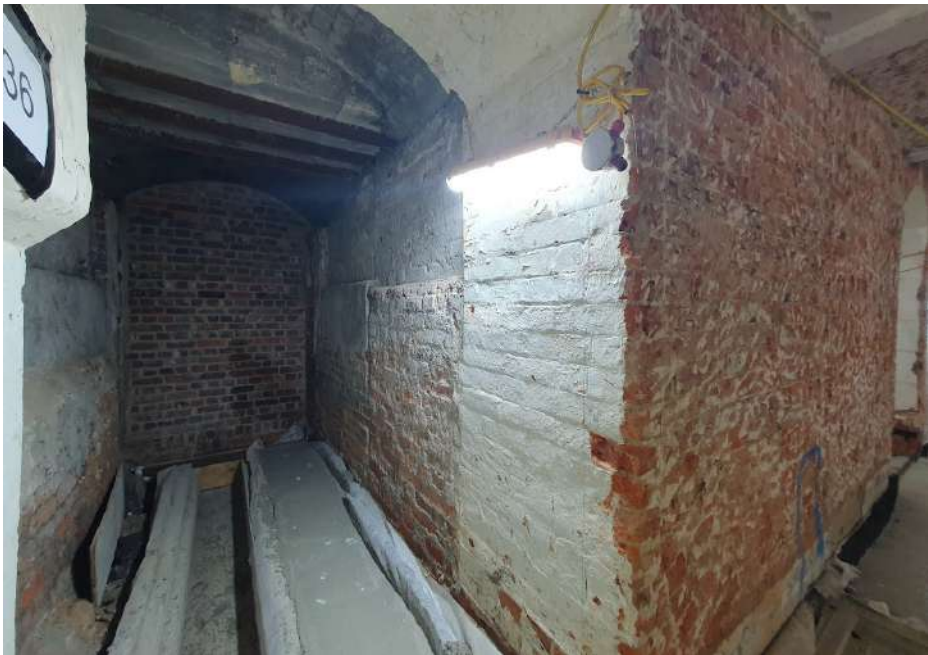
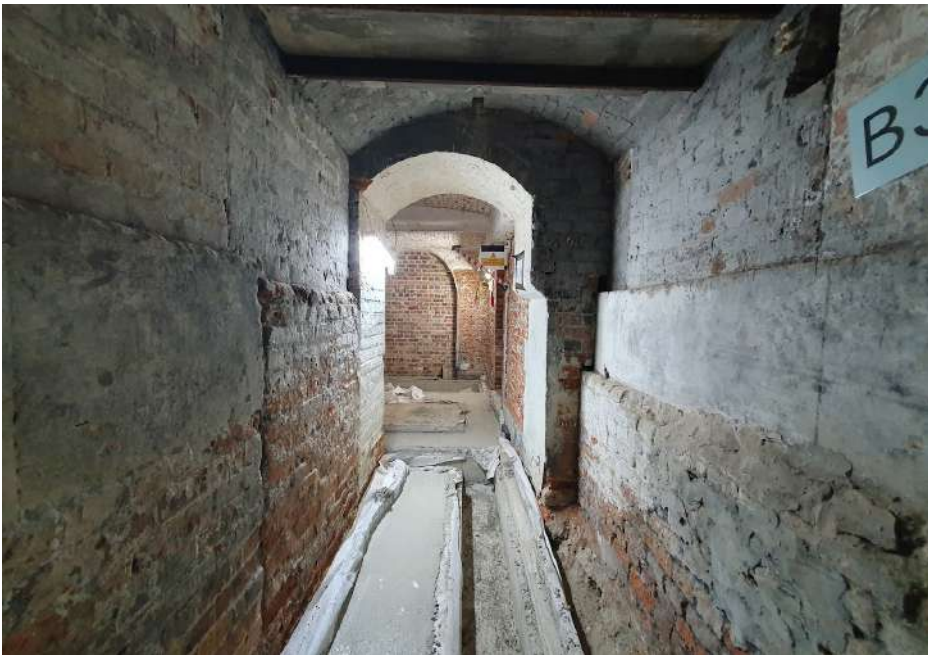
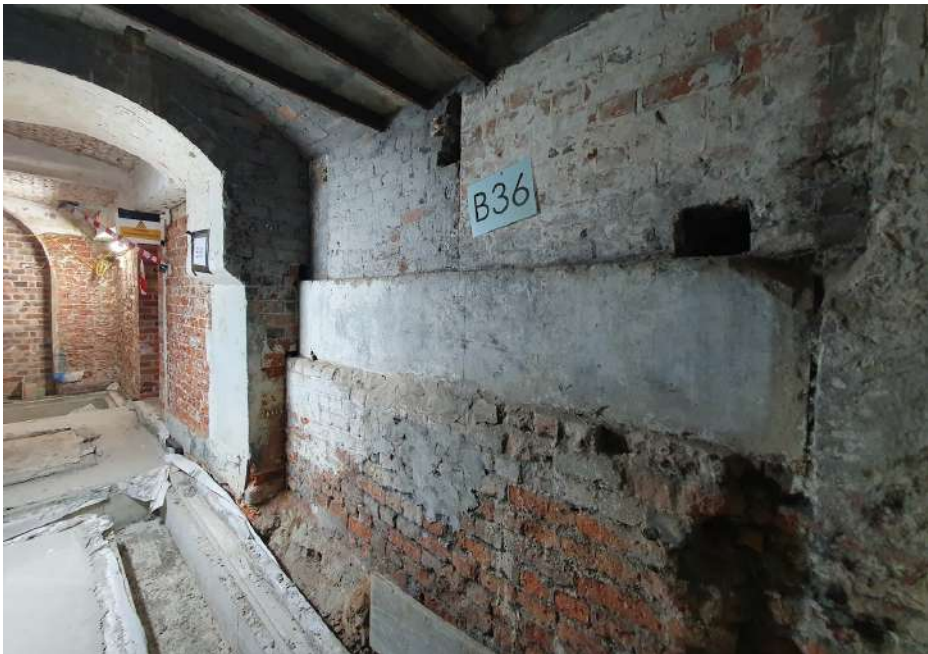
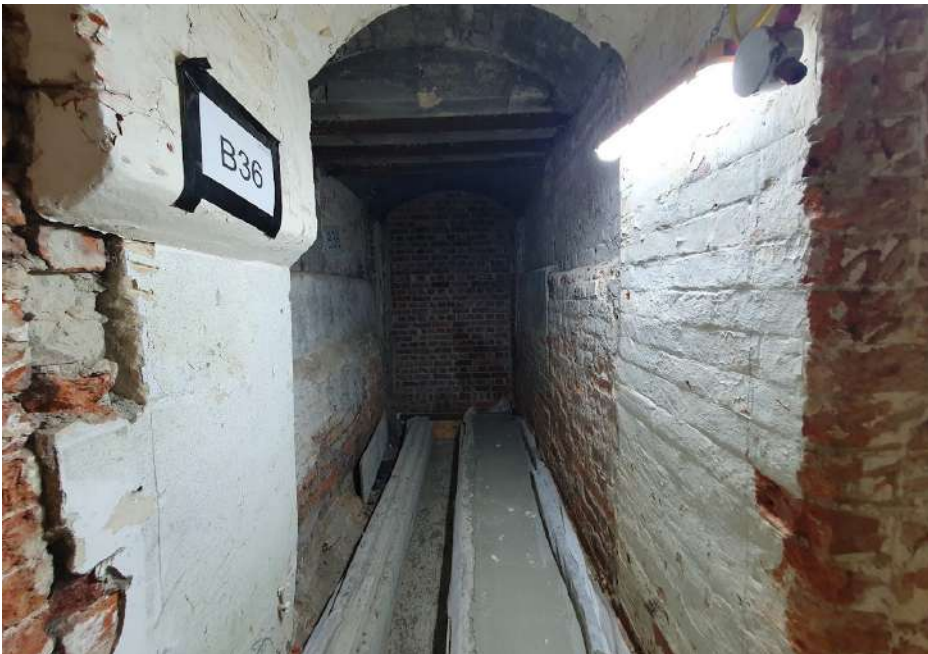
**Walls** – a mix of stone and brickwork. Fabric cleaned and consolidated with repointing in matching lime mortar.

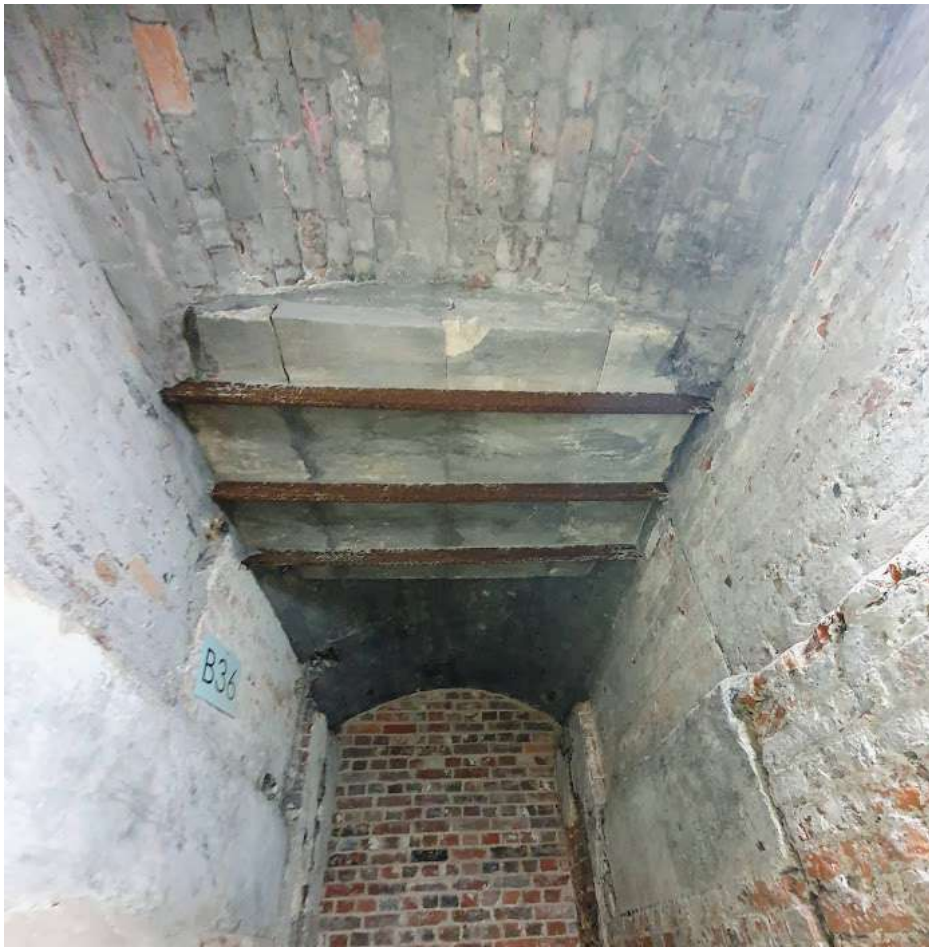
CEILING

**Ceiling** – a mix of stone and brickwork. Fabric cleaned and consolidated with repointing in matching lime mortar. Cast iron elements cleaned and redecorated to protect from rust.

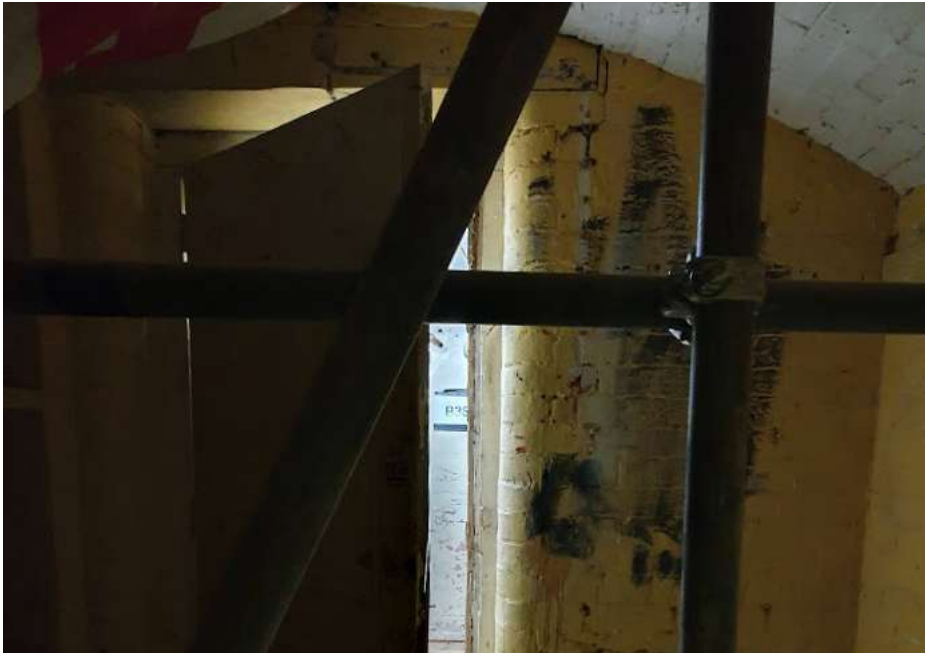
NORTH ELEVATION

**Walls** – brickwork with modern paint finish and masonry shelving to west wall. Modern paint to be cleaned off and substrate consolidated with lime mortar repointing to match. Retained as exposed brickwork.

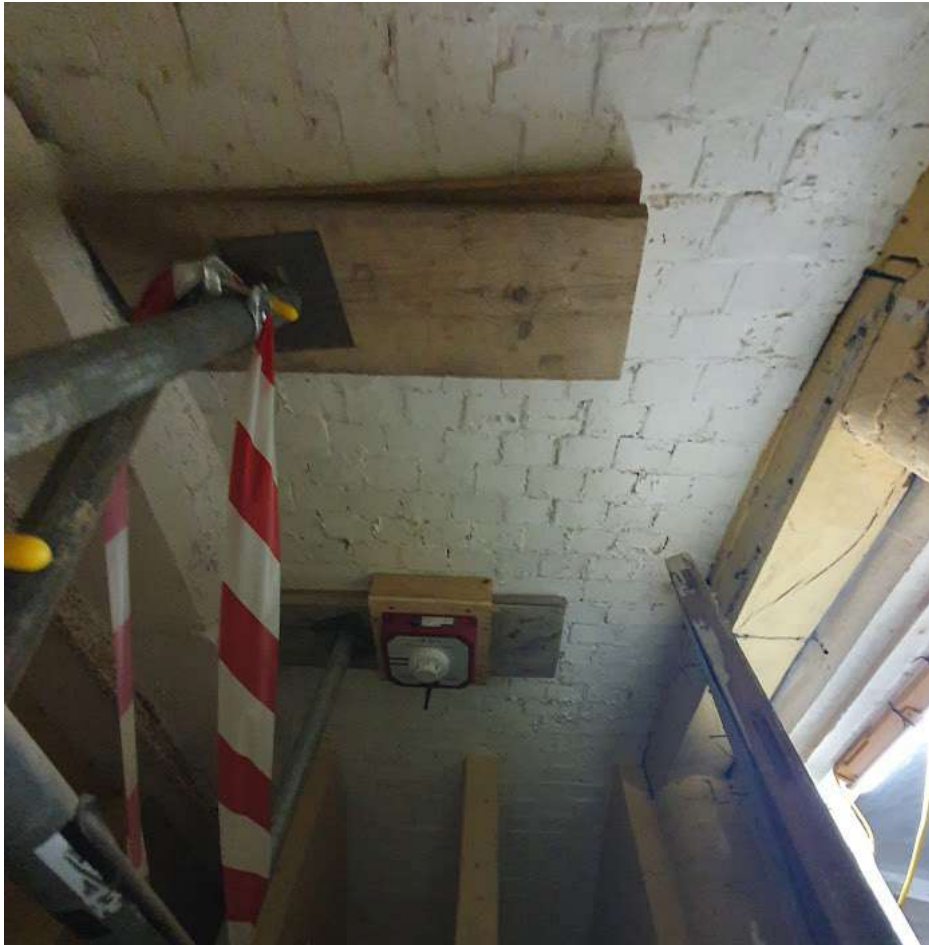
CEILING

**Ceiling** – masonry vault with modern paint finish. Modern paint to be cleaned off and substrate consolidated with lime mortar repointing to match. Retained as exposed brickwork.

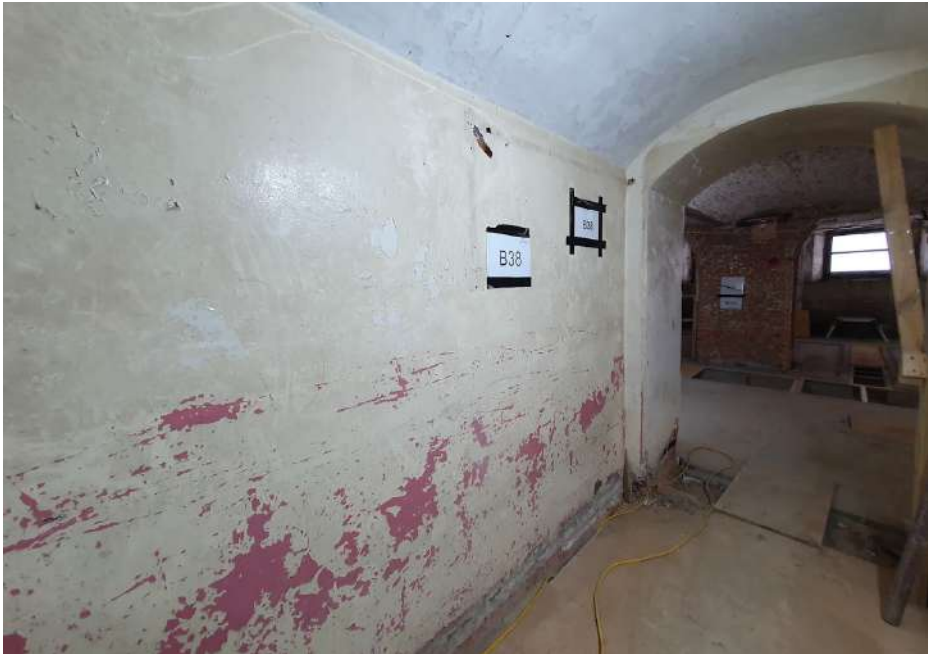
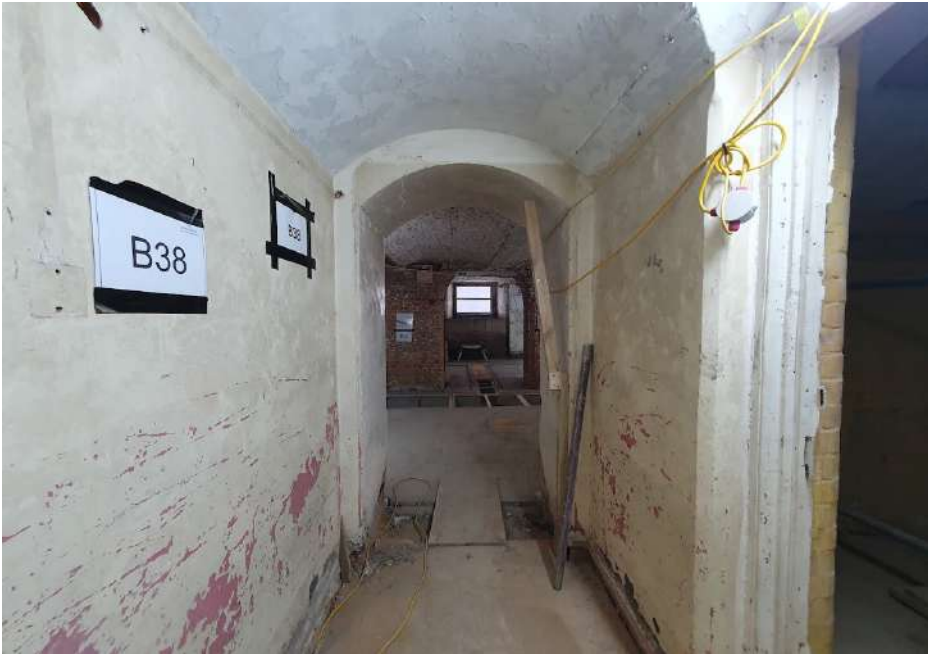
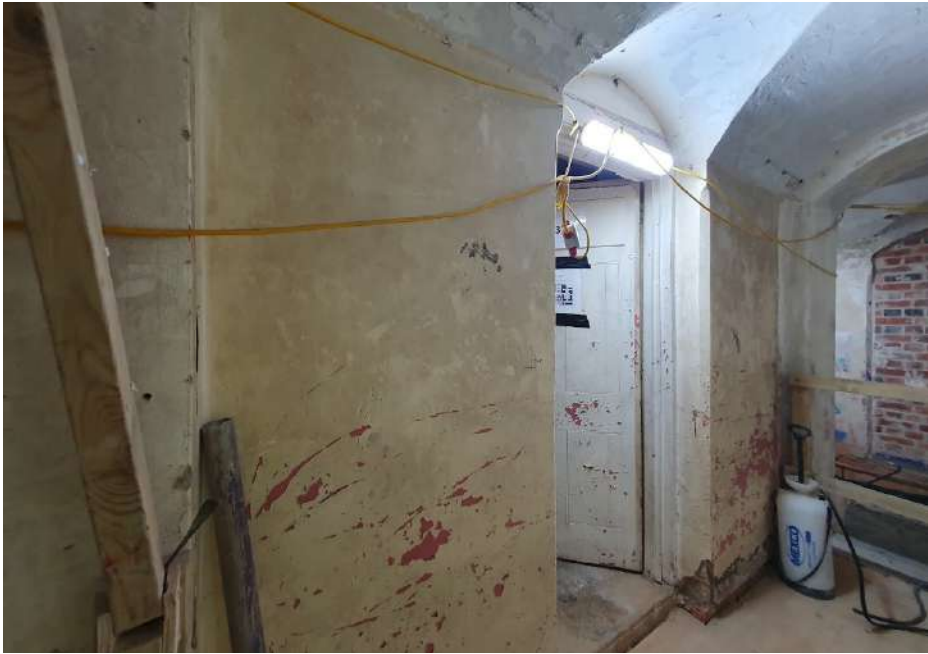
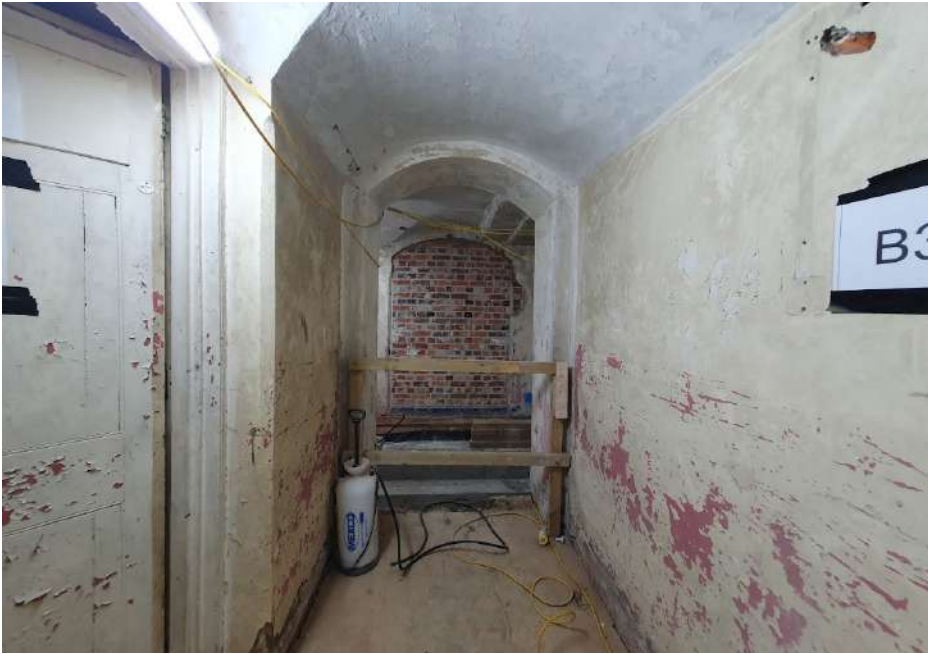
**Walls** – plaster to masonry with modern paint finish. Modern paint to be cleaned off and plaster repaired like for like.

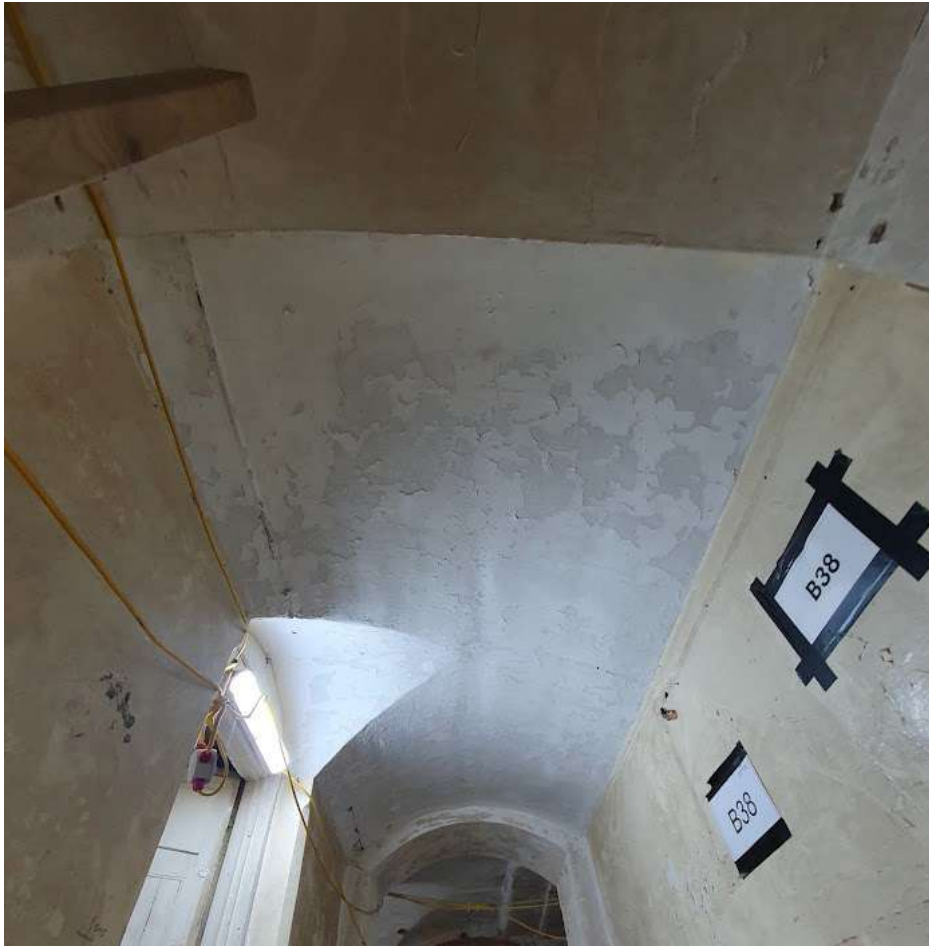
CEILING

**Ceiling** – plaster to masonry vault with modern paint finish. Modern paint to be cleaned off and plaster repaired like for like.

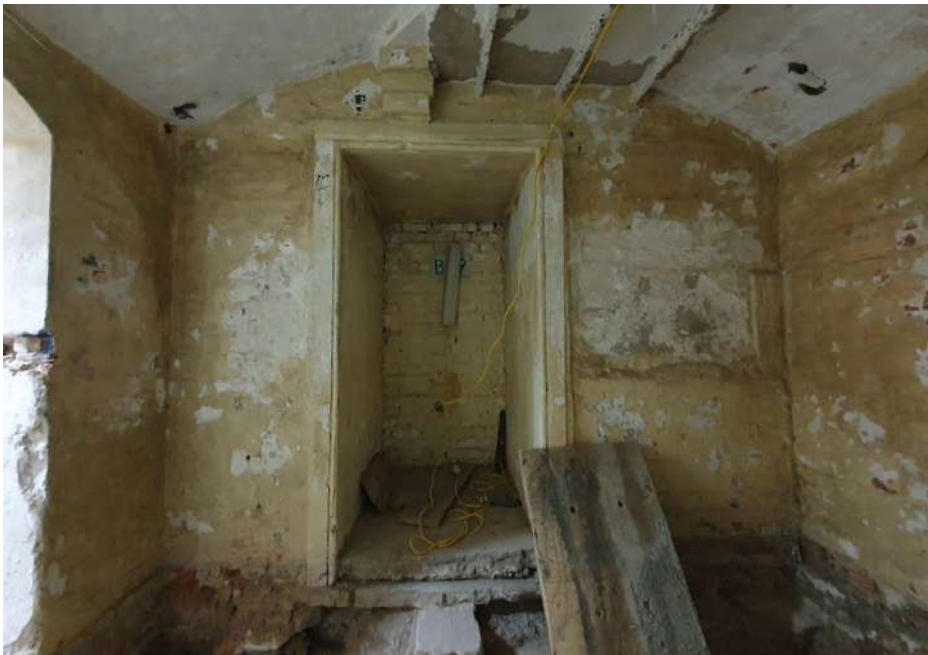
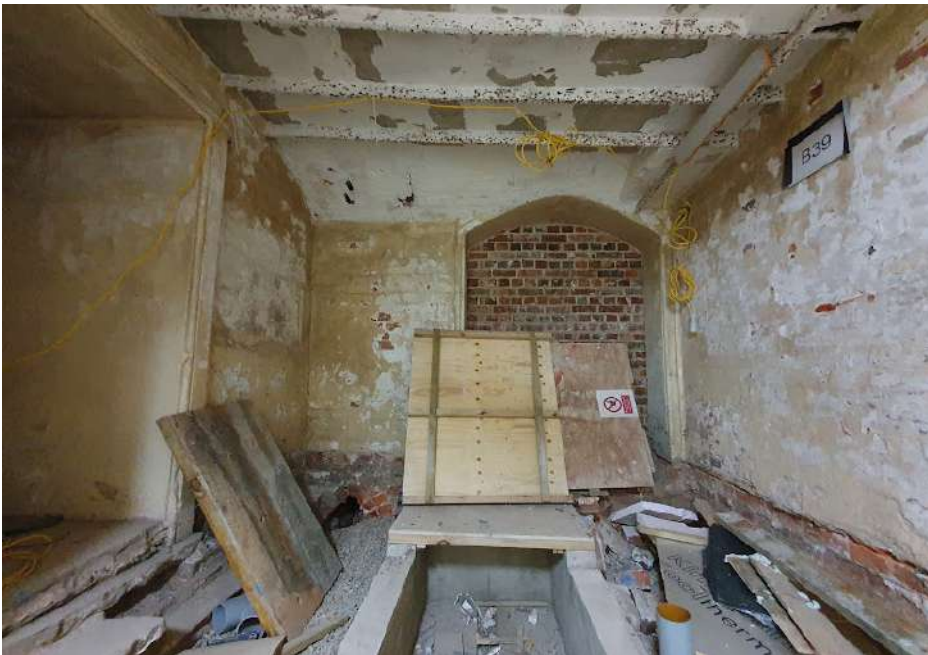
**Walls** – a mix of plaster and brickwork. Fabric cleaned and consolidated with repointing in matching lime mortar. Plaster repaired like for like.

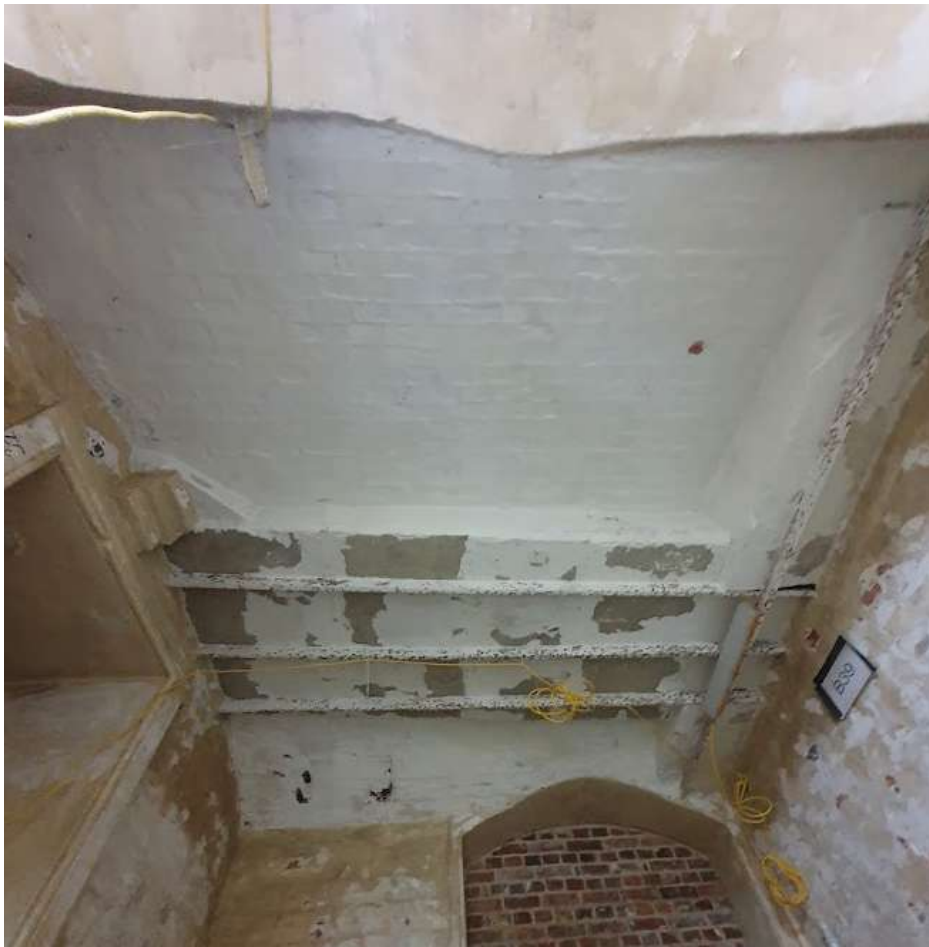
CEILING

**Ceiling** – a mix of stone and brickwork. Fabric cleaned and consolidated with repointing in matching lime mortar. Cast iron elements cleaned and redecorated to protect from rust.

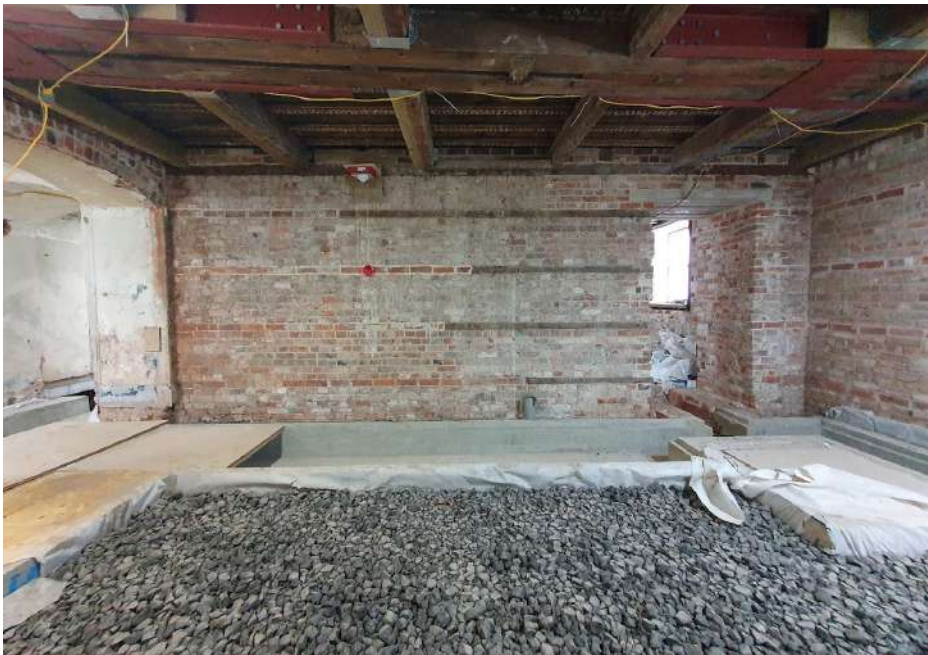
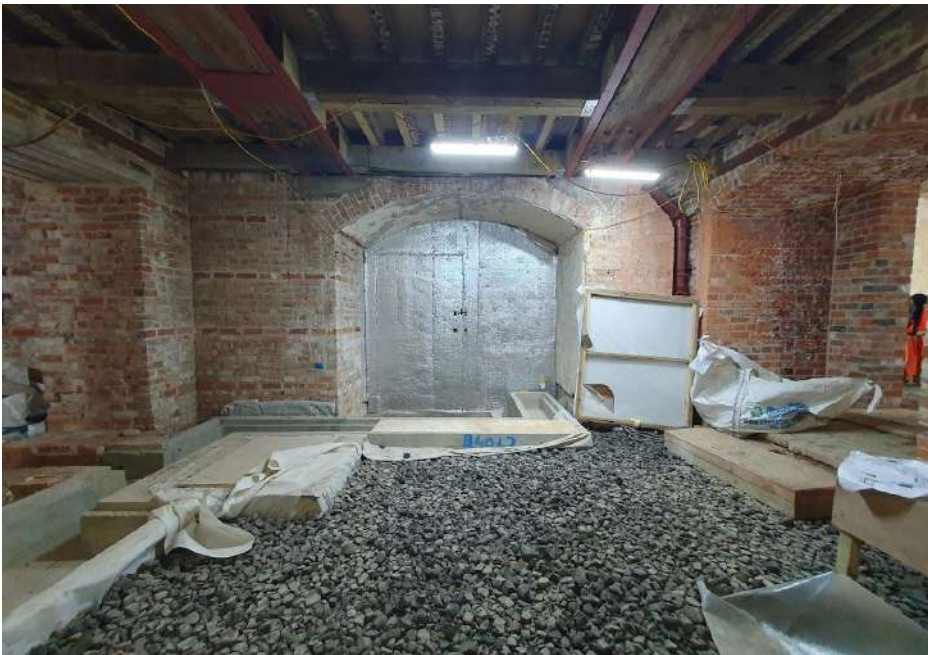
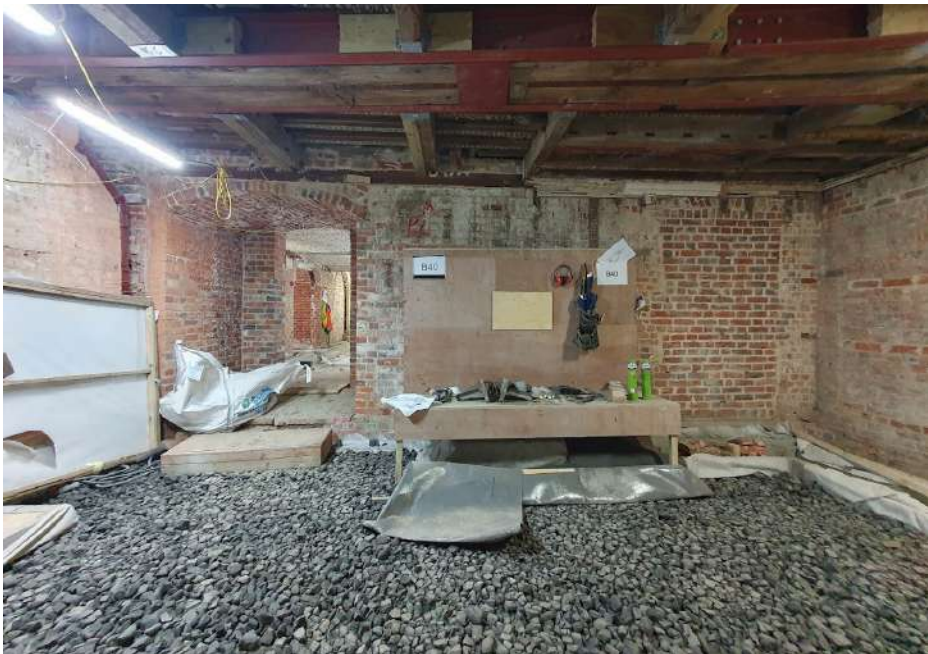
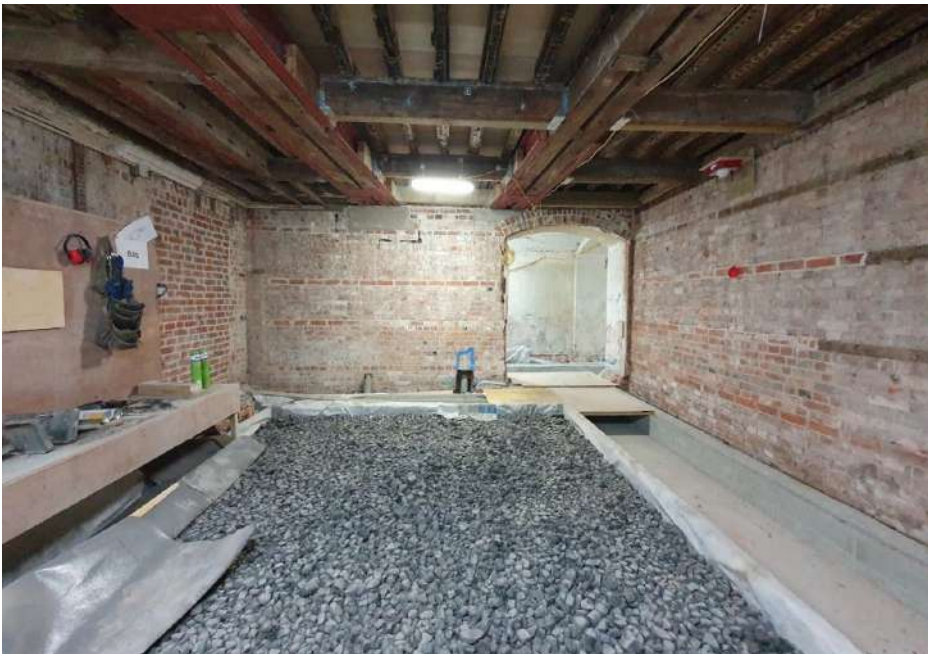
**Walls** – historically lath and plaster with modest cornice. Fabric historically missing due to severe decay. To be reinstated in lath and plaster walls with cornice profile matching adjacent B41 where example remnants are available.

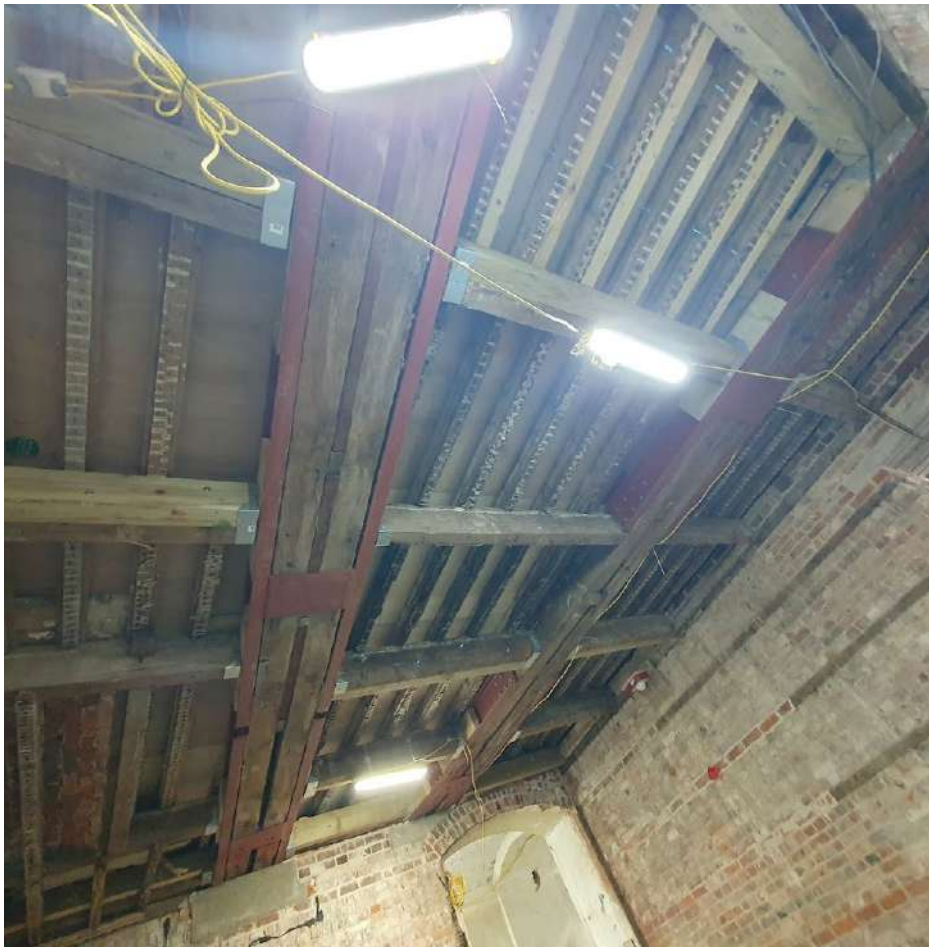
CEILING

**Ceiling** – historically lath and plaster with modest cornice. Fabric historically missing due to severe decay. To be reinstated in lath and plaster.

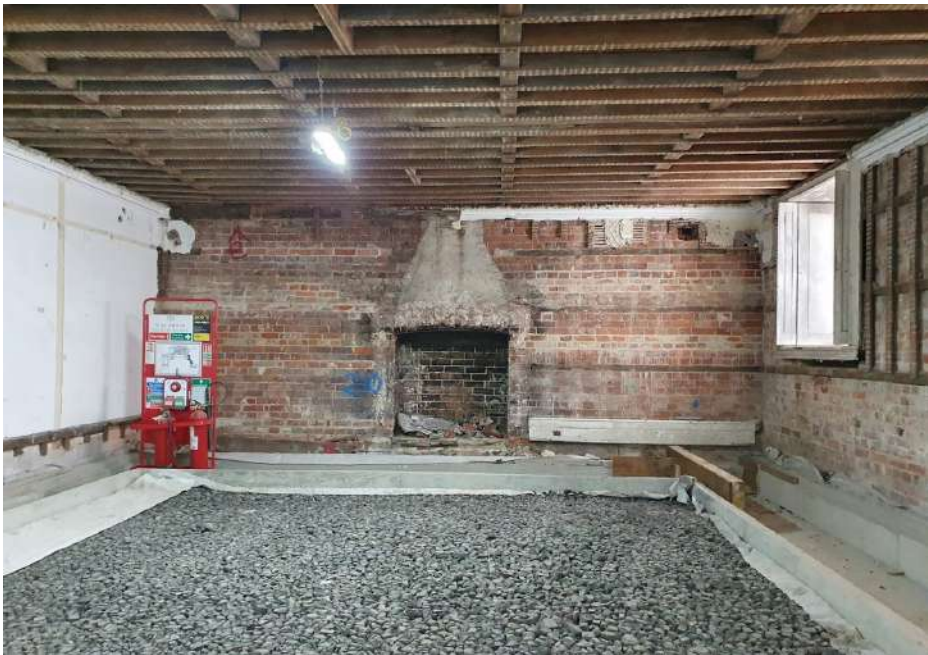
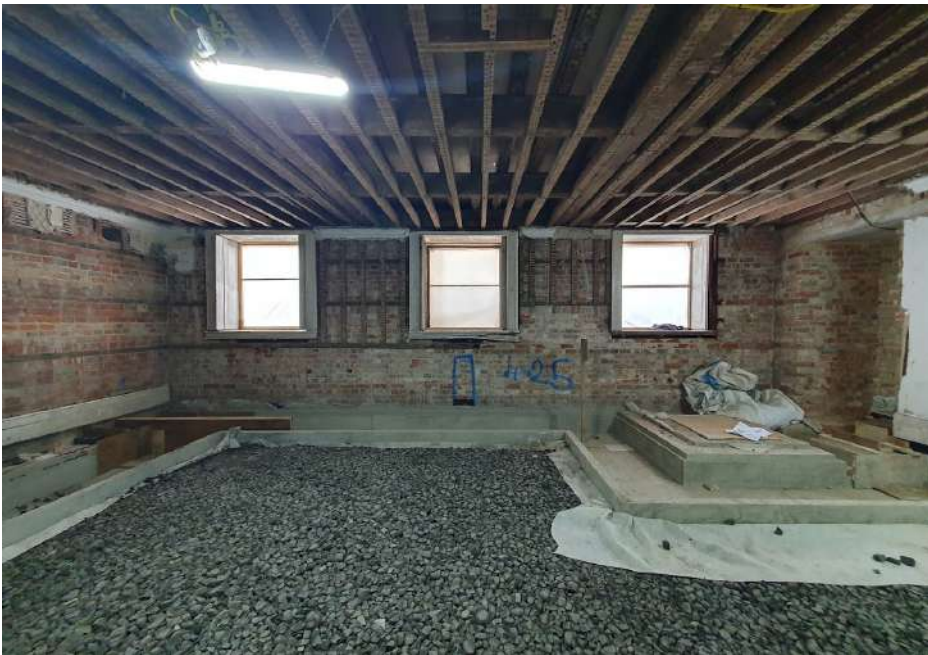
**Walls** – historically lath and plaster with modest cornice. Fabric historically mostly missing due to severe decay. To be reinstated in lath and plaster walls with cornice profile matching existing.

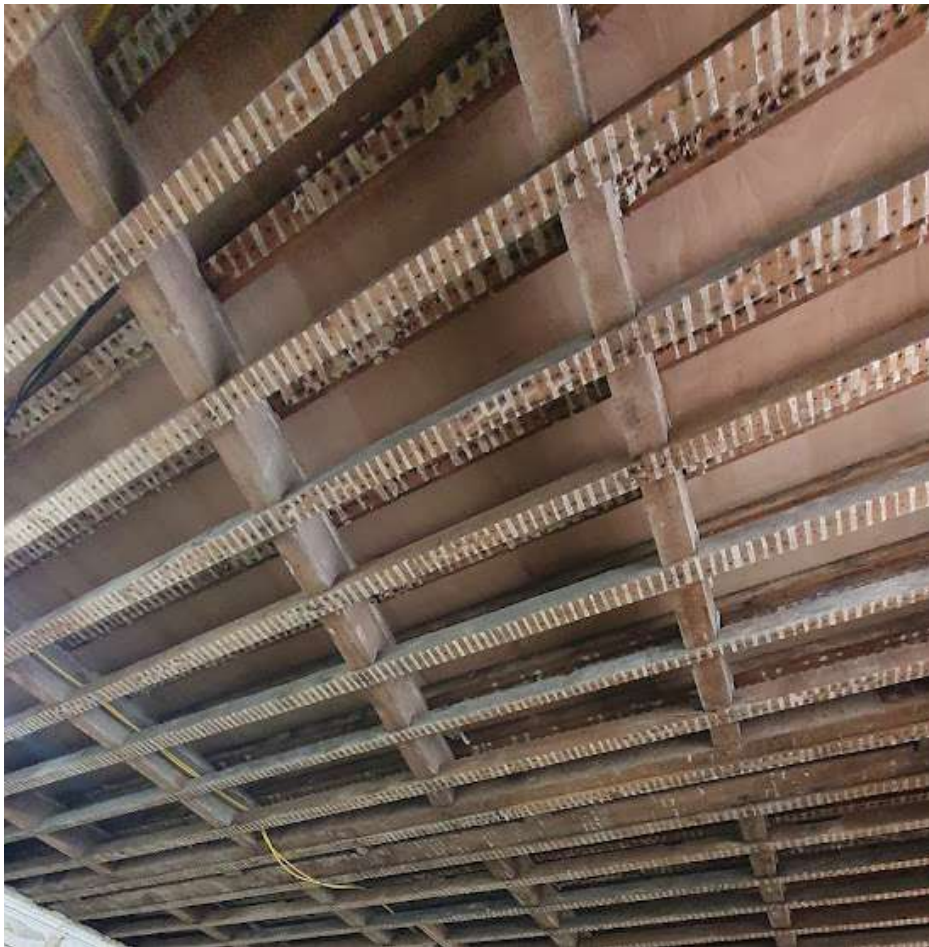
CEILING

**Ceiling** – historically lath and plaster with modest cornice. Fabric historically missing due to severe decay. To be reinstated in lath and plaster.

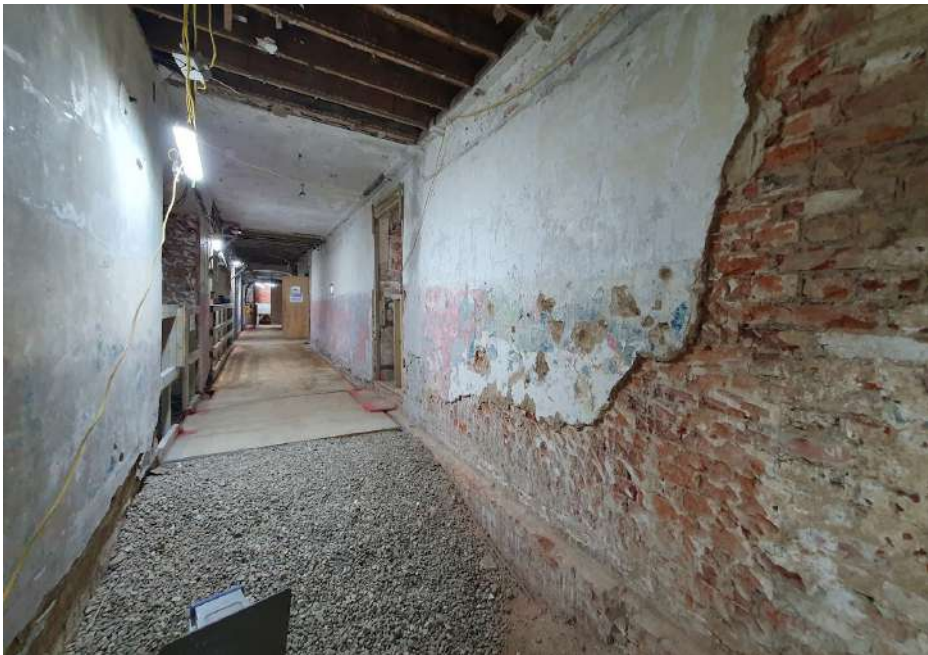
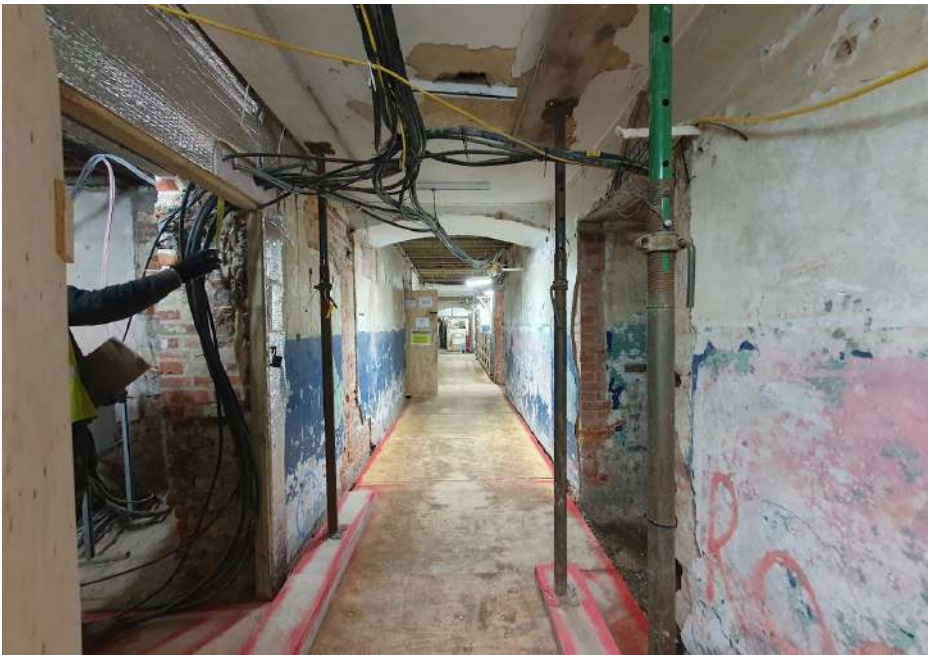
**Walls** – a mix of render (some lime, some cement). Render to be repaired and reinstated in matching materials. Cement render if not causing damage will not be removed but simply repaired. If damp issues present or cement render blown the complete area will be replaced in traditional lime to masonry.

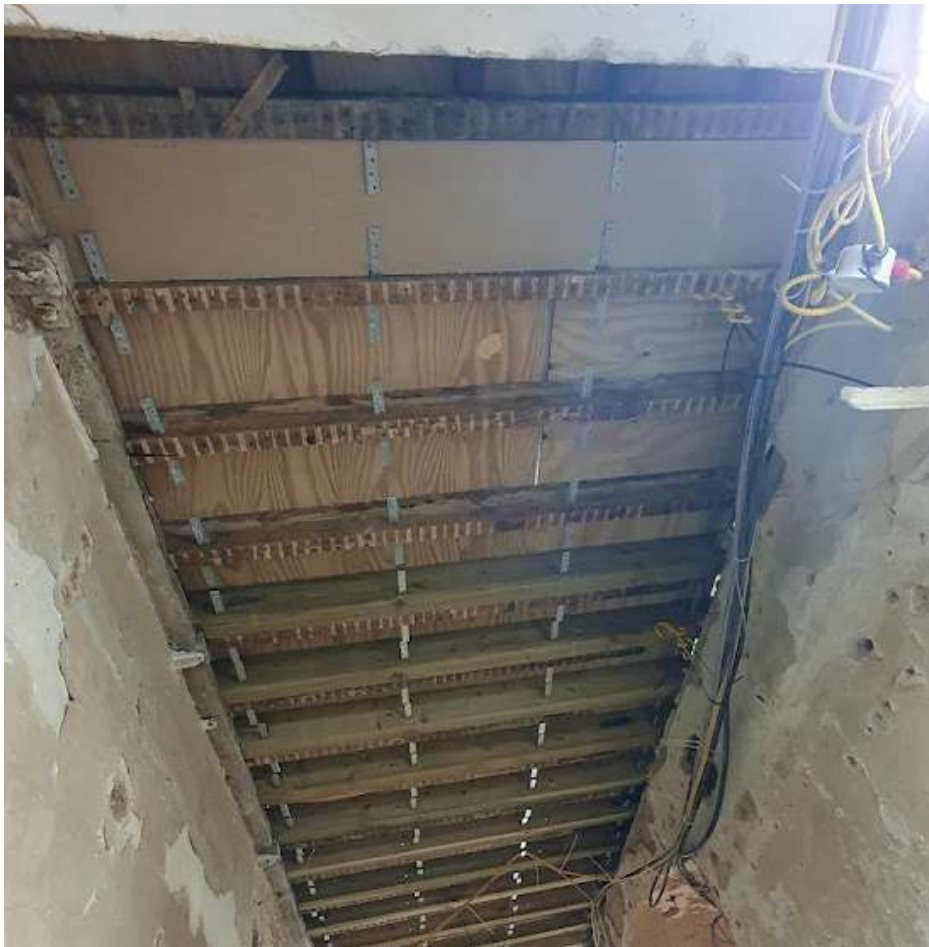
CEILING

**Ceiling** – historically lath and plaster, sections since removed as consented due to severe decay. Fabric to be consolidated and new dropped ceiling introduced as consented to provide essential MEP routes with minimal impact to historic fabric.

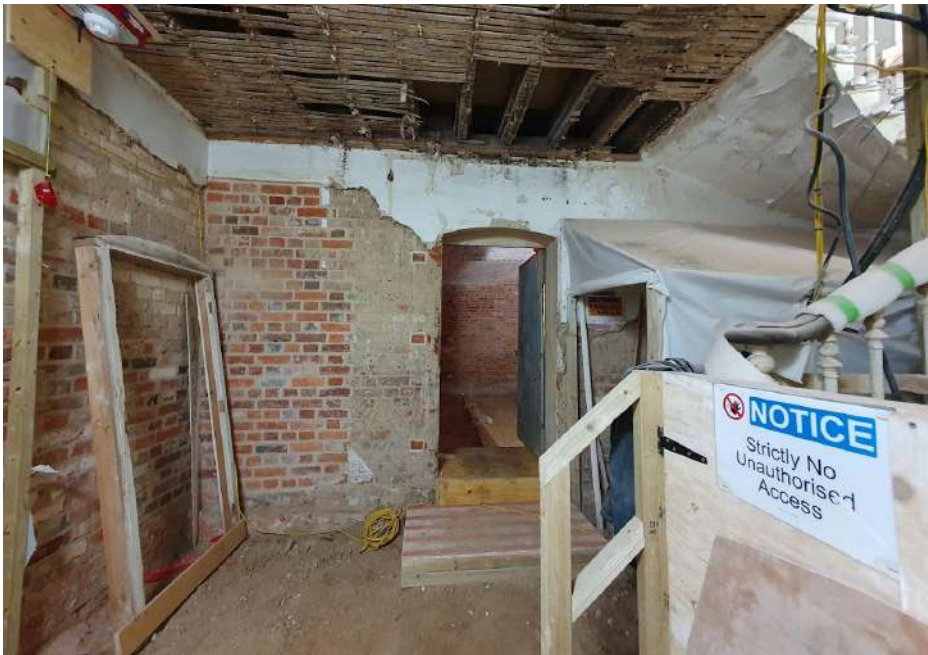
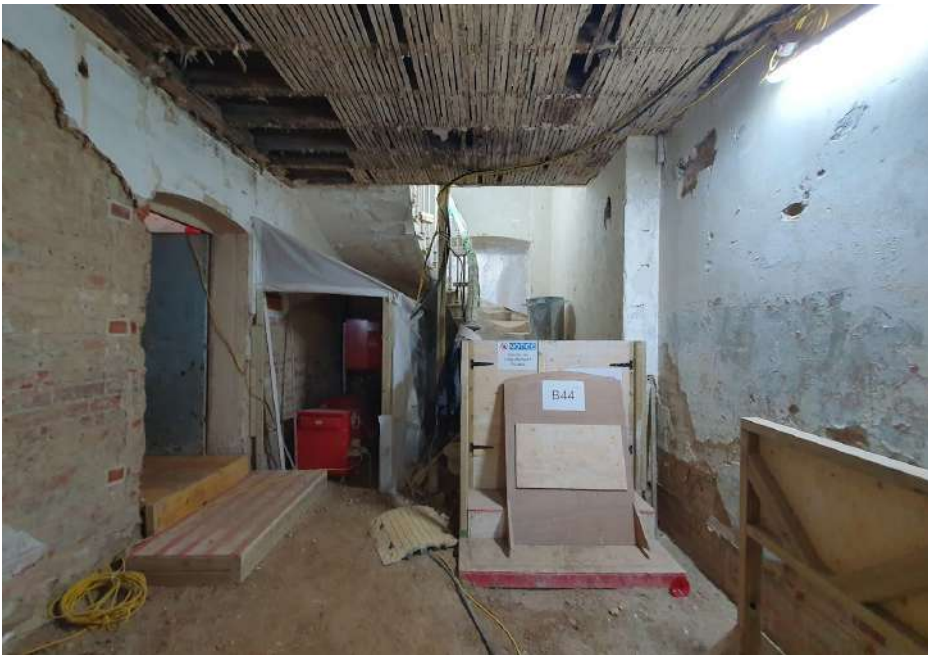
**Walls** – lime plaster to masonry in poor condition. To be repaired and consolidated and missing sections reinstated in traditional lime plaster to masonry.
