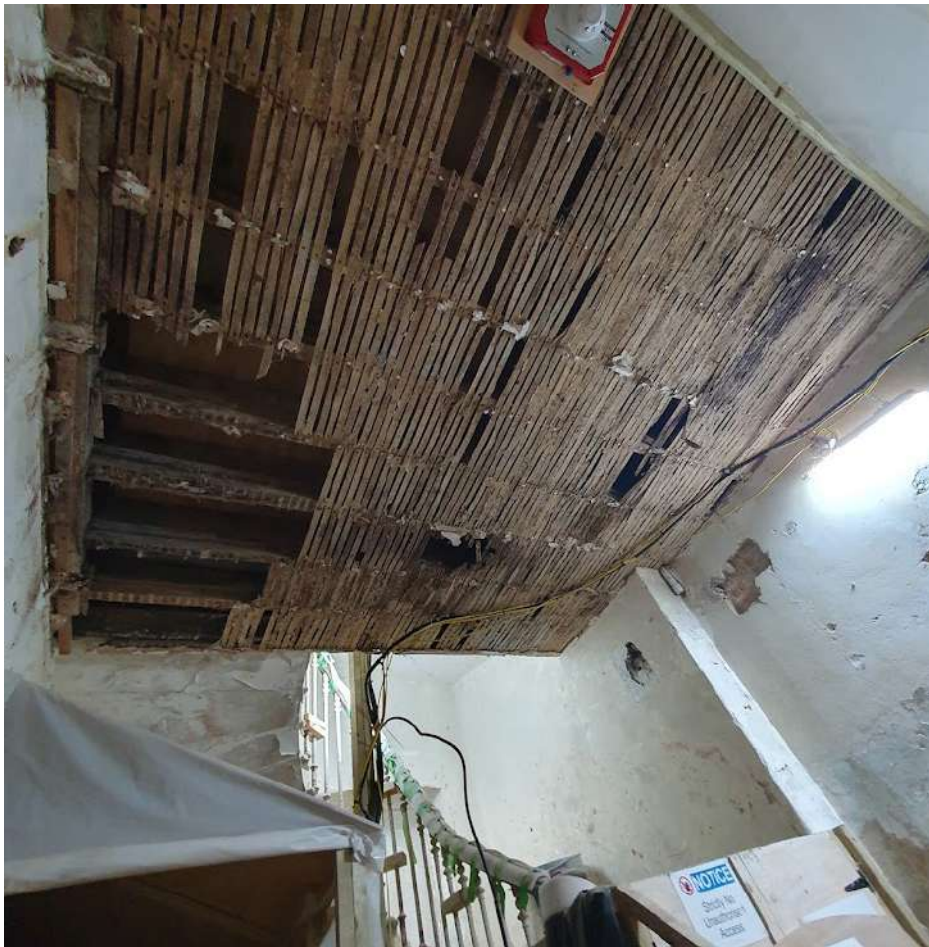
CEILING

**Ceiling** – severely decayed and damaged lath and plaster. Proposal is to remove the decayed fabric and reinstate in like for like traditional lath and plaster ceiling. No cornice present as historically servants' area.

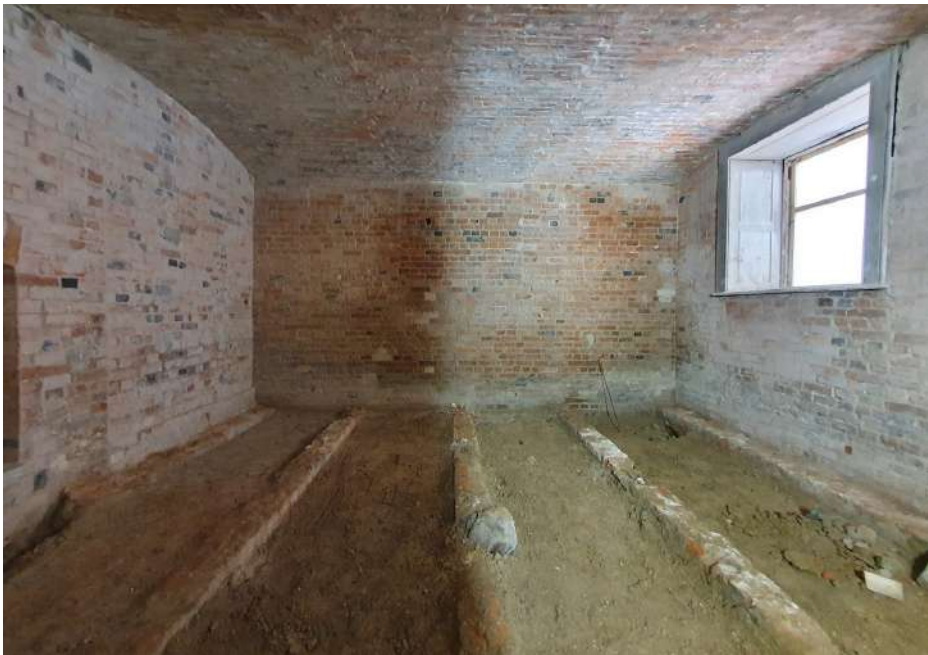
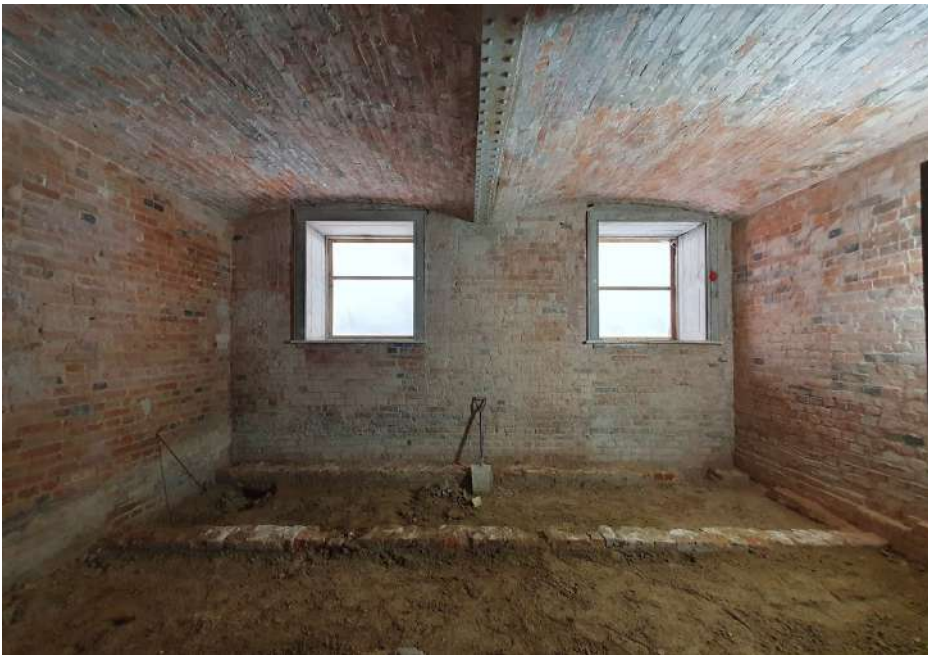
**Walls** – masonry and cleaned as consented. To be retained as brickwork and consolidated with lime mortar to match adjacent.

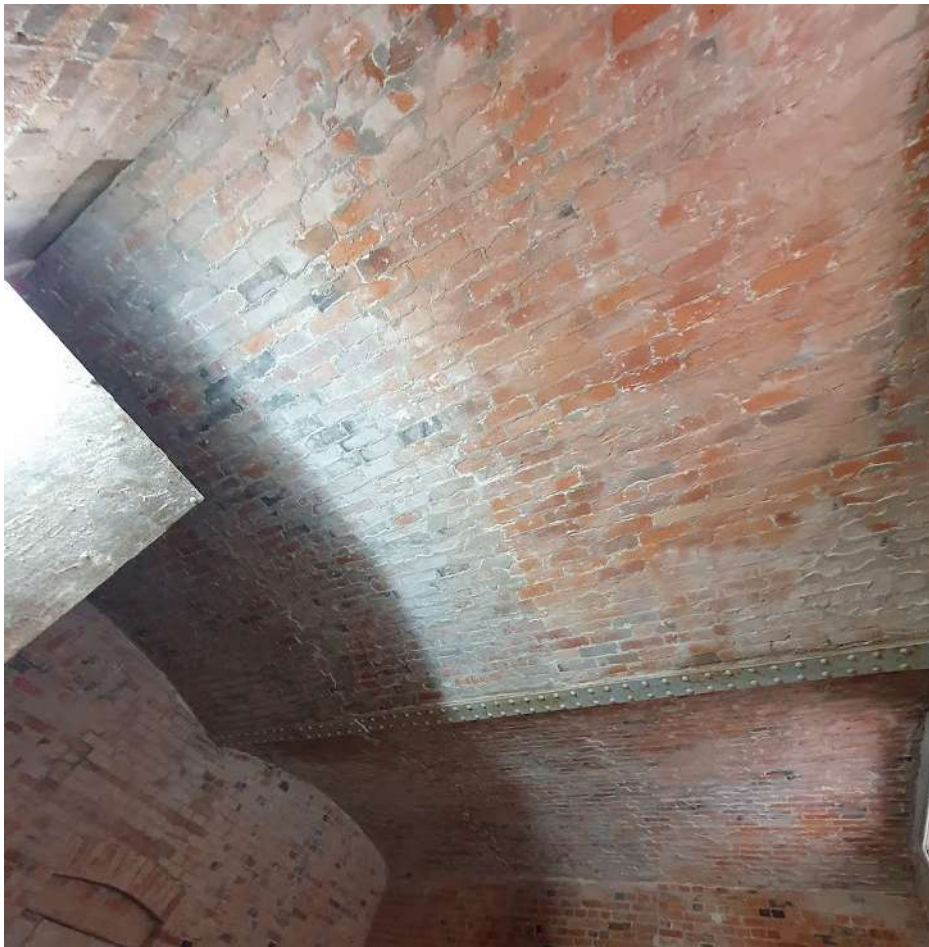
CEILING

**Ceiling** – vaulted masonry and cleaned as consented. To be retained as brickwork and consolidated with lime mortar to match adjacent. Exposed cast iron beam to be cleaned and decorated to protect from rust.

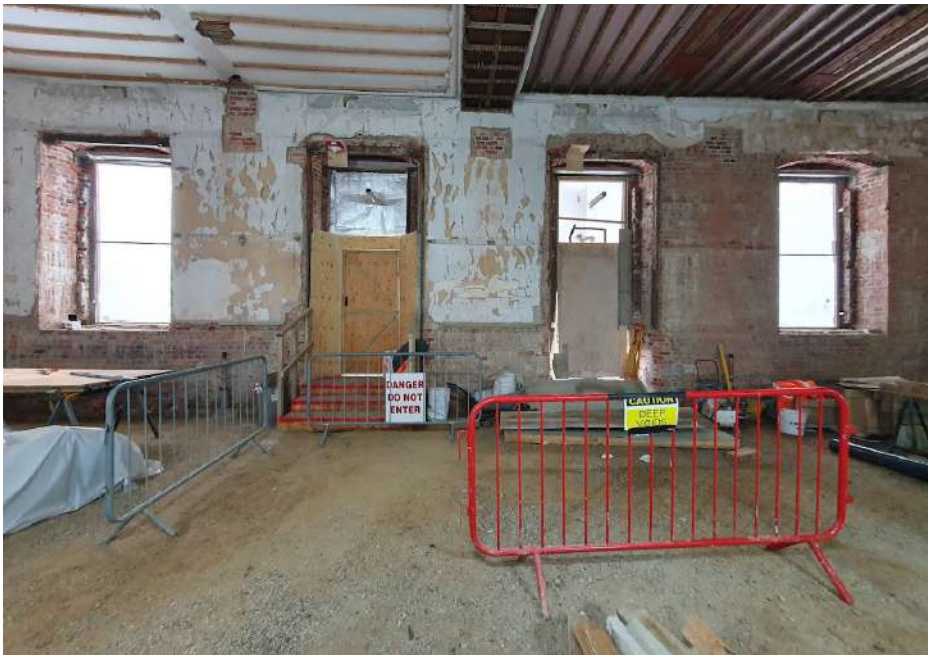
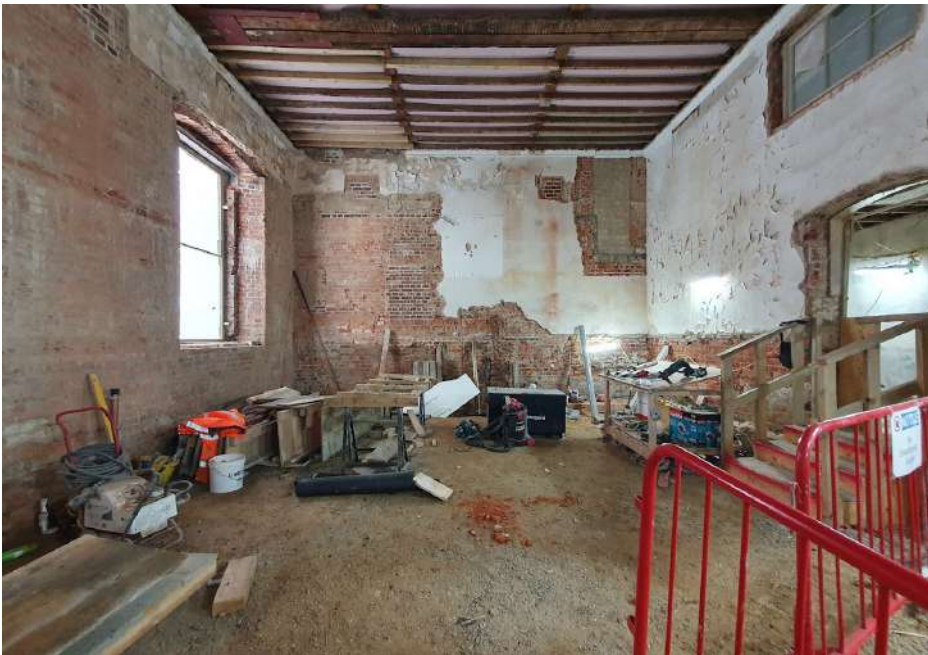
**Walls** – a mix of modern cement and plaster in very poor condition. Proposed to carefully remove the cracked and damaged sections and repaire/reinstate in traditional lime plaster to masonry. Lower section was altered in C20th to have a timber dado, since decayed and removed.

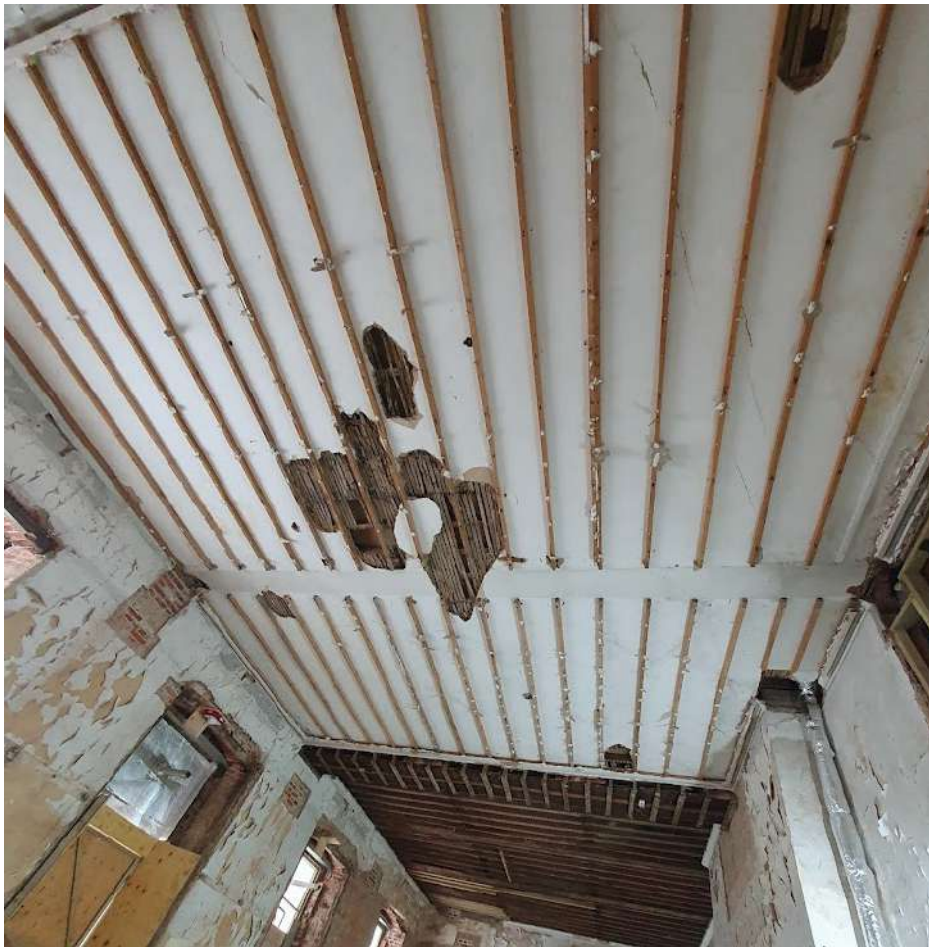
CEILING

**Ceiling** – ceiling partially covered with modern plasterboards since removed and a section already missing. Historically lath and plaster, however the location below severely damaged north wing has caused it to decay. Proposal is to reinstate in lath and plaster as consented with existing cornice repaired.

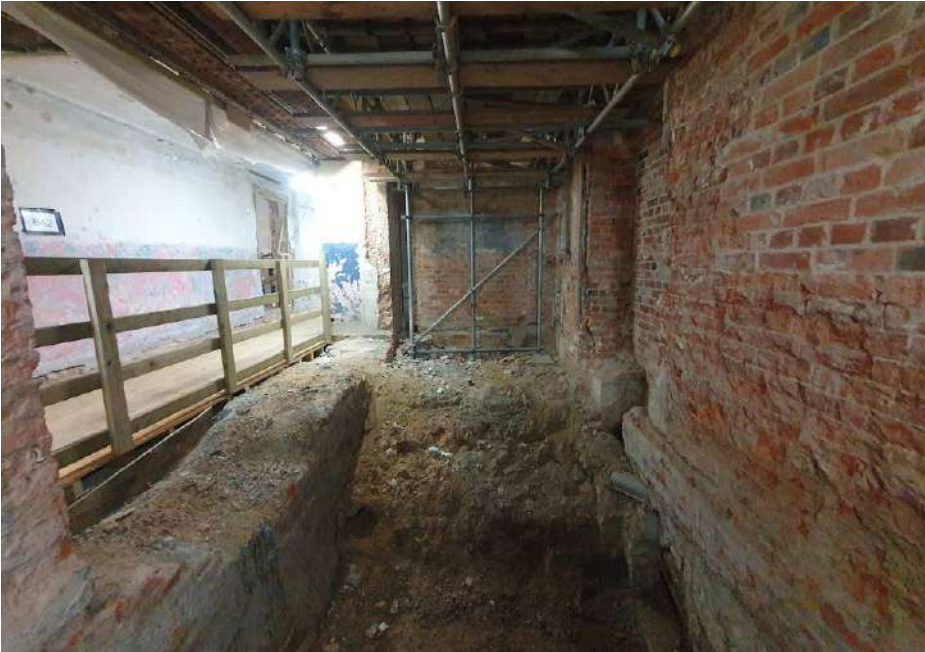
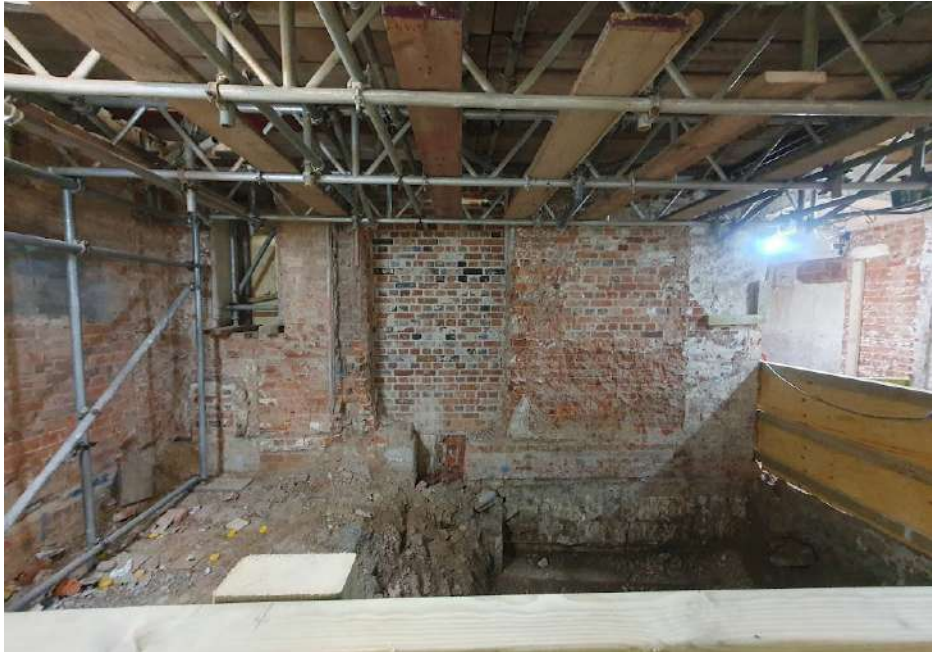
**Walls** – area severely decayed and no fabric present. New works as consented to create a lift shaft and new WC.

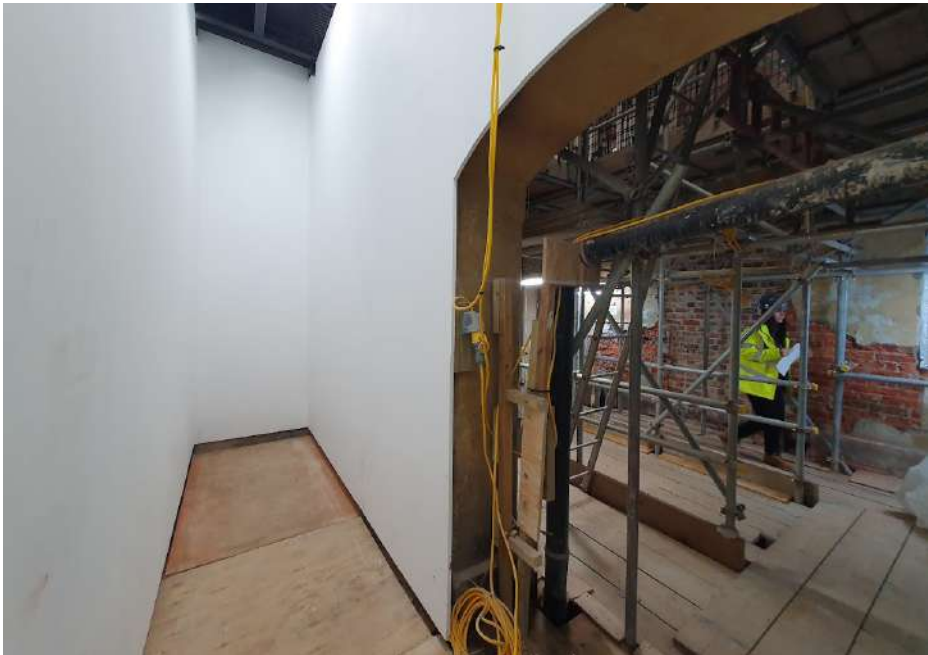
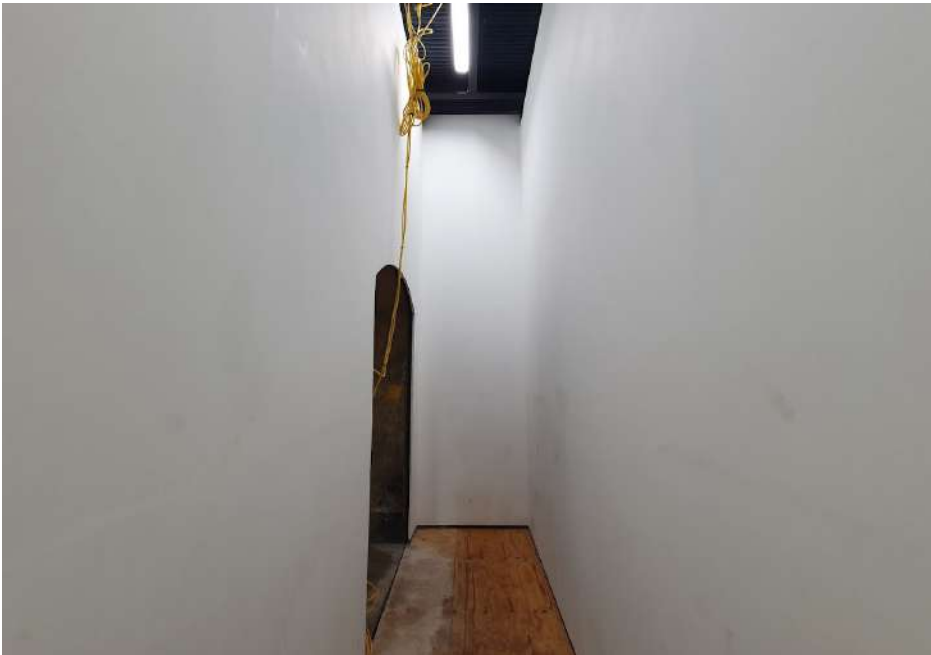
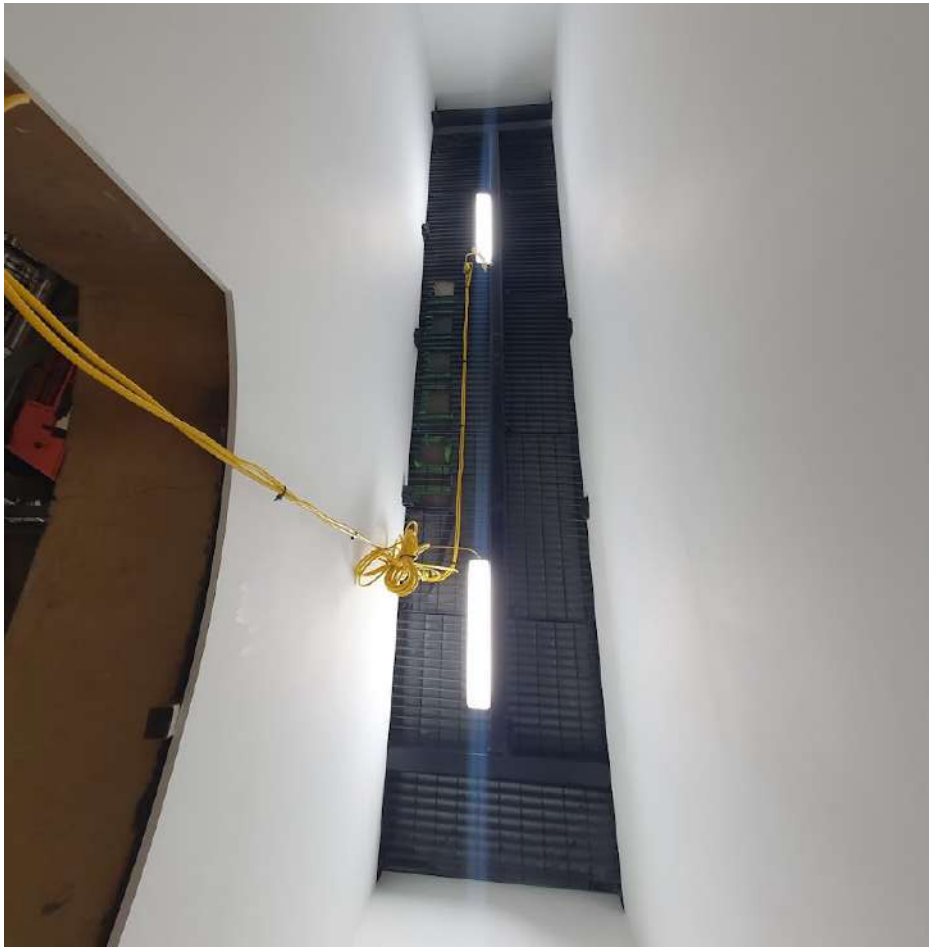
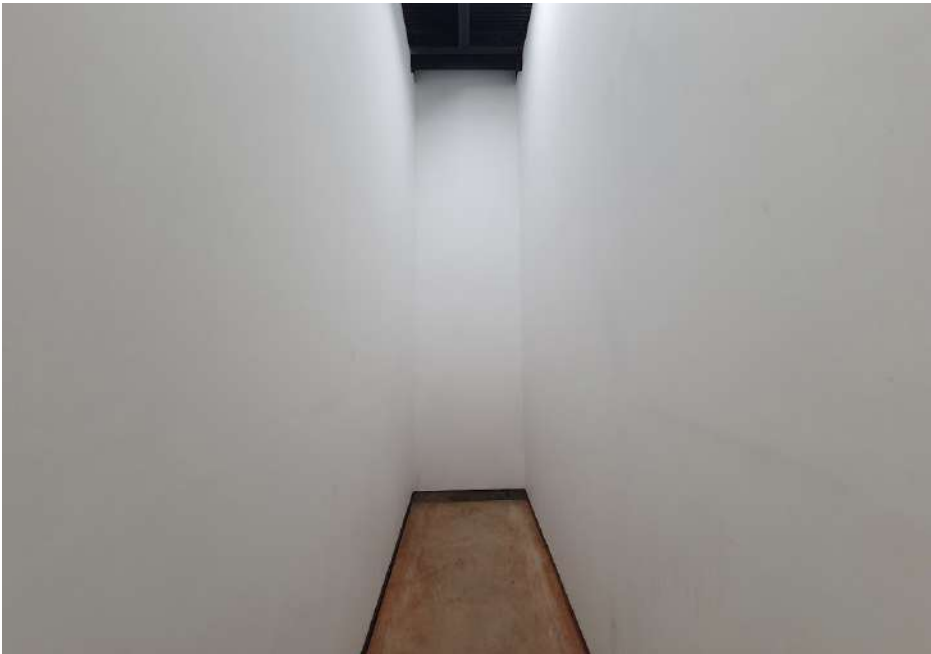
NOTES  
**Walls** – masonry consolidated and lined  
**Ceiling** – removed to form a service riser as consented

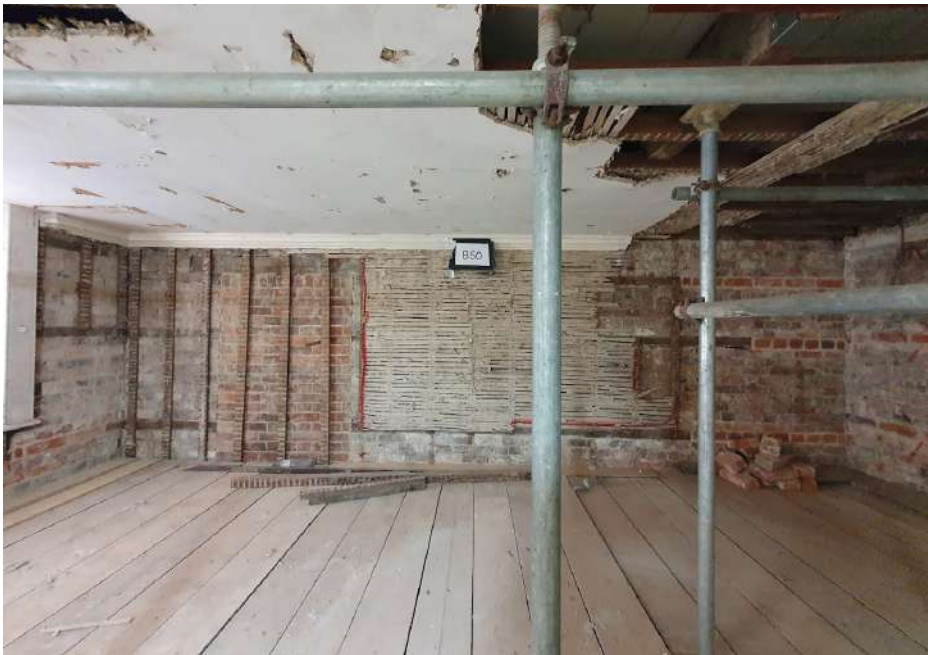
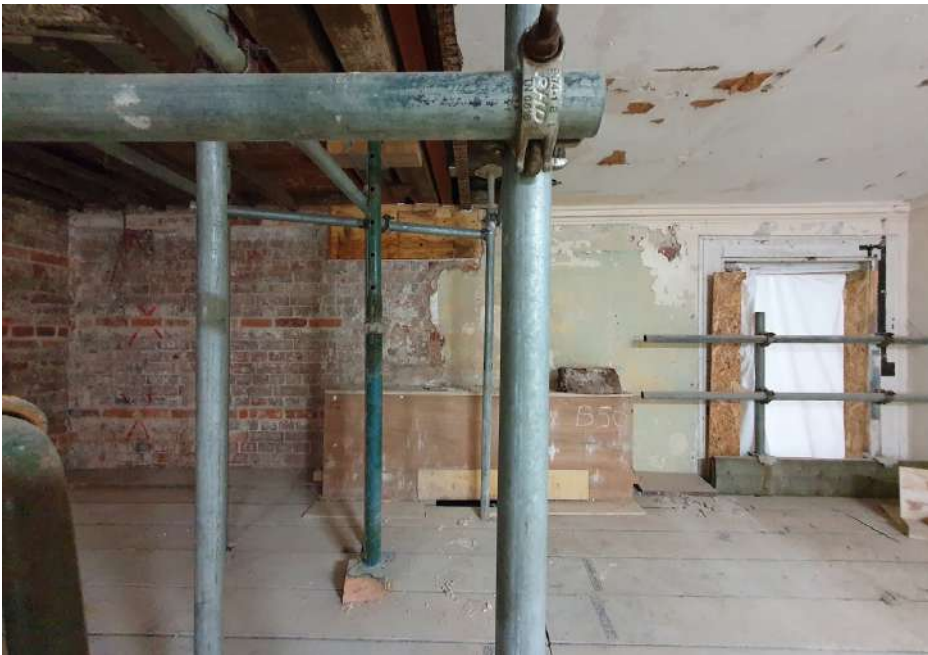
**Walls** – some remnants of the original lath and plaster finish remain, however the entire room is severely decayed and the proposal is to reinstate in new like for like lath and plaster finish with aim to retain south wall if supporting timber structure reasonably sound.

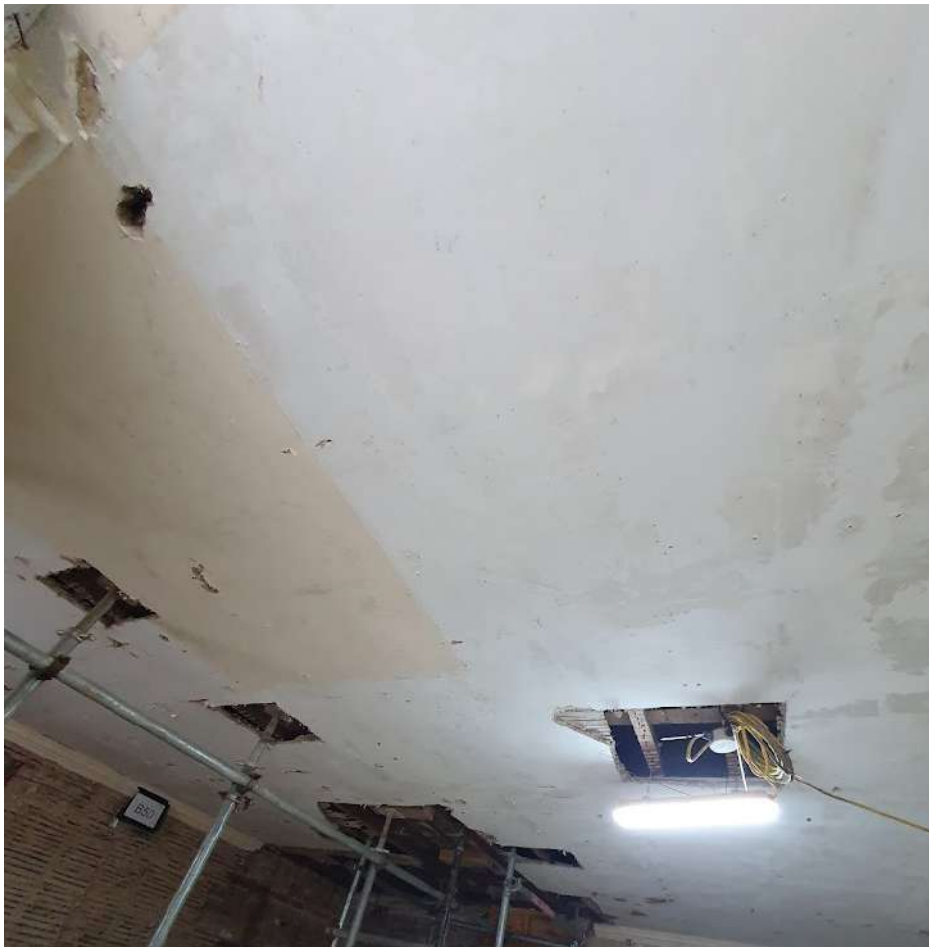
CEILING

**Ceiling** – some remnants of the original lath and plaster ceiling remain, however the entire room is severely decayed and the proposal is to reinstate in new like for like lath and plaster. Cornice will be retained and repaired.

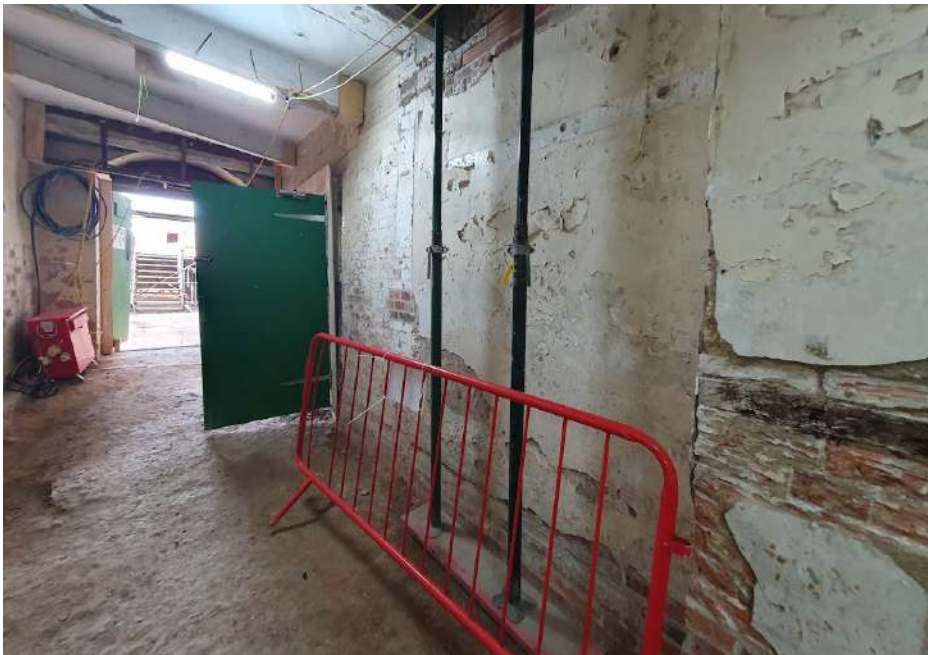
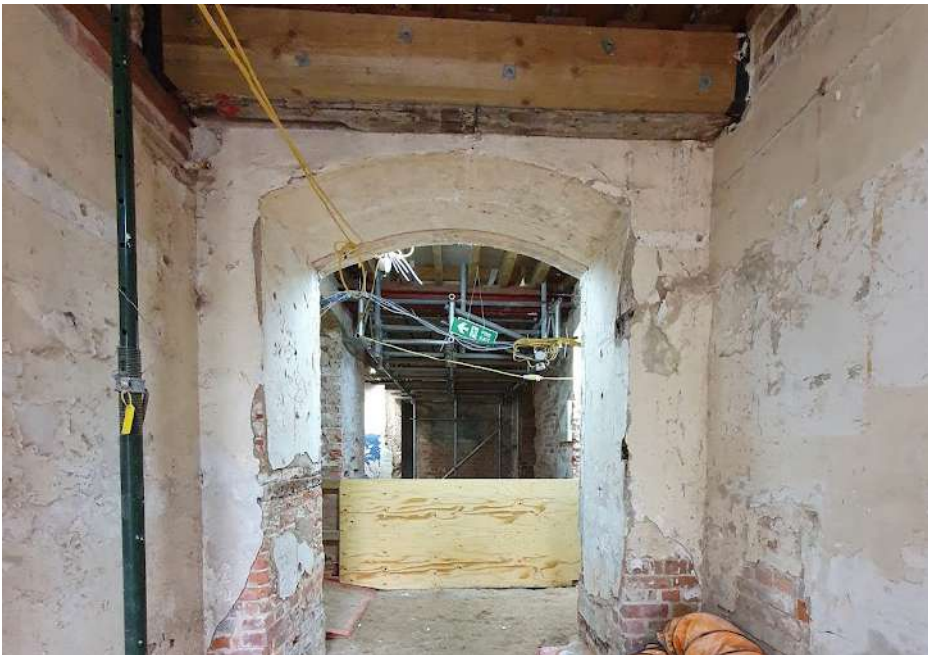
**Walls** – a mix of exposed brickwork and plaster to masonry finish. Walls to be cleaned of modern paint and consolidated. Lime plaster to masonry to be reinstated to all wall surfaces.

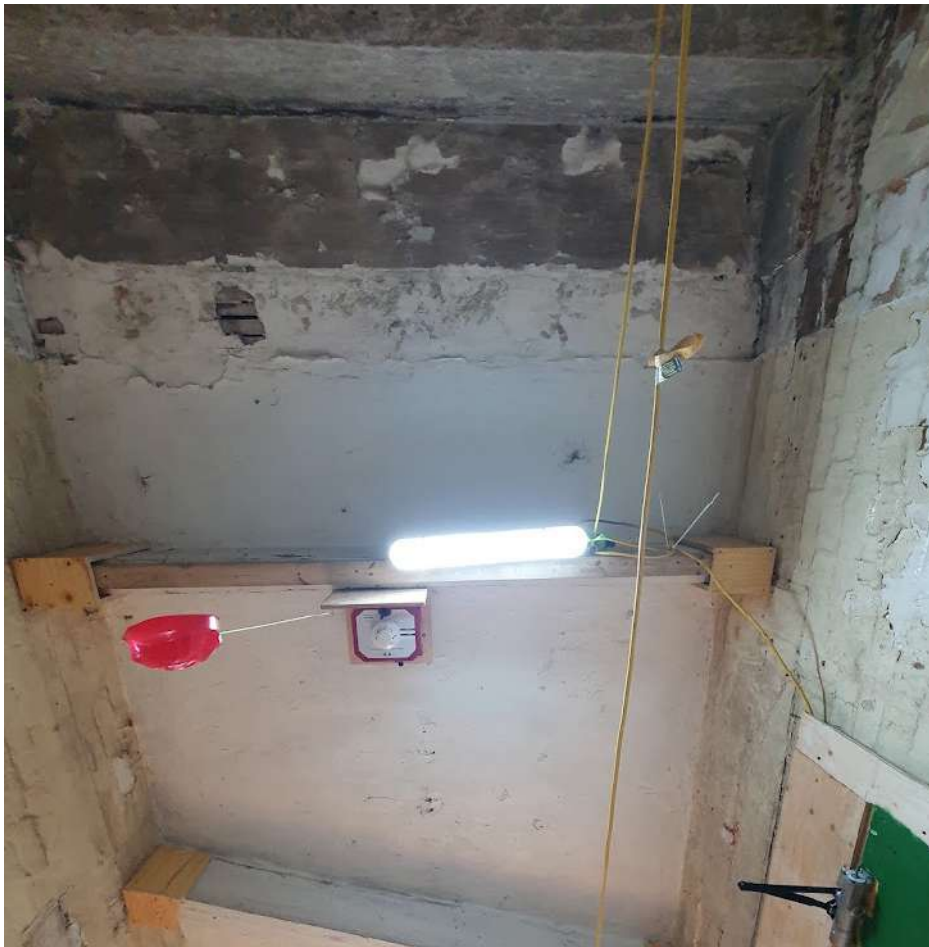
CEILING

**Ceiling** – a mix of modern plasterboard, decayed lath and plaster and underside of pugging. It is proposed to introduce new like for like lath and plaster ceiling.

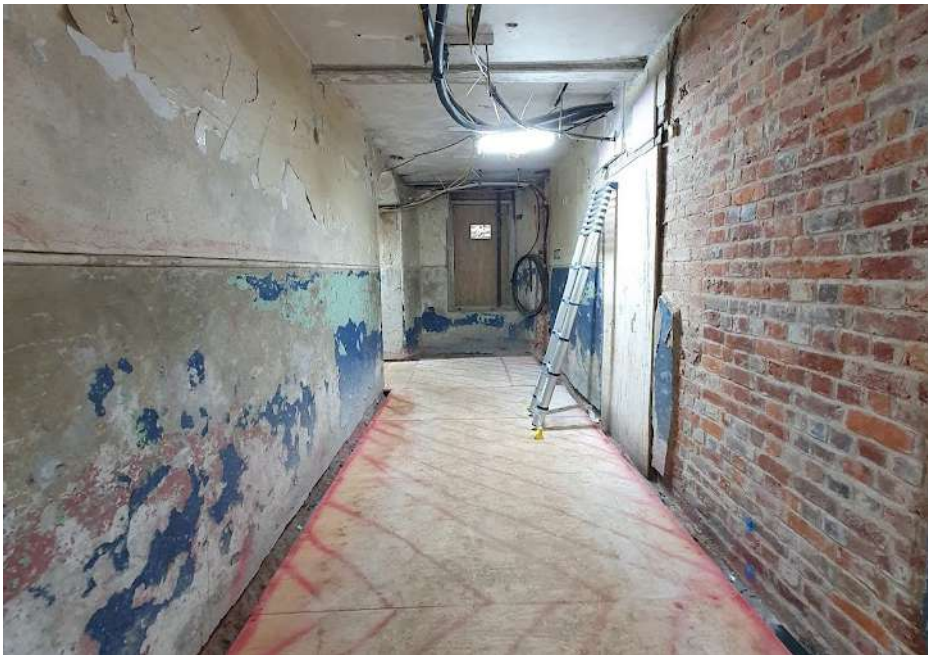
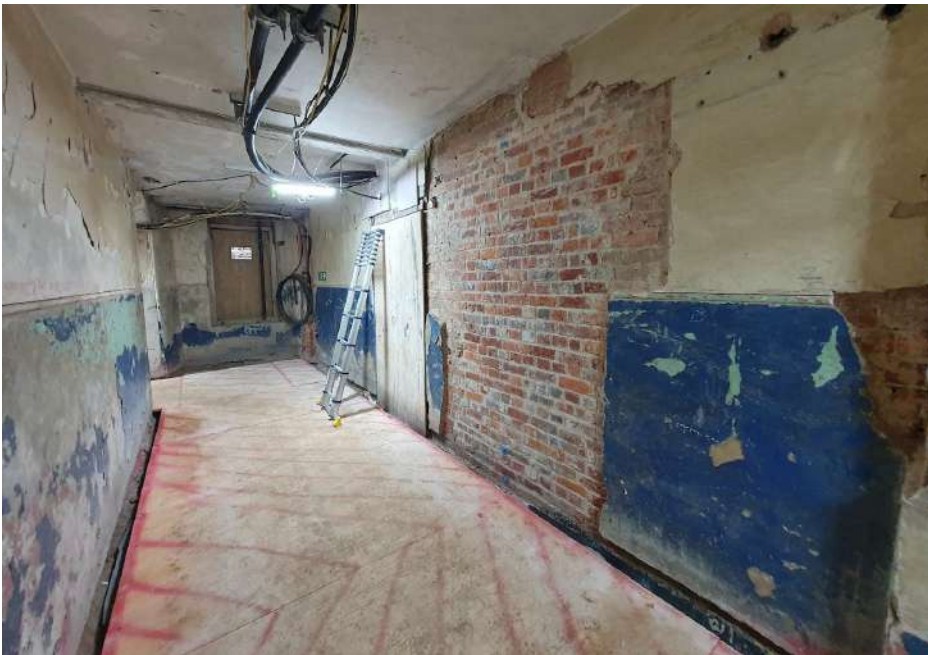
**Walls** – a mix of render (some lime, some cement). Render to be repaired and reinstated in matching materials. If not causing damage, cement render will not be removed but simply repaired. If damp issues present or cement render blown the complete area will be replaced in traditional lime to masonry.

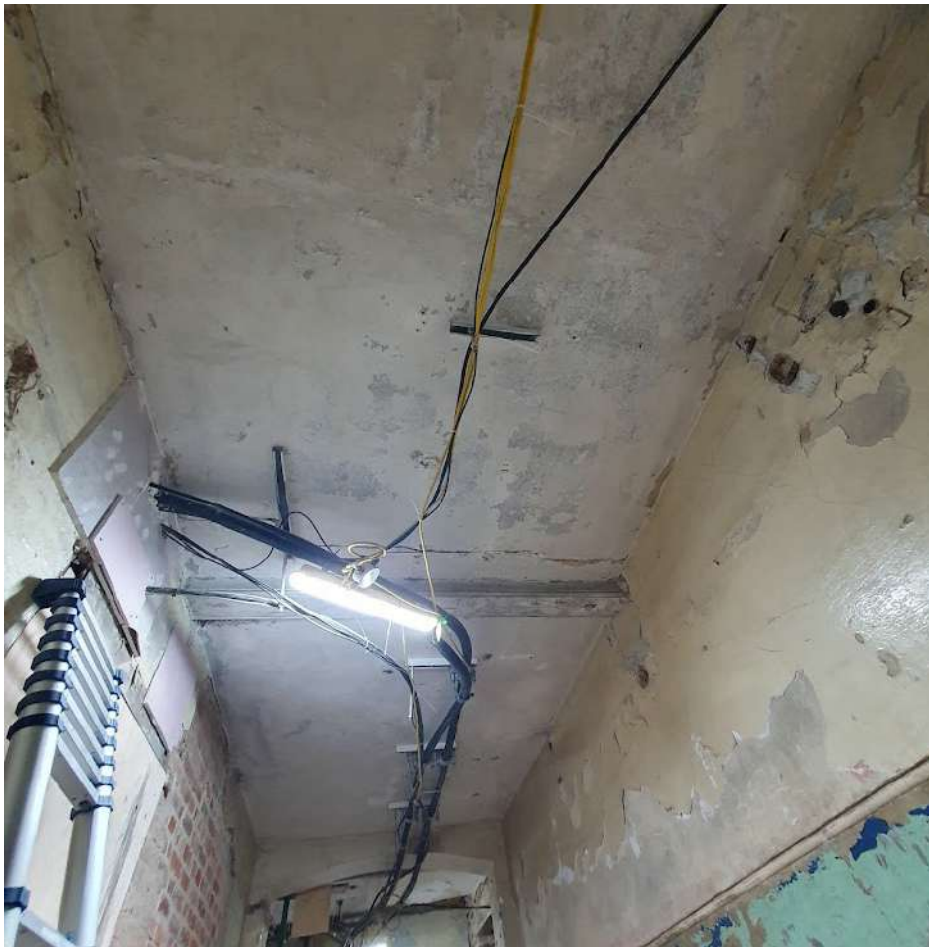
CEILING

**Ceiling** – lath and plaster in reasonable condition. Proposal is to consolidate and repair like for like with traditional lime plaster.

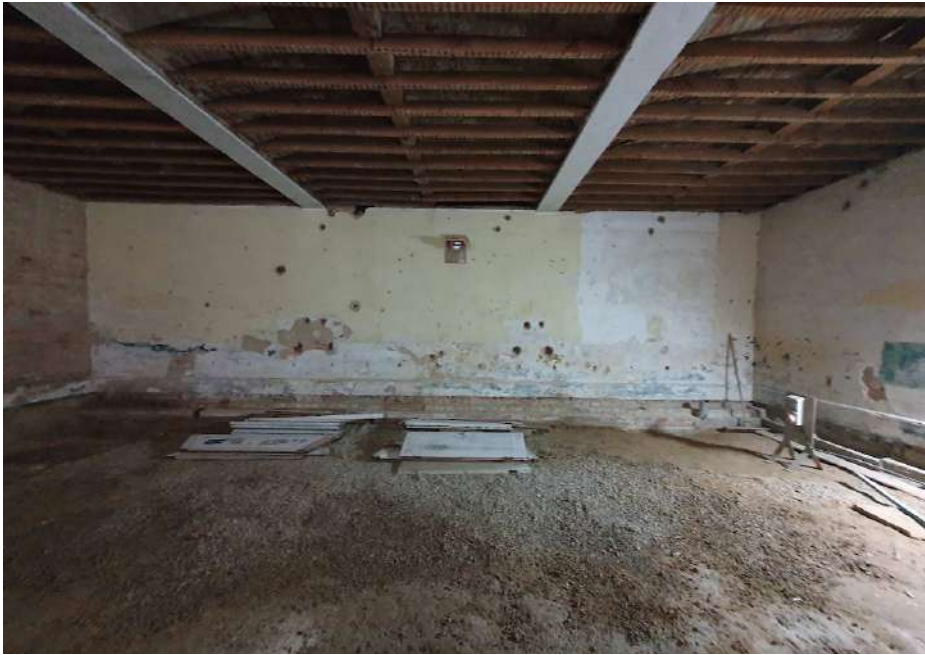
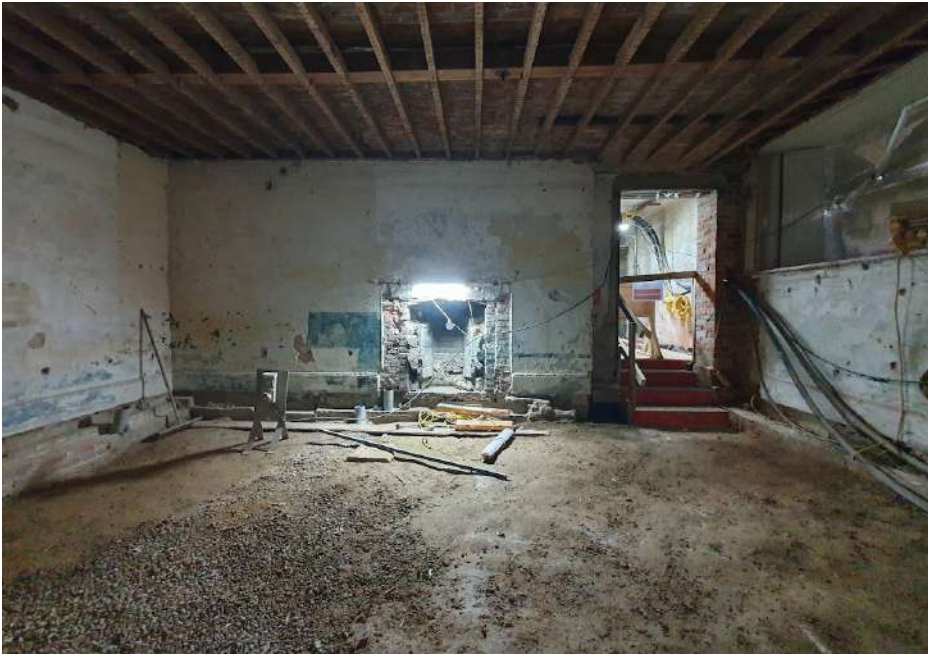
**Walls** – a mix of render (some lime some cement). Render to be repaired and reinstated in matching materials. South wall render to be removed and replaced with waterproofing membrane and lime render as consented.

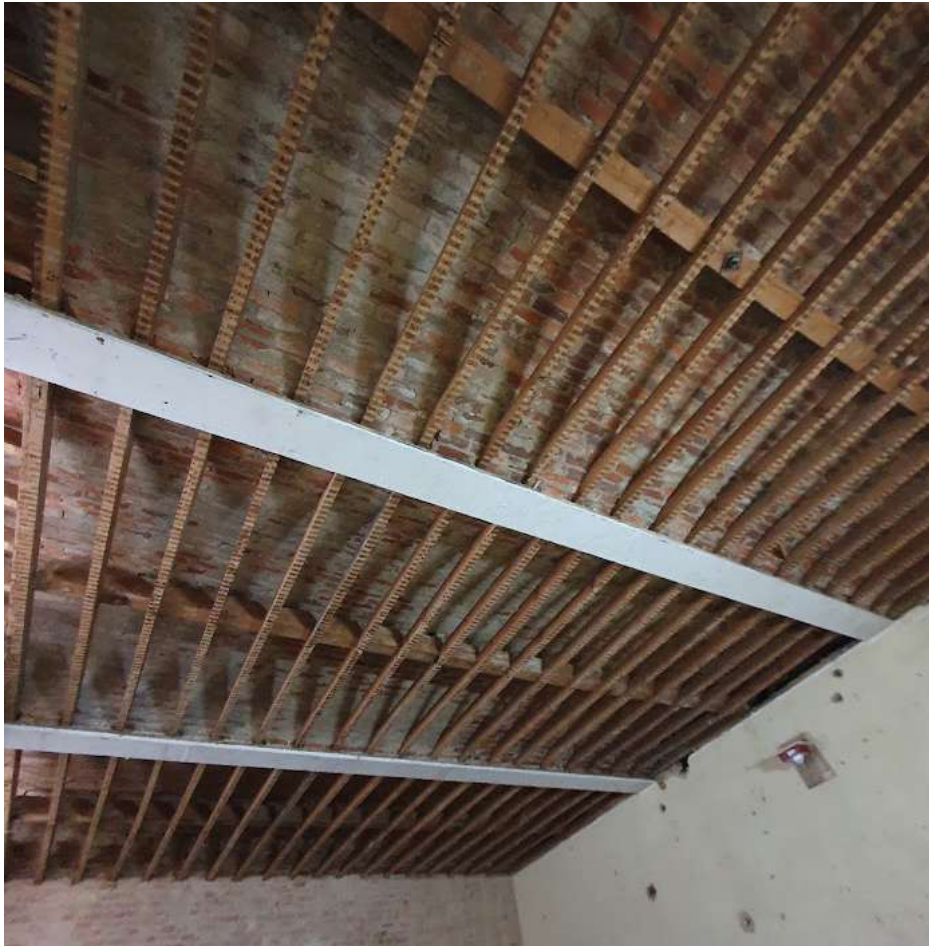
CEILING

**Ceiling** – originally lath and plaster ceiling. Consent has been granted via NMA/ LBS 2024 to remove the existing ceiling and reveal the brick masonry arches.

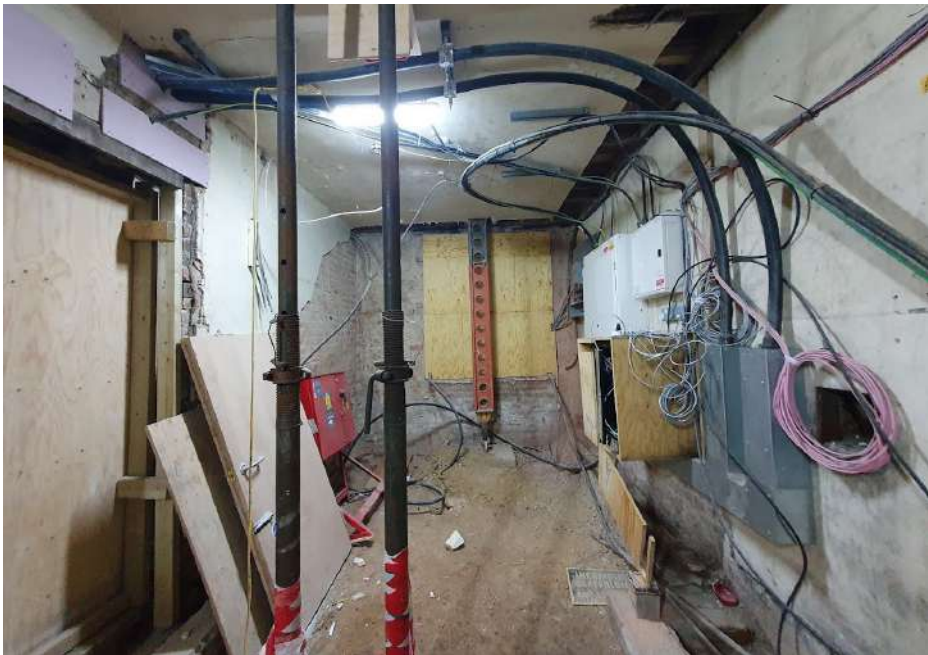
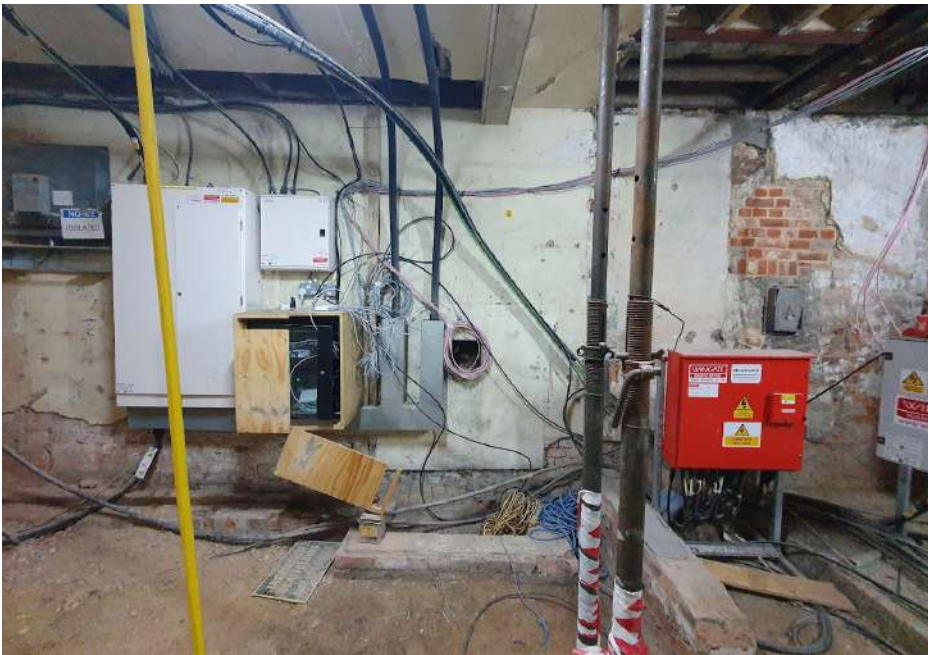
**Walls** – a mix of cement and plaster render in very poor condition. Any remnants to be removed and wall finish reinstated in traditional lime plaster to masonry.

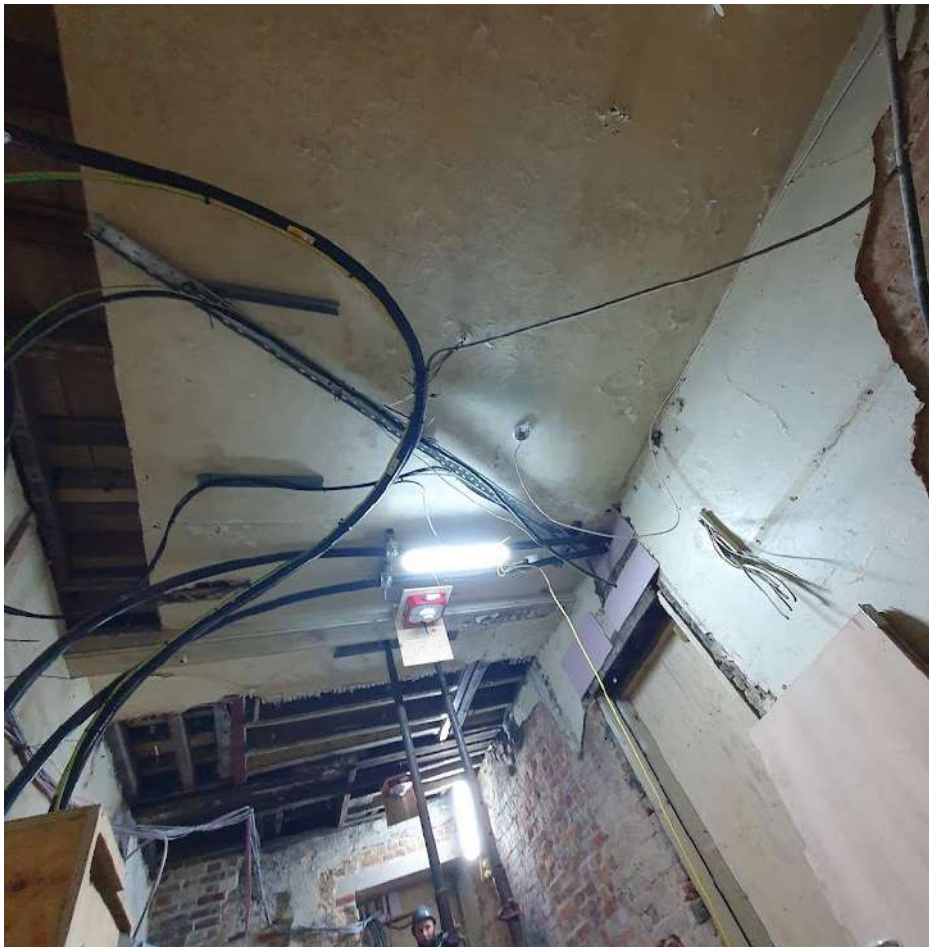
CEILING

**Ceiling** – modern ceiling in sections and partially removed. Ceiling to be consolidated and modern dropped ceiling introduced to provide essential MEP route through the building.

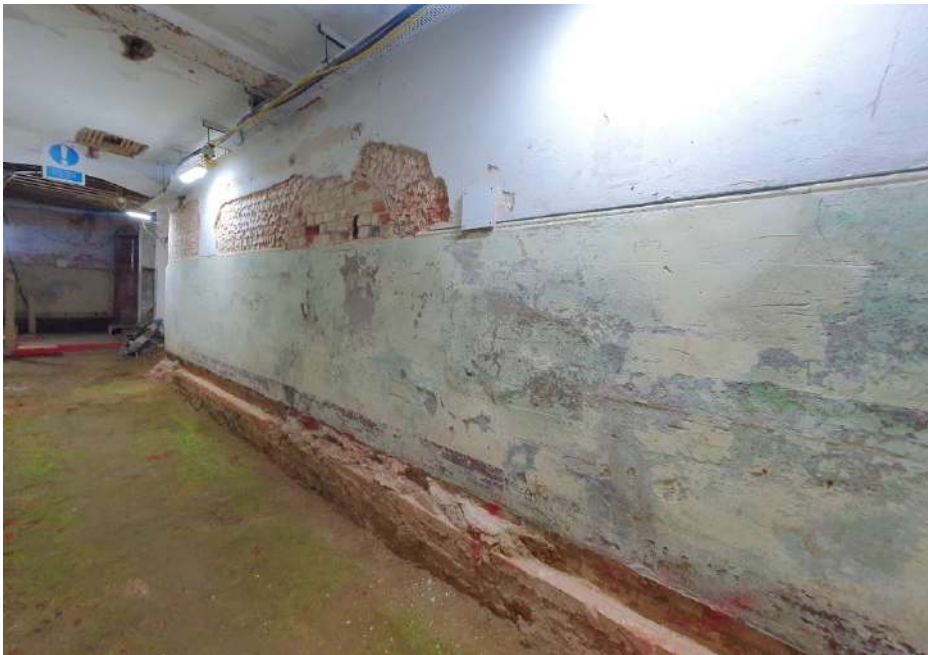
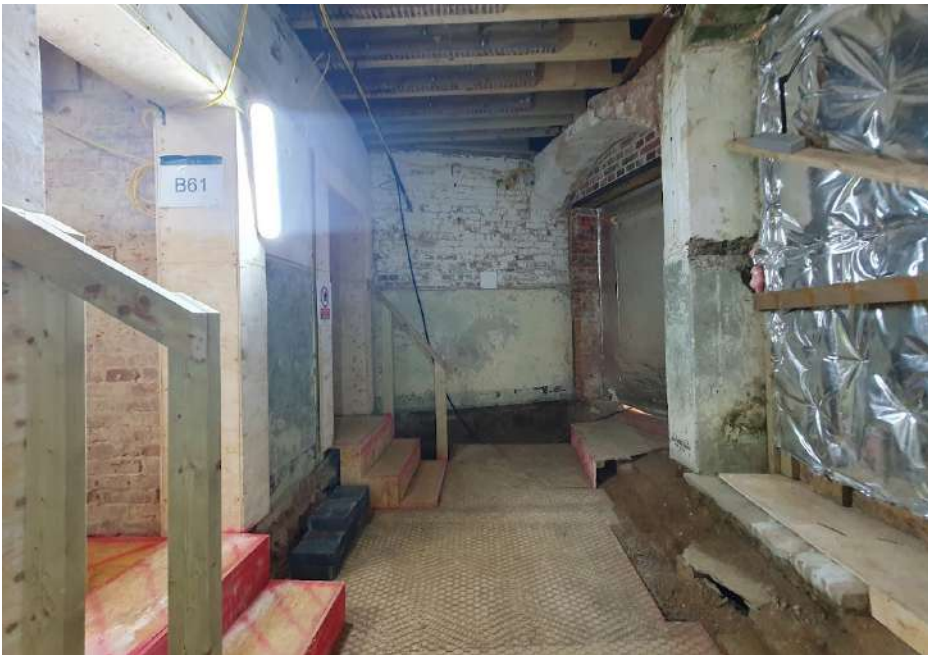
**Walls** – a mix of render (some lime, some cement). Render to be repaired and reinstated in matching materials. Cement render if not causing damage will not be removed but simply repaired. If damp issues present or cement render blown the complete area will be replaced in traditional lime to masonry.

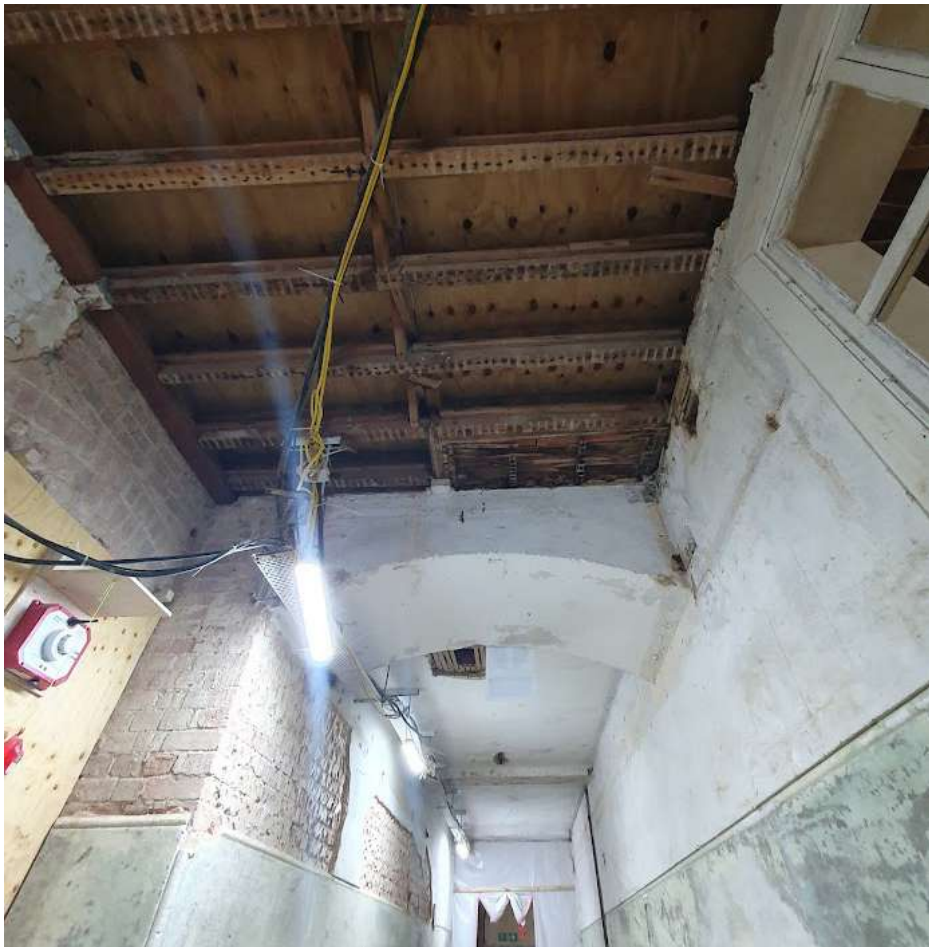
CEILING

**Ceiling** – lath and plaster in poor condition and missing in sections. Proposal is to replicate in new like for like lath and plaster ceiling.
