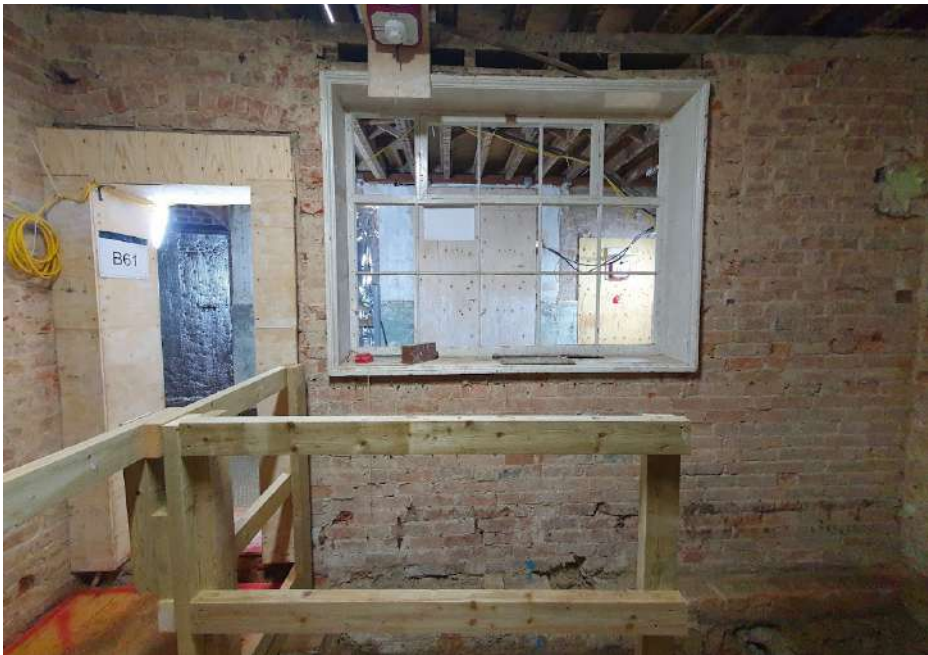
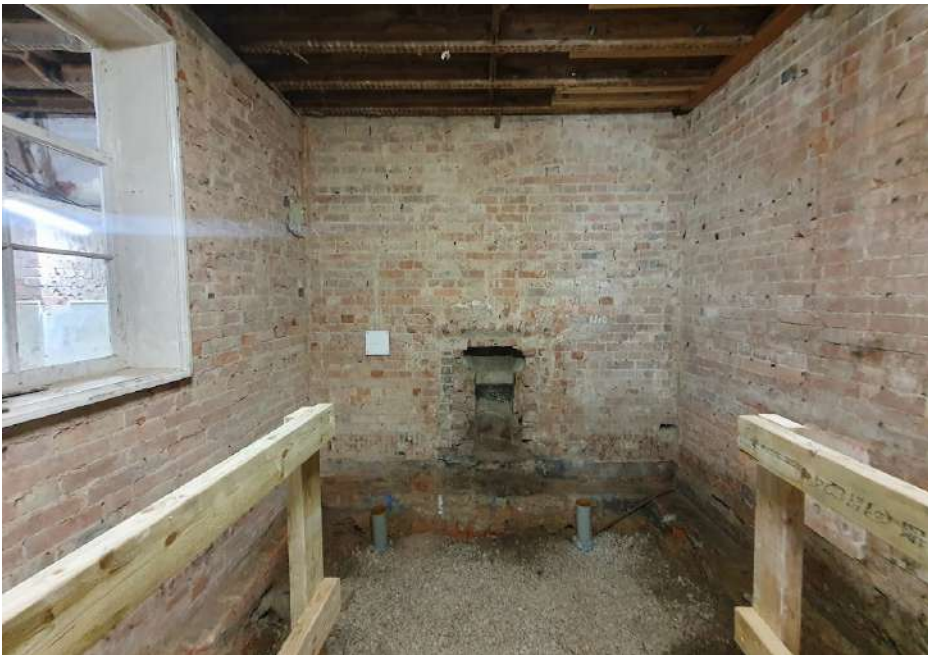
**Walls** – all finishes absent. New tiled finish to be introduced with cavity drain to south wall.

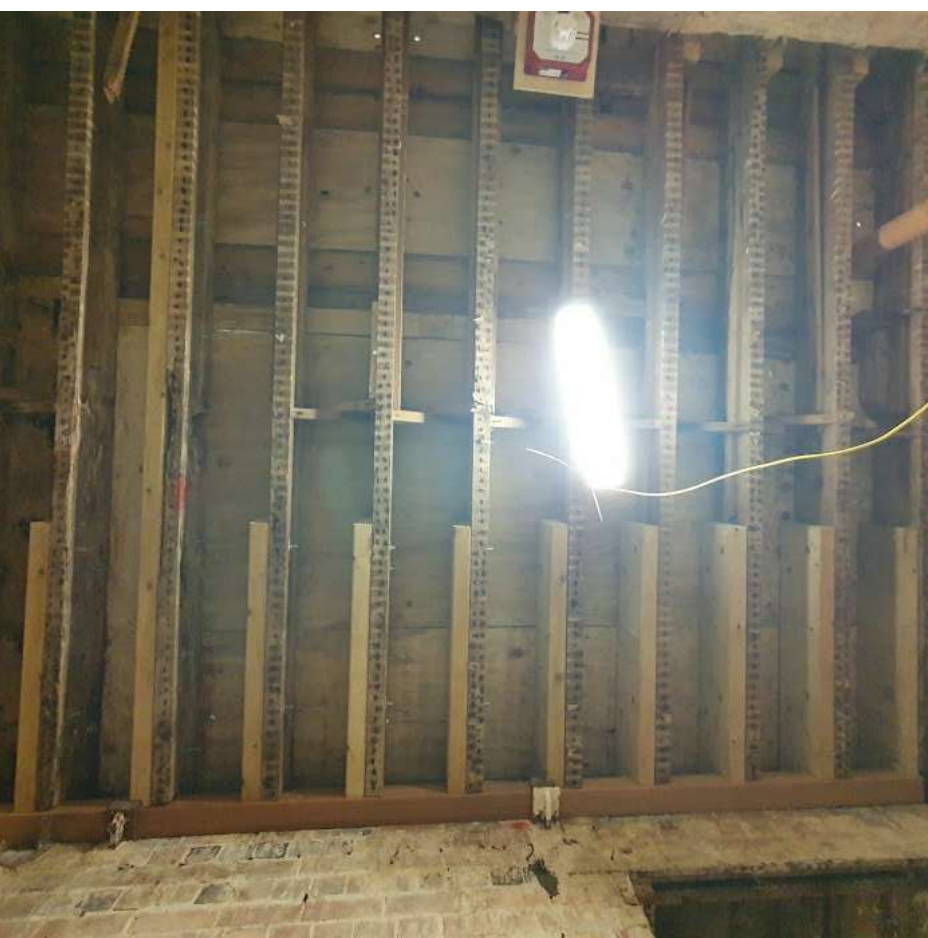
CEILING

**Ceiling** – all finishes absent. New modern ceiling suitable for a wash area to be introduced.

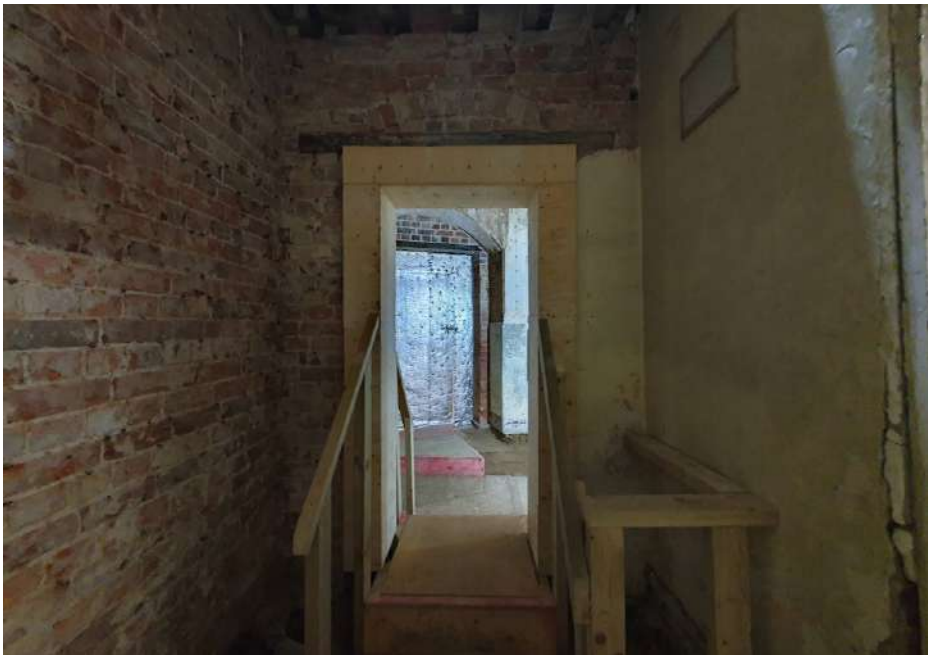
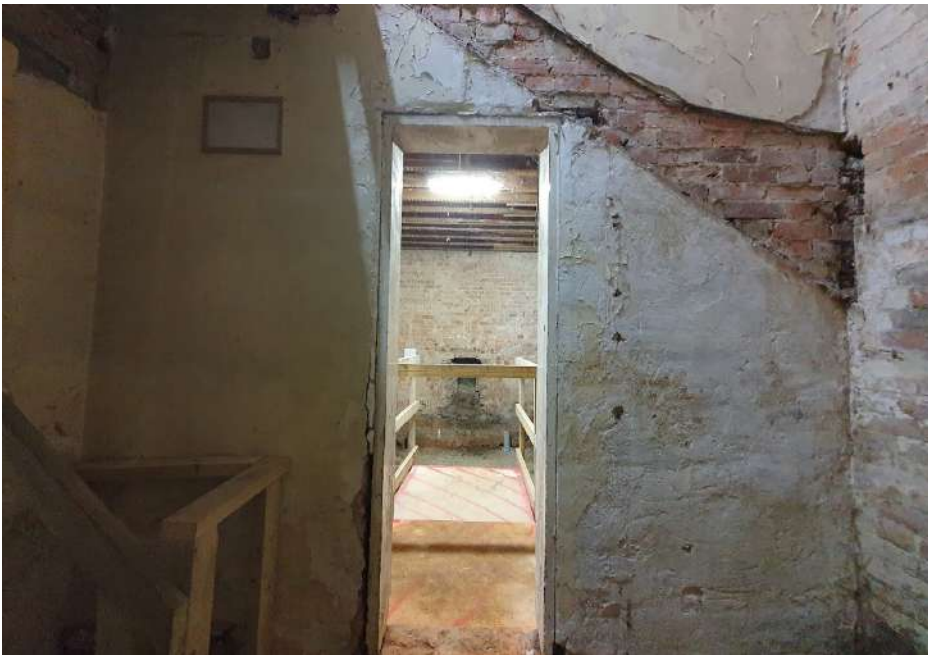
**Walls** – most finishes absent. Traditional plaster to masonry to be reintroduced with modern waterproofing membrane to south wall as consented.

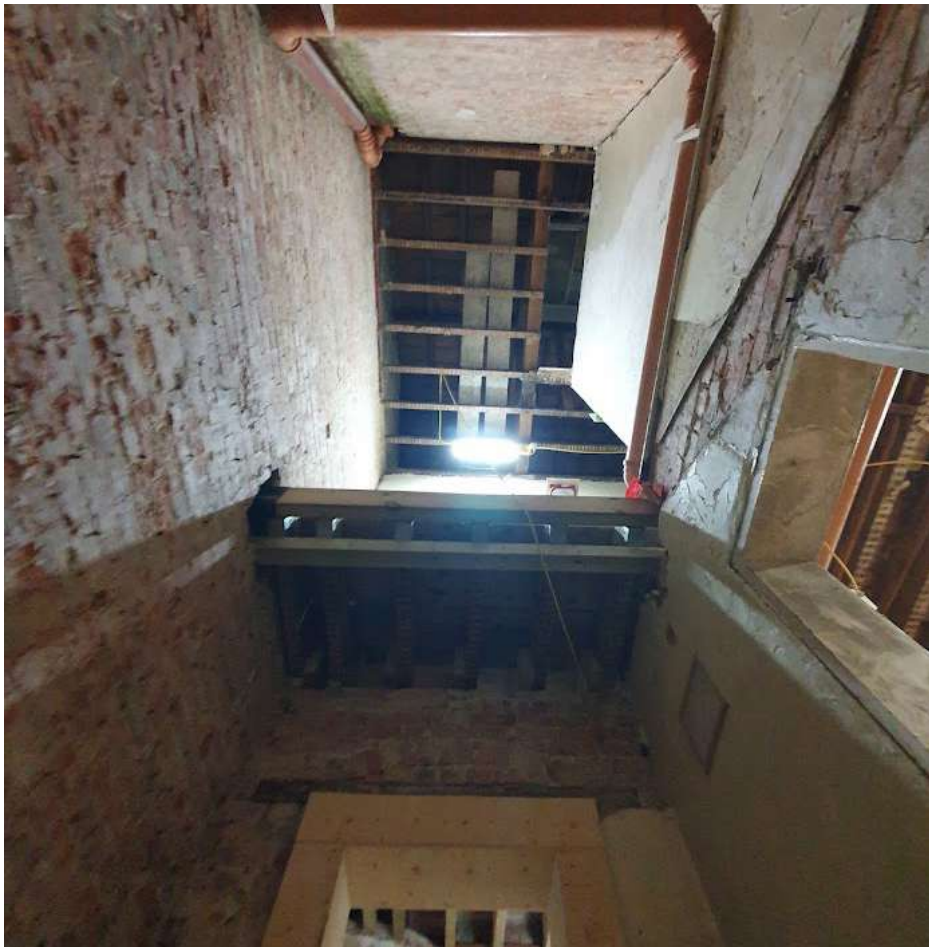
CEILING

**Ceiling** – all finishes absent. Lath and plaster ceiling to work with reinstated stair to be reintroduced.
