# TOTTENHAM HOUSE & ESTATE

Plain Plaster Condition Record PH 1  
LOWER GROUND FLOOR

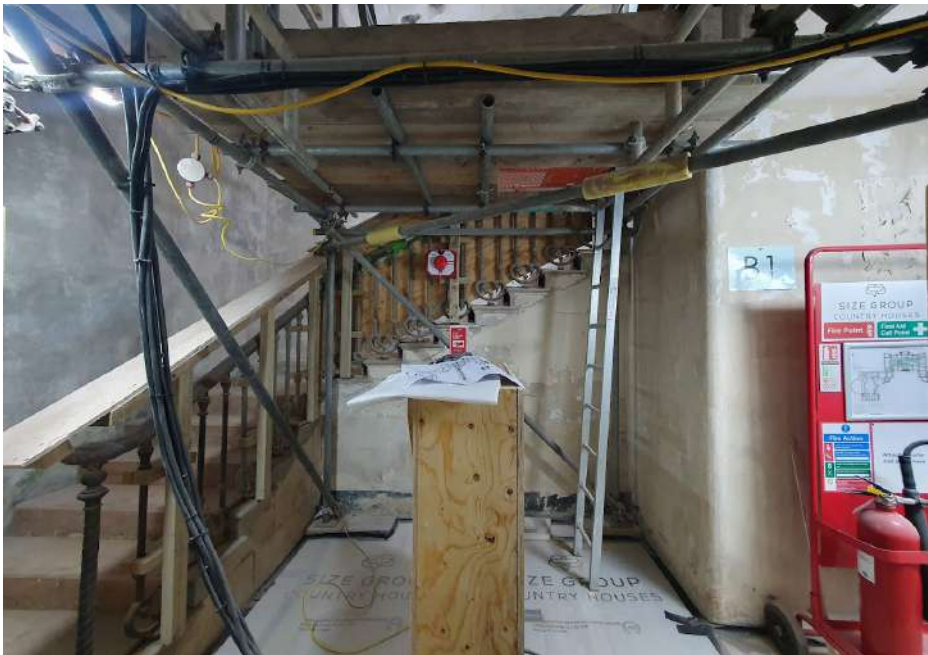
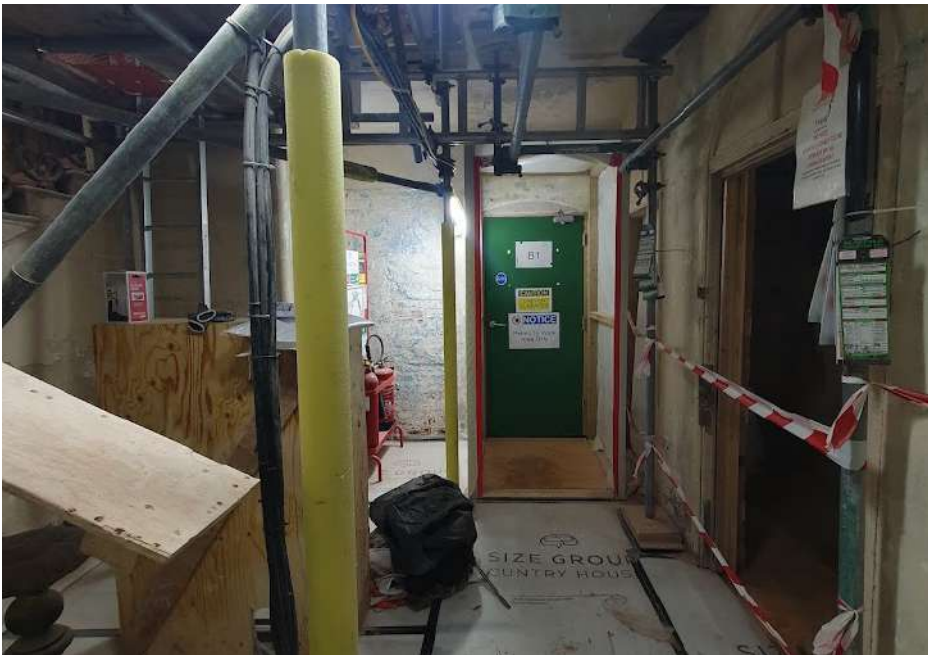
B01 - ARCADE STAIR

**Walls** – modern concrete skim on historic masonry. General approach to the applied concrete finishes on the project is to leave in situ if they are not causing harm to the historic fabric as removal works can cause significant damage to the soft brick face. No damage caused by the concrete skim has been identified, therefore work consists of making good, stripping the modern paint and redecorating the existing finish.

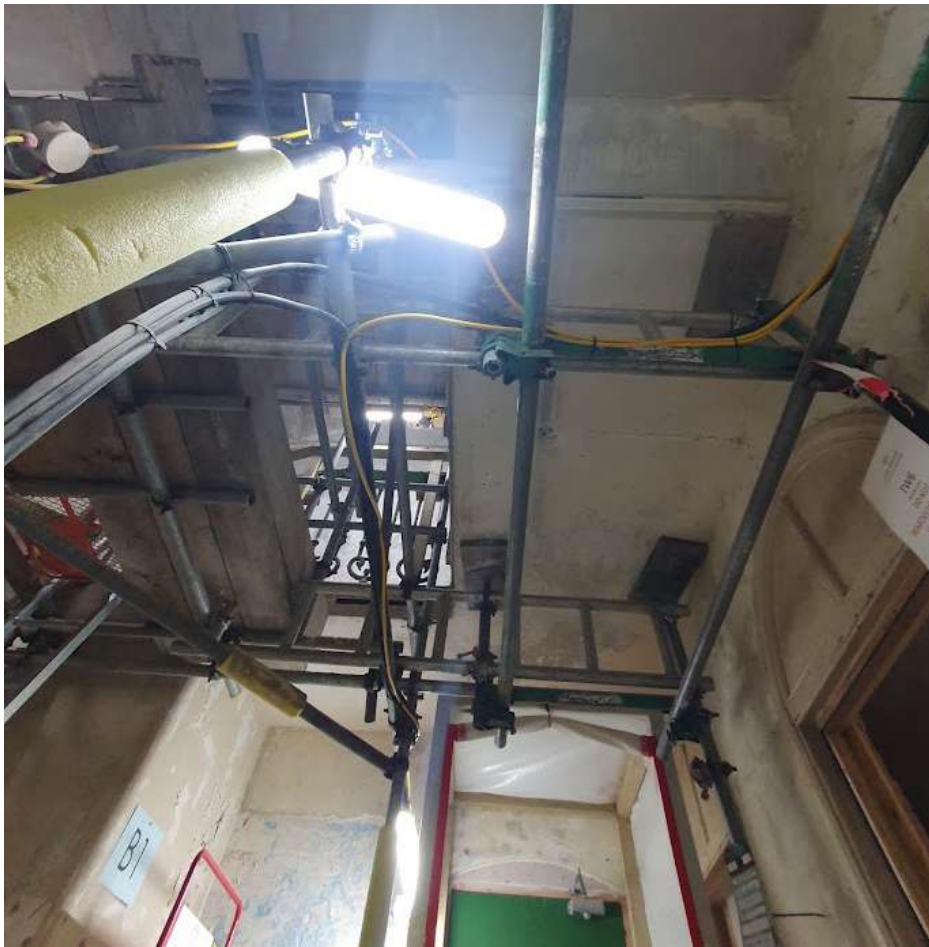
CEILING

**Ceiling** – cantilever stone soffit. Modern flaking paint to be cleaned as part of the stair cleaning consented works. No proposed changes, minimal repointing to any damage or open joints.

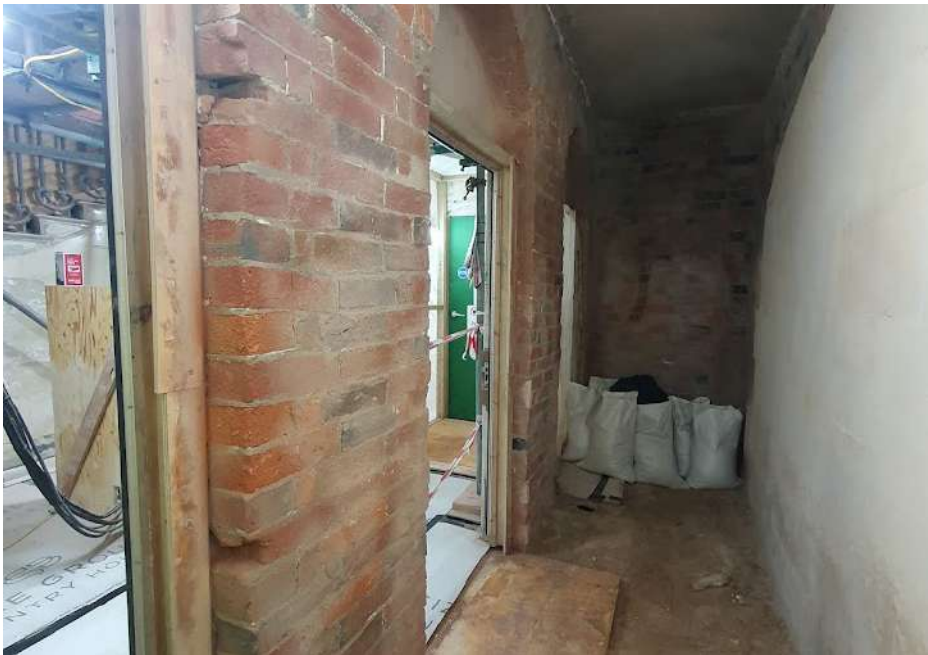
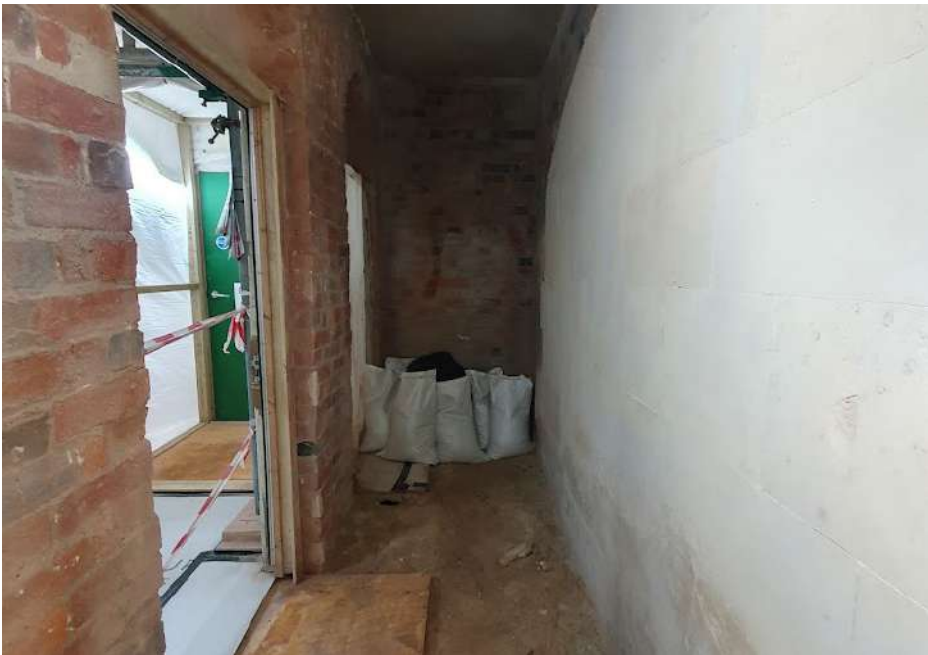
B02 - STORE

**Walls** – north, east and west wall exposed brickwork, carefully cleaned of modern harmful paint. To be retained as unfinished brickwork. South wall of ashlar stone with a masonry arch. It is assumed that the arch might be part of the 18th century basement vaulting and ashlar infill is of 19th century. Stone to be carefully cleaned of any harmful modern finishes and retained undecorated.

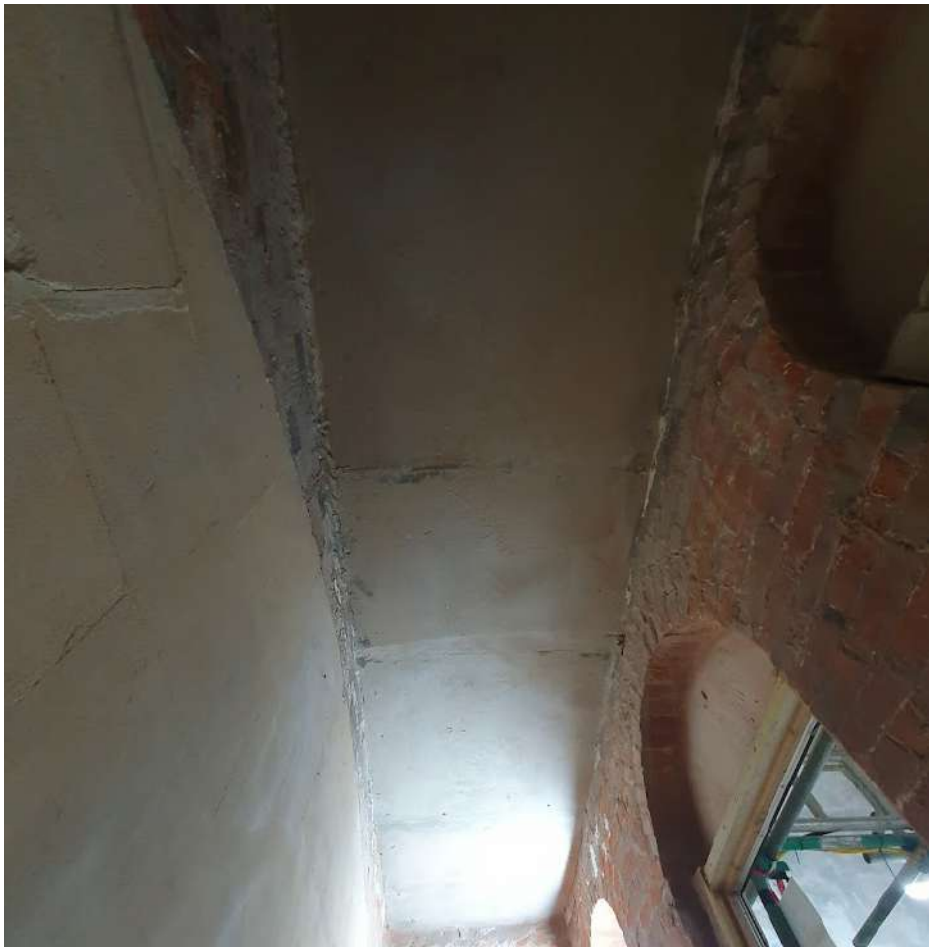
CEILING

**Ceiling** – underside of cantilever stone landing. Sensitive cleaned as part of paint stripping works and minimal repointing to any open joints.

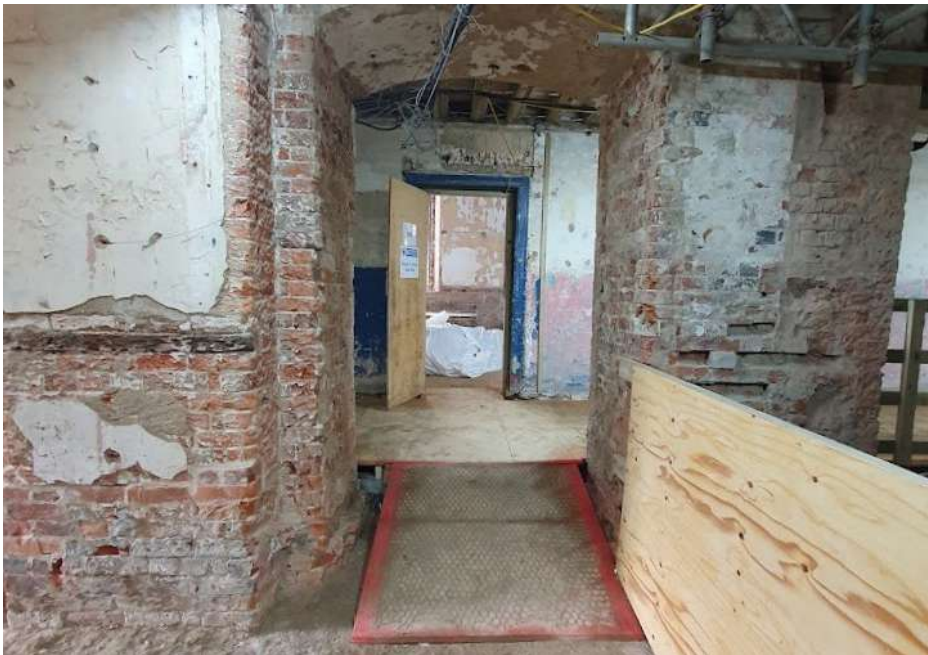
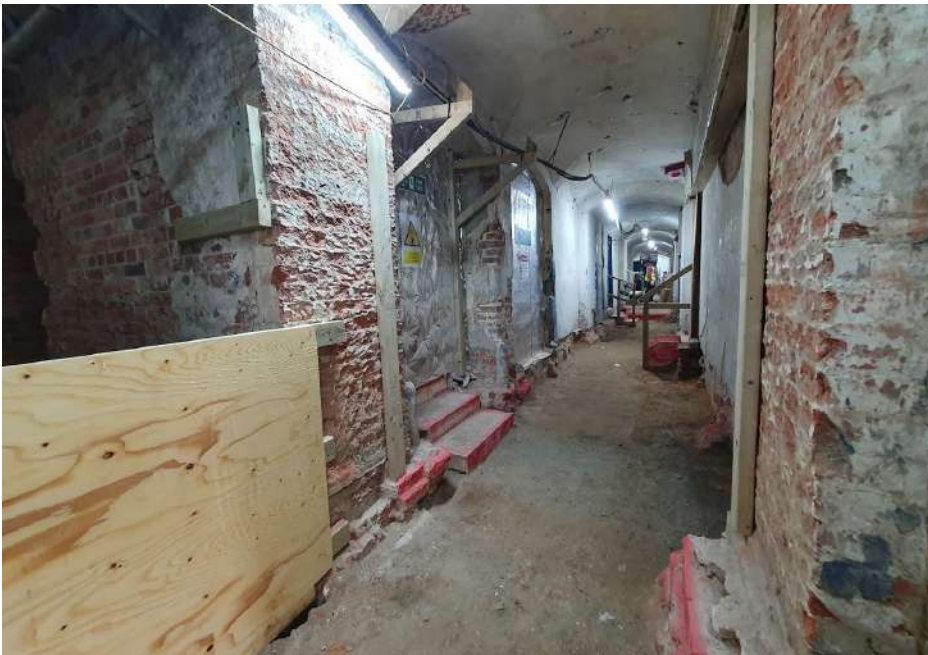
B03 - WEST CORRIDOR

**Walls** – generally a mix of modern concrete and lime plaster, both in poor condition and significantly altered. Surface to be cleaned to remove harmful modern paints and substrate made good. Generally retained like for like, however if large sections of concrete render have delaminated and require replacement preference will be given to replacing in lime render. Similarly, if there is visible damp in an area with cement render this will be carefully removed and replaced with traditional lime plaster. To be redecorated in breathable paint throughout.

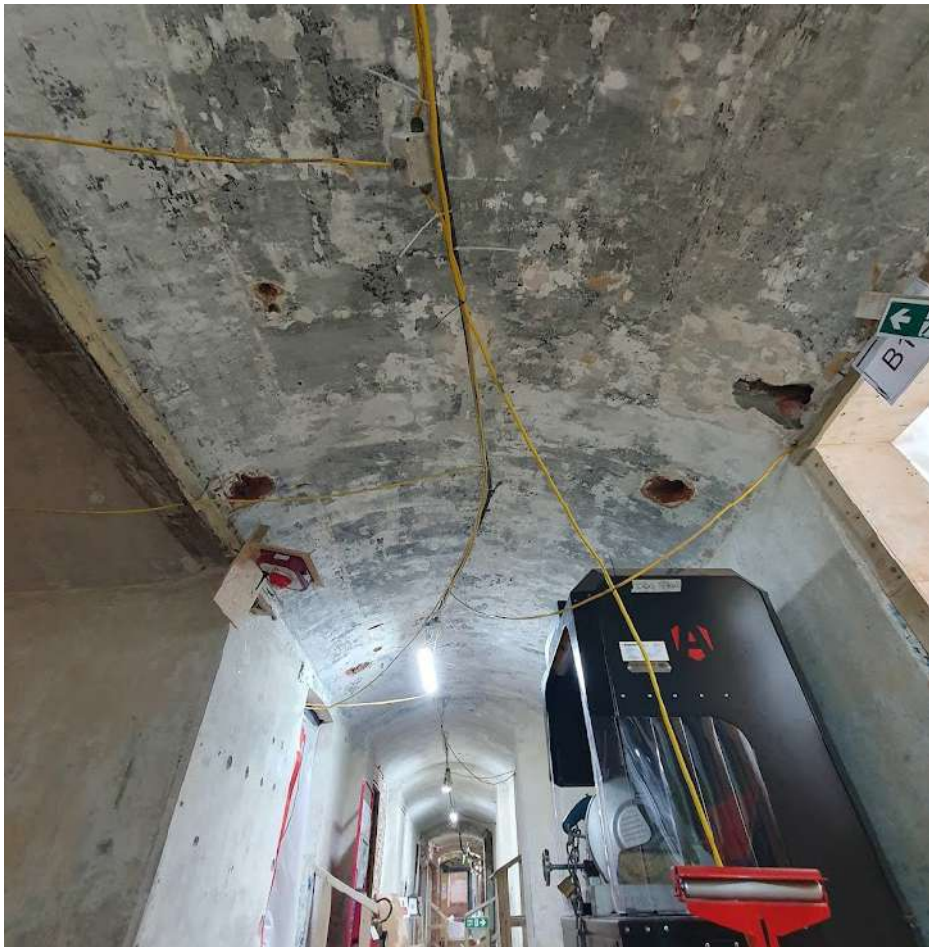
CEILING

**Ceiling** – generally masonry barrel vault ceiling with a mix of lime and concrete render in poor condition. Finish to be cleaned of harmful modern paints and made good. Generally retained like for like, however if large sections of concrete render have delaminated and require replacement preference will be given to replacing in lime render. Redecorated in breathable paint throughout.

Northernmost section historically a lath and plaster ceiling but currently no surviving historic fabric. New dropped ceiling consented for essential MEP distribution.

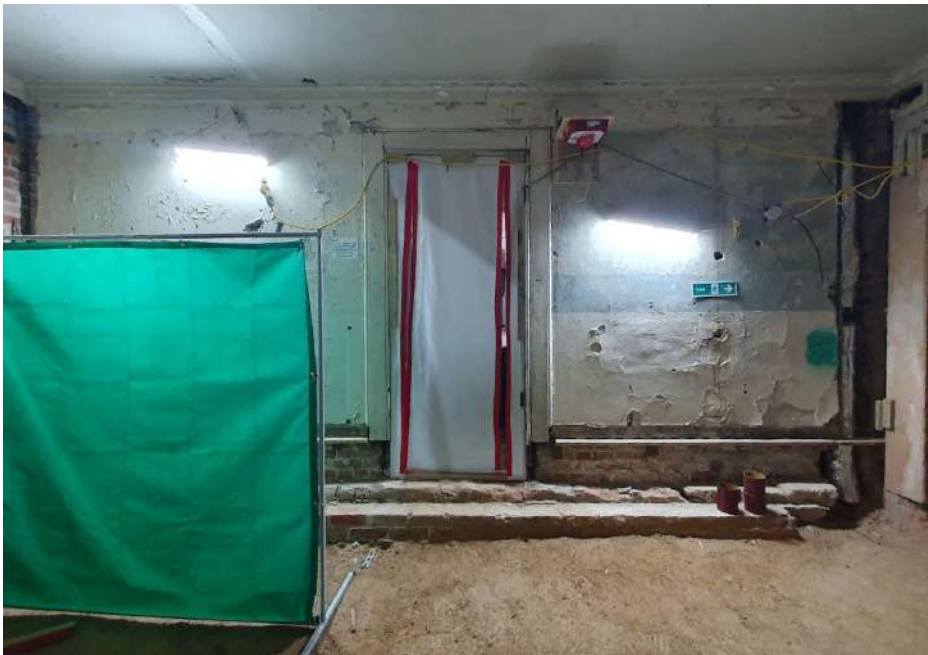
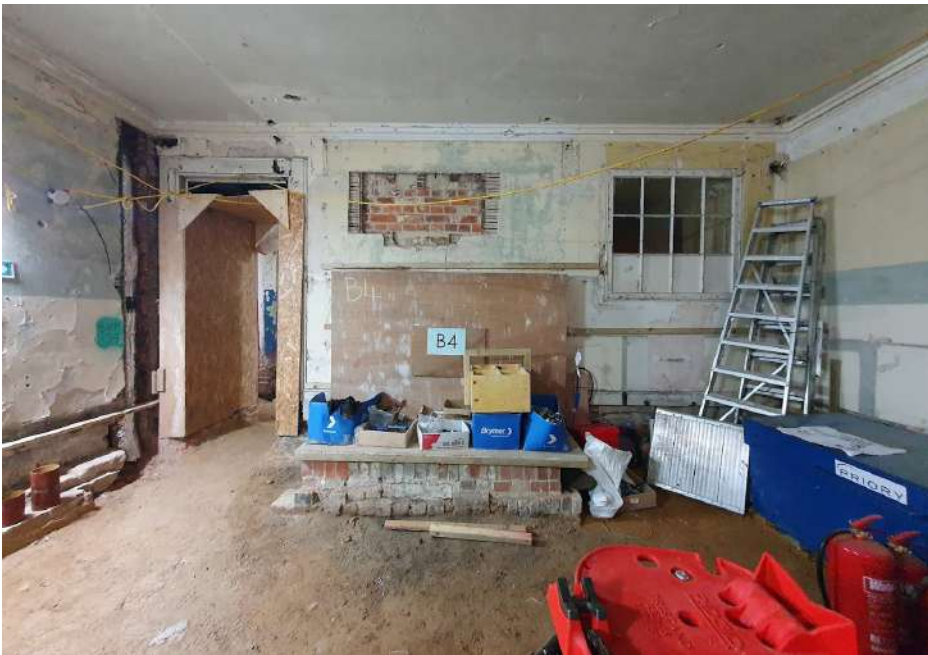
B04 - STAFF KITCHENETTE AND LOUNGE

**Walls** – one of the rare areas on LGF with lath and plaster finish with a cornice and timber skirtings. Generally in very poor condition due to severe water ingress from adjacent west portico and embedded RWP in south west corner. All areas to be either reinstated in traditional lime lath and plaster or retained and repaired where reasonable. South wall built out to house essential MEP services. New wall scribed around existing fabric and any sound fabric consolidated and retained in situ behind new. New partition formed in breathable wood wool board with lime plaster finish.

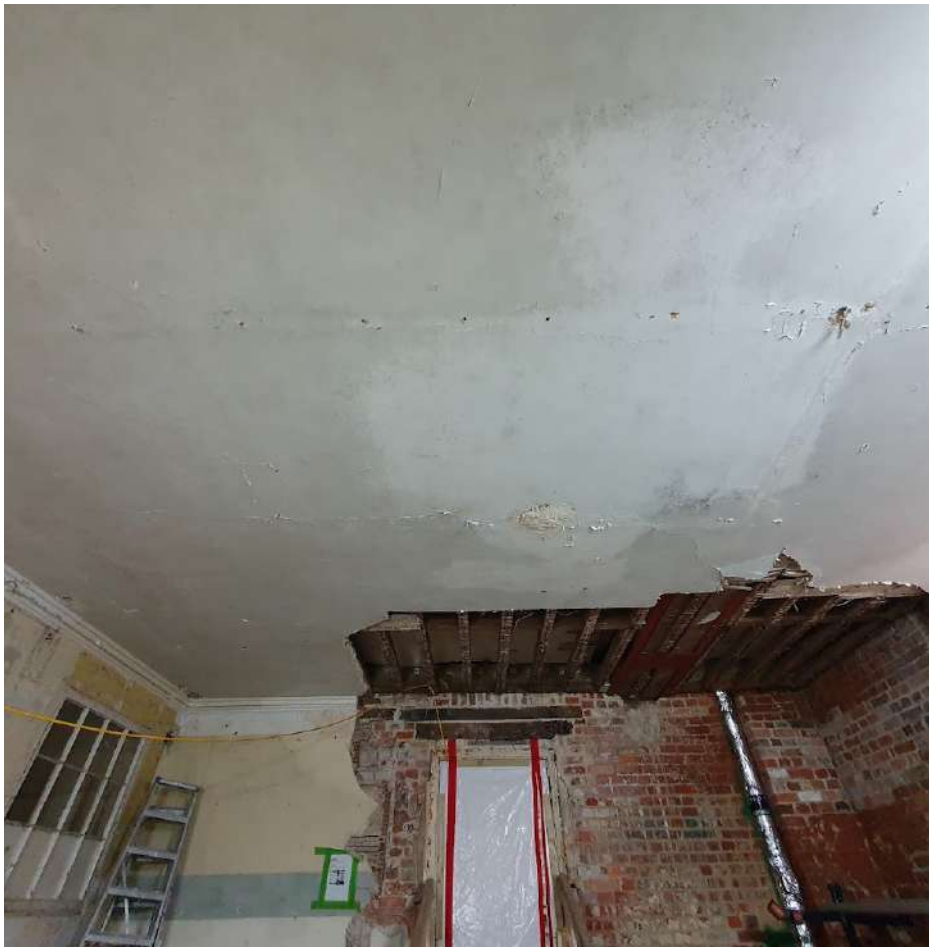
CEILING

**Ceiling** – lath and plaster ceiling in very poor condition and sections removed as consented due to severe decay. Any sound areas to be repaired like for like and missing sections replicated like for like.

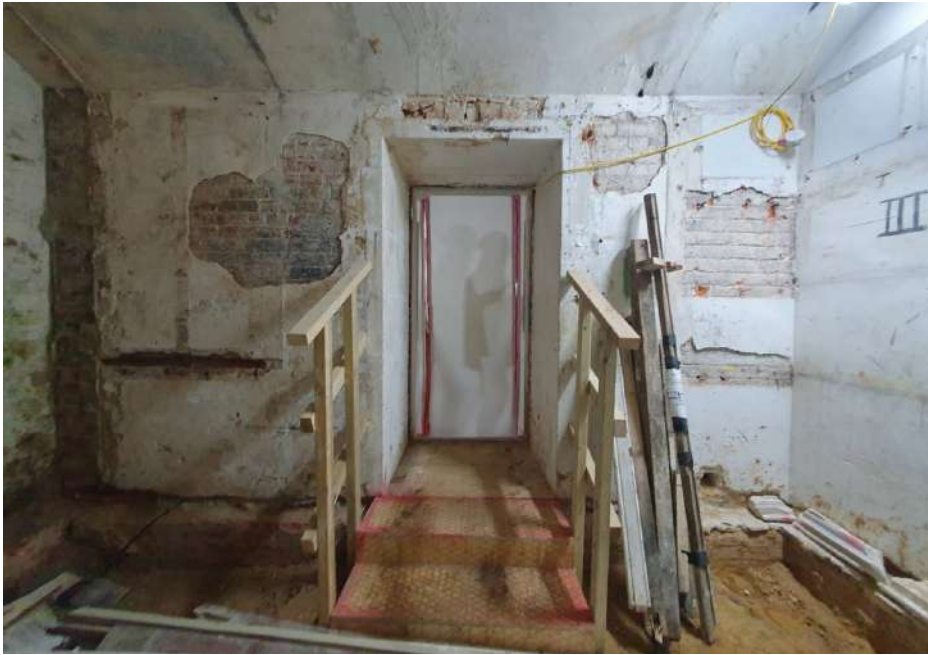
NORTH ELEVATION

**Walls** – masonry brickwork with remnants of paint and plaster. To be cleaned of all finishes and masonry consolidated. Consented area of waterproofing due to required hygienic finishes in a bathroom setting. West wall built out with masonry to create a void for MEP distribution without affecting the original masonry and to avoid any chasing.

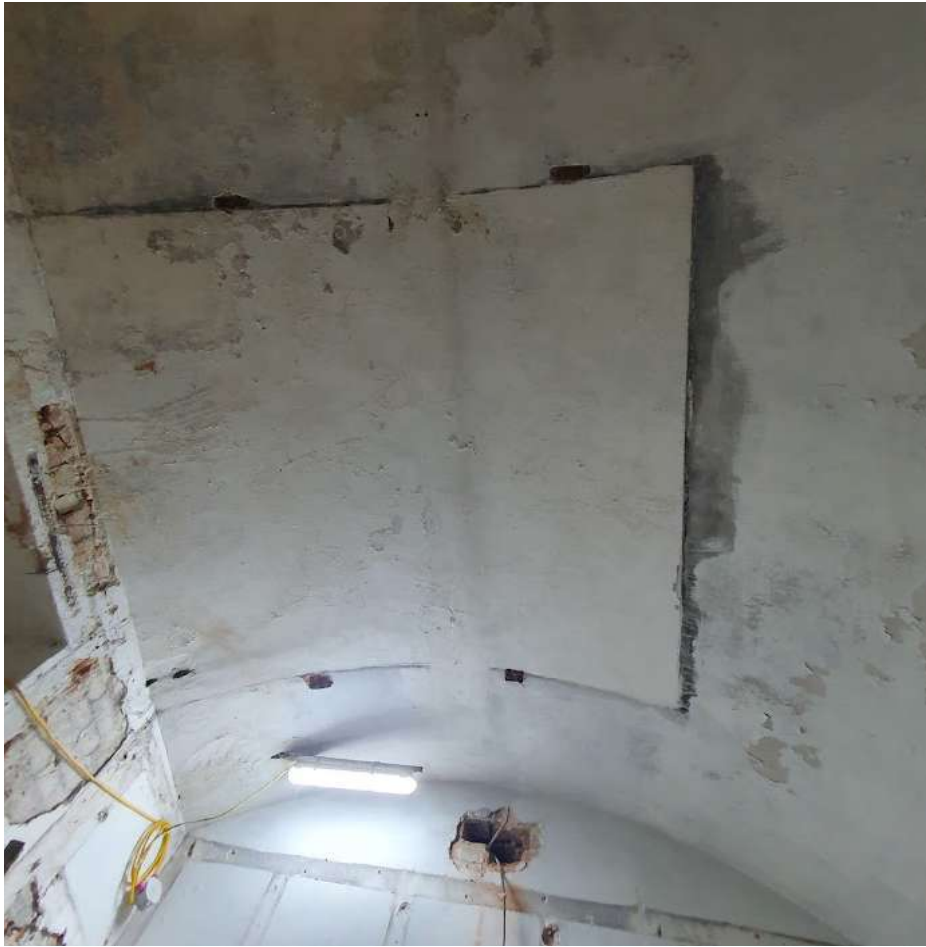
CEILING

**Ceiling** – masonry barrel vault with remnants of paint and plaster. To be cleaned of all finishes and masonry consolidated. Consented area of waterproofing due to required hygienic finishes in a bathroom setting.

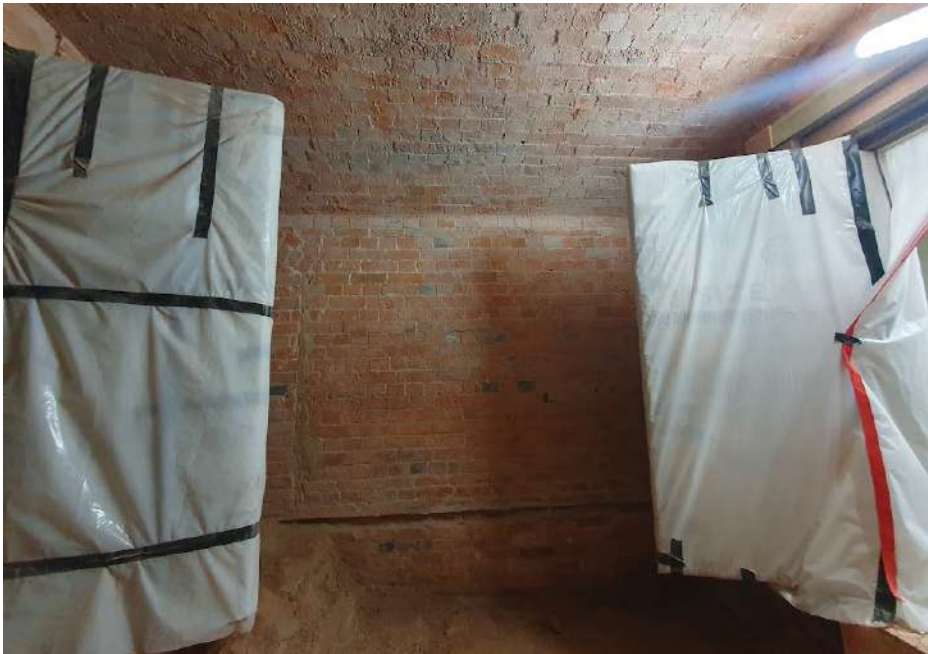
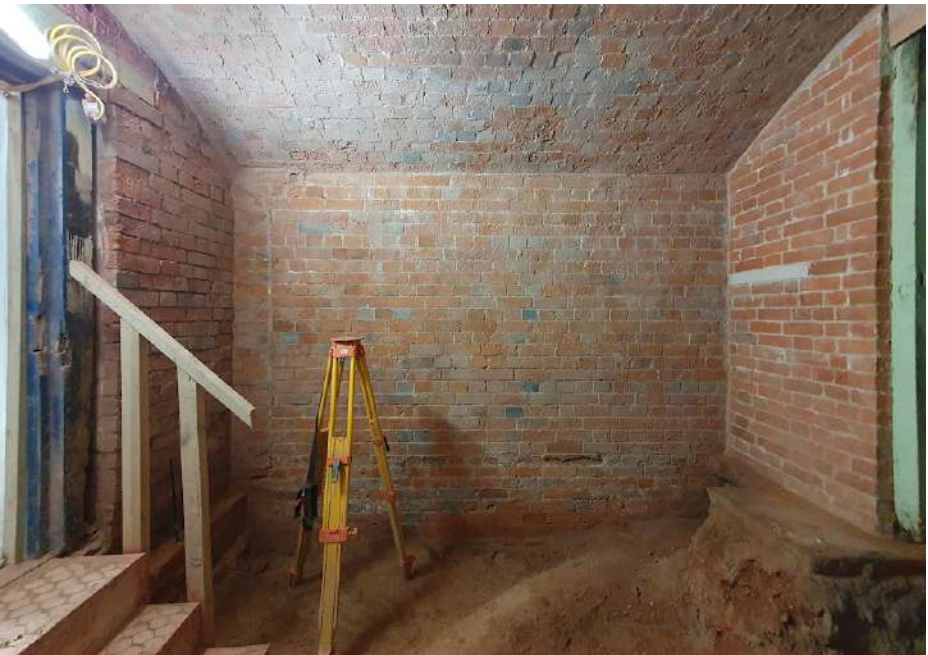
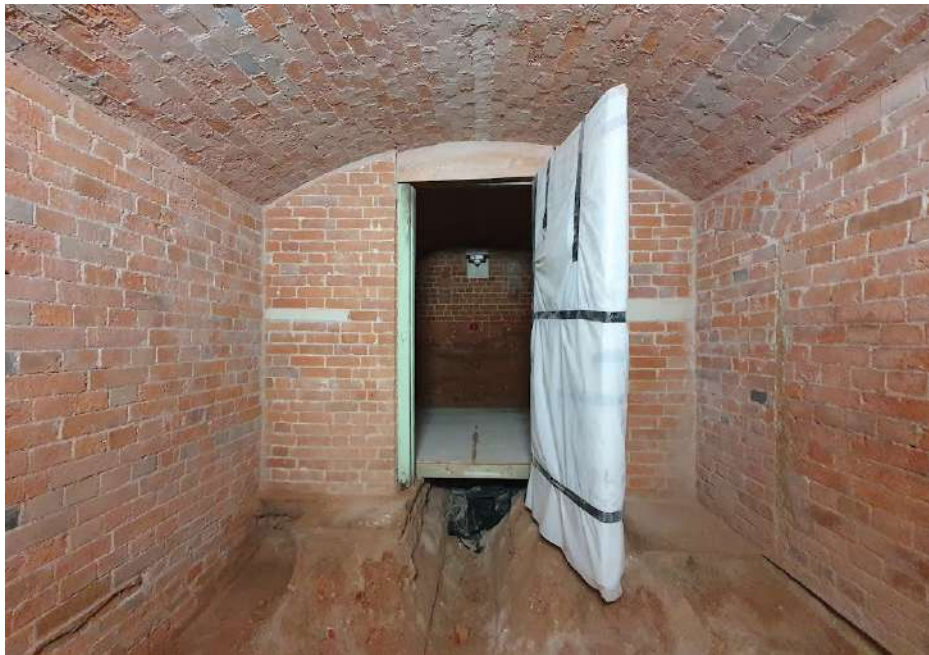
B06b - STORE

**Walls** – masonry brickwork cleaned as consented from residual modern paint. To be consolidated and any areas of missing pointing to be made good with traditional lime mortar to match adjacent.

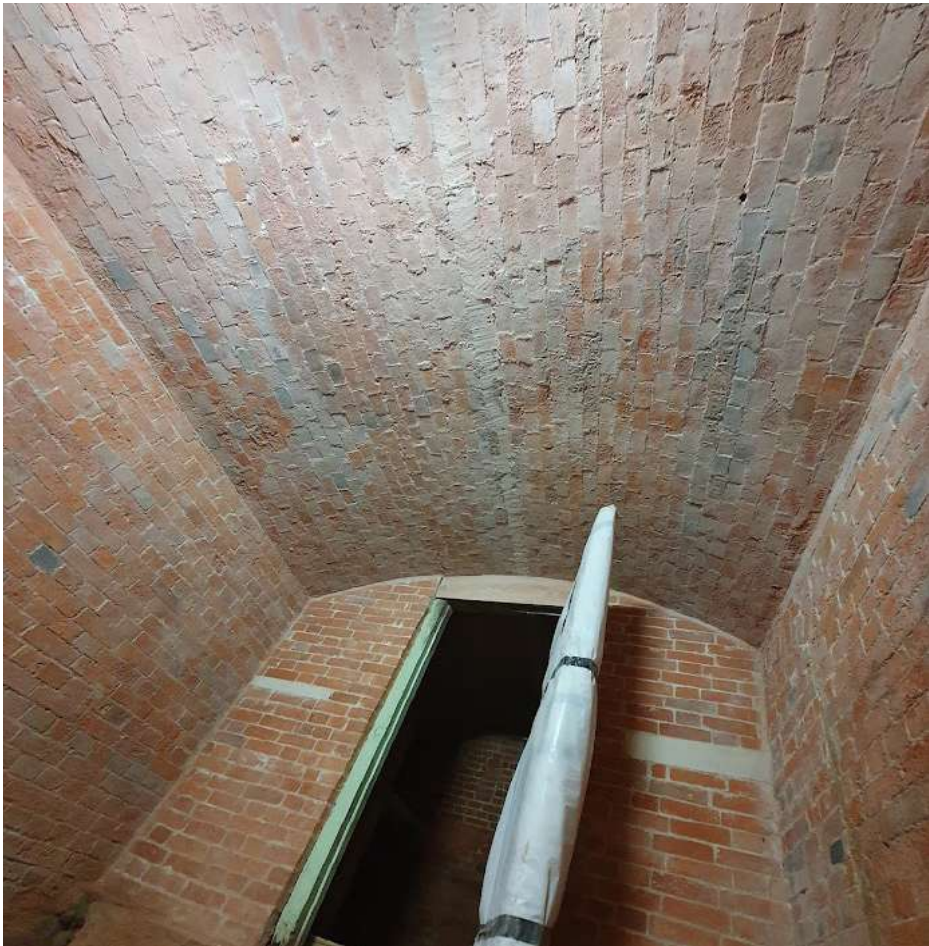
CEILING

**Ceiling** – masonry barrel vault cleaned from residual modern paint as consented. To be consolidated and any areas of missing pointing to be made good with traditional lime mortar to match adjacent.

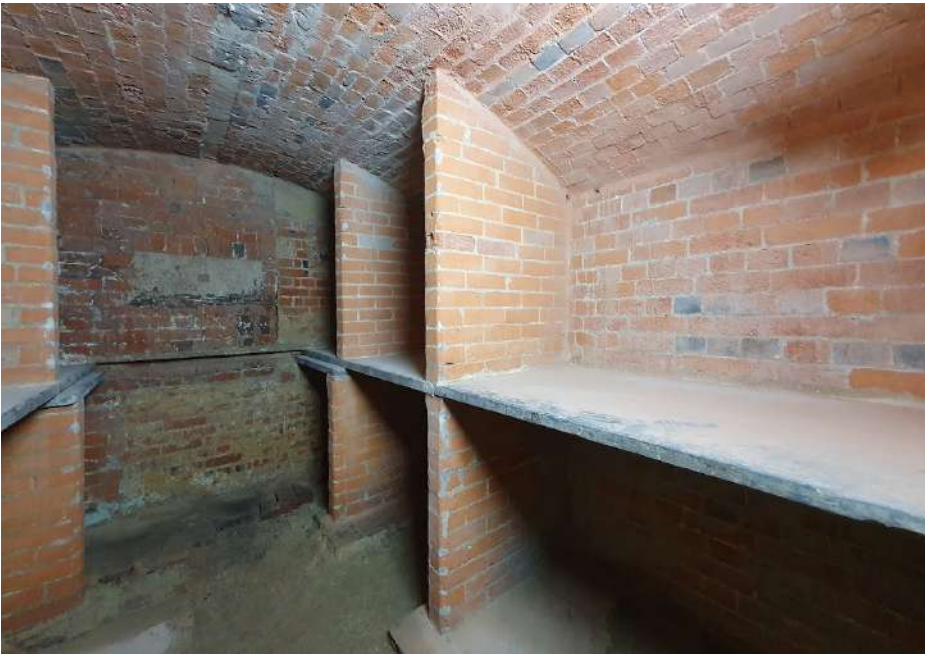
NORTH ELEVATION

**Walls** – masonry brickwork cleaned as consented from residual modern paint. To be consolidated and any areas of missing pointing to be made good with traditional lime mortar to match adjacent. Integrated masonry partitions and shelving retained in situ.

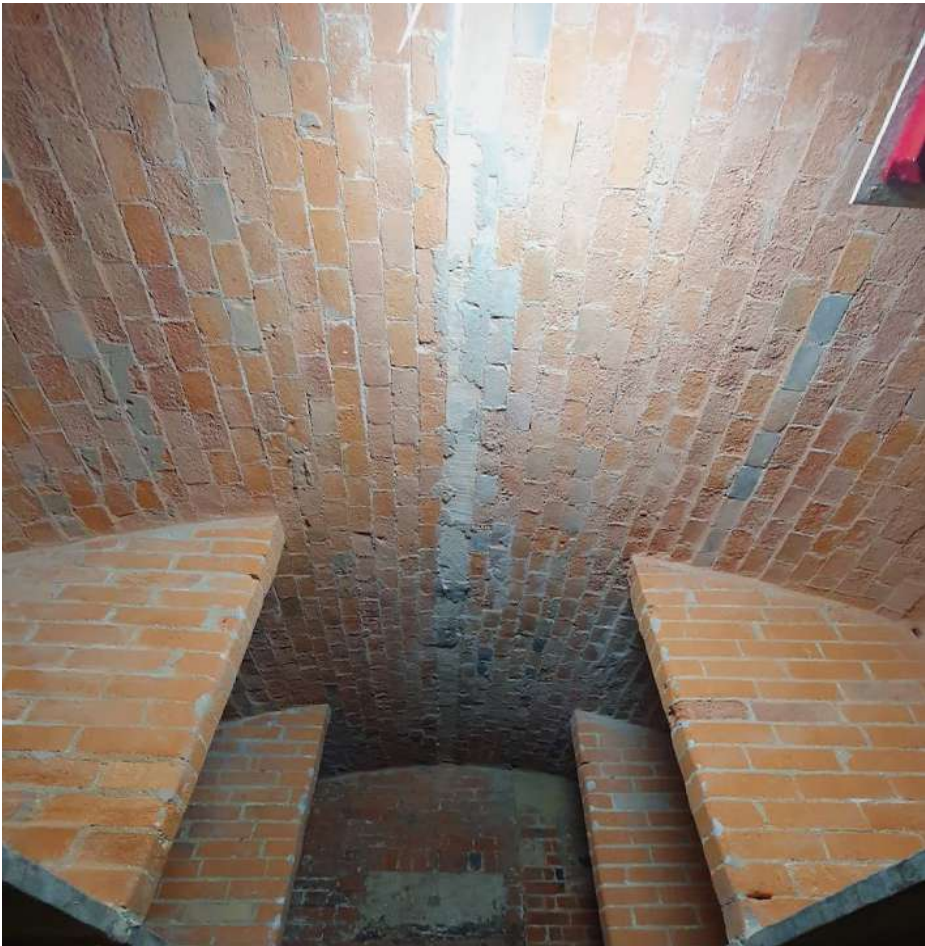
CEILING

**Ceiling** – masonry barrel vault cleaned as consented from residual modern paint. To be consolidated and any areas of missing pointing to be made good with traditional lime mortar to match adjacent.

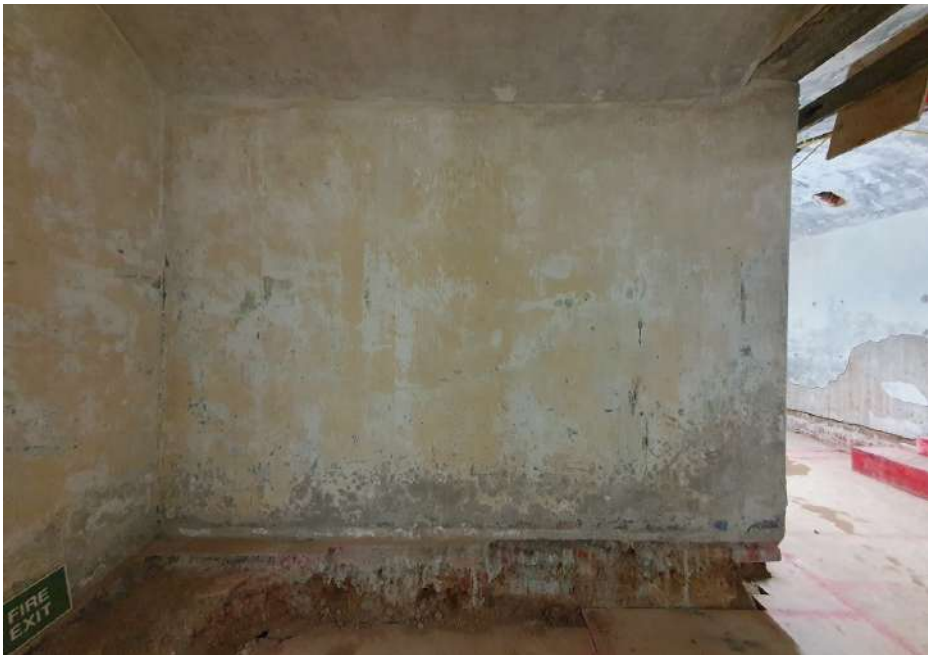
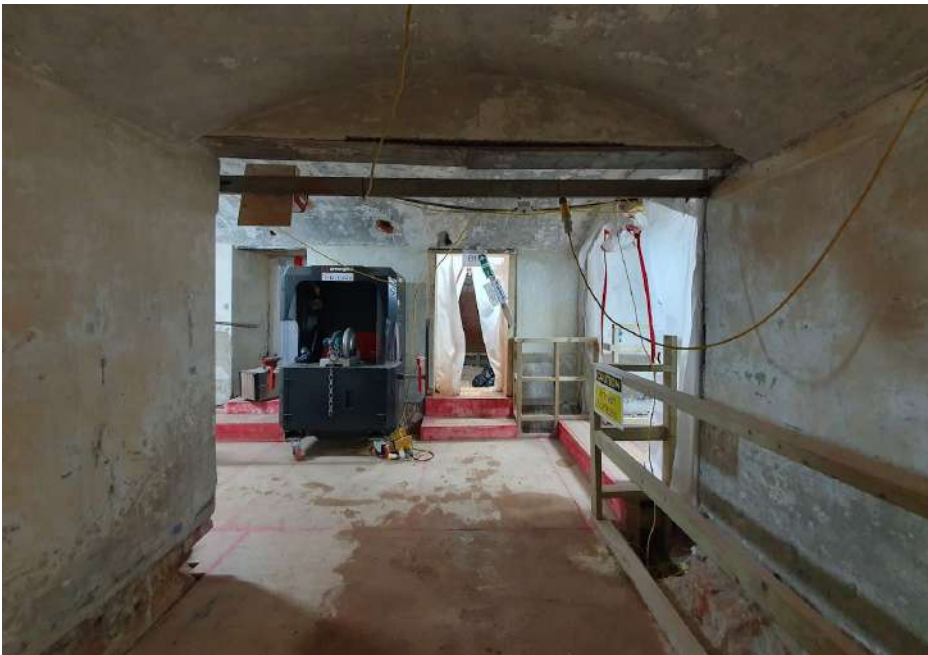
B07a - LOBBY

**Walls** – generally a mix of modern concrete and lime plaster, both in poor condition and significantly altered. Surface to be cleaned to remove harmful modern paints and substrate made good. Generally retained like for like, however if large sections of concrete render have delaminated and require replacement preference will be given to replacing in lime render. Similarly if there is visible damp in an area with cement render this will be carefully removed and replaced with traditional lime plaster. Redecorated in breathable paint throughout.

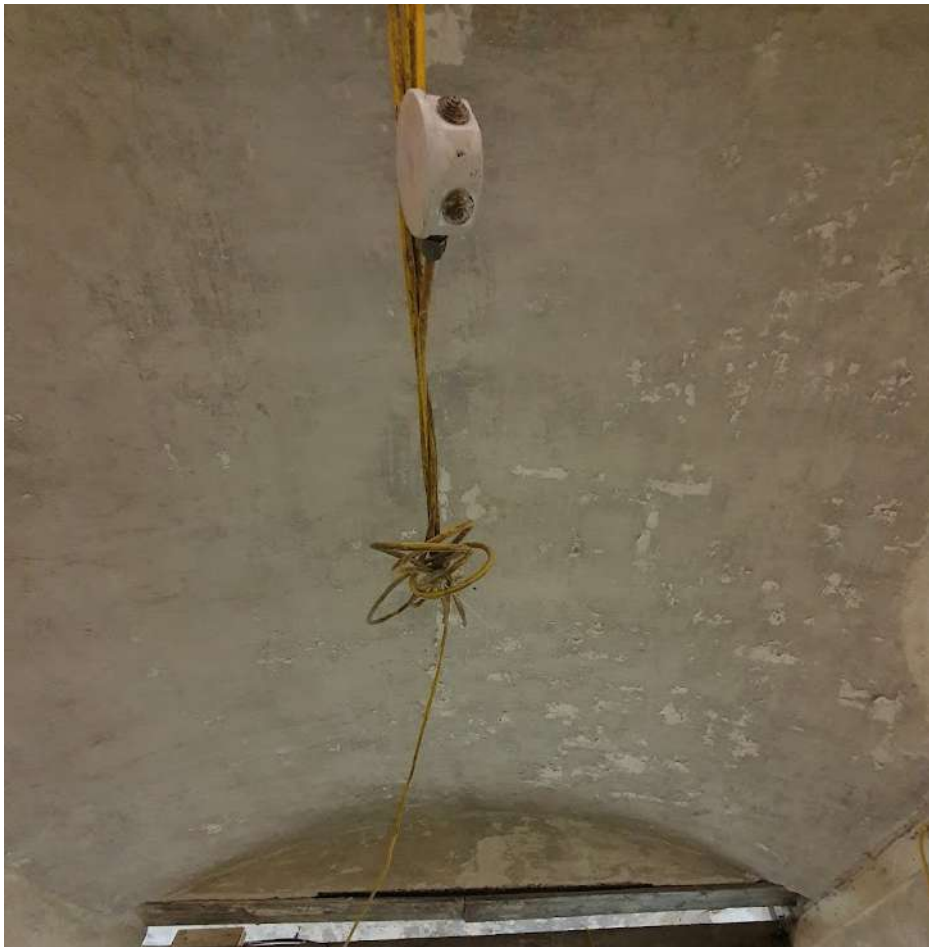
CEILING

**Ceiling** – masonry barrel vault ceiling with a mix of lime and concrete render in poor condition. Finish to be cleaned of harmful modern paints and made good. Generally retained like for like, however if large sections of concrete render have delaminated and require replacement preference will be given to replacing in lime render. Redecorated in breathable paint throughout.

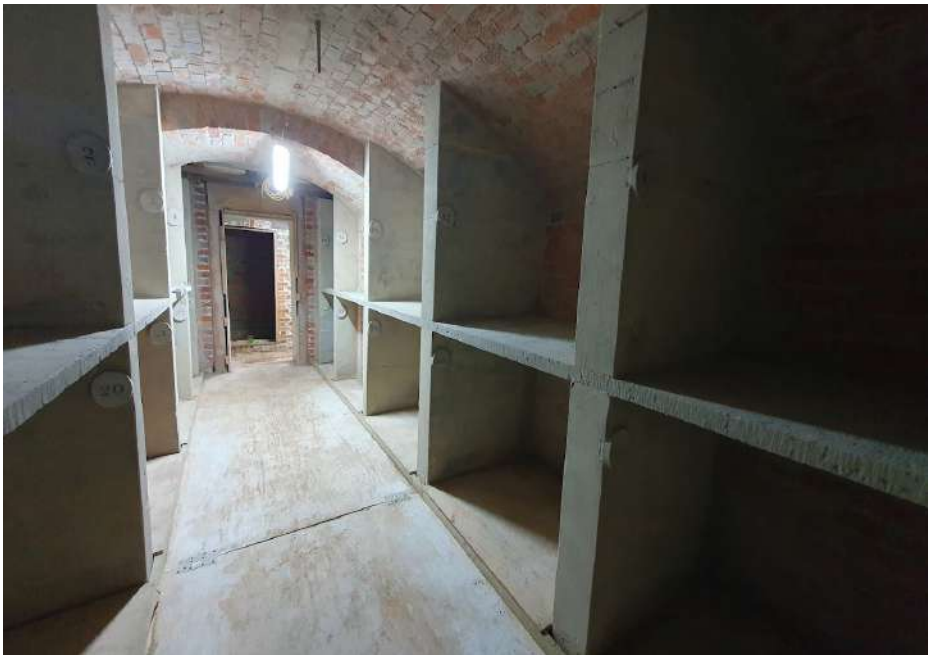
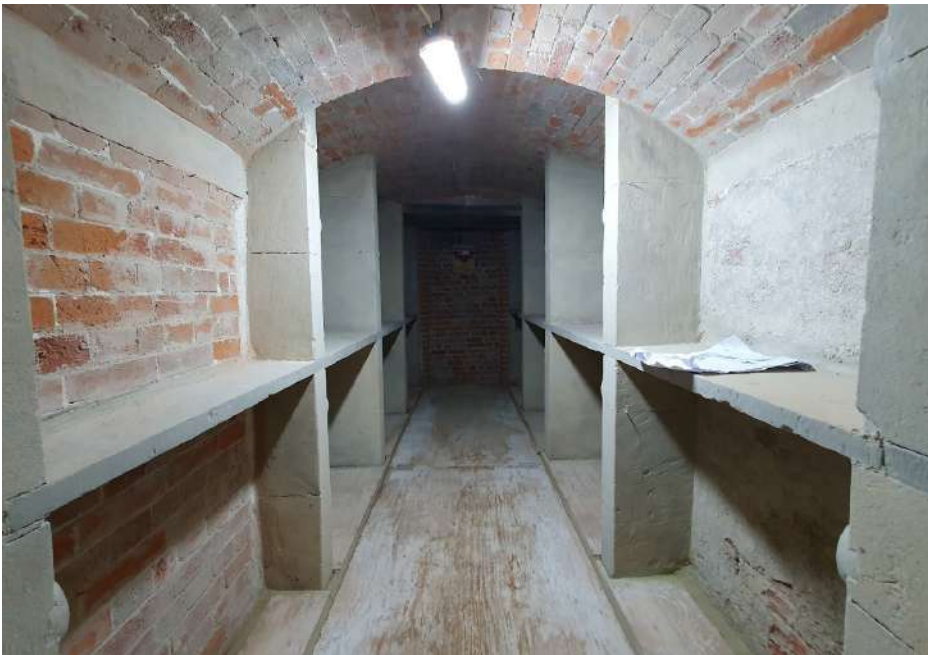
B08 - STORE

**Walls** – masonry brickwork cleaned from residual modern paint as consented. To be consolidated, and any areas of missing pointing to be made good with traditional lime mortar to match adjacent. Integrated stone partitions and shelving retained in situ.

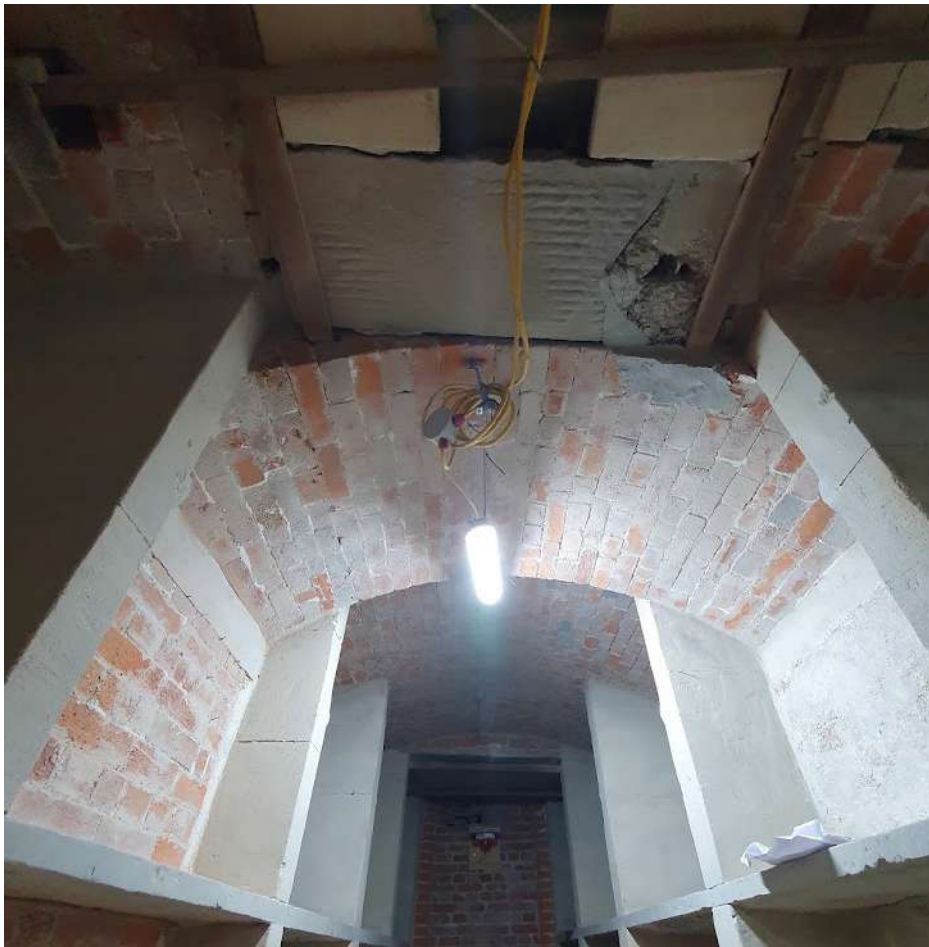
CEILING

**Ceiling** – masonry barrel vault cleaned from residual modern paint as consented. To be consolidated, and any areas of missing pointing to be made good with traditional lime mortar to match adjacent.

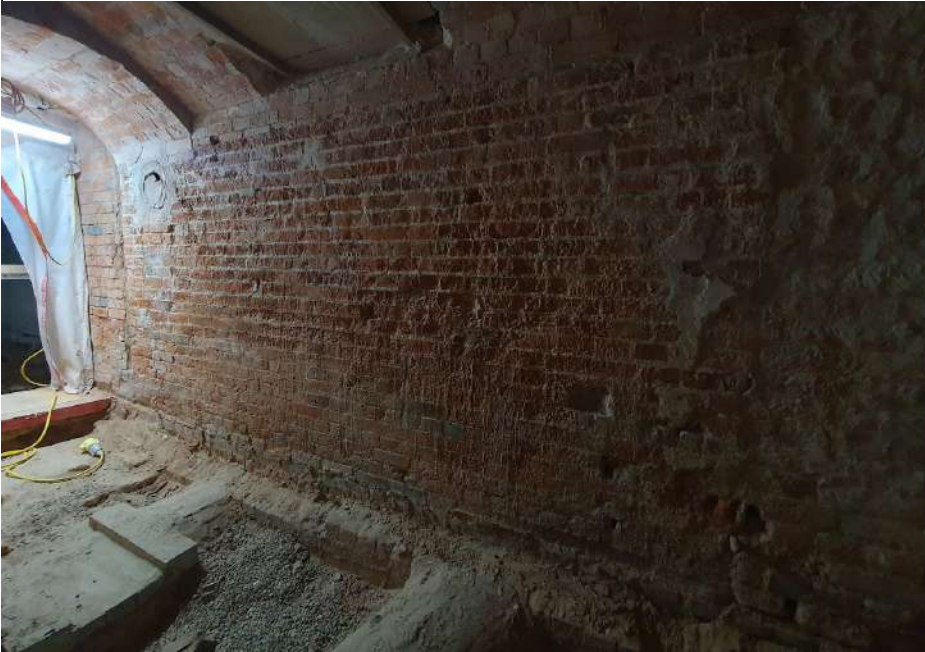
NORTH ELEVATION

**Walls** – masonry brickwork cleaned from residual modern paint as consented. To be consolidated, and any areas of missing pointing to be made good with traditional lime mortar to match adjacent. Visible areas of different building periods present themselves in variations of brickwork.

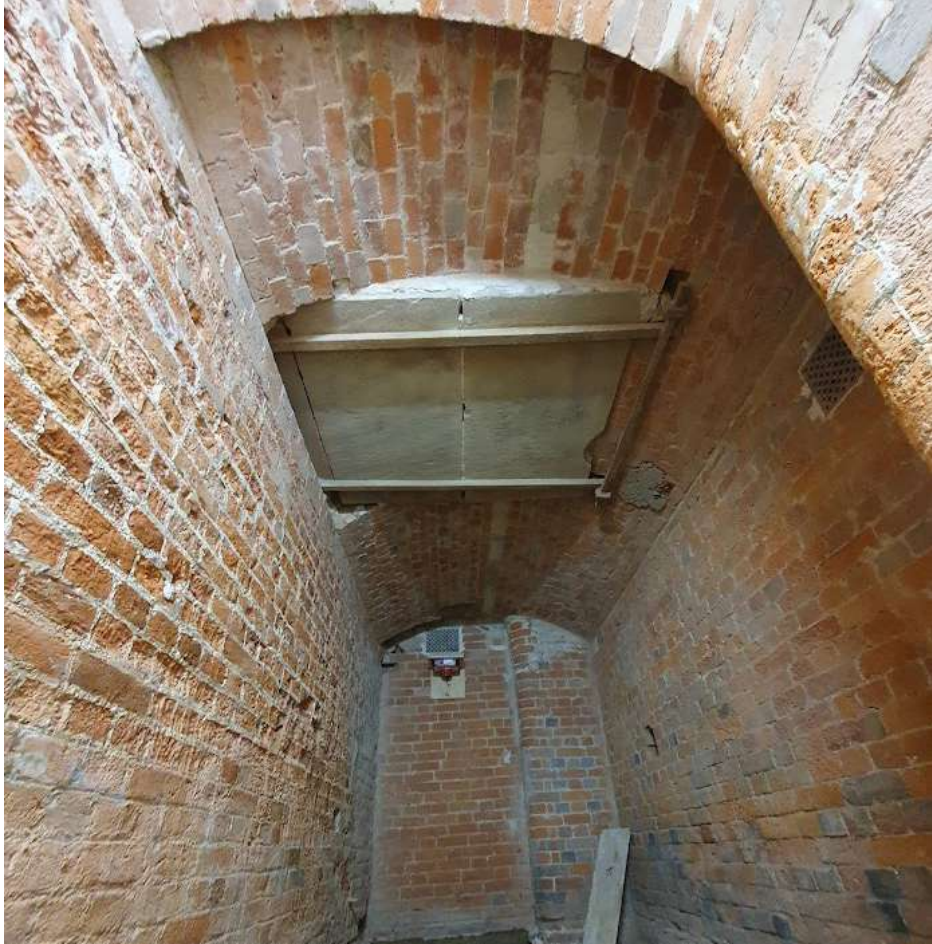
CEILING

**Ceiling** – masonry barrel vault with cross sections of stone ductwork cleaned from residual modern paint as consented. To be consolidated, and any areas of missing pointing to be made good with traditional lime mortar to match adjacent.

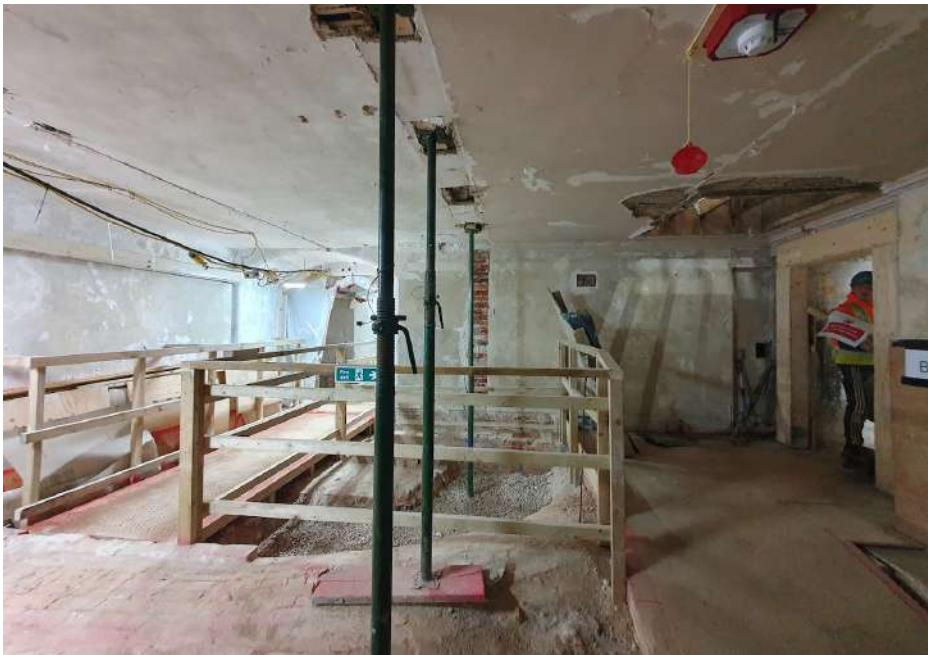
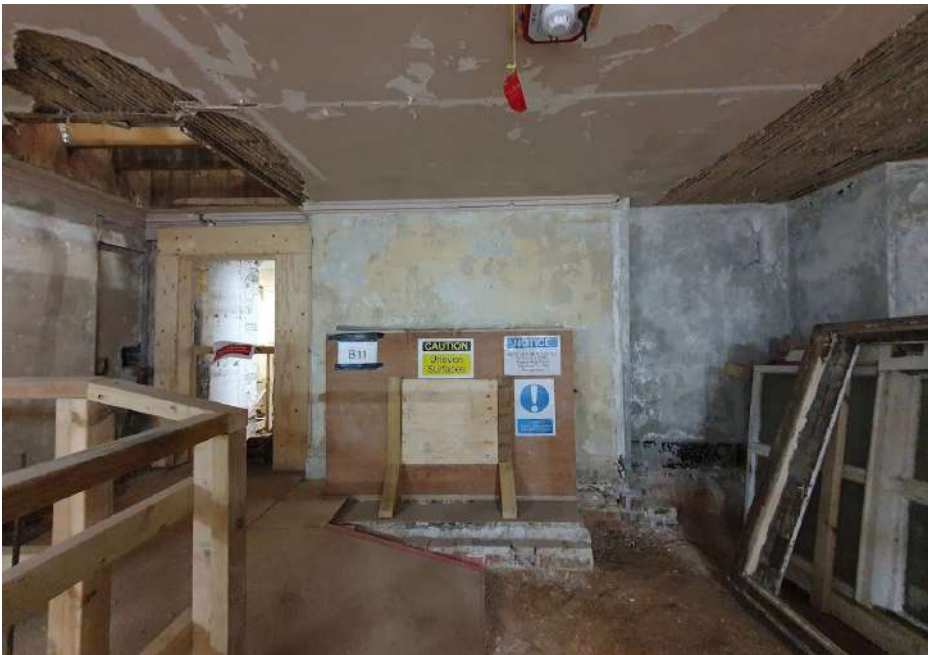
B11 - LOBBY BREAKOUT

**Walls** – generally a mix of modern concrete and lime plaster, both in poor condition and significantly altered. Surface to be cleaned to remove harmful modern paints and substrate made good. Generally retained like for like, however if large sections of concrete render have delaminated and require replacement preference will be given to replacing in lime render. Similarly, if there is visible damp in an area with cement render this will be carefully removed and replaced with traditional lime plaster. Redecorated in breathable paint throughout.
