# TOTTENHAM HOUSE & ESTATE

Plain Plaster Condition Record PH 1  
LOWER GROUND FLOOR

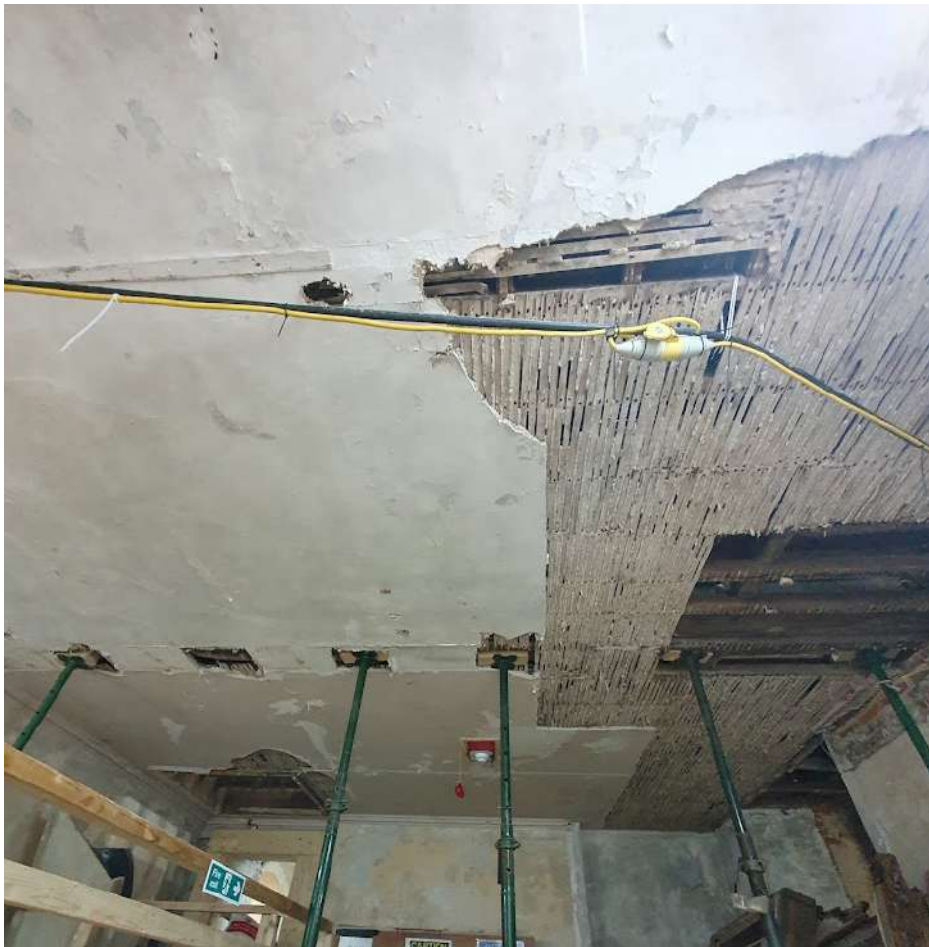
CEILING

**Ceiling** – originally lath and plaster. Some remnants remain in very poor condition. Allow for like for like replacement. Original cornice in some sections can be retained and consolidated, missing sections to be replicated like for like.

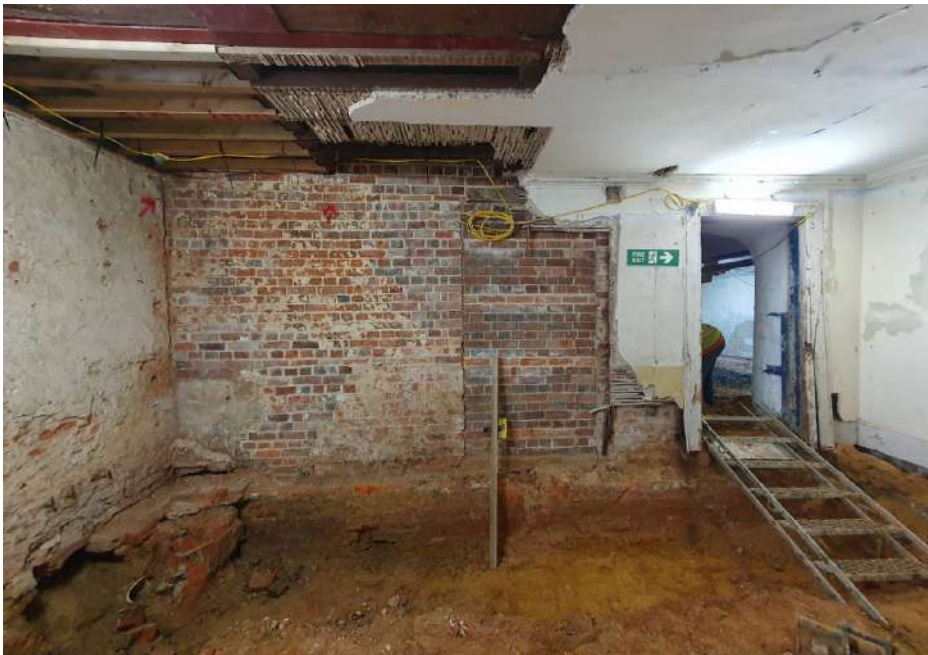
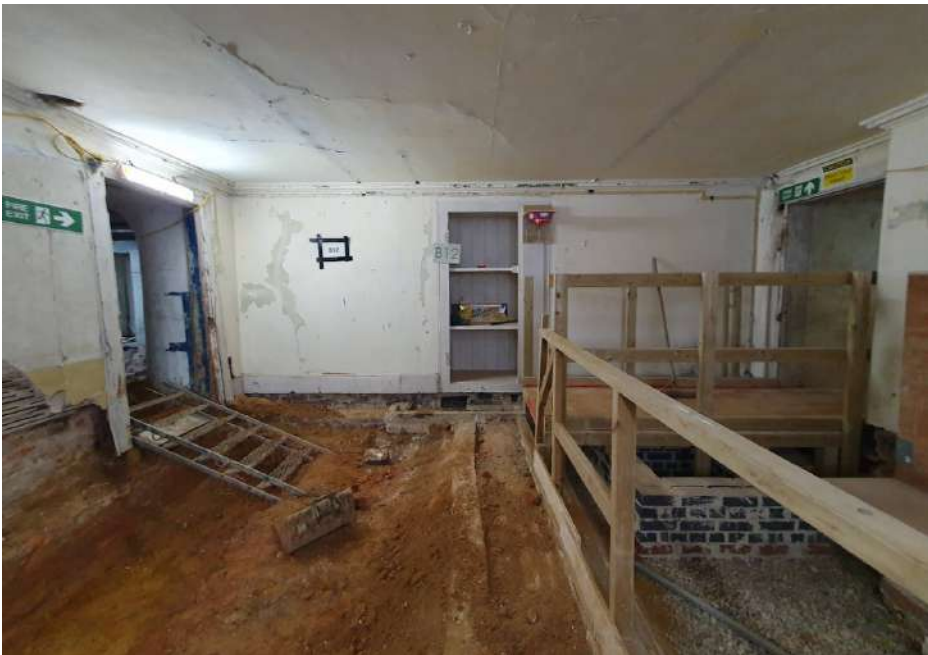
B12 - HOUSE MANAGER'S OFFICE

**Walls** – one of the rare areas on LGF with lath and plaster finish with a cornice and timber skirtings. Generally in very poor condition due to severe water ingress from adjacent west portico and embedded RWP in north west corner. All areas to be either reinstated in traditional lime lath and plaster or retained and repaired where reasonable.

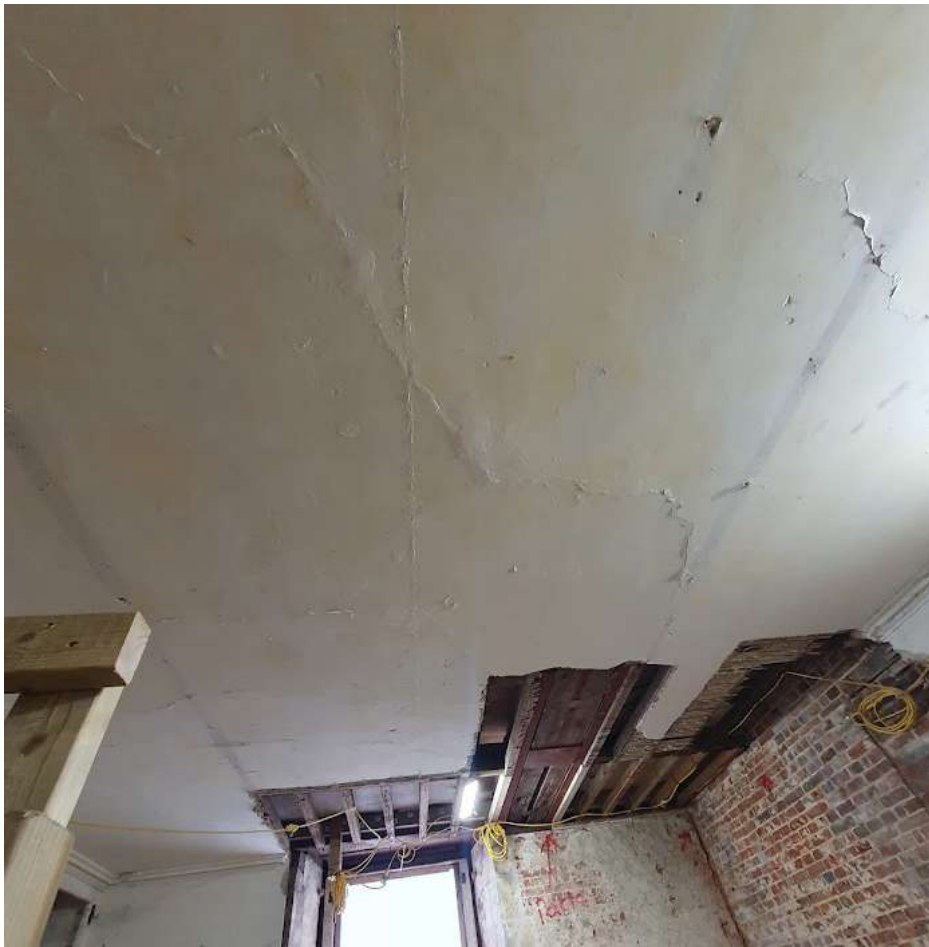
CEILING

**Ceiling** – lath and plaster ceiling in very poor condition and sections removed as consented due to severe decay. Any sound areas to be repaired like for like, and missing sections also replicated like for like.

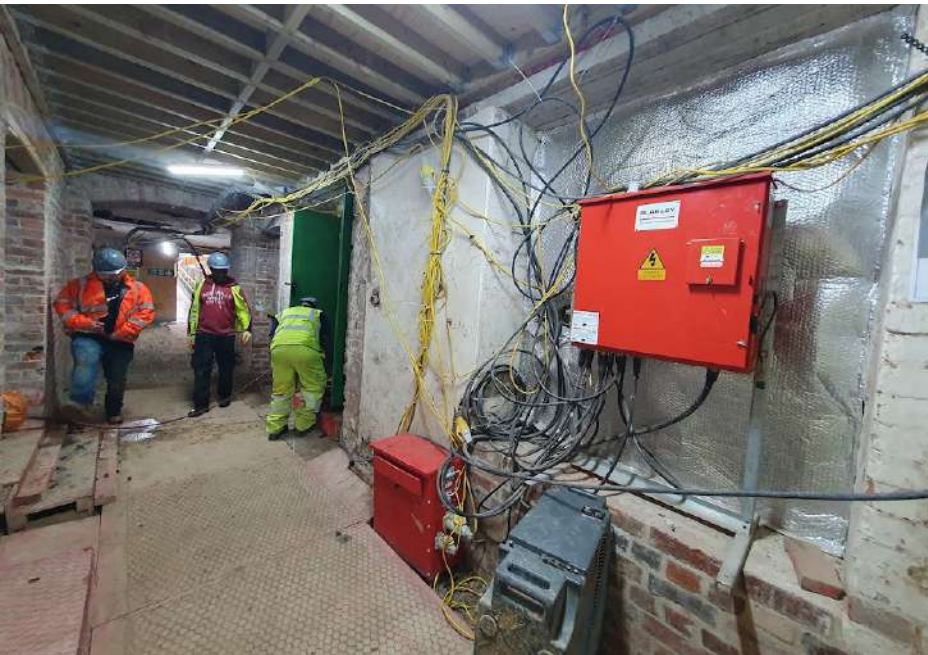
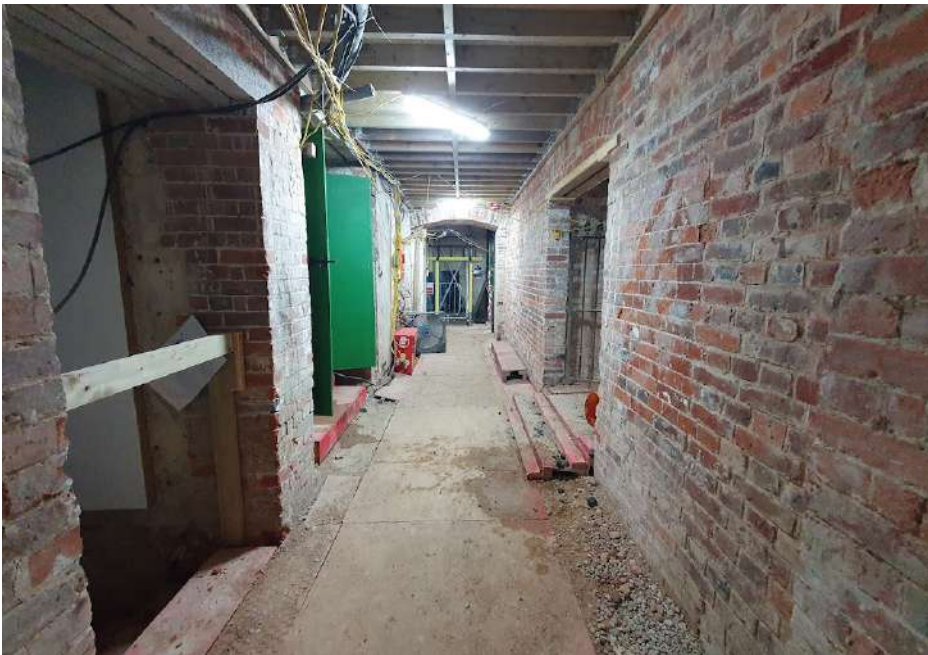
B14-15 - SOUTH CORRIDOR (EASTERN SECTION)

**Walls** – historically plaster to masonry with stone skirtings. To be reinstated like for like with traditional lime plaster and salvaged/replicated stone skirtings.

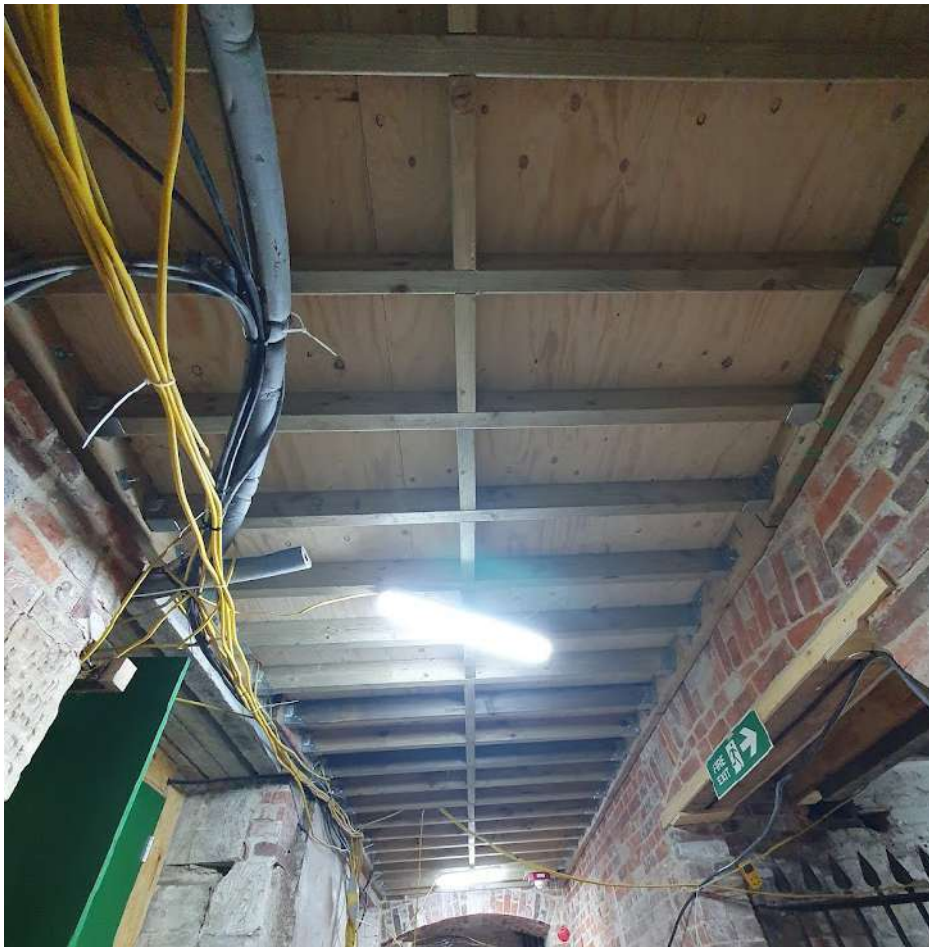
CEILING

**Ceiling** – historically lath and plaster ceiling. Absent due to severe decay. Consented to be replaced with new floor structure and dropped ceiling as part of MEP and floor works. No cornices historically.

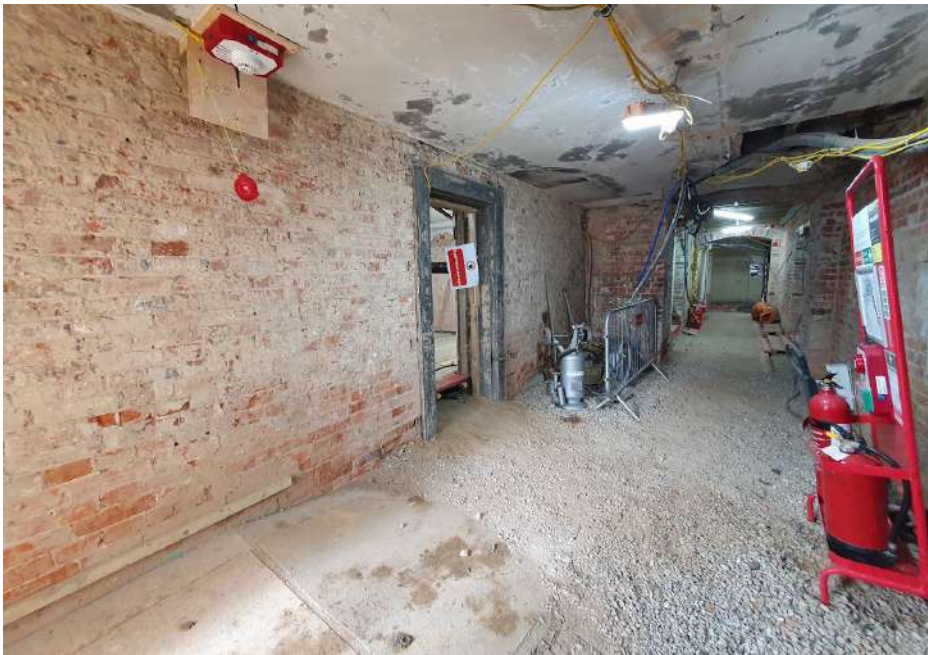
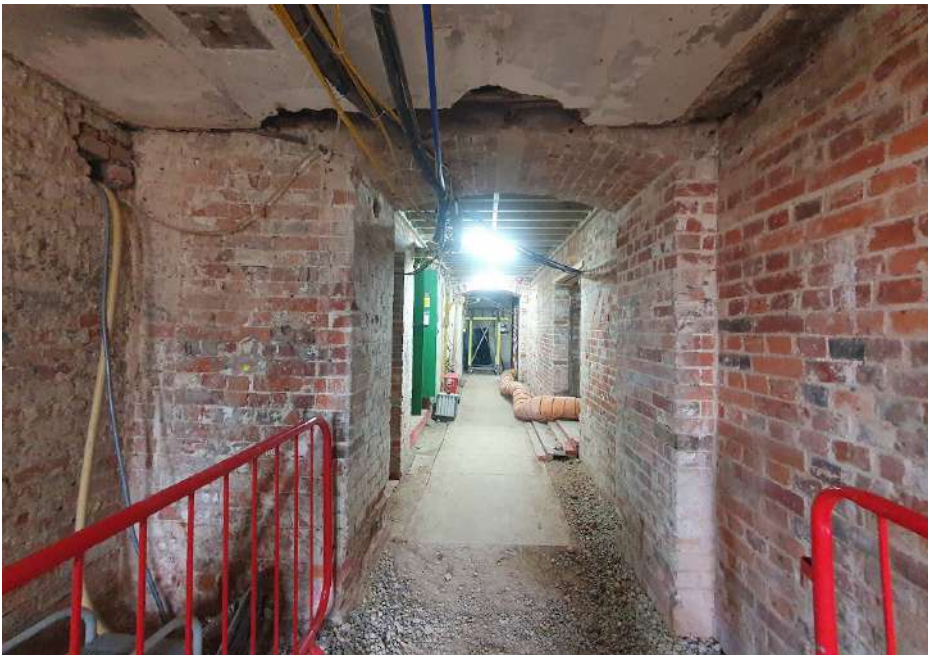
B14-15 - SOUTH CORRIDOR (WESTERN SECTION)

**Walls** – historically plaster to masonry with stone skirtings. To be reinstated like for like with traditional lime plaster and salvaged/replicated stone skirtings.

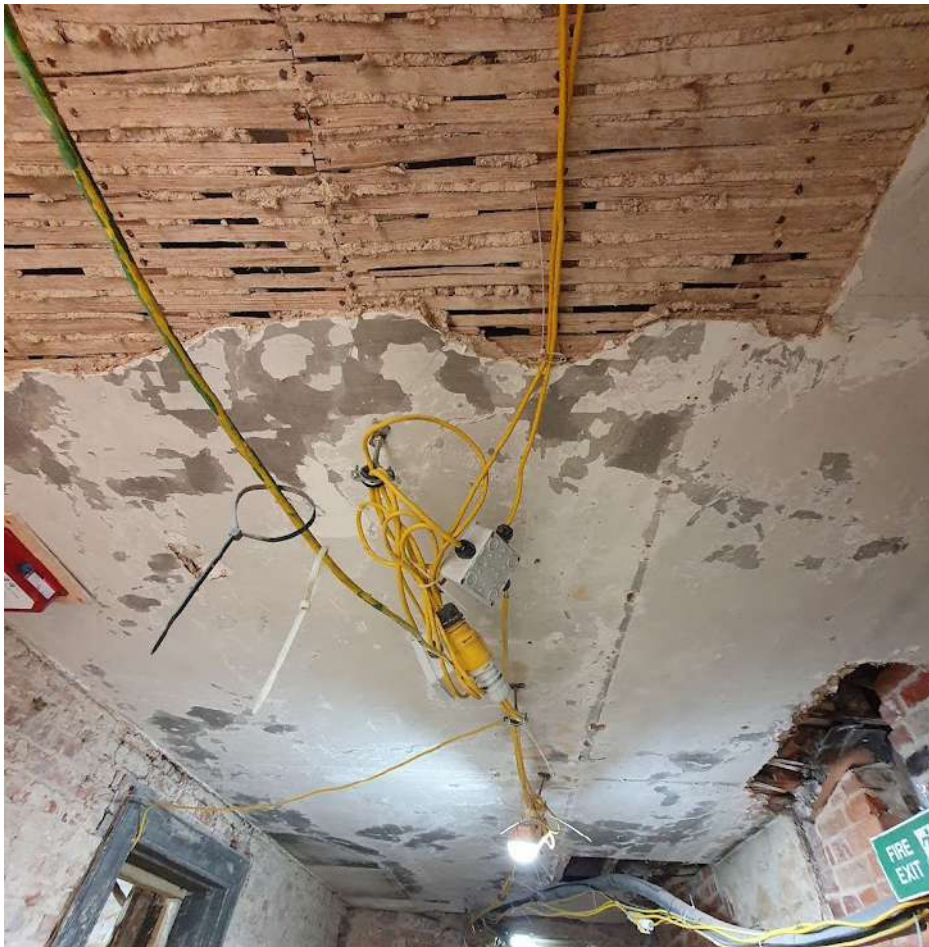
CEILING

**Ceiling** – lath and plaster ceiling in very poor condition. Consented to be removed and replaced as part of MEP and floor works as B15 is located below G4 where decorative floor retained in situ and MEP installation carried out from below. No cornices historically.

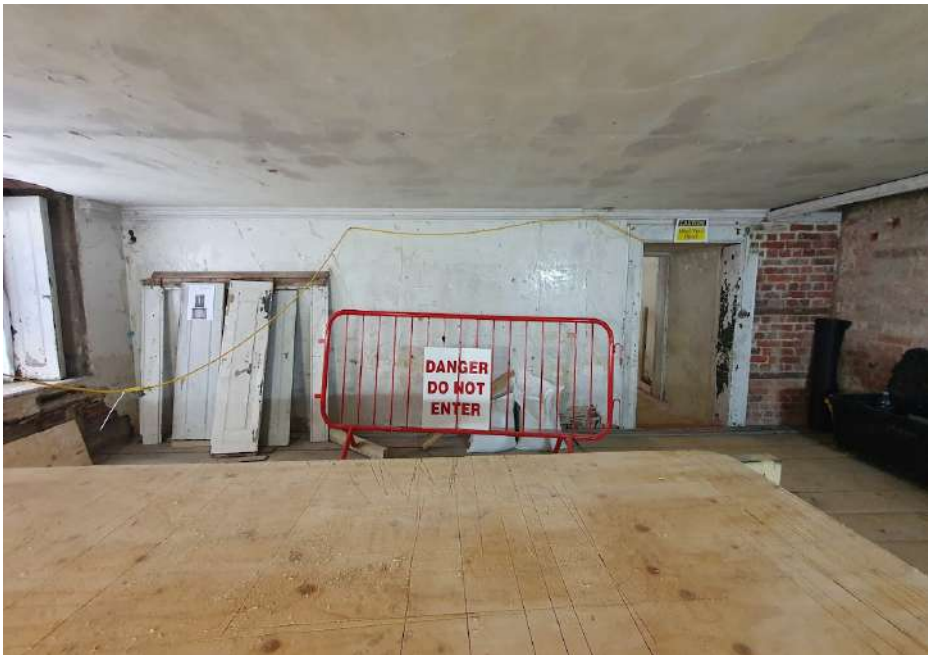
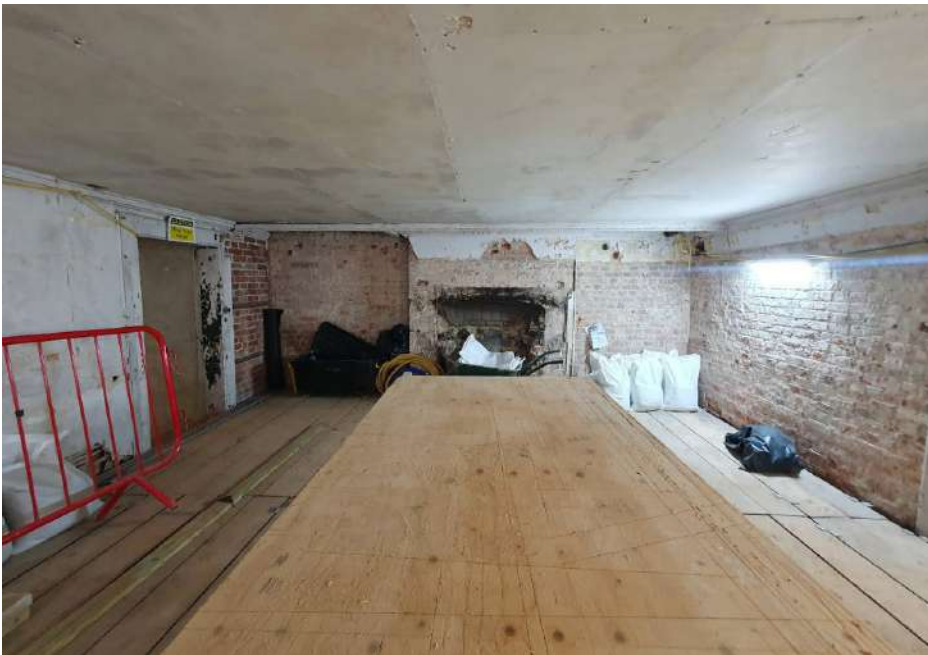
B17 - CHEF'S OFFICE

**Walls** – plaster to masonry with stone skirtings. Generally in very poor condition. All areas to be either reinstated in traditional lime plaster or retained and repaired where reasonable.

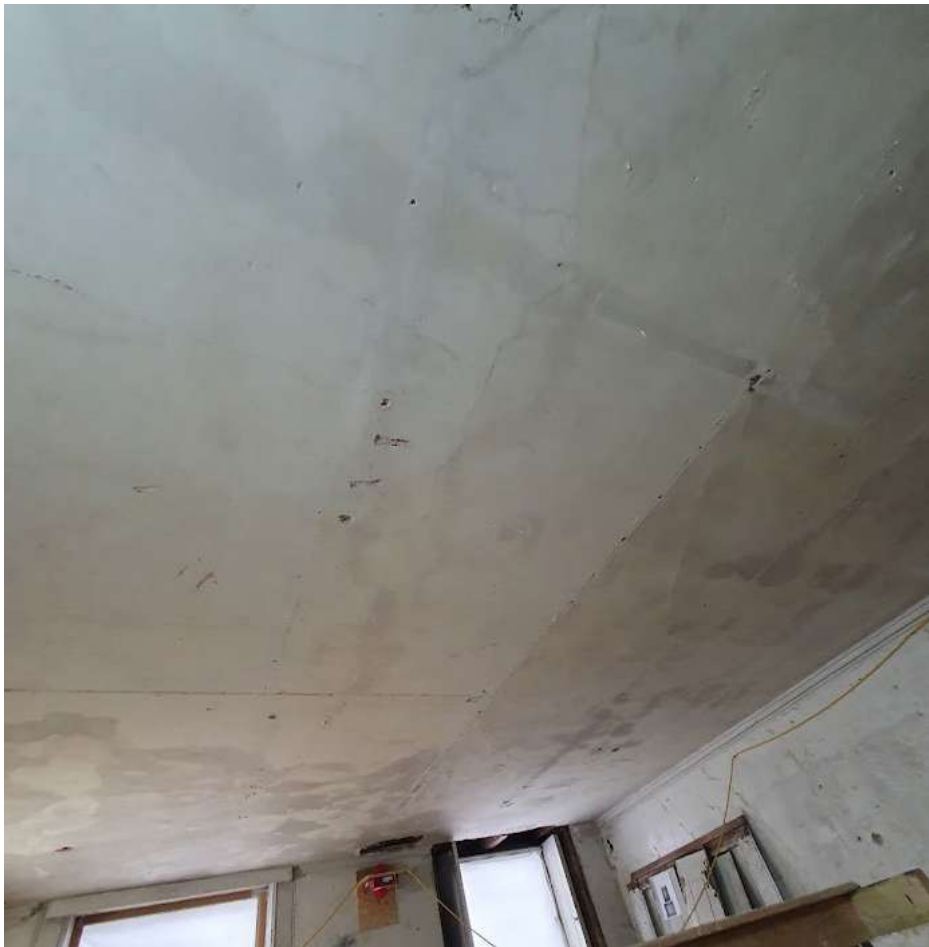
CEILING

**Ceiling** – lath and plaster ceiling in poor condition. Consented to be removed and replicated as part of MEP and floor works. B17 is located below G4 where decorative floor retained in situ and MEP installation carried out from below. Simple cornice retained in situ and repaired.

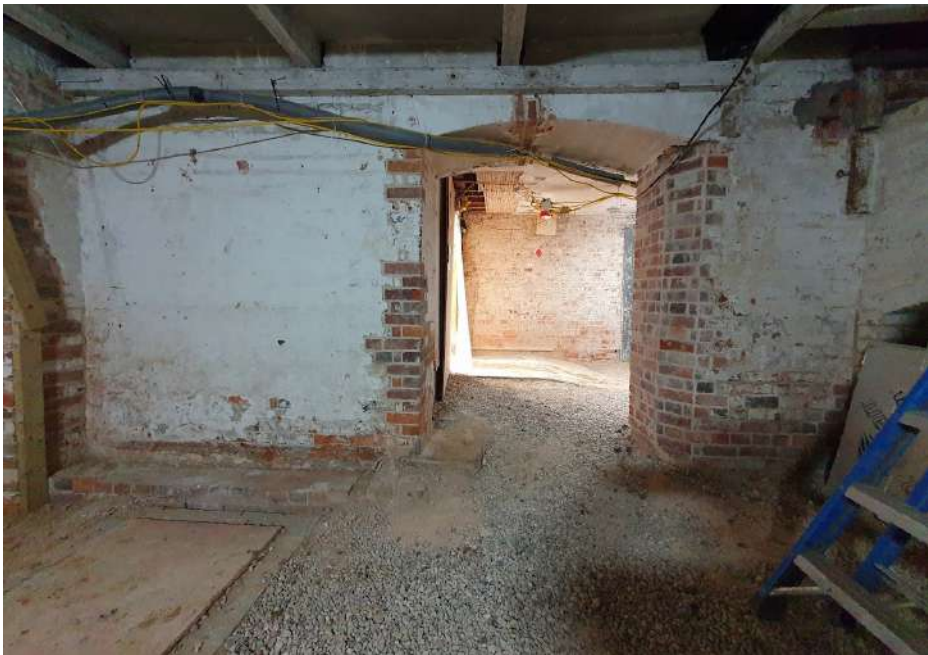
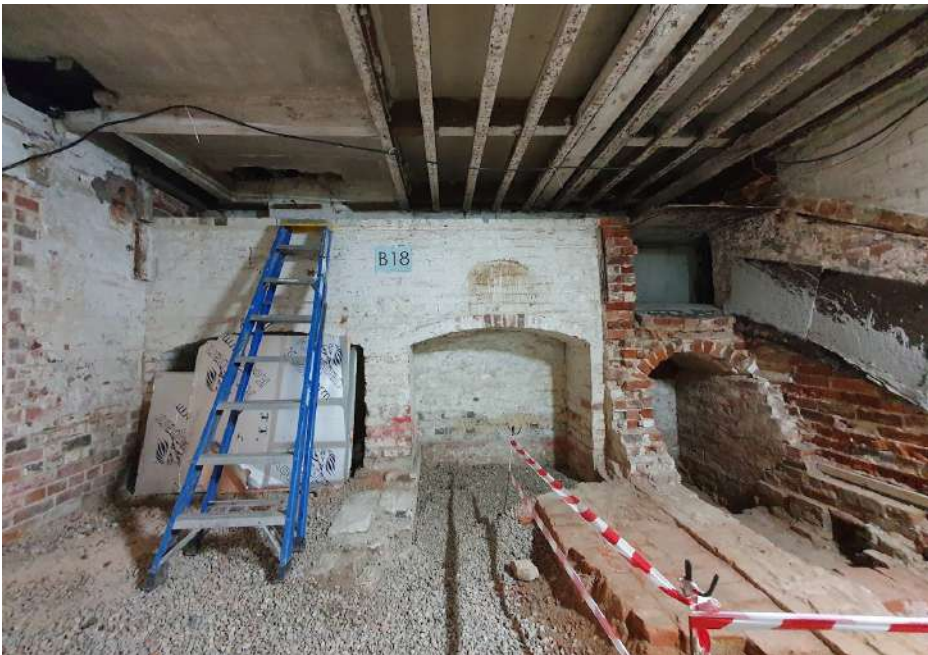
B18a - LOBBY

**Walls** – masonry formed of various infills and ducts. To be cleaned of any modern paint and decoration residue and consolidated. Repointed as required in traditional lime mortar to match adjacent and retained as exposed brickwork.

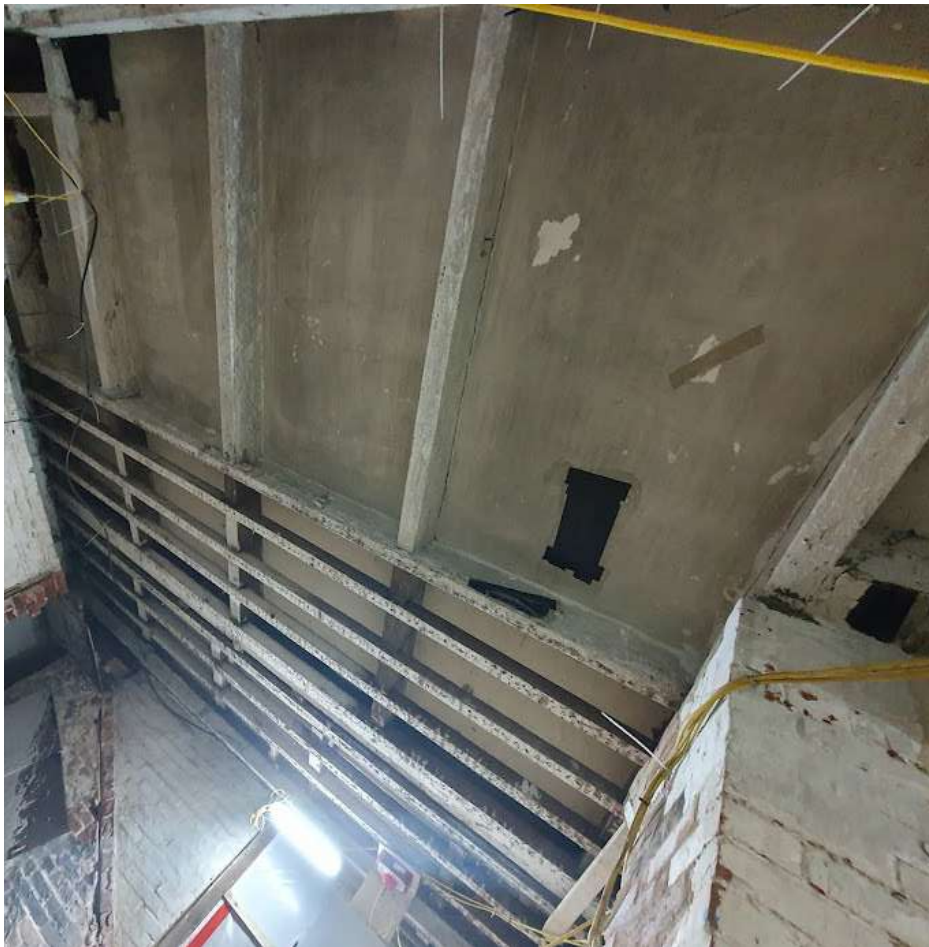
CEILING

**Ceiling** – historically lath and plaster ceiling. Currently no ceiling in situ. Lath and plaster ceiling reinstated post completion of MEP works as room above G7 decorative floor is retained in situ. No cornice historically and none to be introduced.

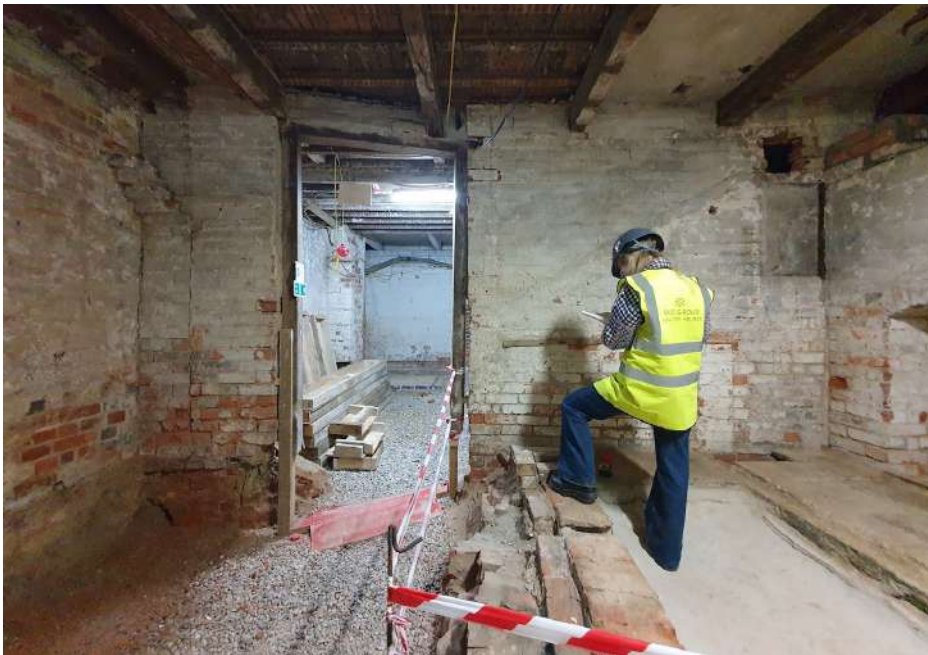
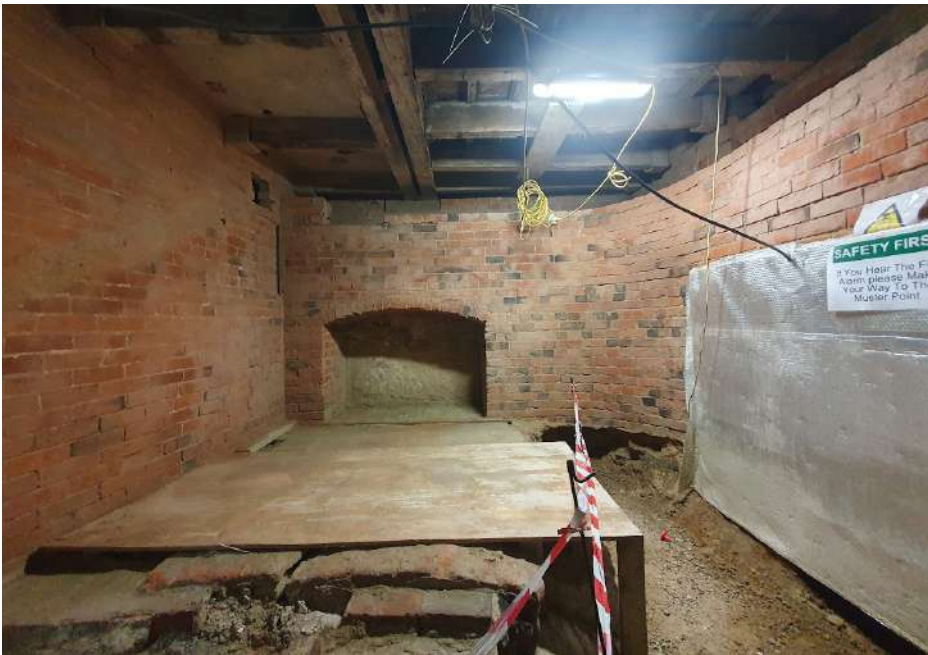
B18b - WINE CELLAR

**Walls** – masonry formed of various infills and ducts. To be cleaned of any modern paint and decoration residue and consolidated. Repointed as required in traditional lime mortar to match adjacent and retained as exposed brickwork.

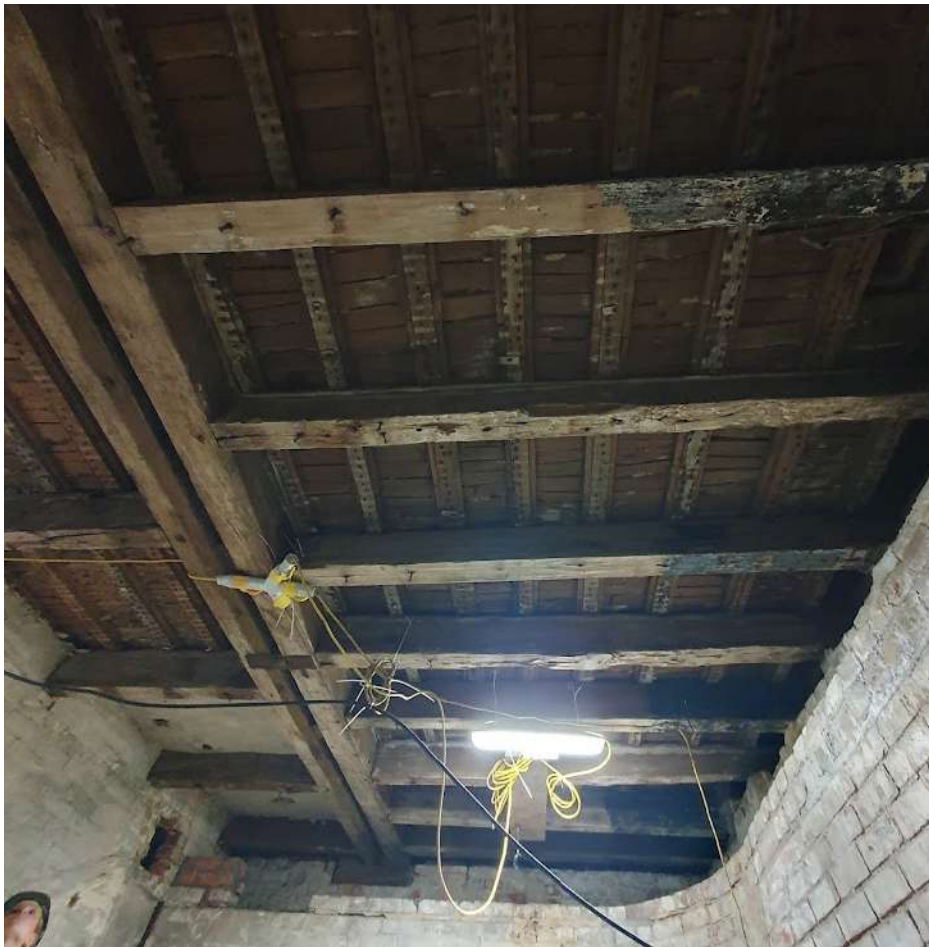
CEILING

**Ceiling** – historically lath and plaster ceiling. Currently no ceiling in situ. Lath and plaster ceiling reinstated post completion of MEP works as room above G7 decorative floor is retained in situ. No cornice historically and none to be introduced.

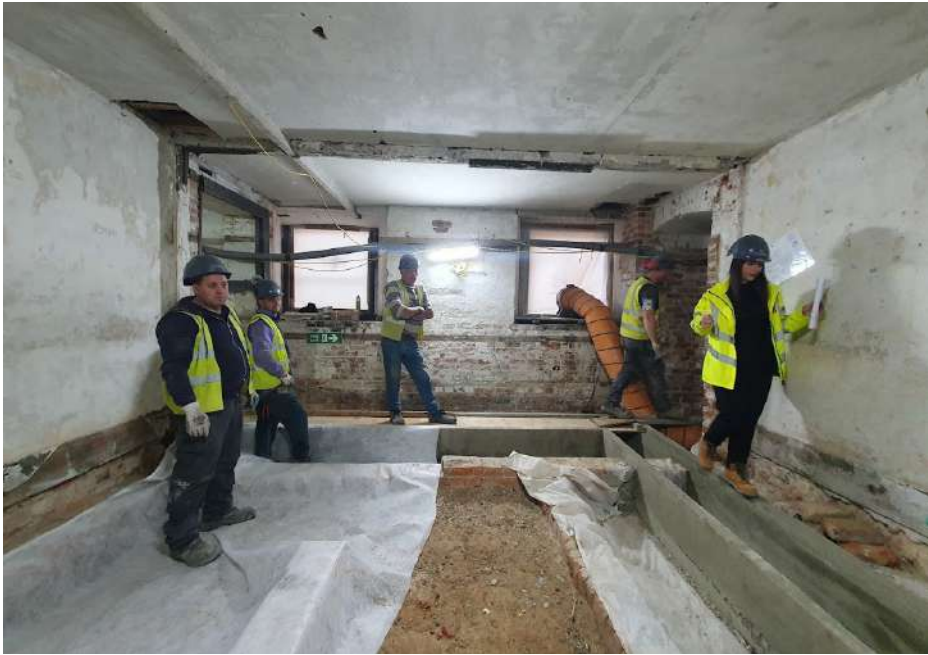
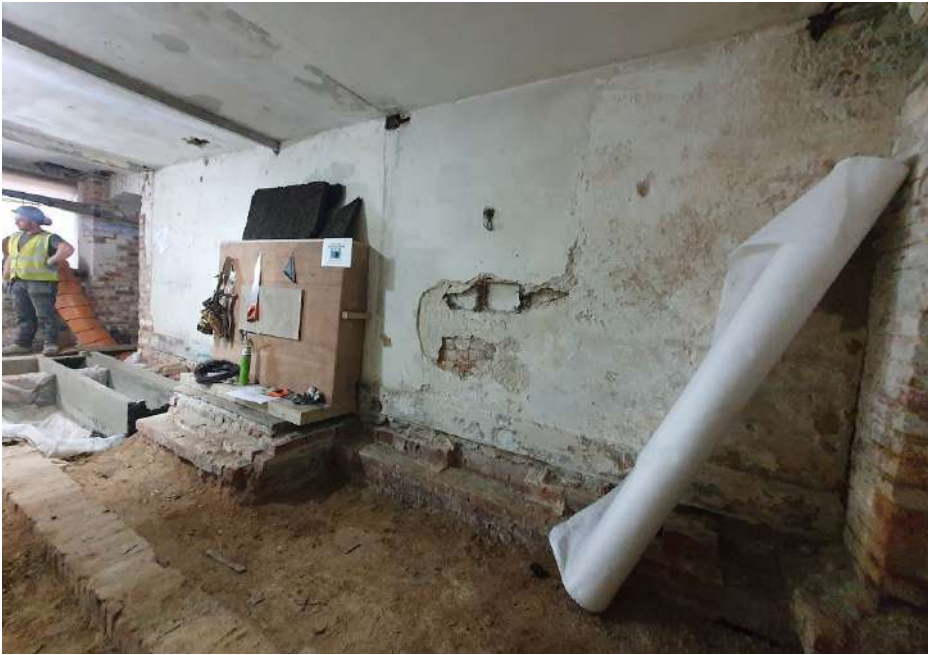
B19 - LOBBY & B20 - WINE CELLAR

**B20 Walls** – south wall masonry, to be cleaned and consolidated behind new breathable wood wool wall to house FCU units for G6 above and B20 discreetly. East and west wall rendered in concrete, very poor condition. To be carefully investigated and consolidated or removed with minimal damage to brickwork below to be replaced with lime render. Skirting formed in concrete. To be replaced with stone in matching profile to adjacent areas. North wall new partition in masonry and to be plastered in traditional lime to match adjacent.

**B19 Walls** – brick masonry. To be cleaned and consolidated and retained as exposed brickwork. Repointed as required in traditional lime mortar to match.

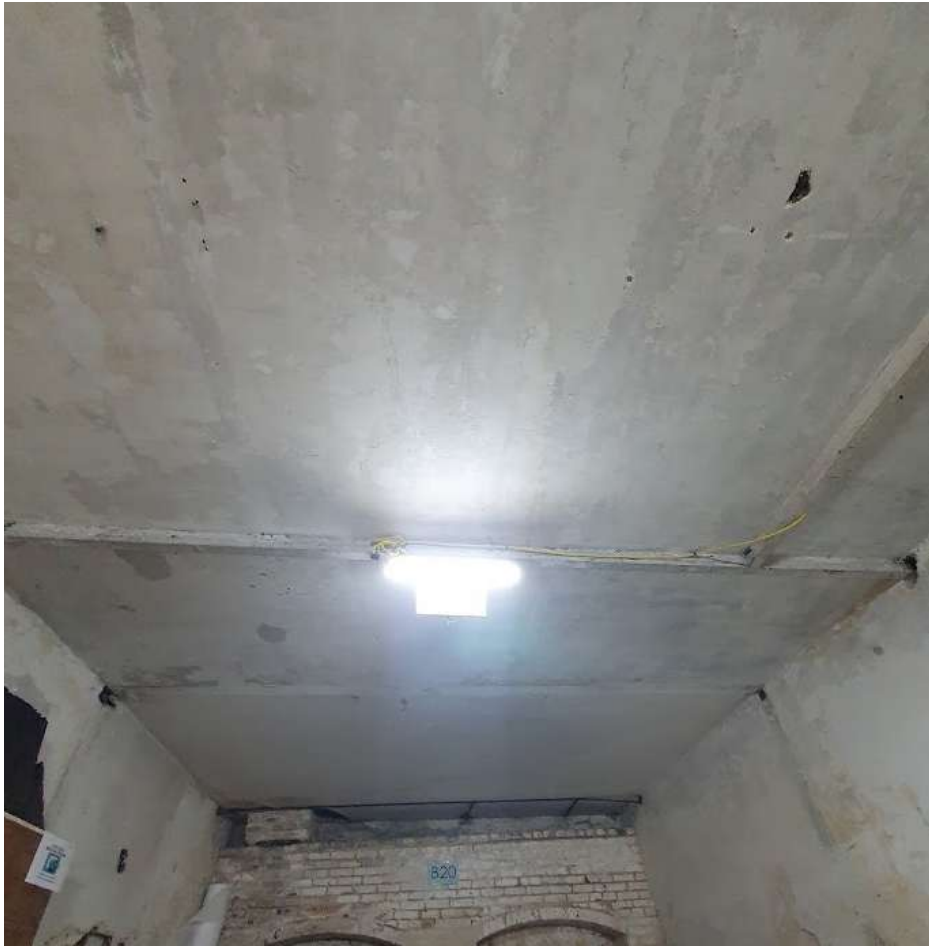
CEILING

**Ceiling** – lath and plaster ceiling in good condition. To be repaired like for like and consolidated. No cornice historically and none to be introduced.

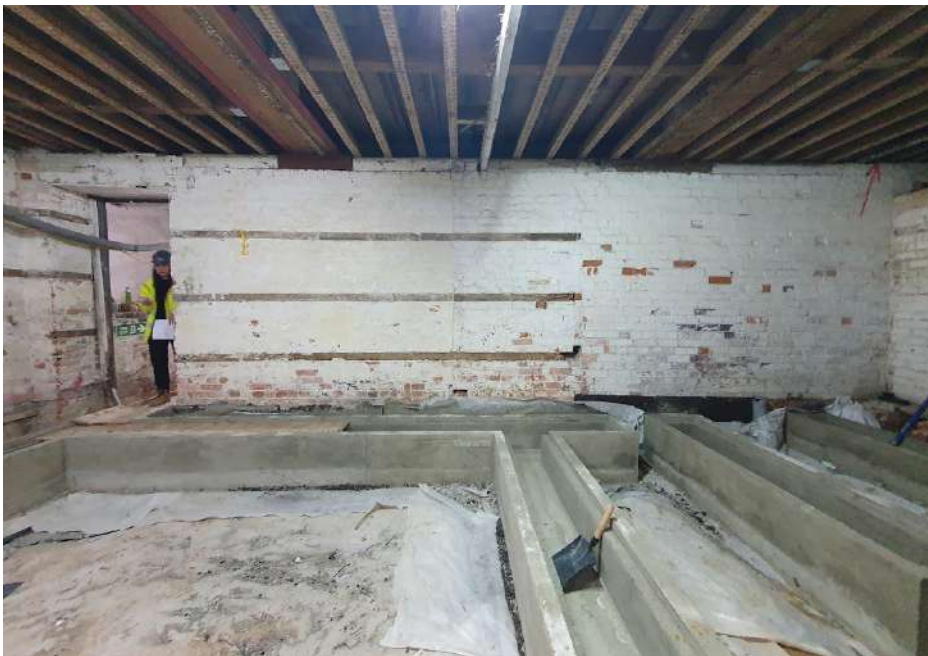
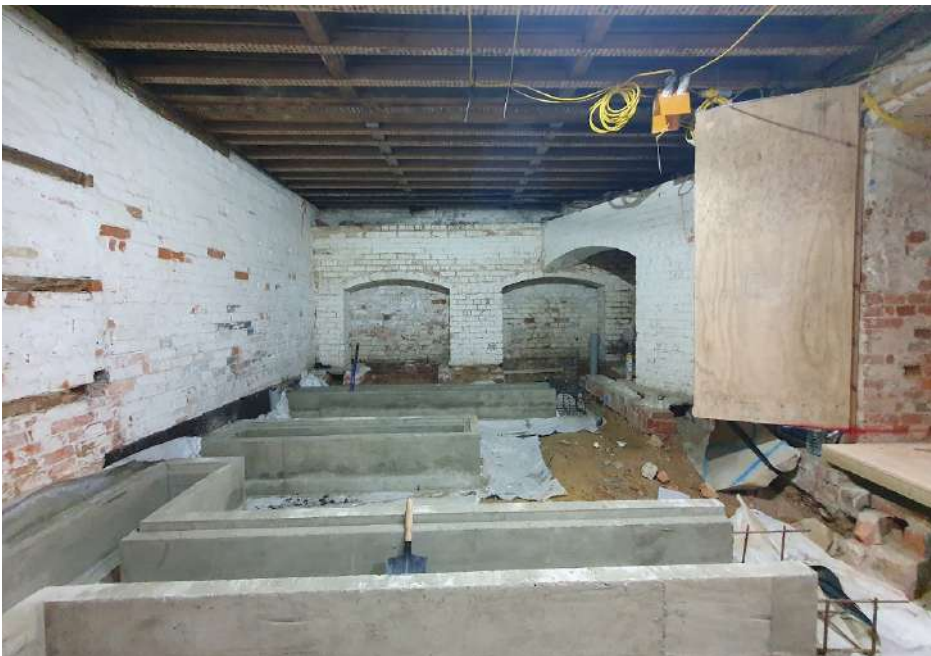
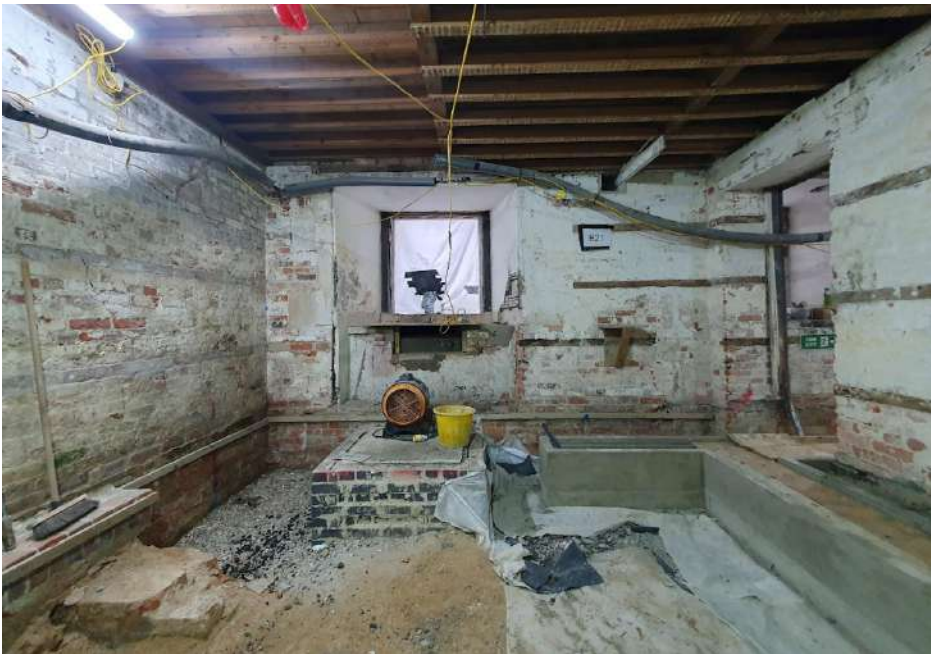
B21a - CHANGING ROOM & B21b - WC

**B21a Walls** – masonry walls with various modern paint finishes. To be cleaned and consolidated, repointed in traditional lime mortar as required. Joinery to conceal FCU unit for G6 above and provide storage for changing room. Walls clad in timber panelling with 50mm gap for breathability and ventilation slots.

**B21b Walls** – masonry walls with various modern paint finishes. To be cleaned and consolidated, repointed in traditional lime mortar as required. Walls overlaid with metal panelling with 50mm gap for free air circulation and breathability.

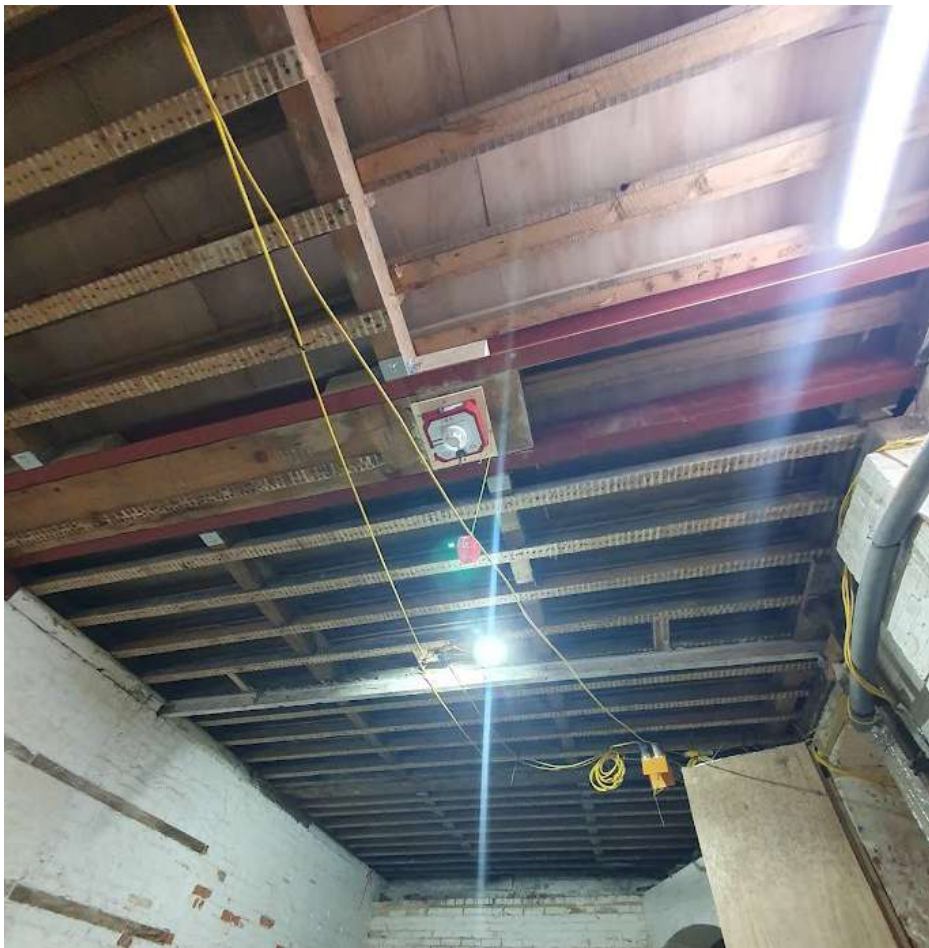
CEILING

**Ceiling** – historically lath and plaster ceiling. None present currently. To be reinstated like for like in traditional lath and plaster. No cornice historically and none to be introduced. B21b WC ceiling overlaid with metal panelling with 50mm gap for free air circulation and breathability.

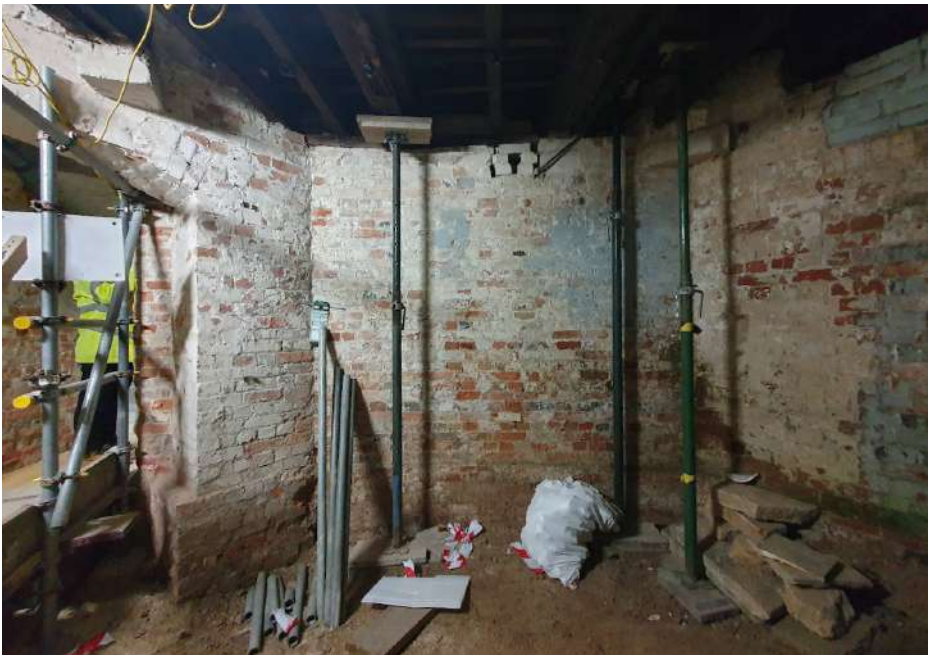
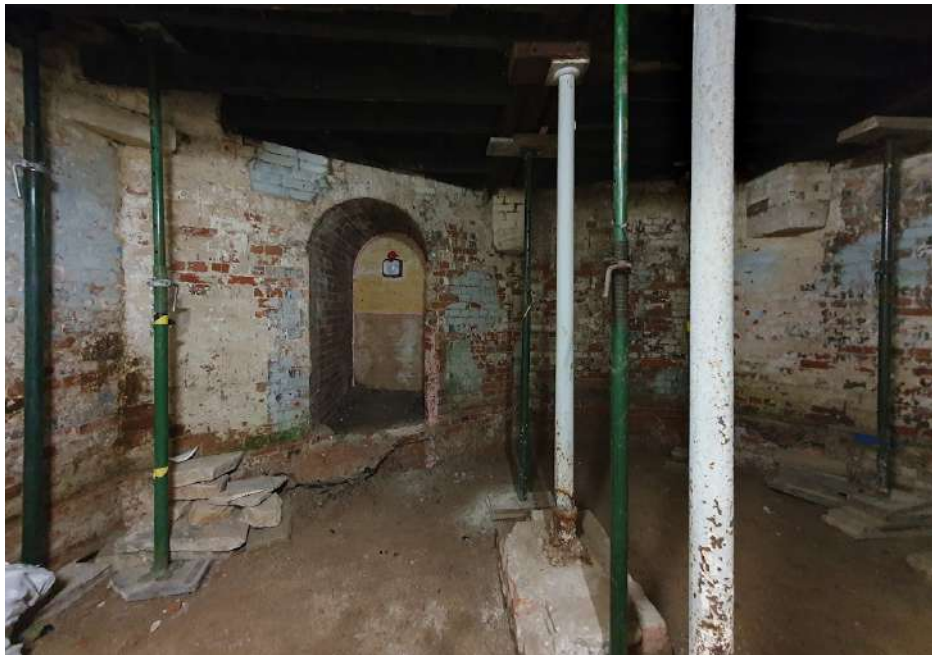
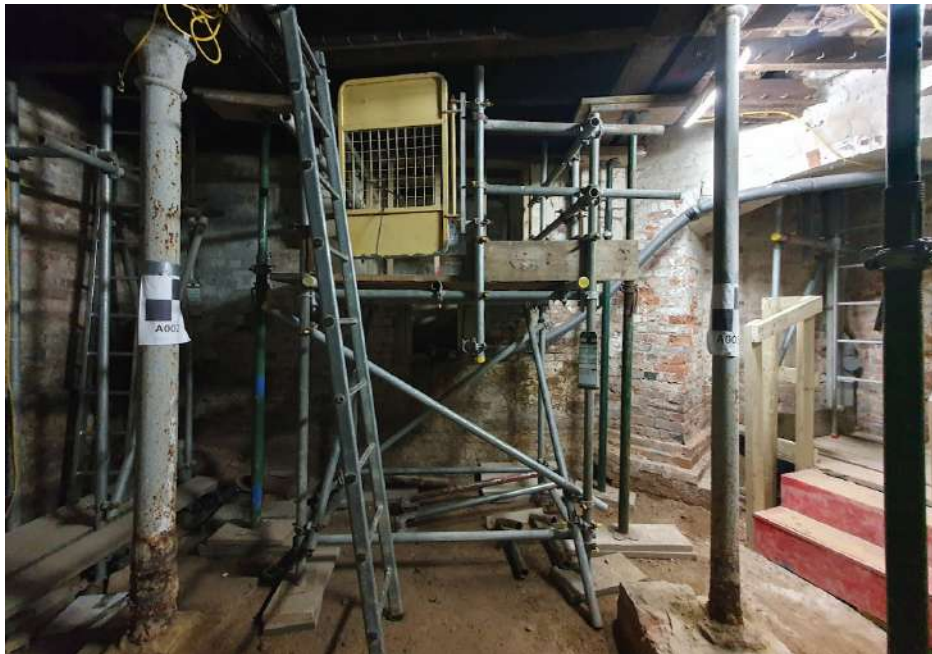
B22 - STONE BATH

**Walls** – masonry formed of various infills. To be cleaned of any modern paint and decoration residue and consolidated. Repointed as required in traditional lime mortar to match adjacent. Due to severe damp issues in the area it is proposed to introduce a cavity drain wall system to this area. This also aligns with the need for washable hygienic finishes of bathroom use.

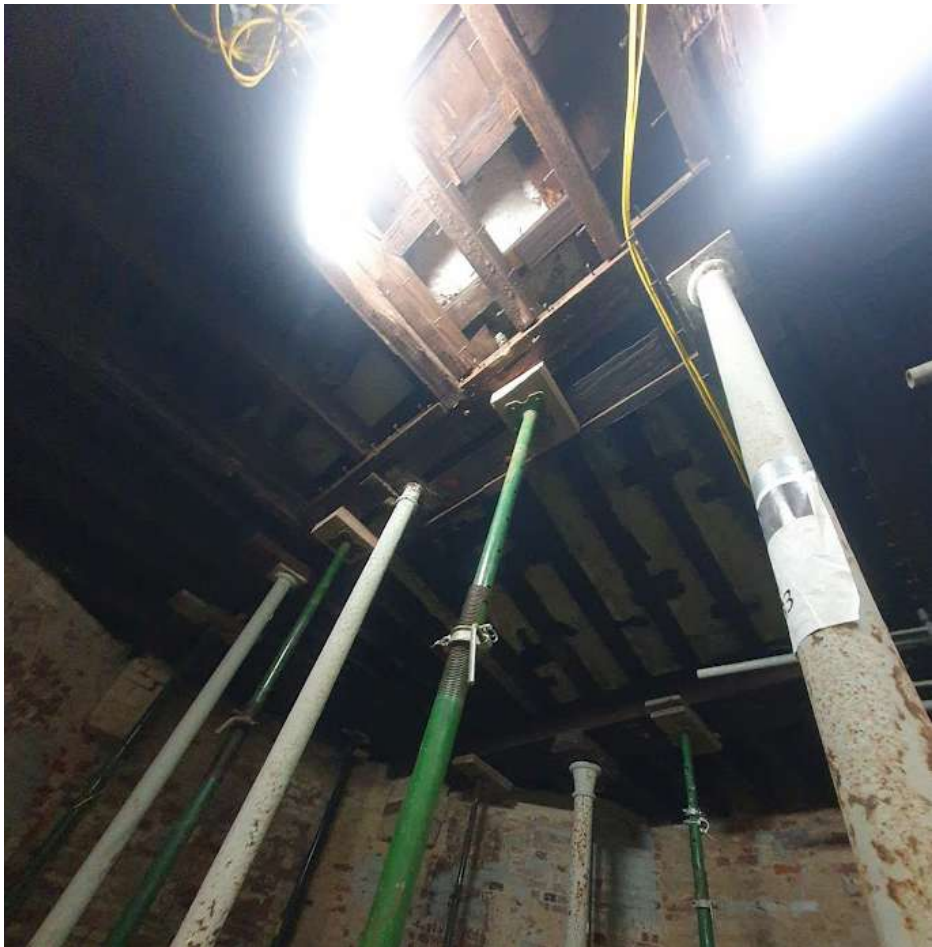
CEILING

**Ceiling** – historically lath and plaster ceiling. Currently no ceiling in situ. New modern ceiling reinstated post completion of MEP works to provide moisture separation between the bathroom and sensitive historic fabric above of G5 Rotunda. No cornice historically and none to be introduced.
