# TOTTENHAM HOUSE & ESTATE

Plain Plaster Condition Record PH 1  
LOWER GROUND FLOOR

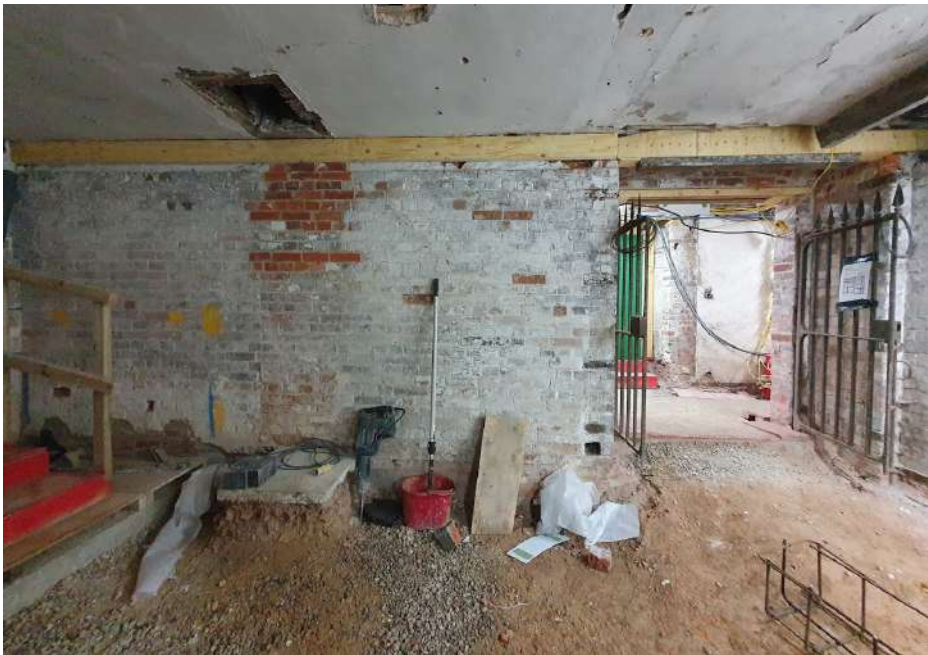
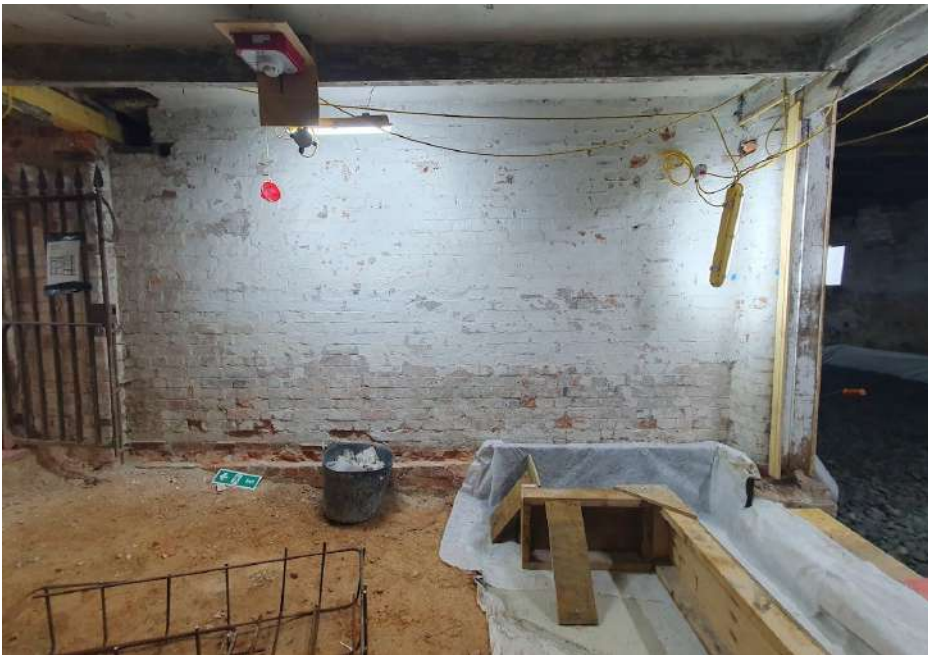
B23a LOBBY & B23b PLANT

**Walls** – painted brickwork to be cleaned and retained as exposed brickwork. Consolidate and repaint in lime mortar to match adjacent.

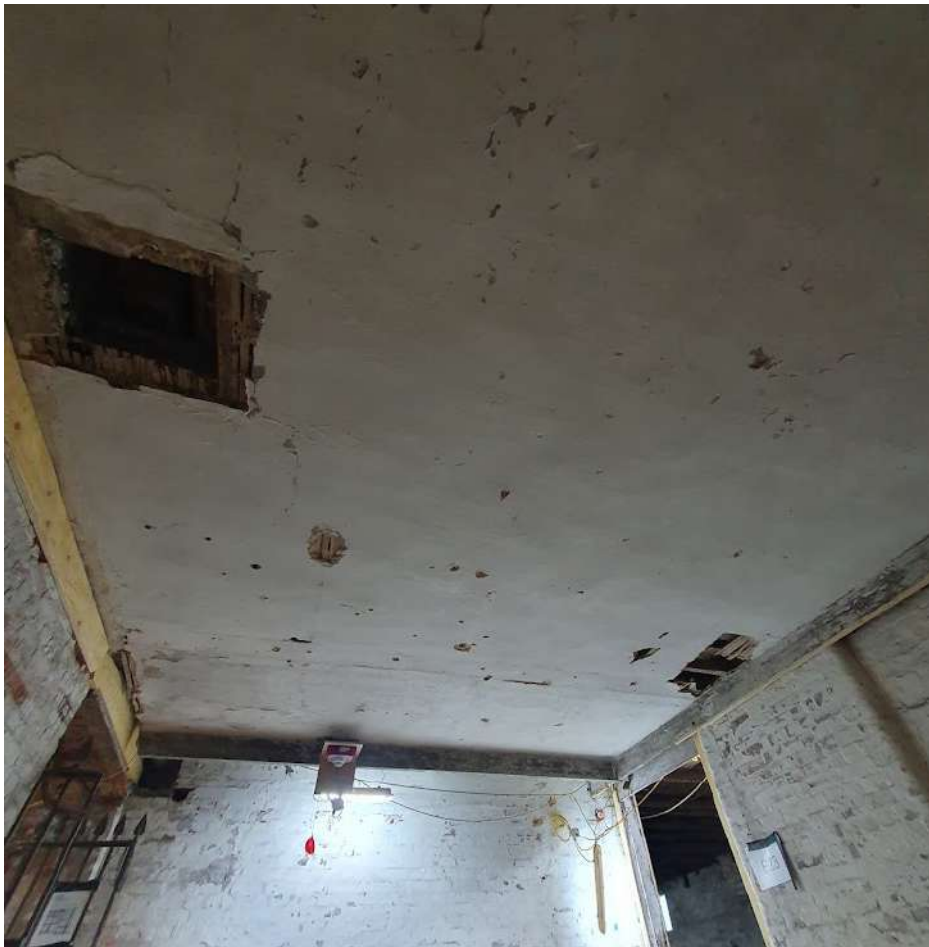
CEILING

**Ceiling** – lath and plaster ceiling in poor condition to be replaced with modern acoustic ceiling to maintain acoustic separation between plant and G8 library above. Alternative dropped ceiling would clash with existing door openings and would not be feasible.

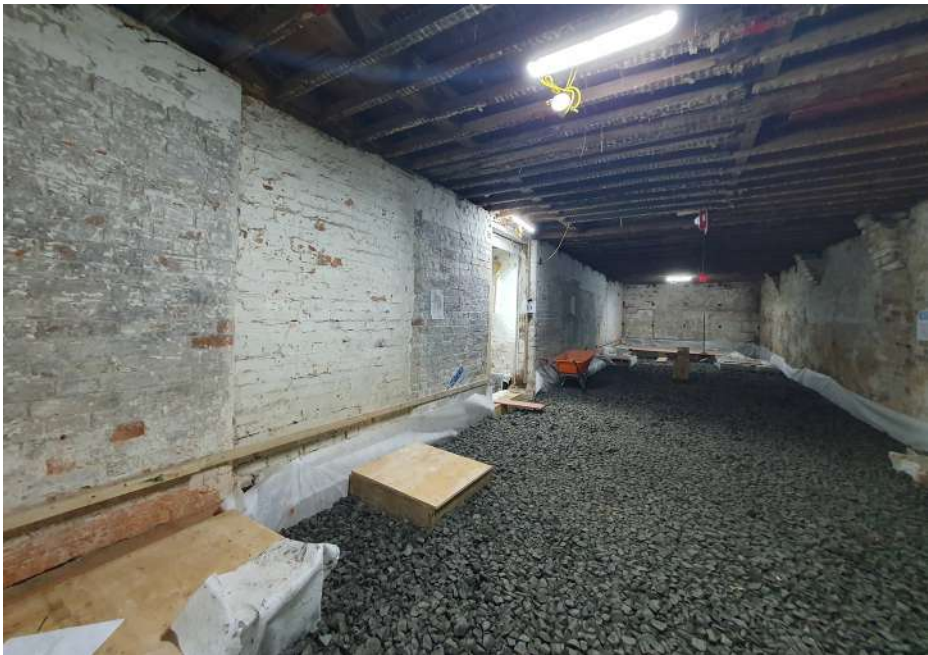
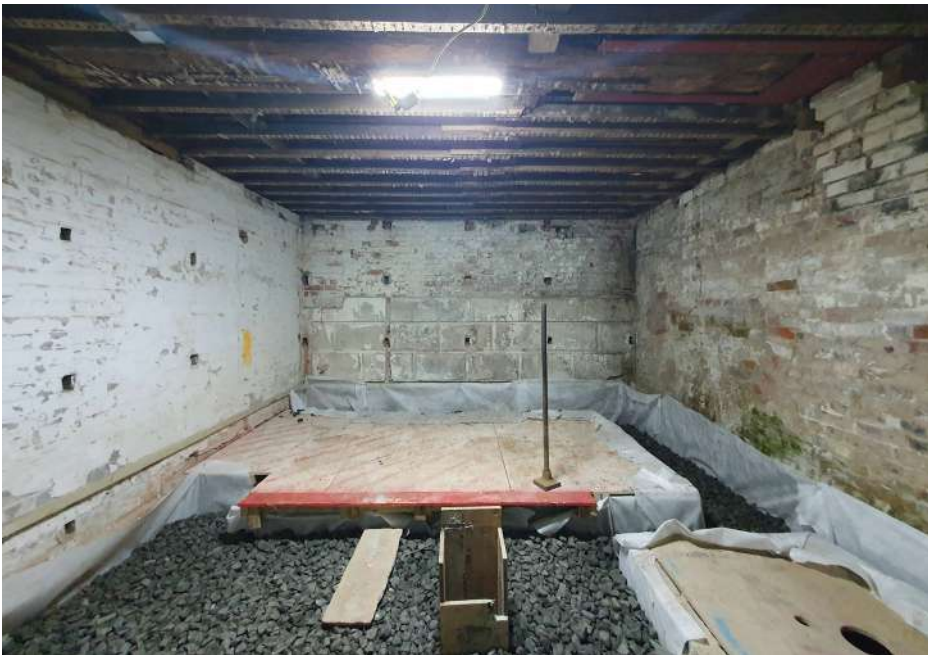
B24 - PLANT

**Walls** – masonry formed of various infills and fragments of stone rustication. Stone remnants from C18th pavilions. To be cleaned of any modern paint and decoration residue and consolidated. Repointed as required in traditional lime mortar to match adjacent and retained as exposed brickwork or stone.

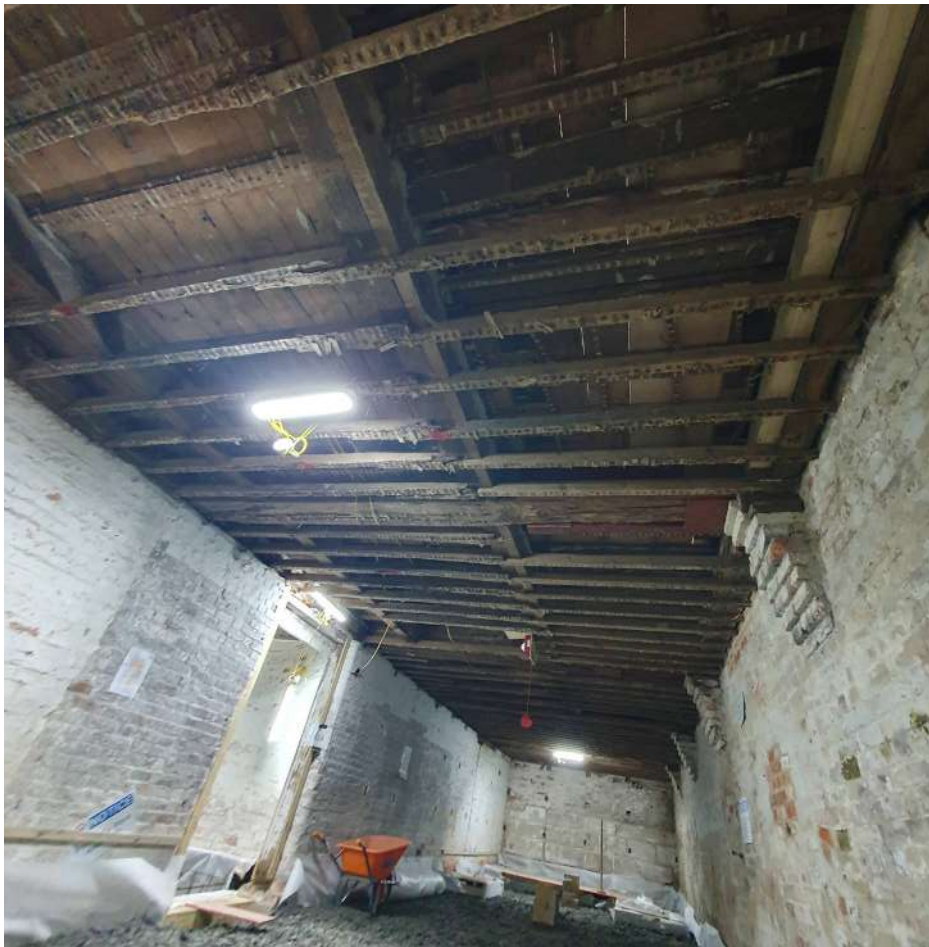
CEILING

**Ceiling** – historically lath and plaster. Currently no ceiling in situ. Modern acoustic ceiling to be introduced to meet acoustic requirements to separate G8 library above from plantroom.

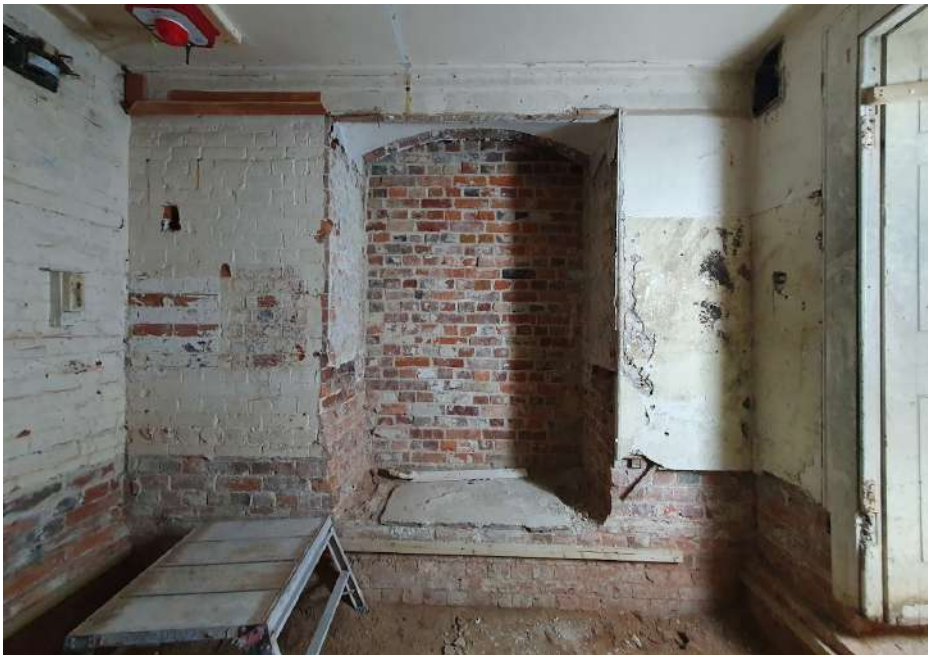
NORTH ELEVATION

**Walls** – masonry walls with shelving marks and plaster fragments. To be cleaned of any modern paint and decoration residue and consolidated. Repointed as required in traditional lime mortar to match adjacent and retained as exposed brickwork. Plaster corner to be retained and consolidated in plaster.

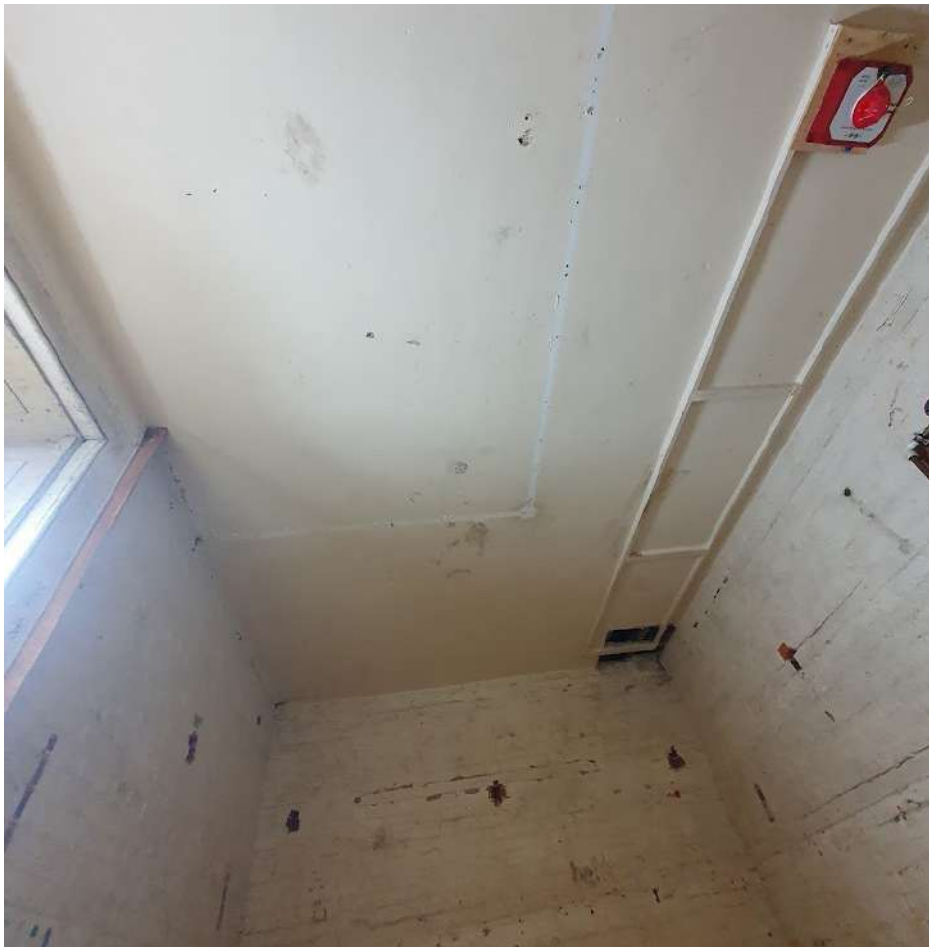
CEILING

**Ceiling** – lath and plaster ceiling. Ceiling to be removed and replaced with modern acoustic ceiling to comply with acoustic requirements of plant and G8 environment separation. An option to retain the existing ceiling and introduce independent sub ceiling was explored but this would either clash with door openings or if mechanically fixed to existing ceiling would negate the acoustic separation properties.

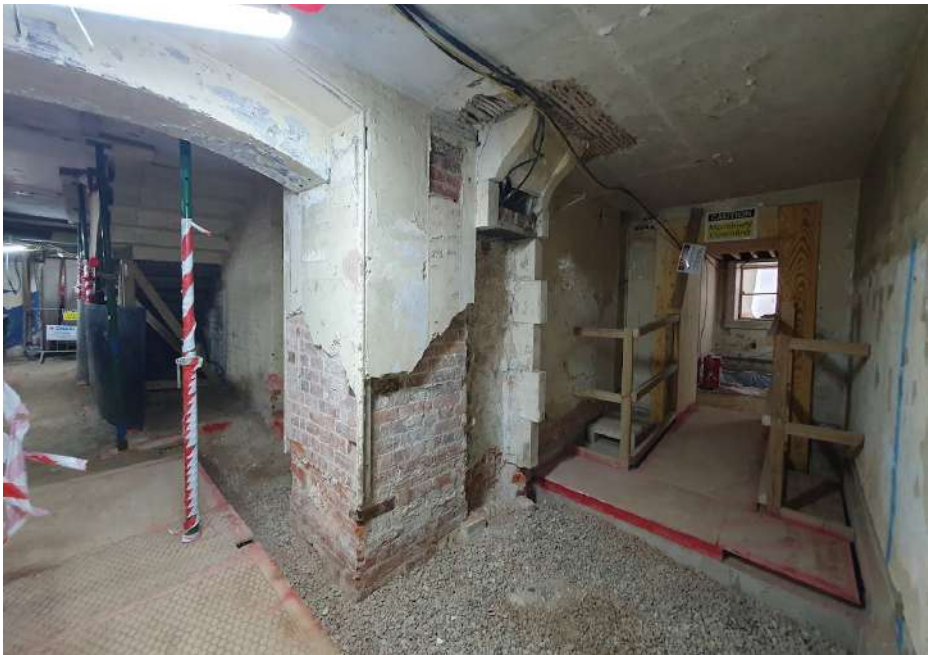
NORTH ELEVATION

**Walls** – masonry walls with plaster to masonry. To be cleaned of any modern paint and decoration residue and consolidated. To be repaired like for like and stone air duct reinstated as consented.

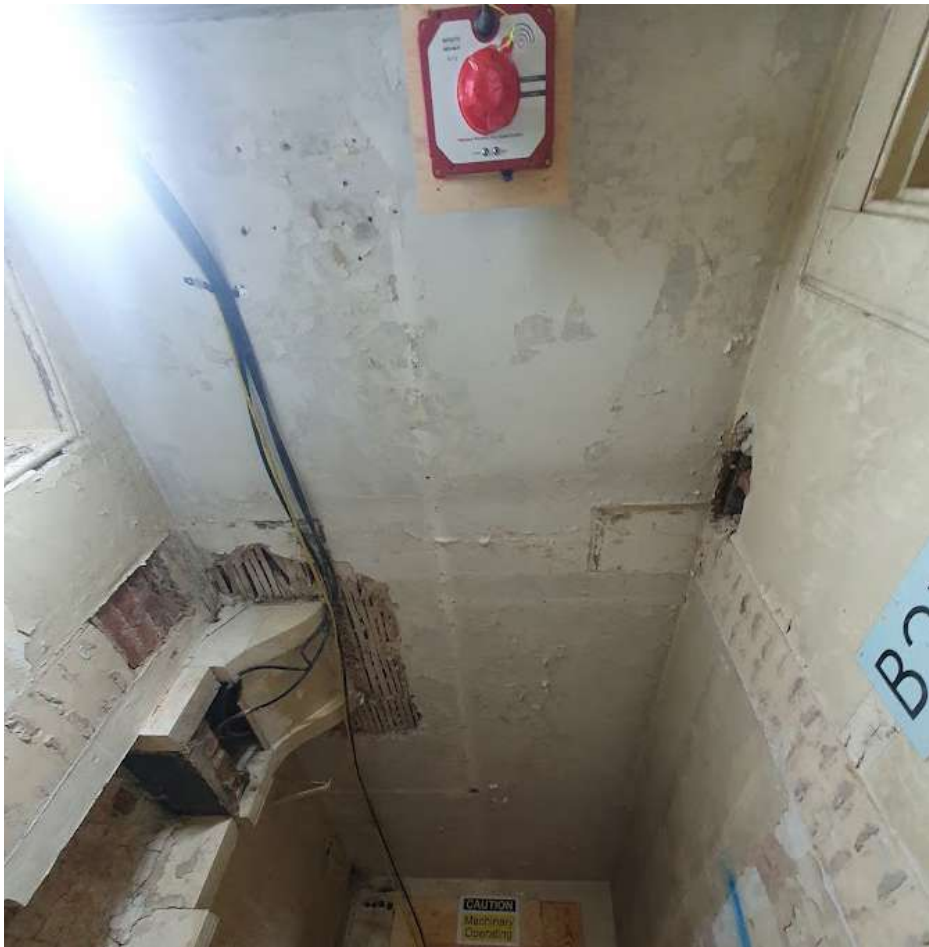
CEILING

**Ceiling** – lath and plaster ceiling in fair condition. To be repaired like for like in traditional lath and plaster.
