B27 - BIN STORE

Condition June 2025

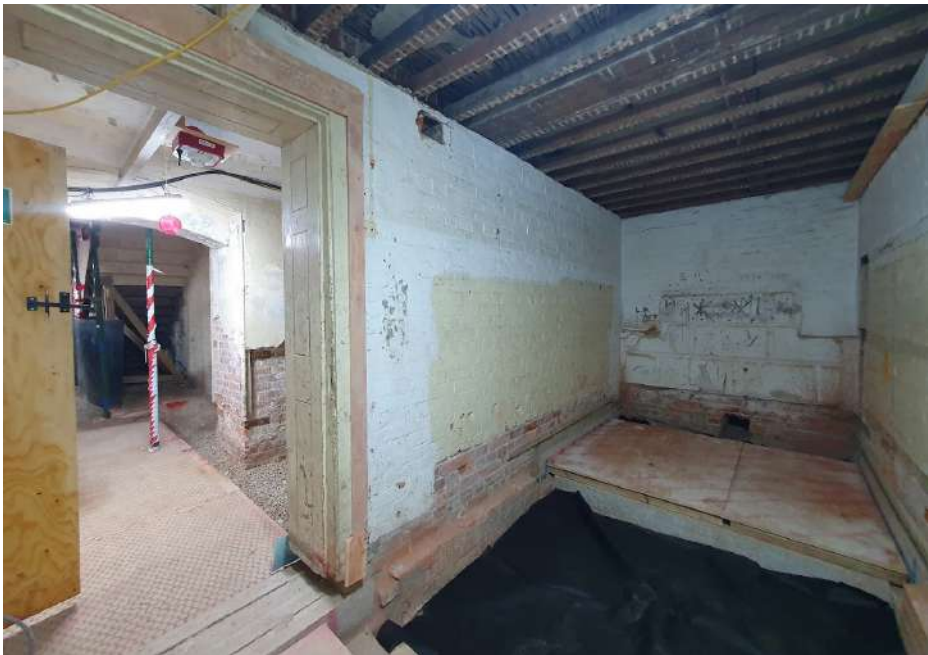
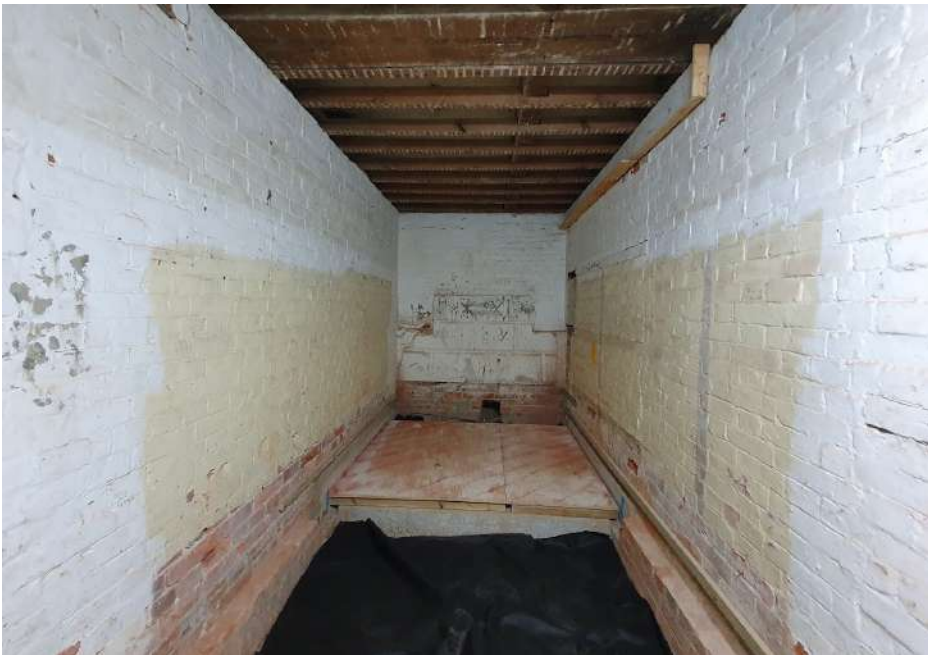
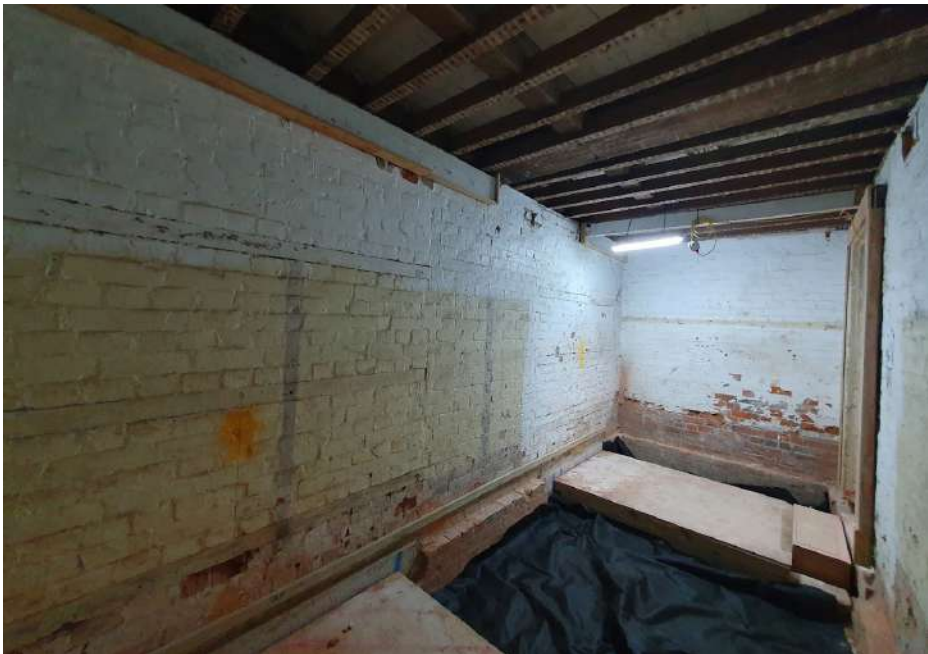
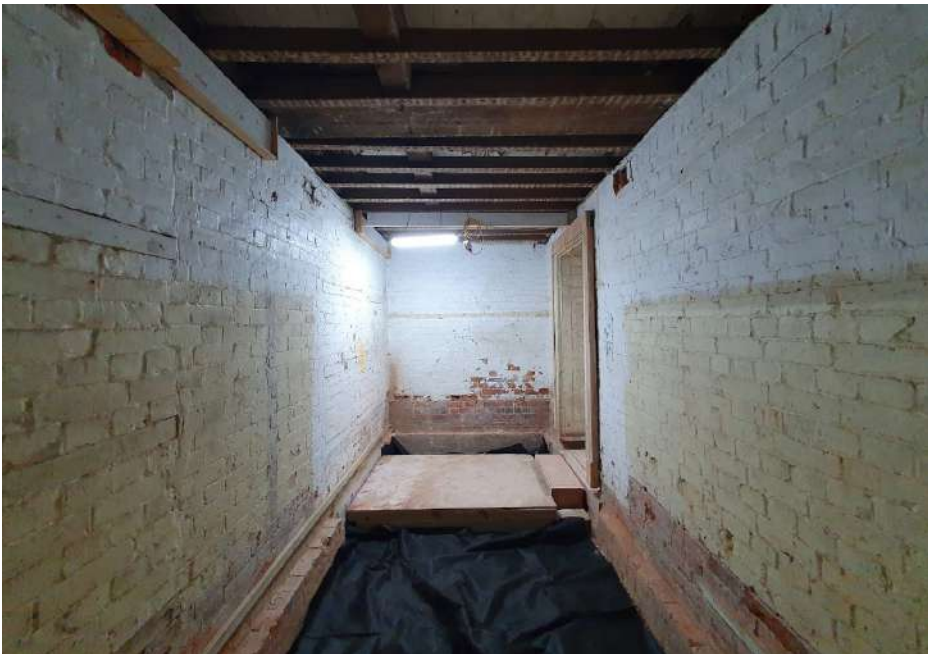
**Walls** – masonry walls with shelving marks and modern paint. To be cleaned of any modern paint and decoration residue and consolidated. Repointed as required in traditional lime mortar to match adjacent and retained as exposed brickwork.

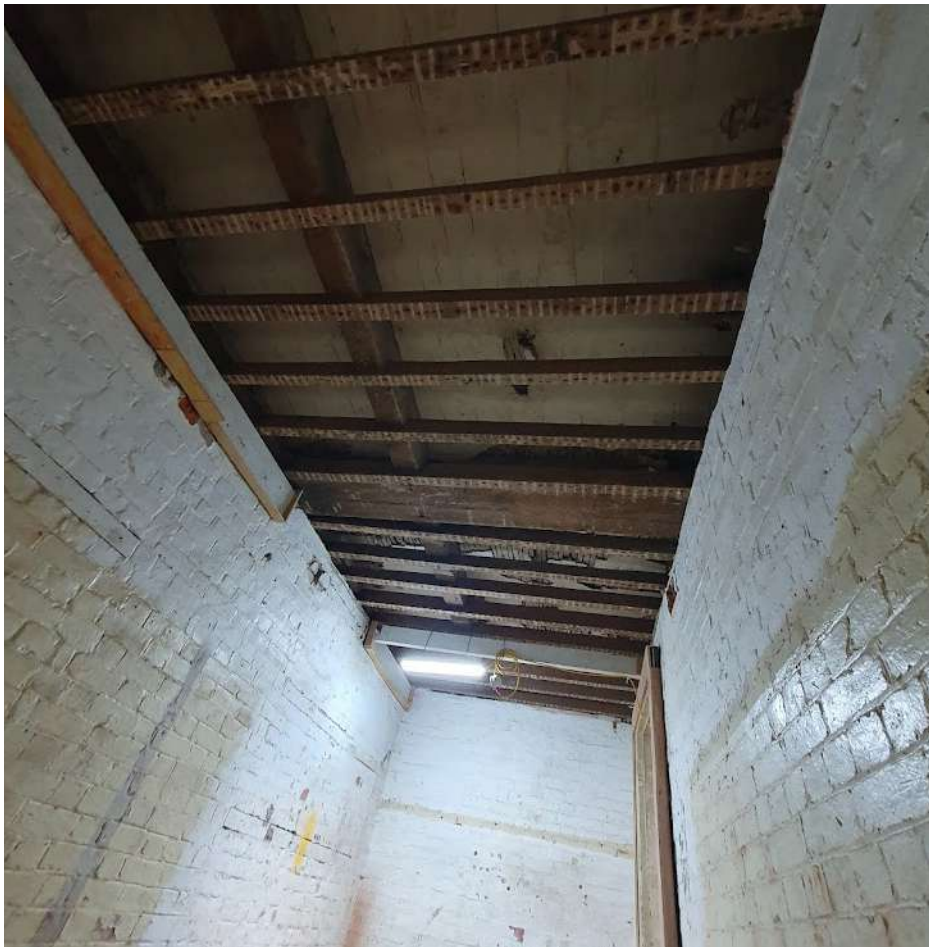
CEILING

**Ceiling** – decayed lath and plaster ceiling removed. Ceiling to be reinstated in modern acoustic ceiling to comply with acoustic requirements of back of house and G8 library environment separation.

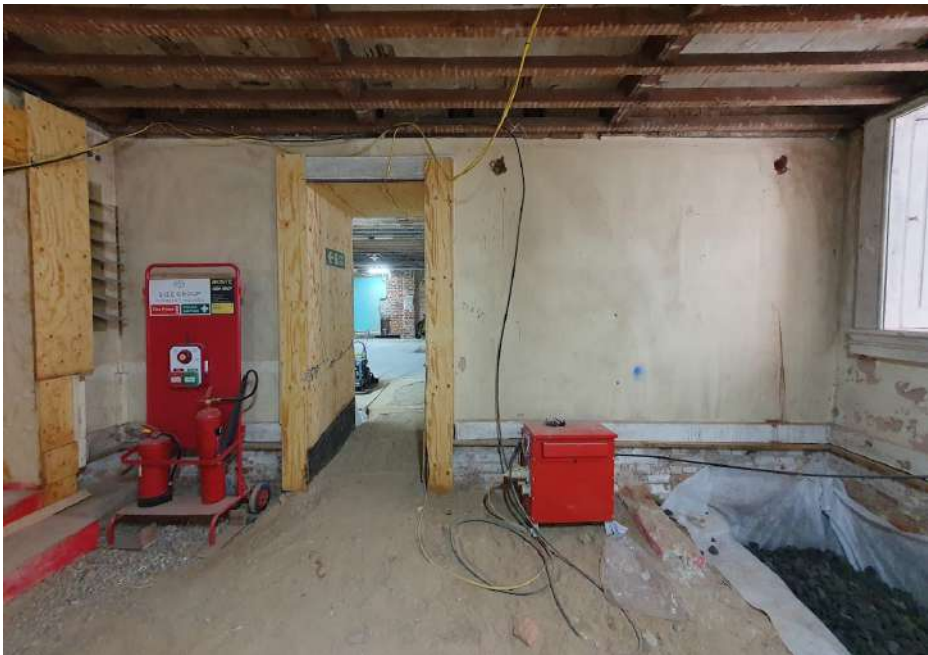
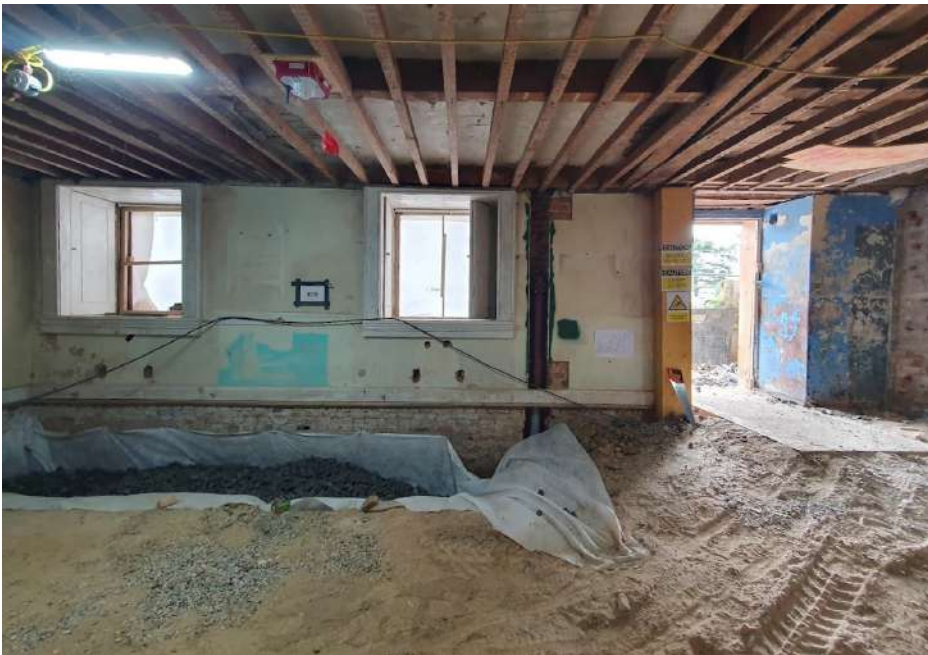
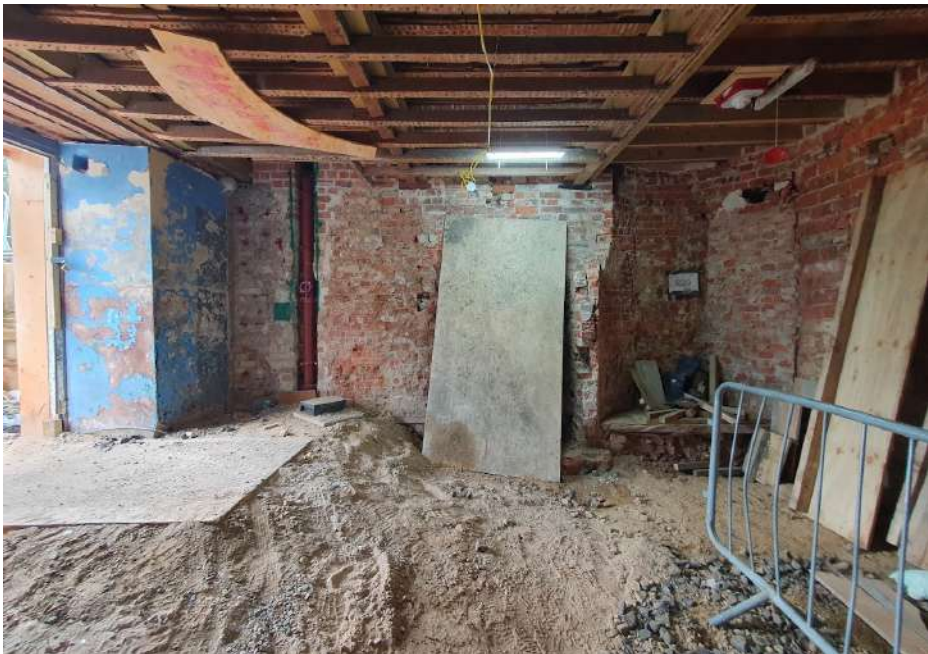
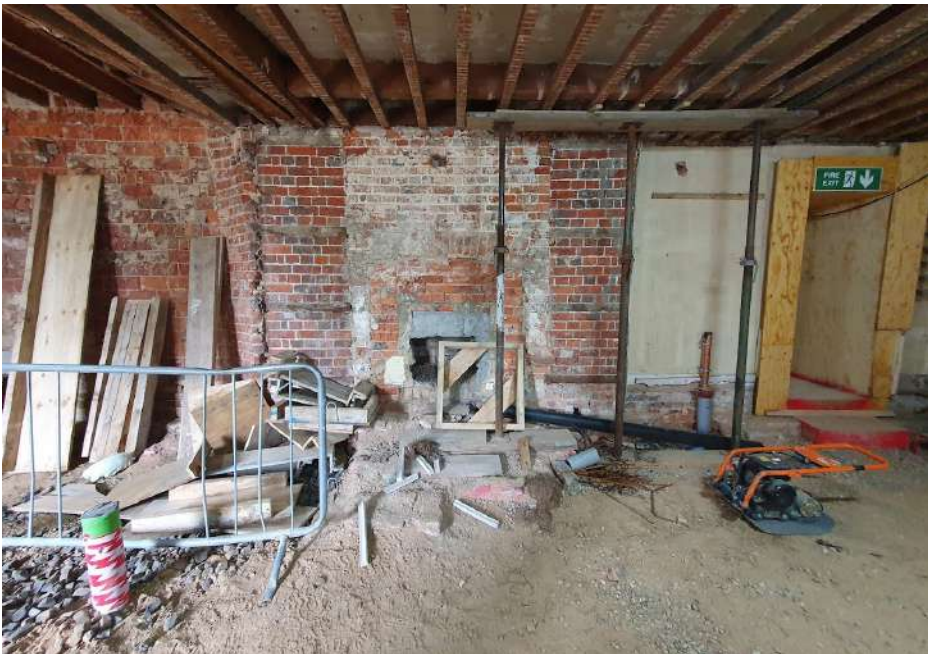
**Walls** – area heavily altered in C20th. Walls rendered in cement, fragments carefully removed due to delamination and cracking. Partitional wall carefully deconstructed for reinstatement as consented due to lack of foundations. At deconstruction it was discovered that east section is fully constructed of blockwork, as is the blocked fireplace. All modern render to be removed and walls reinstated in traditional lime plaster to masonry as appropriate finish in C19th basement.

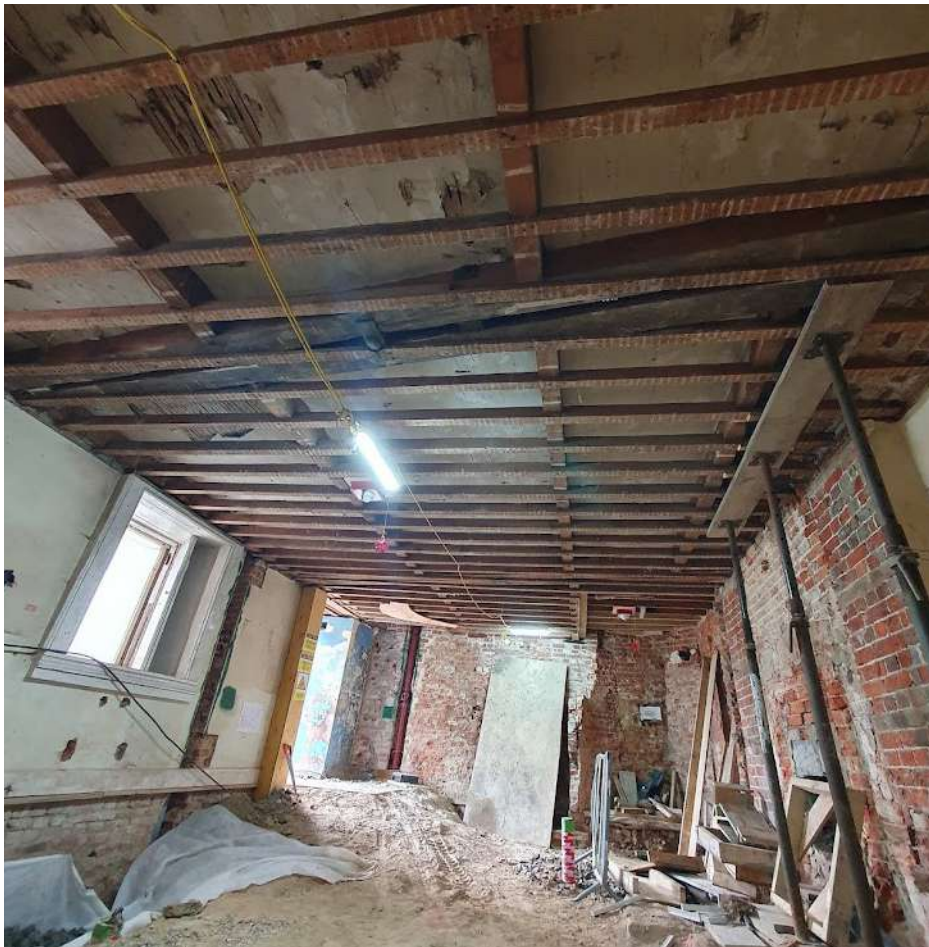
CEILING

**Ceiling** – north section mostly modern plasterboard and modern decayed south section removed in 2019. Currently all modern ceiling fabric removed and to be reinstated in modern acoustic ceiling to comply with acoustic requirements of back of house and G9-12 family area environment separation.

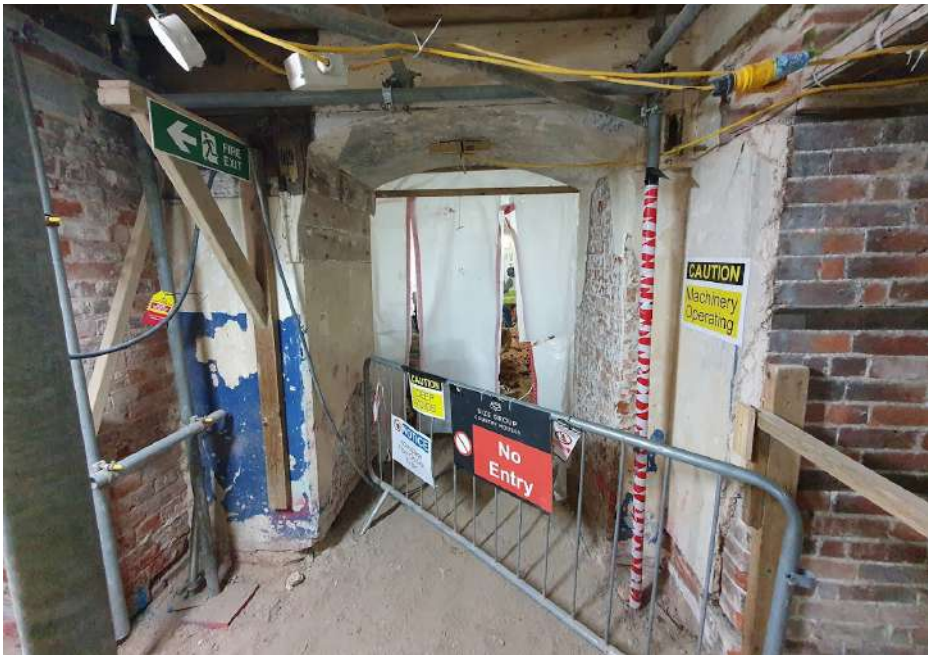
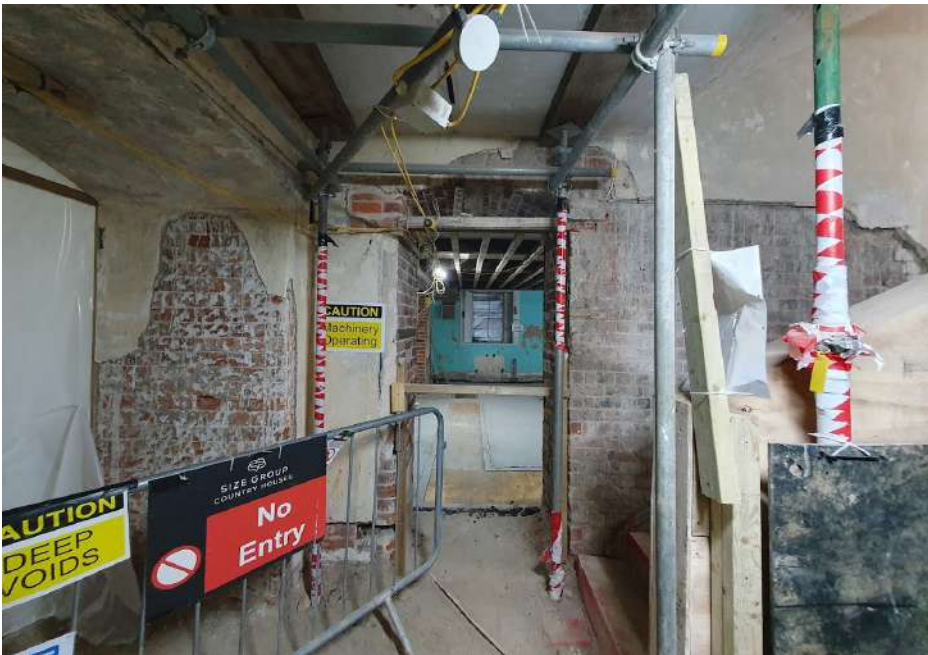
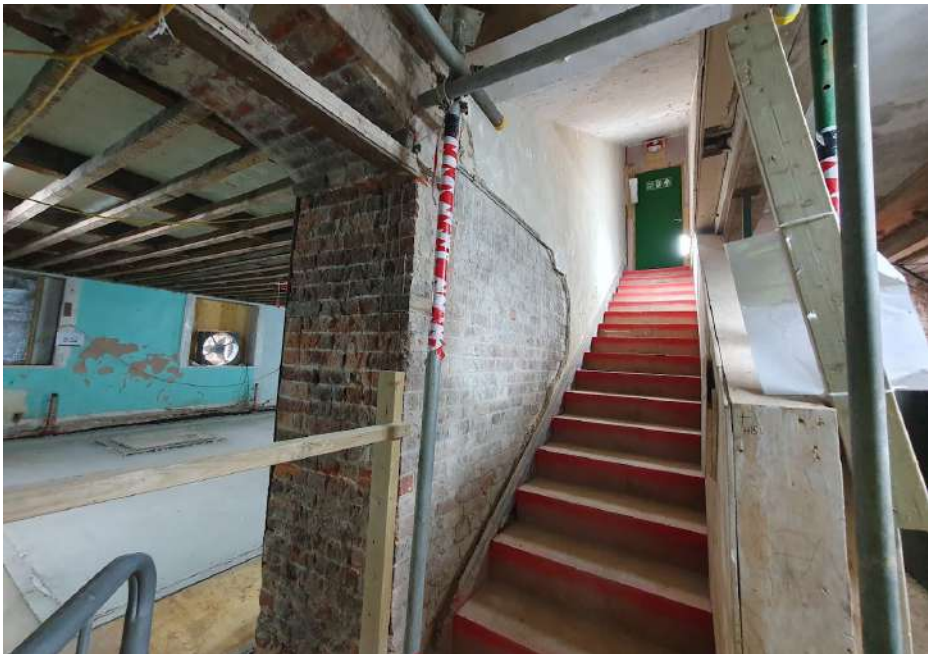
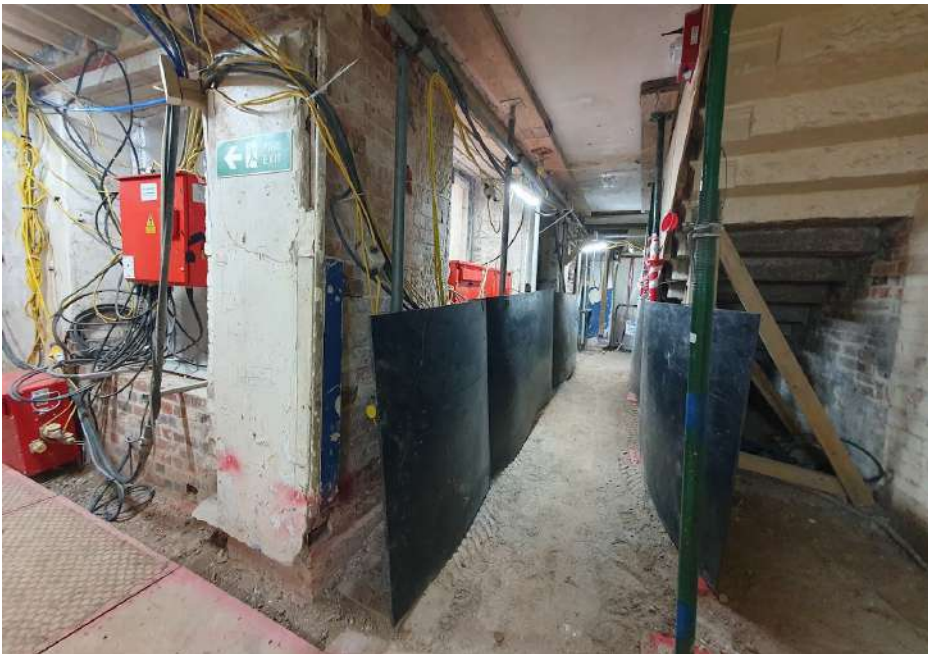
**Walls** – a mix of render (some lime some cement) and painted brickwork below the stairs. Render to be repaired and reinstated in matching materials. Cement render if not causing damage will not be removed but simply repaired. If damp issues present or cement render blown, the complete area will be replaced in traditional lime to masonry. Areas with painted brickwork cleaned and refinished in breathable masonry paint.

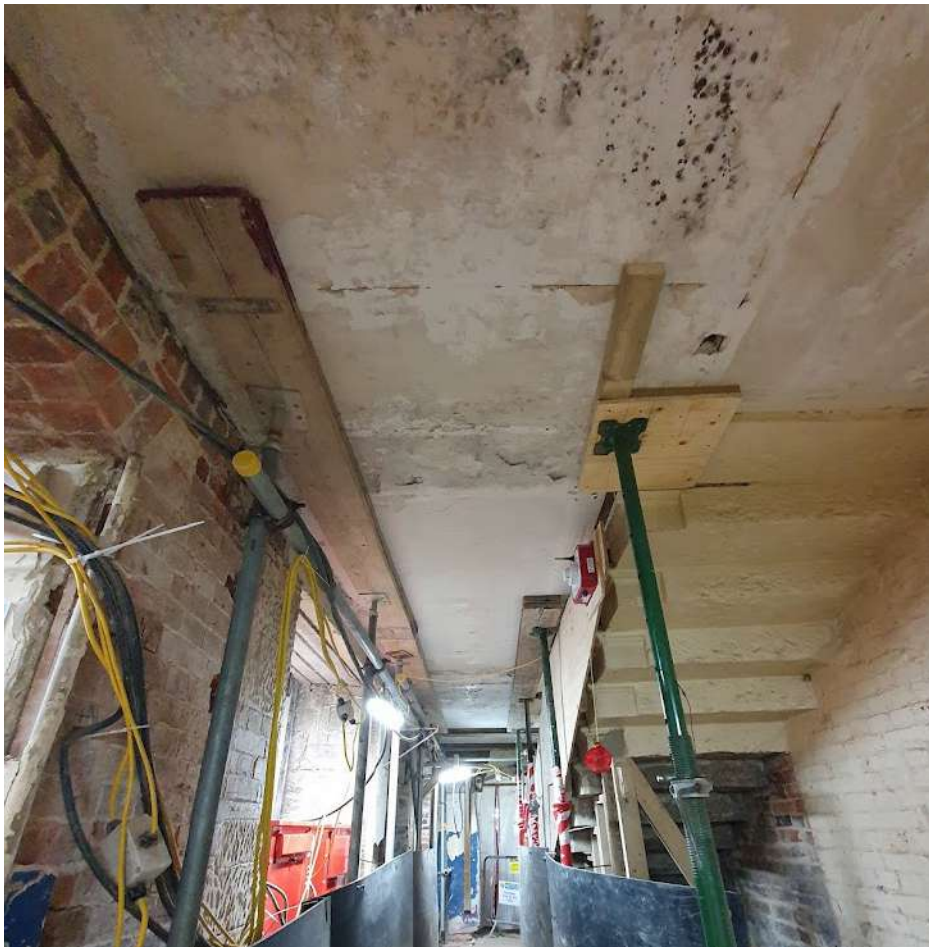
CEILING

**Ceiling** – stone cantilever landing ceiling throughout. Stone to be carefully cleaned and treated for any mould. New freestanding ceiling below introduced as consented to run essential MEP services without impacting the cantilever stone.

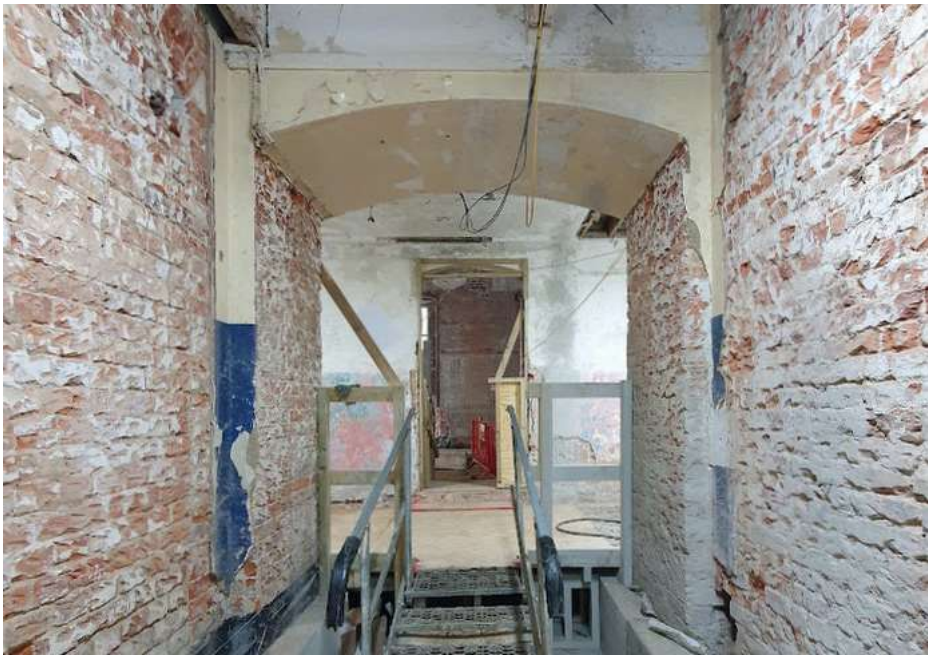
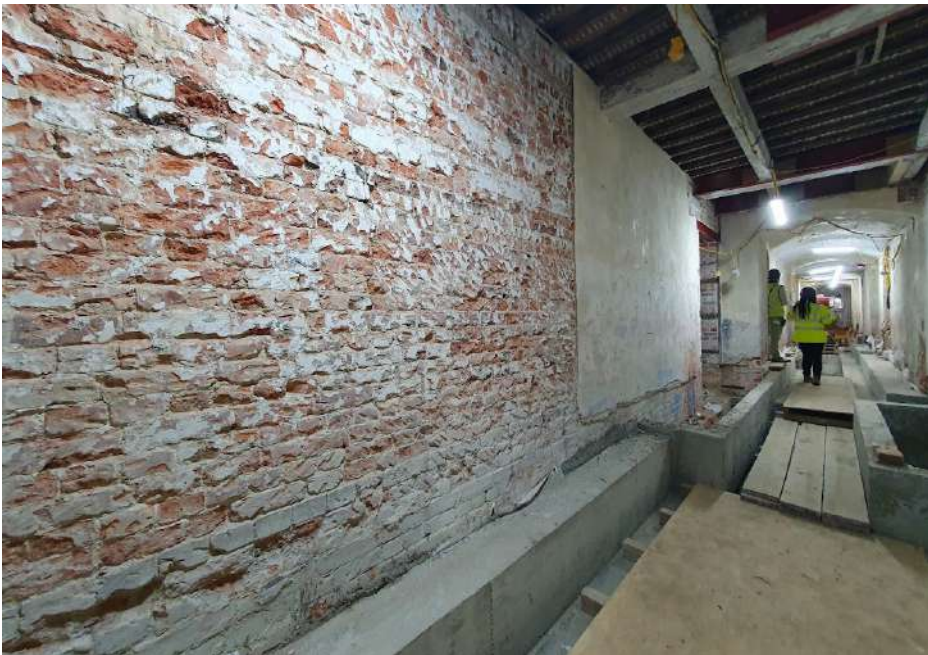
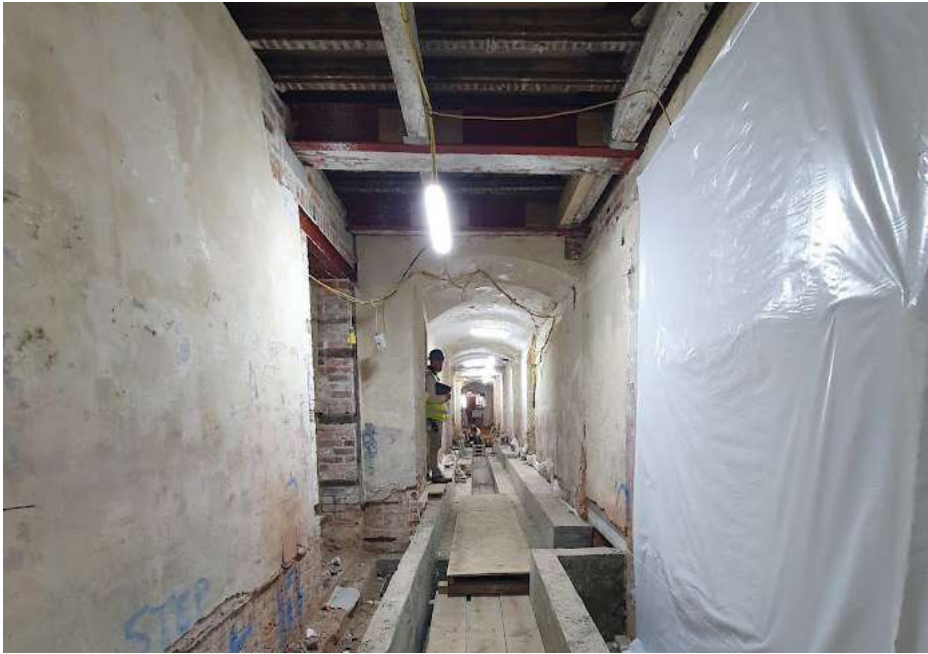
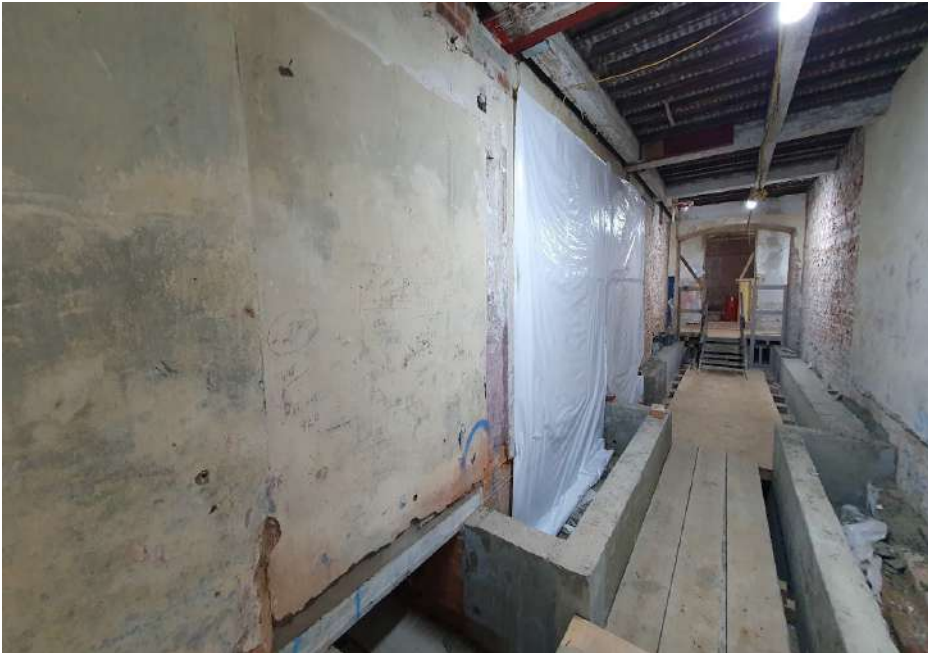
**Walls** – a mix of render (some lime some cement). Render to be repaired and reinstated in matching materials. Cement render if not causing damage will not be removed but simply repaired. If damp issues present or cement render blown, the complete area will be replaced in traditional lime to masonry.

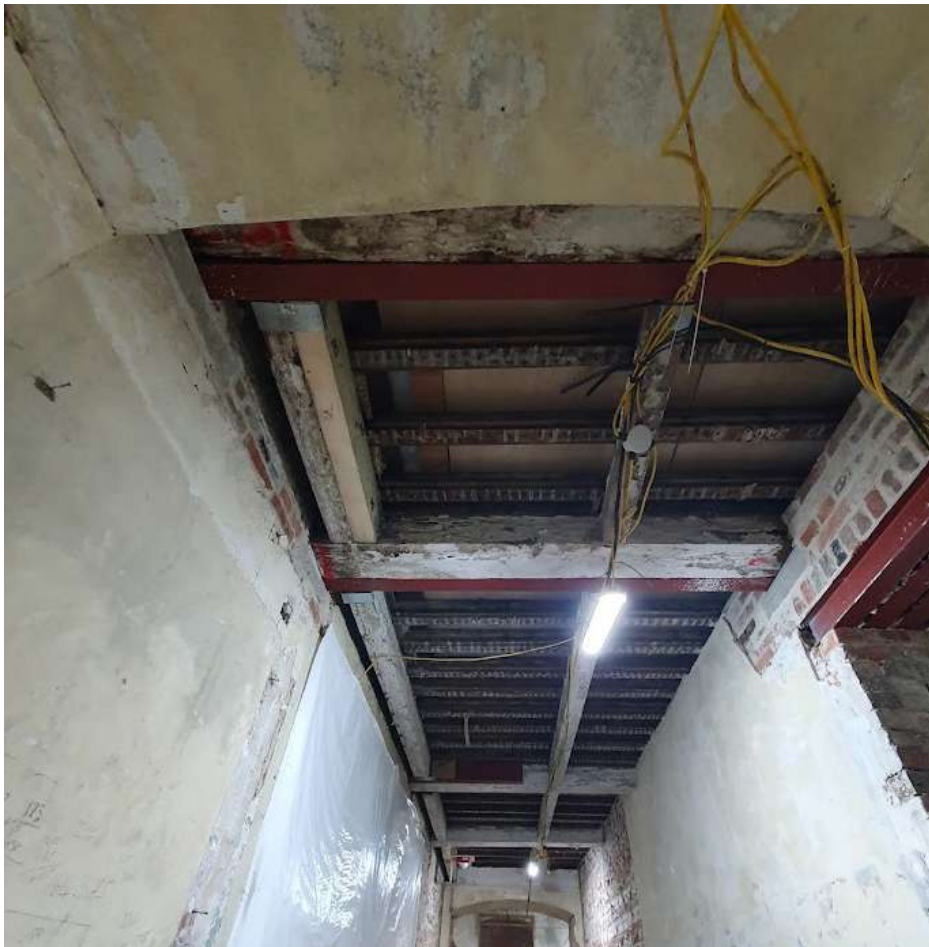
CEILING

**Ceiling** – central section all masonry vaults with mostly lime render. To be repaired and consolidated like for like. Northern section historically lath and plaster since removed, as consented, due to severe decay. North section ceiling to be reinstated in lath and plaster.

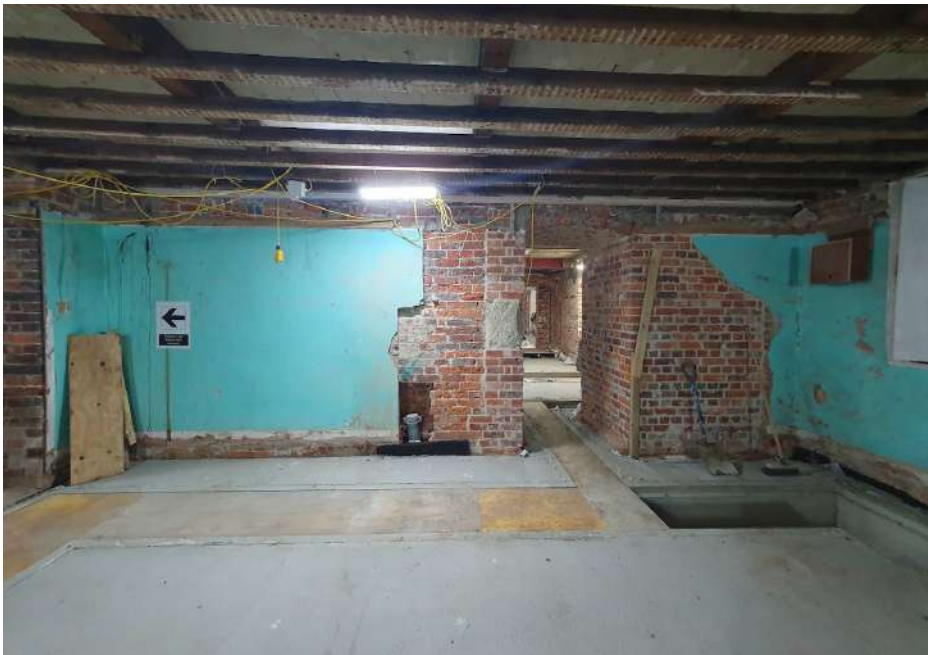
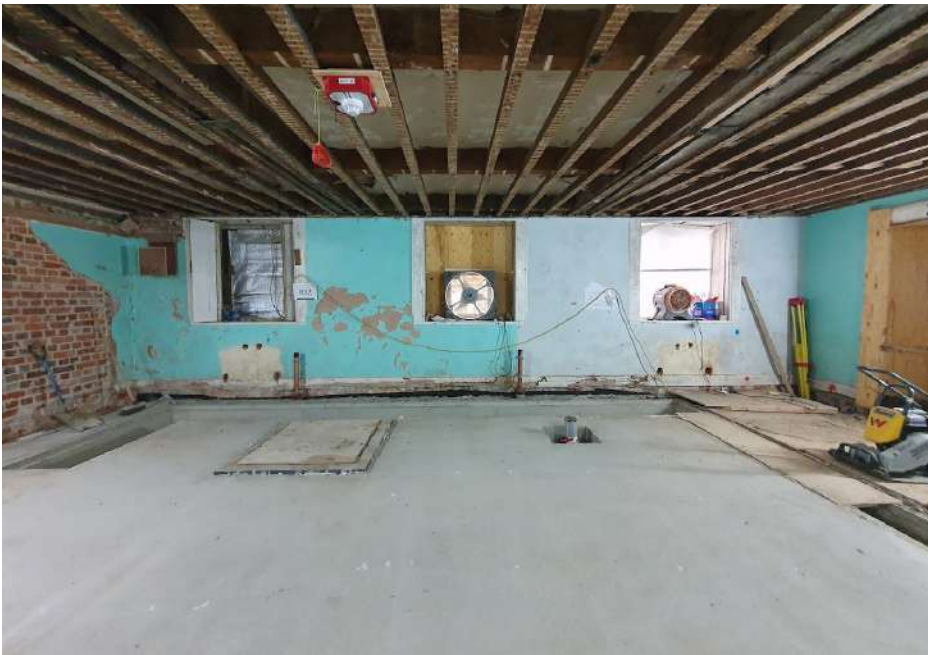
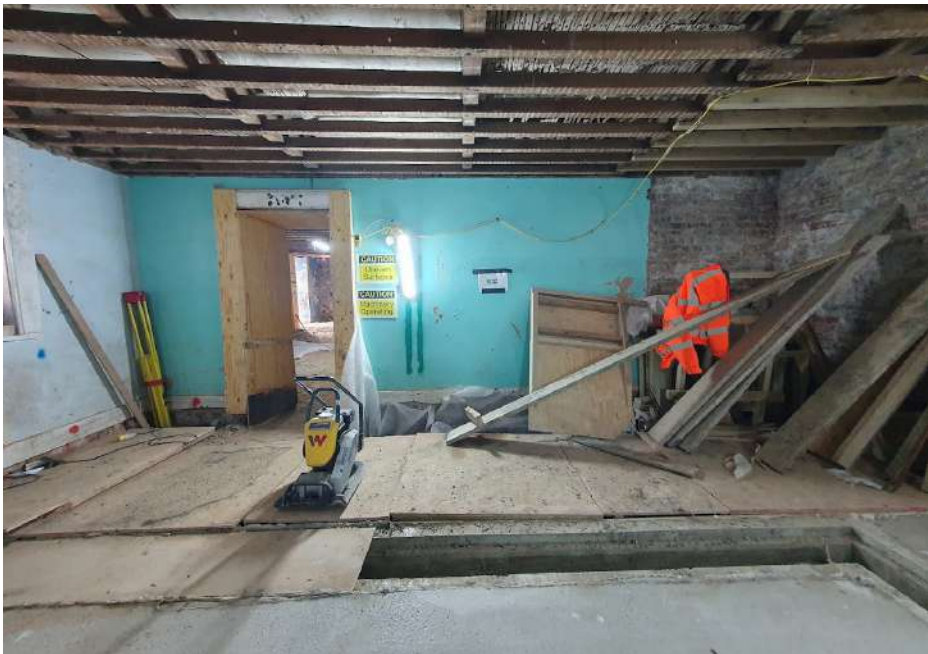
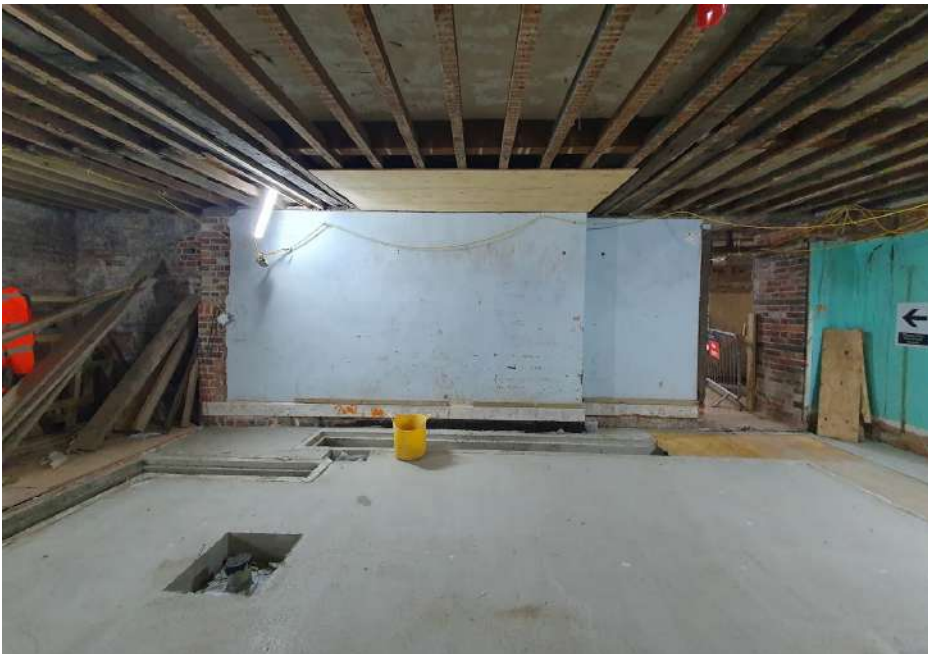
**Walls** – a mix of render (some lime some cement). Render to be repaired and reinstated in matching materials. Cement render if not causing damage will not be removed and simply repaired. If damp issues present or cement render blown the complete area will be replaced in traditional lime to masonry.

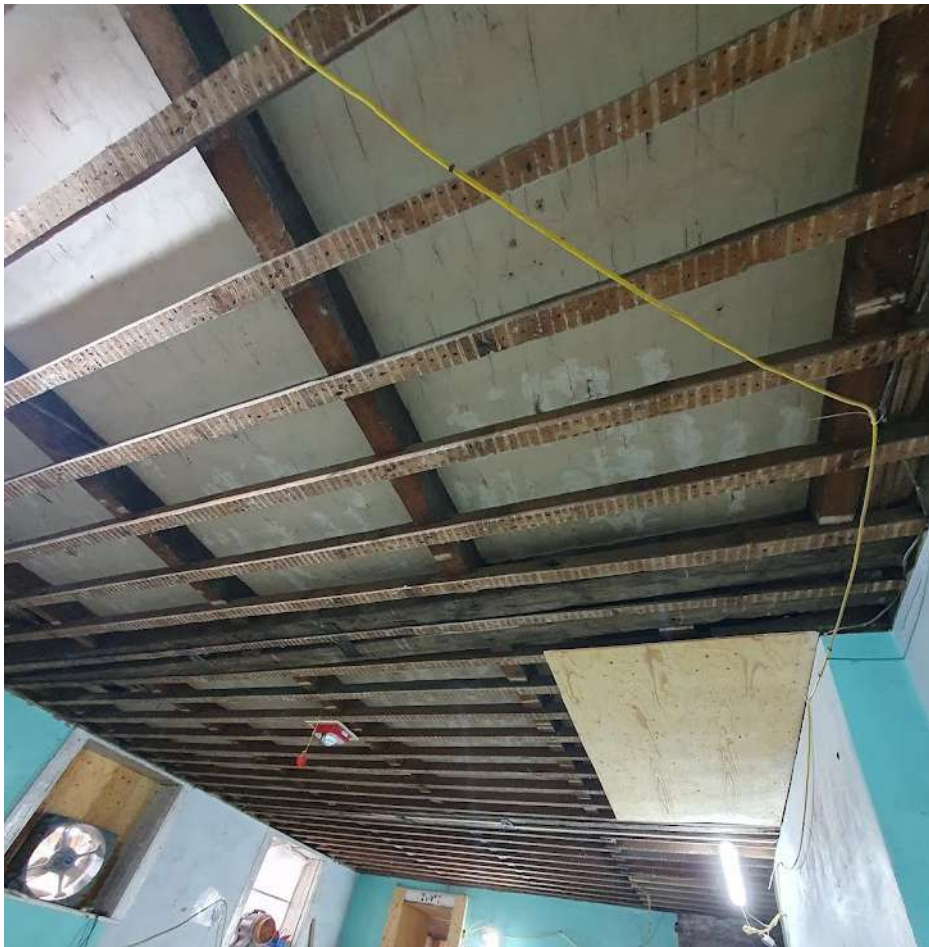
CEILING

**Ceiling** – previously modern plasterboard, historically lath and plaster. Currently all modern ceiling fabric removed and to be reinstated in modern acoustic ceiling to comply with acoustic requirements of back of house and G13 dining area environment separation.

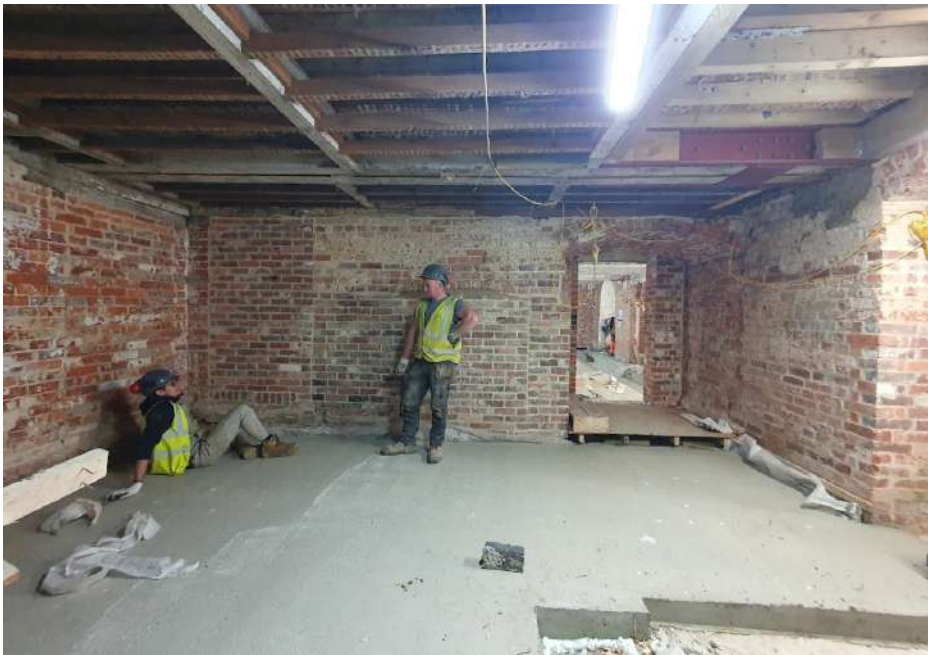
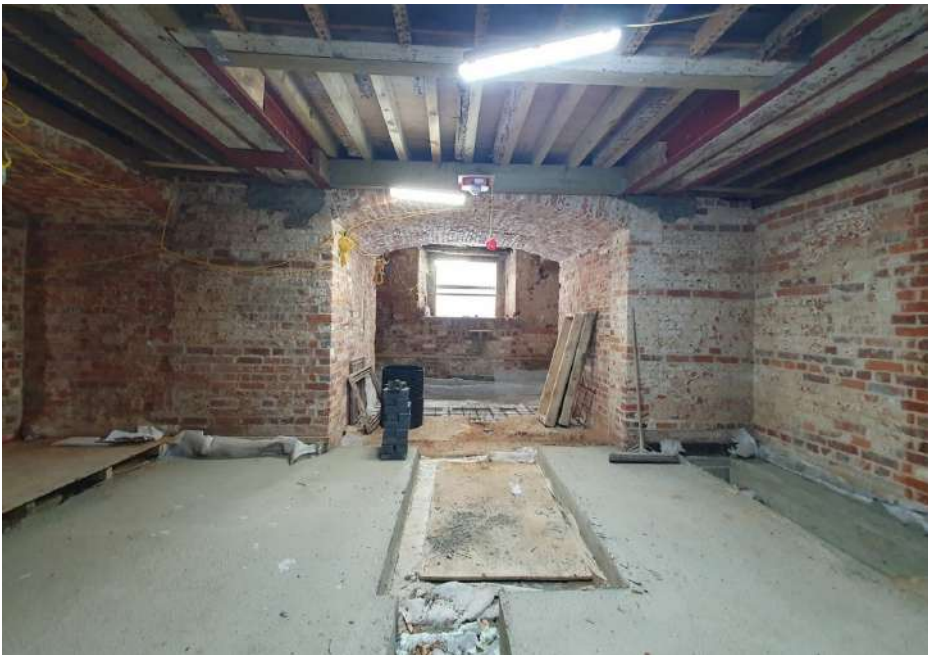
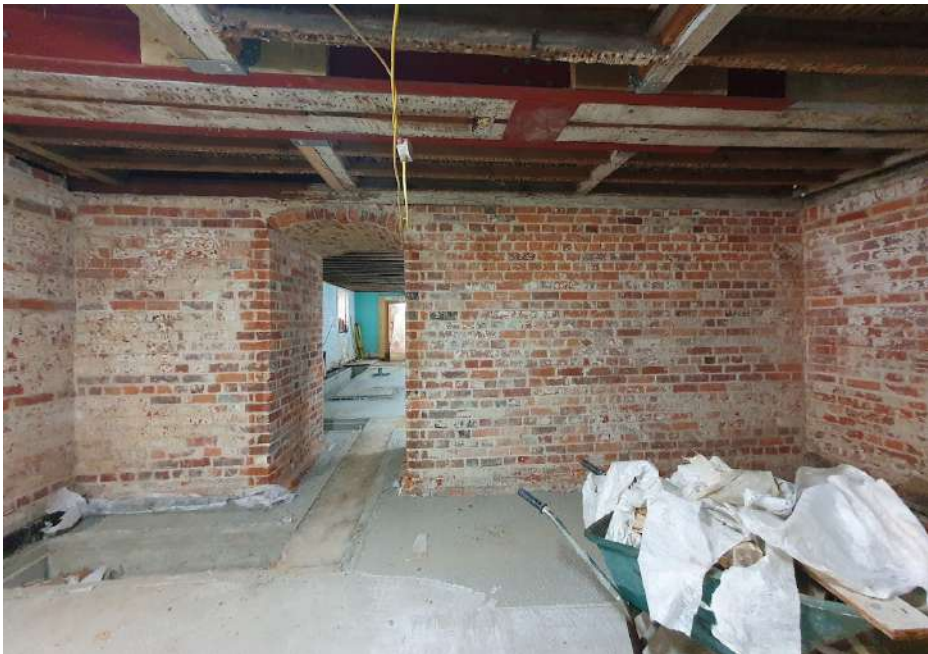
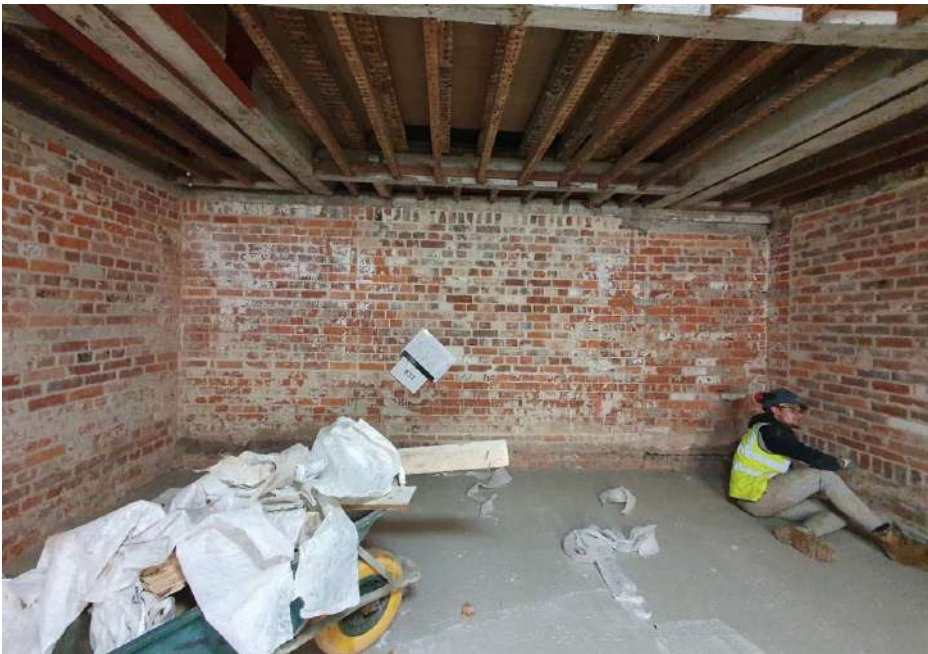
**Walls** – area stripped from modern cement and plasterboard finishes as well as modern tiling. Area was previously converted into bathrooms. Wall finish to be reinstated in traditional lime plaster to masonry.

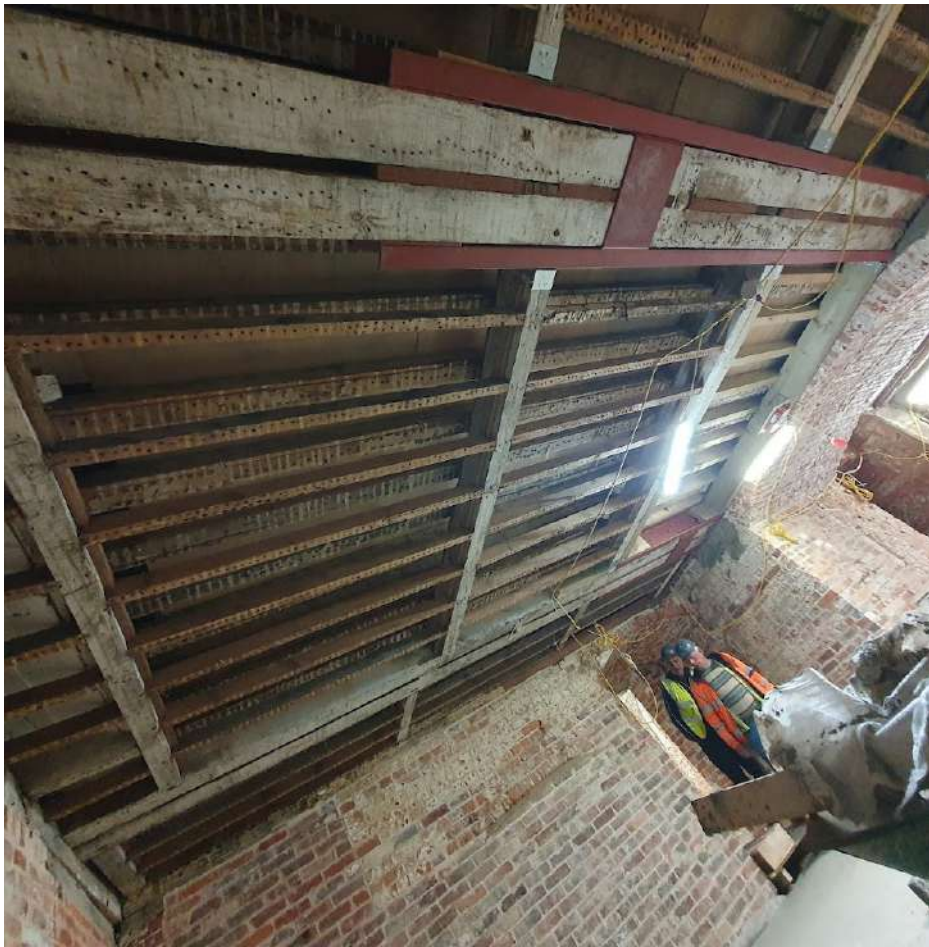
CEILING

**Ceiling** – modern plasterboard ceiling stripped due to decay and harm to fabric. To be reinstated in lath and plaster. Front section vaulted and reinstated in traditional lime plaster to masonry.

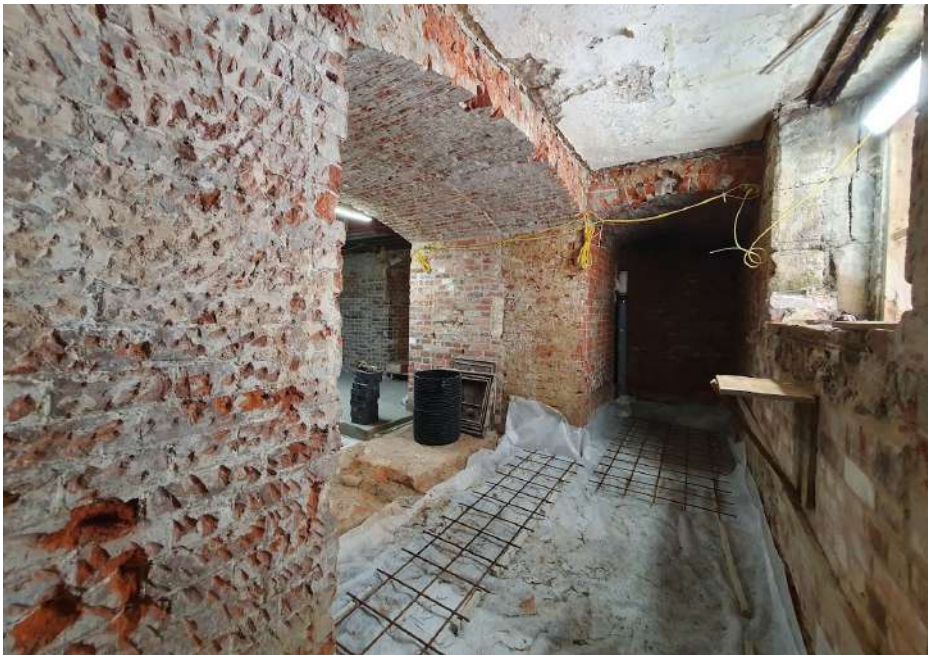
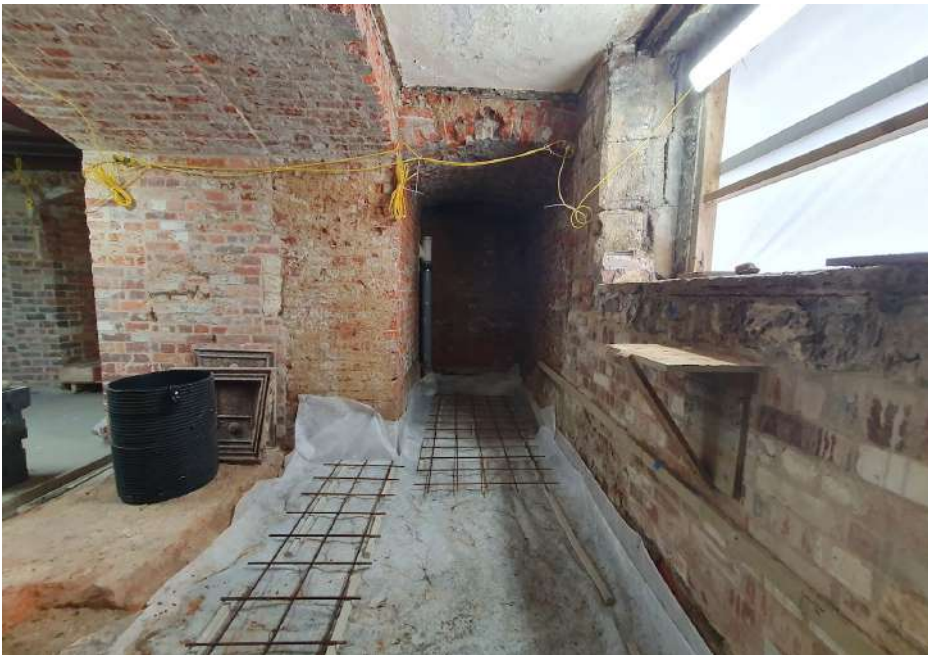
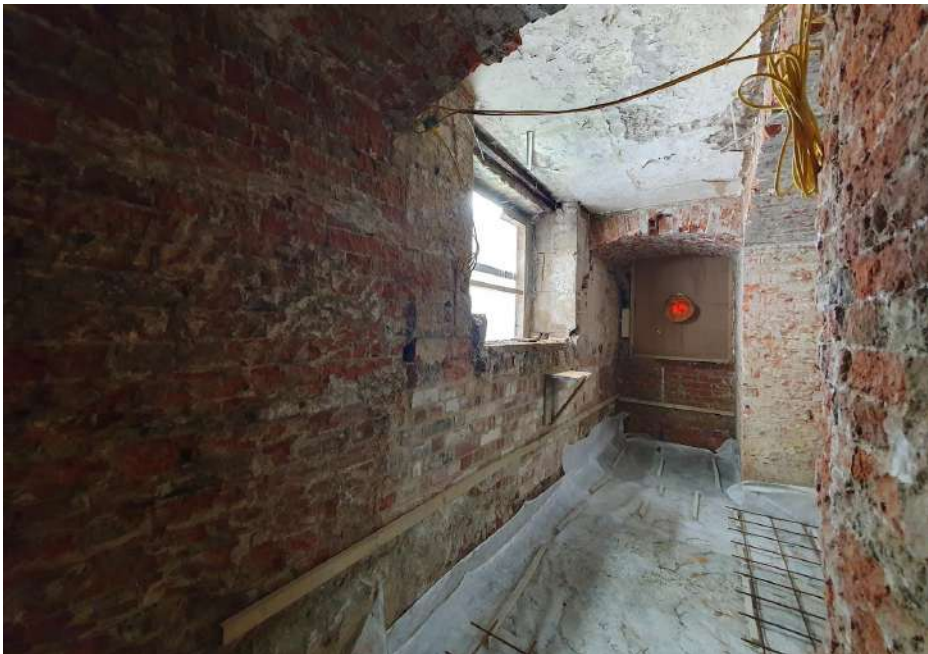
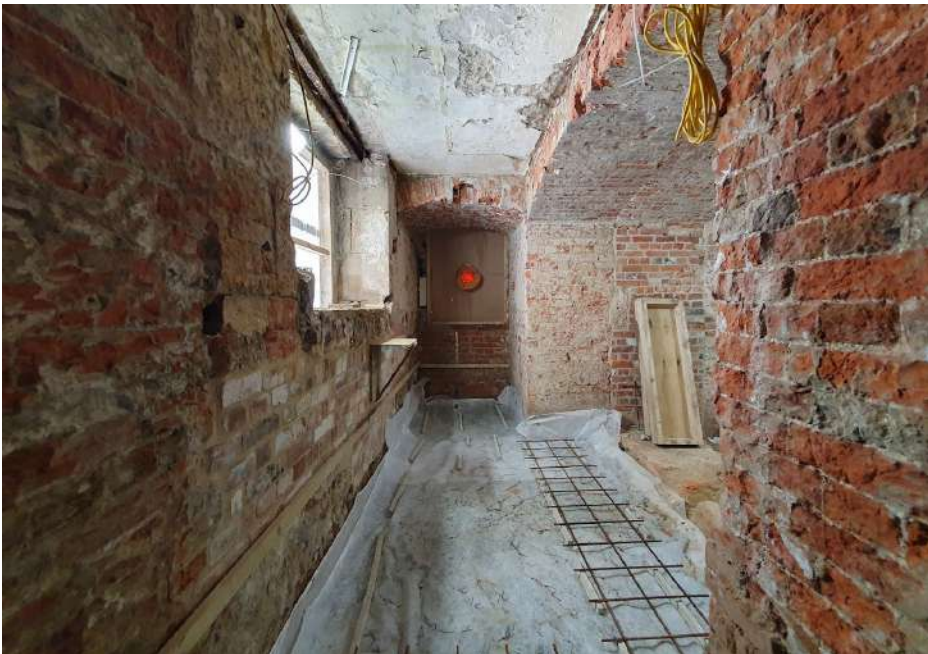
**Walls** – fabric absent. Traditional lime plaster to masonry to be introduced.
