B27 - BIN STORE

Condition June 2025

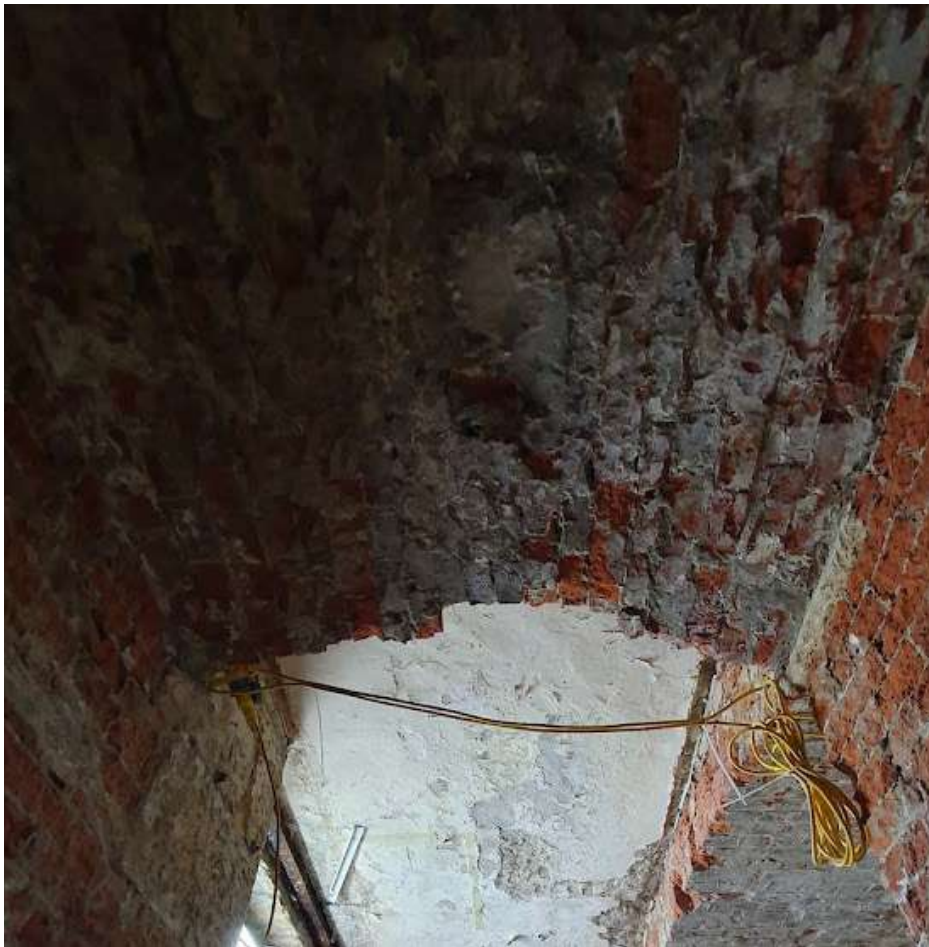
CEILING

**Ceiling** – sections in stone and masonry. Stone sections cleaned and left undisturbed, vaulted areas plastered in lime plaster to masonry.

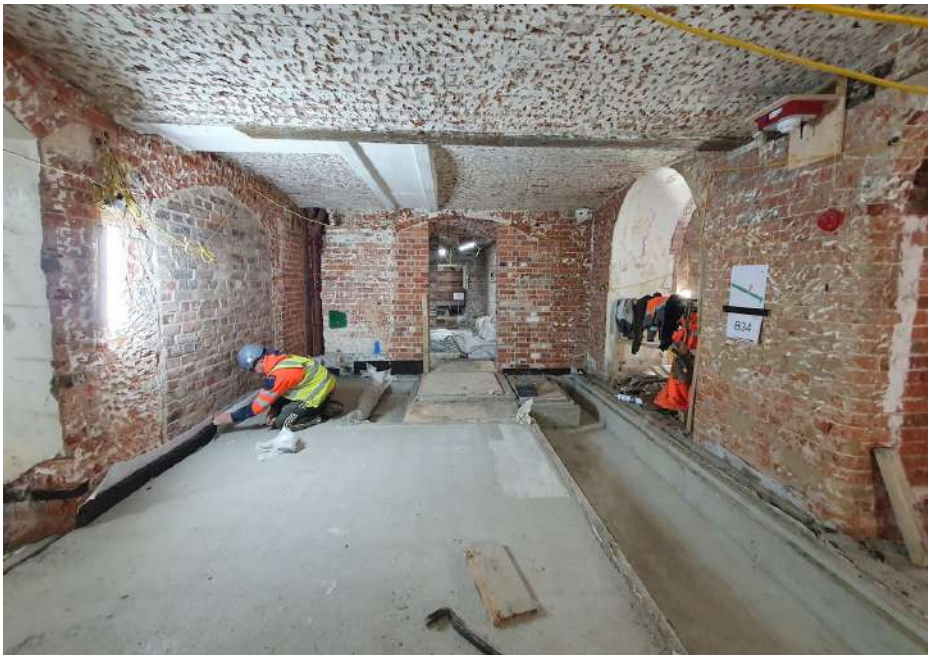
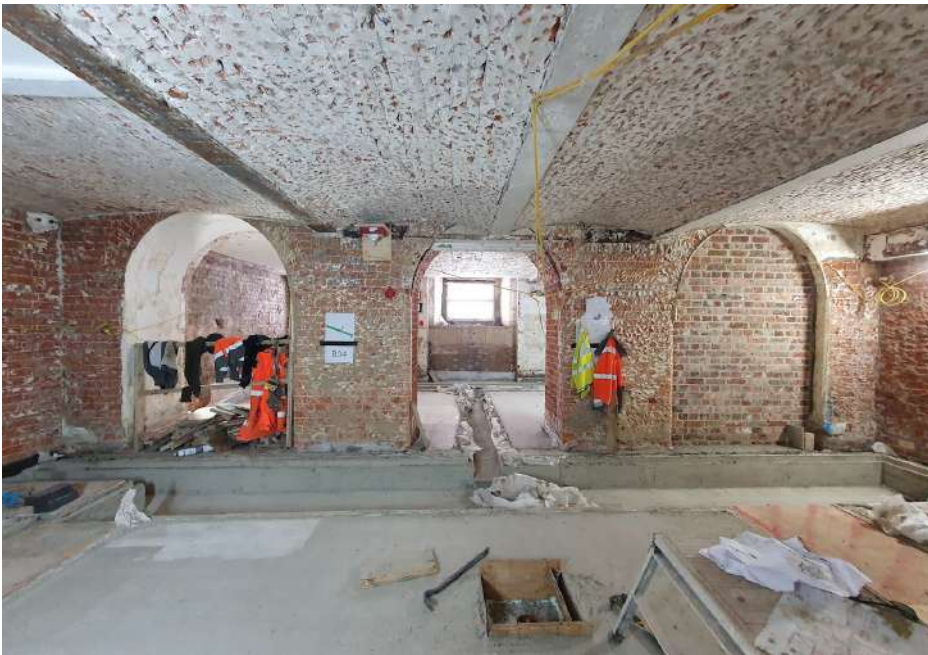
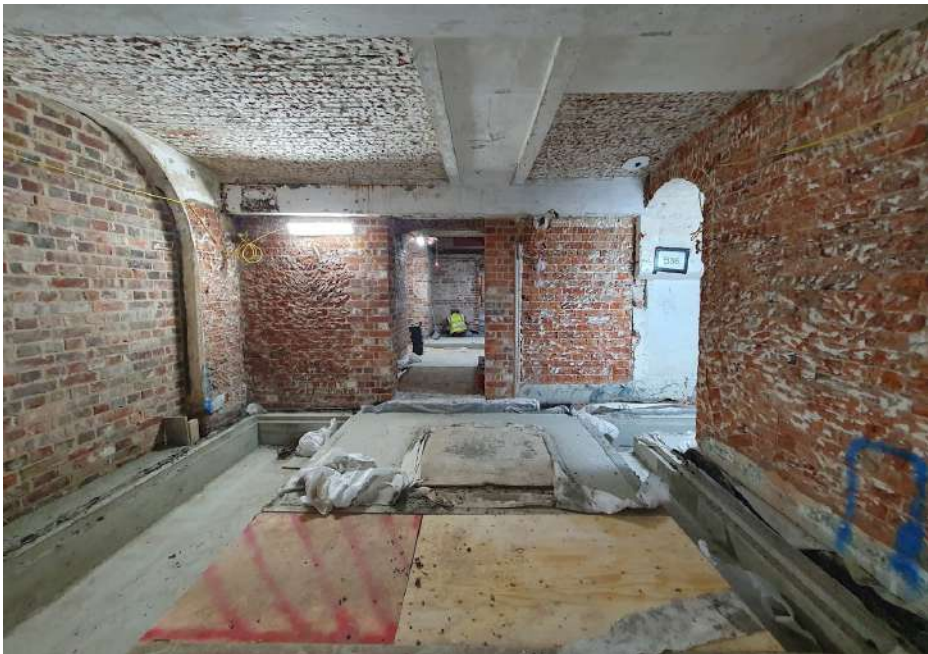
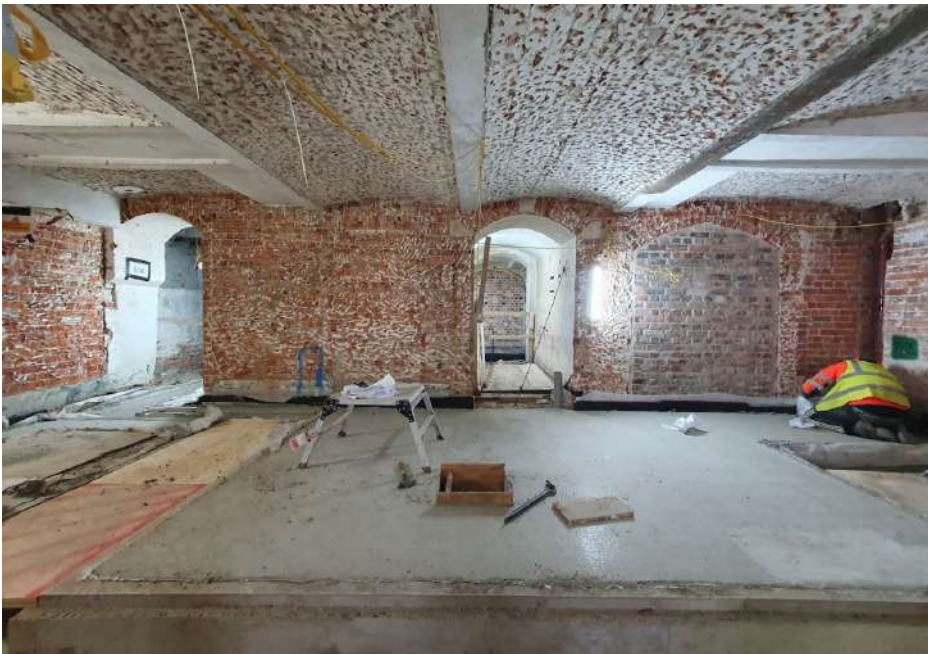
**Walls** – finishes not present. Traditional lime plaster to masonry reinstated.

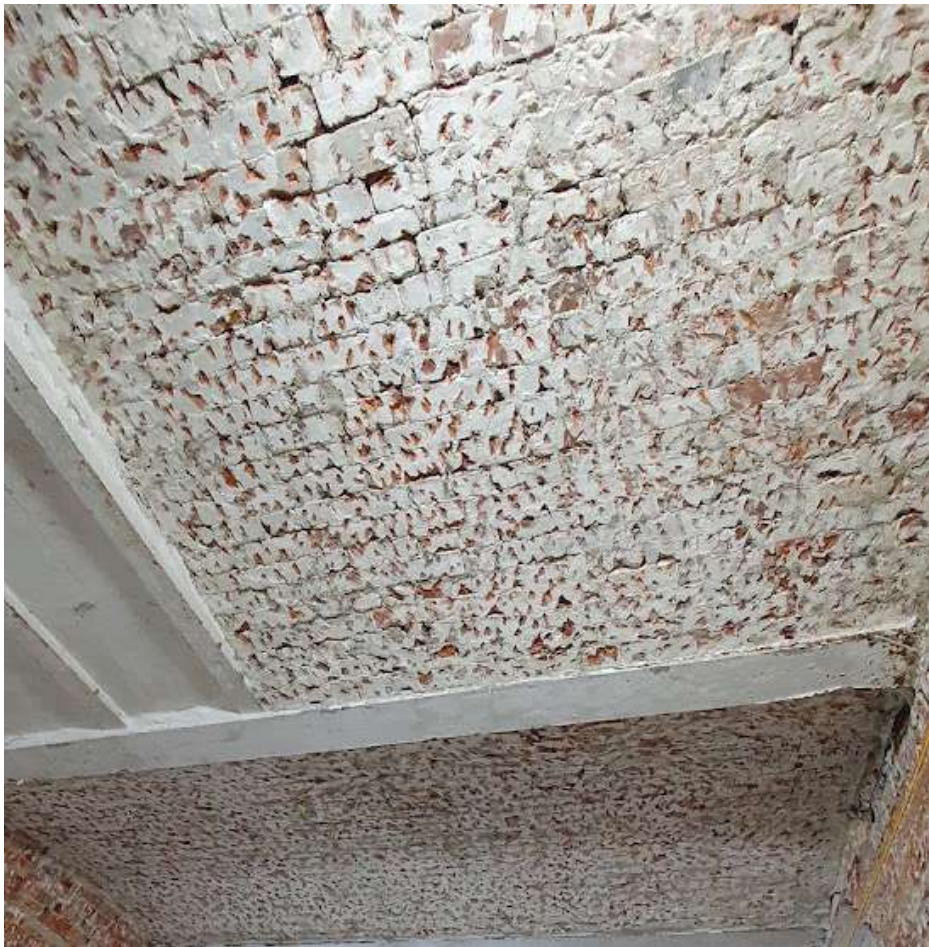
CEILING

**Ceiling** – finishes not present. Traditional lime plaster to masonry reinstated.
