# PRELIMINARY ARBORICULTURAL REPORT

Meadow View Cottage Vicarage Lane, Charlton, Malmesbury SN16 9DW

PRI Ref: 347376

Survey Date: 13-01-2026

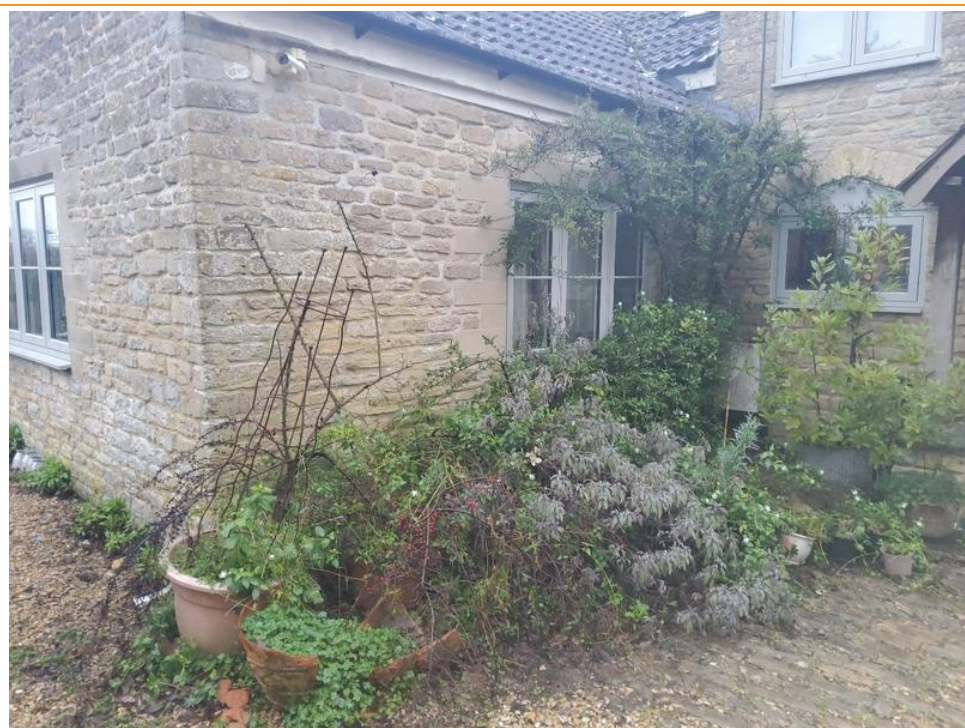
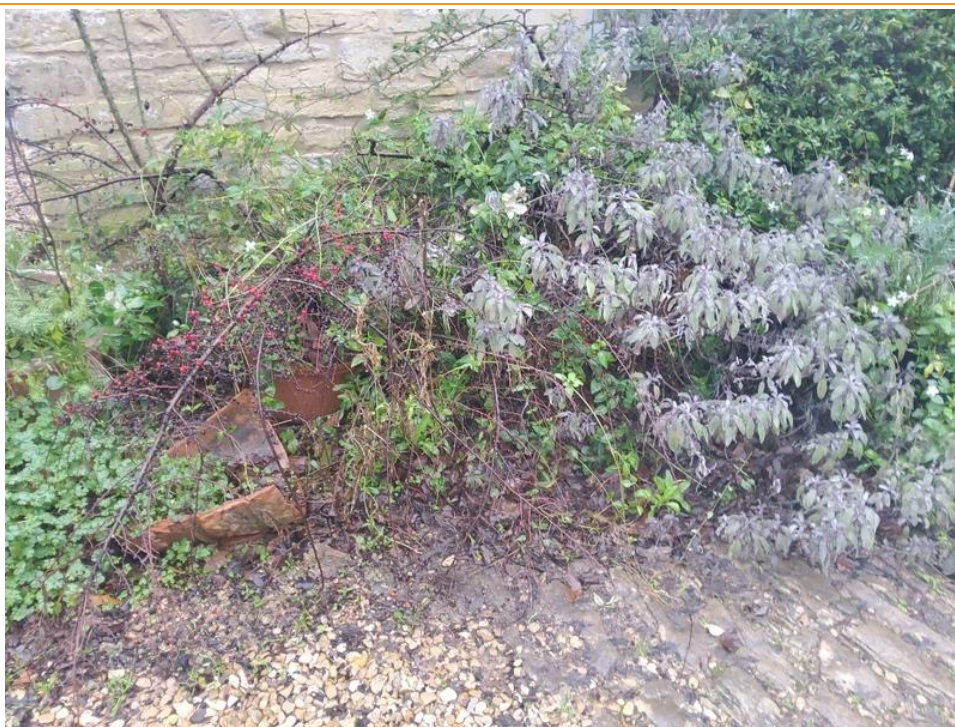
SG2 Mixed species group

| Tree No: | Common Name | Age Class | Condition | Height (m) | Crown Spread (m) | Stem diam. (mm) | No. of Stems | Dist to bldg. (m) | Roots Implicated | Pruning History | Recommendation | Tree Work Constraints | Notes | Owner address | Owner |
|---|---|---|---|---|---|---|---|---|---|---|---|---|---|---|---|
| SG2 | Mixed species group | Mature | Fair | 3.00 | 1.50 | 25 | 20 | 0.00 | Unavailable | Managed by regular pruning. | Fell and treat stump with eco plugs (broadleaved). | There are no restrictions to the site or to the tree - scheduled rates may apply. | Some measurements estimated due to lack of access. Distance is to closest point to property. Group consists of Pyracantha, Sage, Rose, Cotoneaster, and other low level herbaceous plants (some of which is within pots but view obstructed and unable to confirm origins) with an approximate DBH range of 5mm - 50mm. | Meadow View Cottage<br>Vicarage Lane<br>Charlton<br>Malmesbury<br>SN16 9DW | PH |

| Tree No: | Species | Works Required | CA | TPO | Ownership |
|---|---|---|---|---|---|
| SG2 | Mixed species group | Fell and treat stump with eco plugs (broadleaved). | No | No | PH |

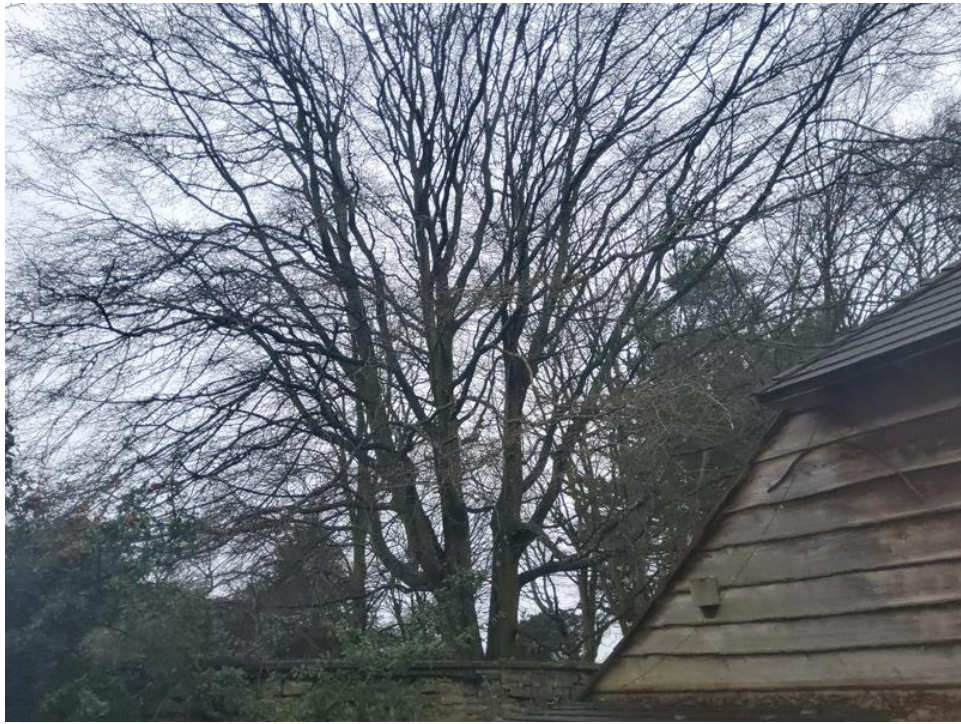
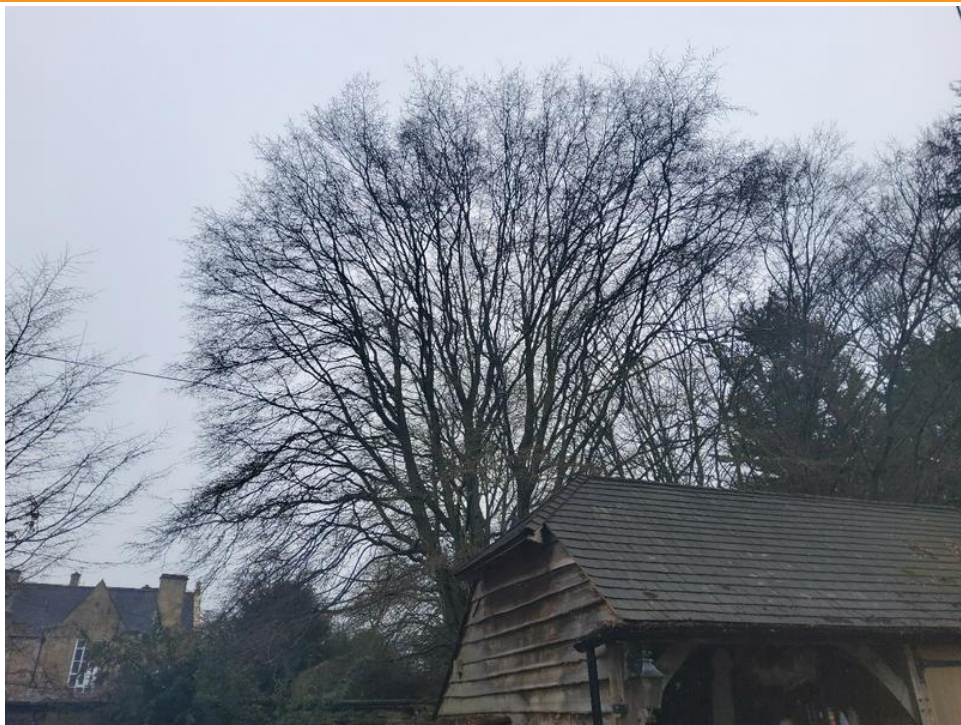
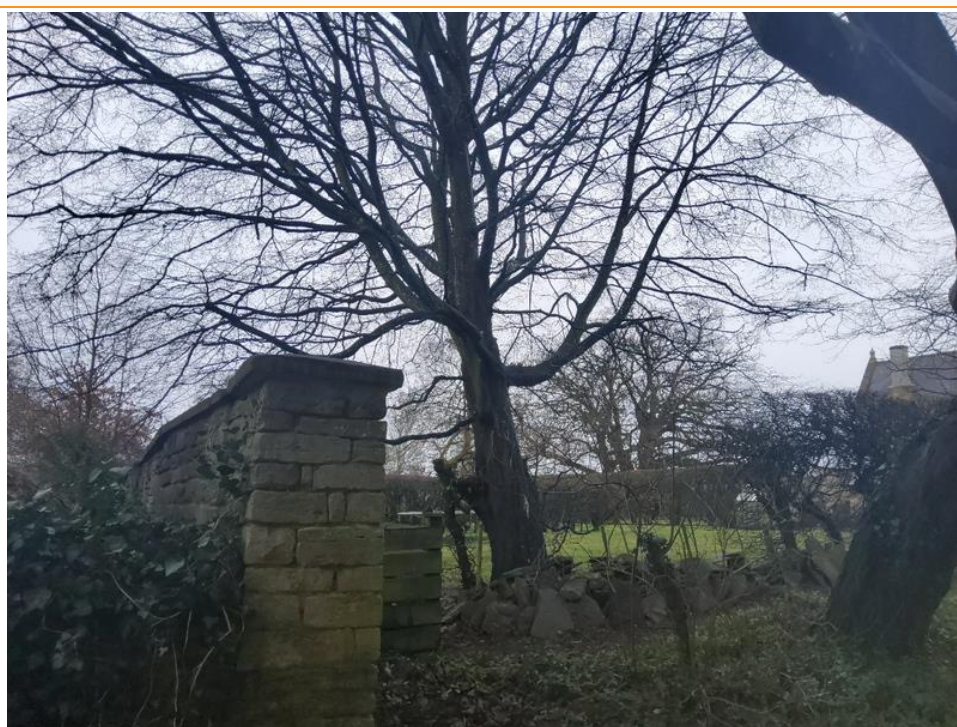
T1 Hornbeam (Common)

| Tree No: | Common Name | Age Class | Condition | Height (m) | Crown Spread (m) | Stem diam. (mm) | No. of Stems | Dist to bldg. (m) | Roots Implicated | Pruning History | Recommendation | Tree Work Constraints | Notes | Owner address | Owner |
|---|---|---|---|---|---|---|---|---|---|---|---|---|---|---|---|
| T1 | Hornbeam (Common) | Mature | Fair | 16.00 | 15.00 | 700 | 1 | 10.00 | Unavailable | No significant past works. | Pruning - Approx. 20-30% overall crown reduction removing an estimated 2-3m from the height and from around the crown or to the next closest growth point. Managed as such on biennial basis going forwards. | The third party may be responsible for works. | All measurements estimated due to lack of access. Distance is to closest point to property with approximate distance to area of damage being 19m. Crown lopsided to the north. | The Old Vicarage<br>Vicarage Lane<br>Charlton<br>Malmesbury<br>SN16 9DN | P3P |

| Tree No: | Species | Works Required | CA | TPO | Ownership |
|---|---|---|---|---|---|
| T1 | Hornbeam (Common) | Pruning - Approx. 20-30% overall crown reduction removing an estimated 2-3m from the height and from around the crown or to the next closest growth point. Managed as such on biennial basis going forwards. | Yes | No | P3P |

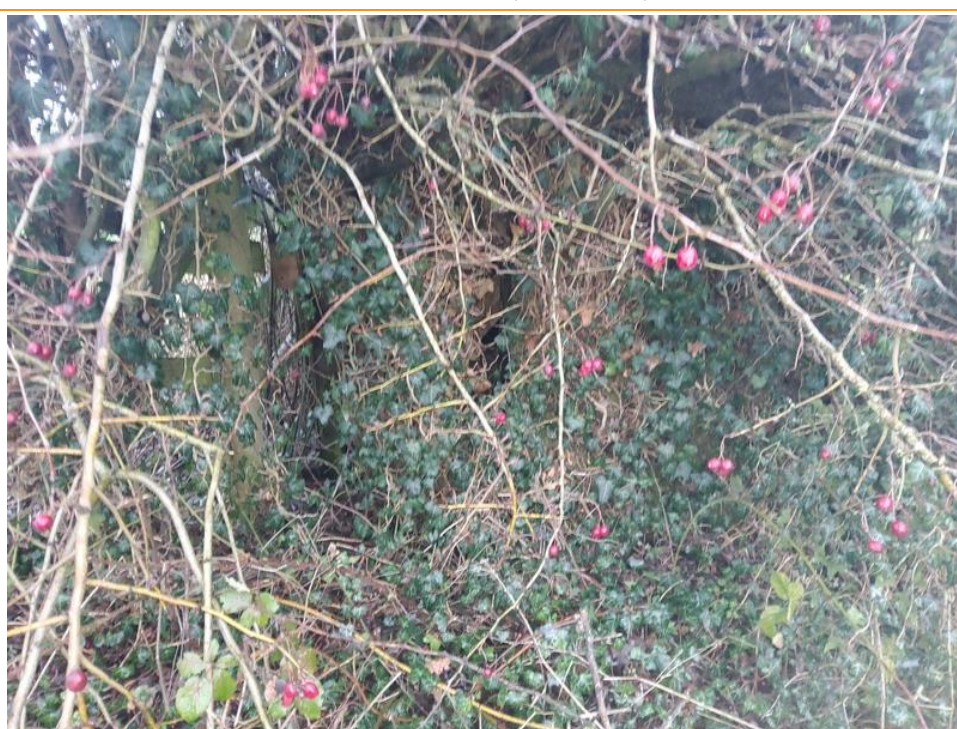
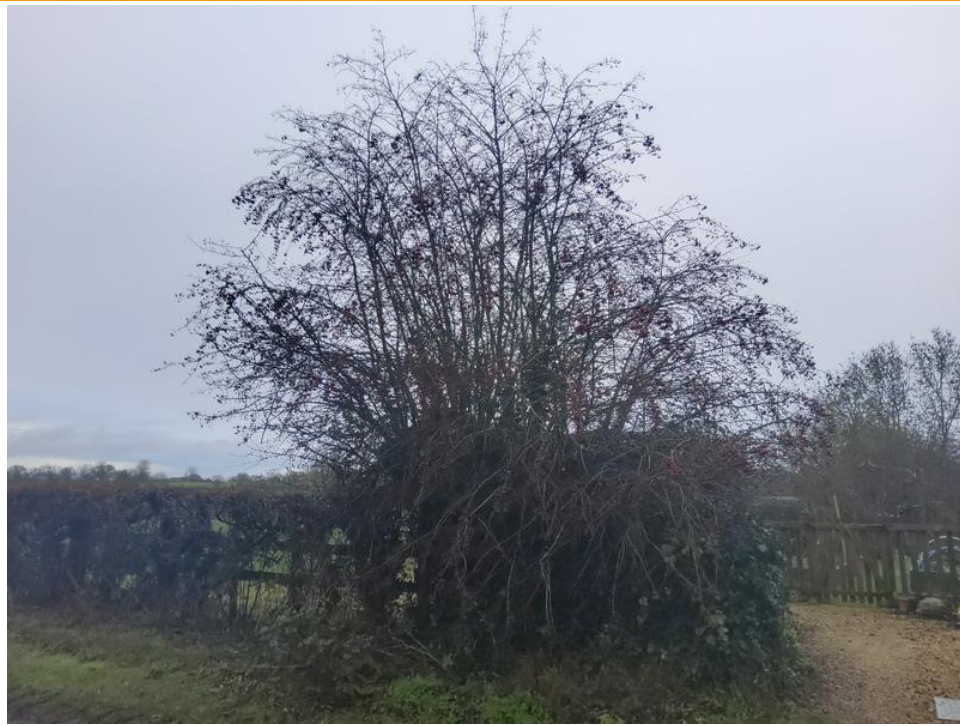
T4 Hawthorn

| Tree No: | Common Name | Age Class | Condition | Height (m) | Crown Spread (m) | Stem diam. (mm) | No. of Stems | Dist to bldg. (m) | Roots Implicated | Pruning History | Recommendation | Tree Work Constraints | Notes | Owner address | Owner |
|---|---|---|---|---|---|---|---|---|---|---|---|---|---|---|---|
| T4 | Hawthorn | Mature | Fair | 5.50 | 4.50 | 125 | 5 | 8.50 | Unavailable | Subject to historic crown reduction management. | Fell and treat stump with eco plugs (broadleaved). | There are restrictions to the site or to the tree - contractor should quote. Located on boundary and adjacent to fenced off oil tank area. | Some measurements estimated due to limited access. Distance is to closest point to property. Tree covered in ivy. Approximate DBH range of 75mm - 150mm. . | Meadow View Cottage<br>Vicarage Lane<br>Charlton<br>Malmesbury<br>SN16 9DW | PH |

| Tree No: | Species | Works Required | CA | TPO | Ownership |
|---|---|---|---|---|---|
| T4 | Hawthorn | Fell and treat stump with eco plugs (broadleaved). | Yes | No | PH |

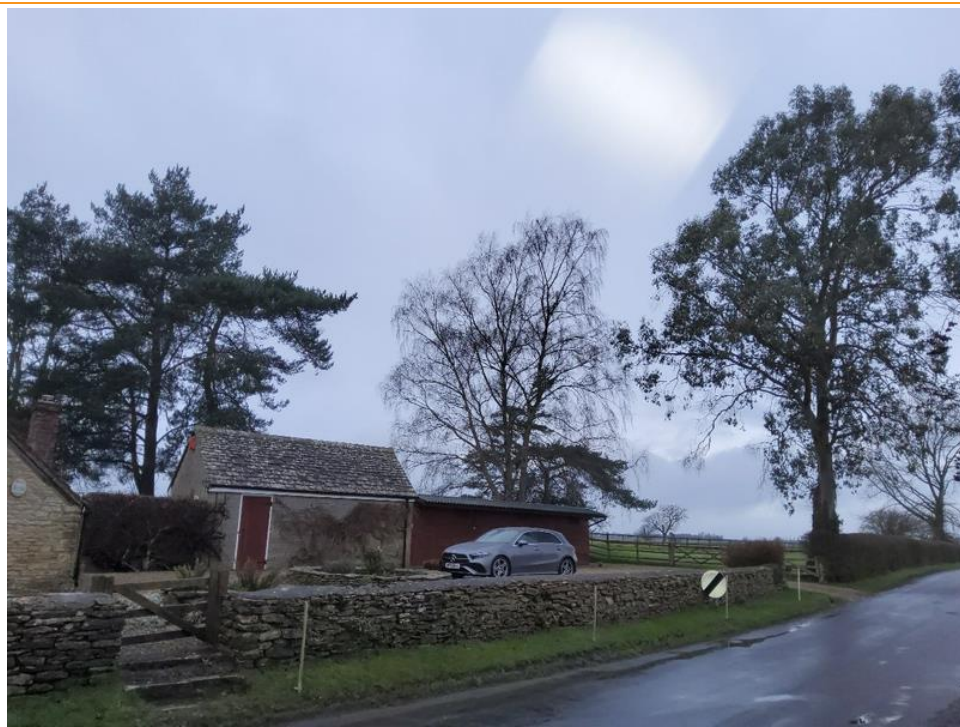
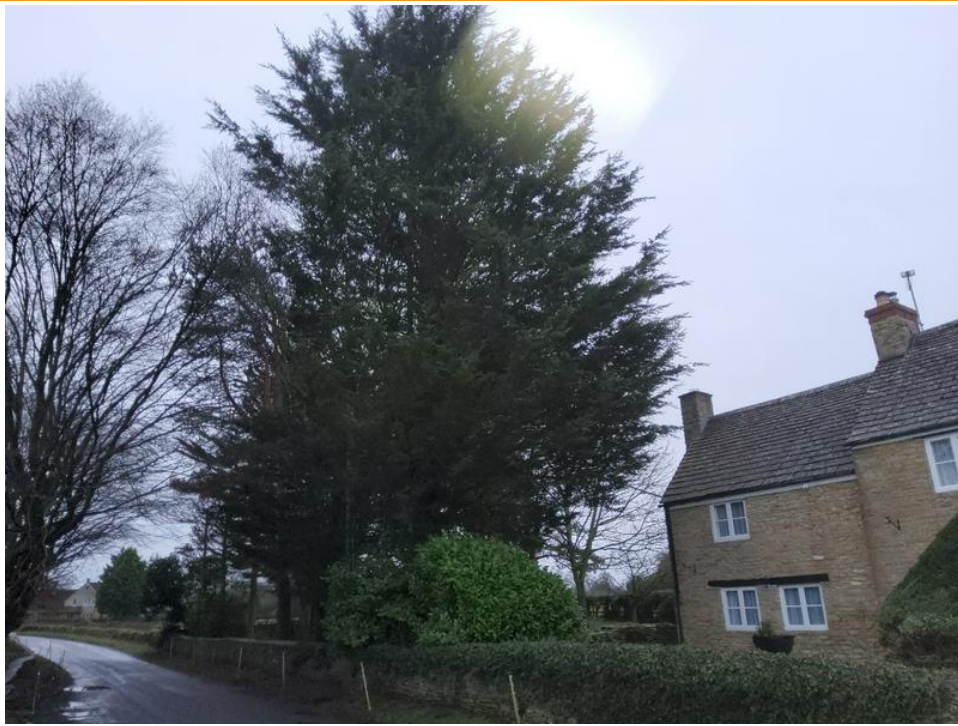
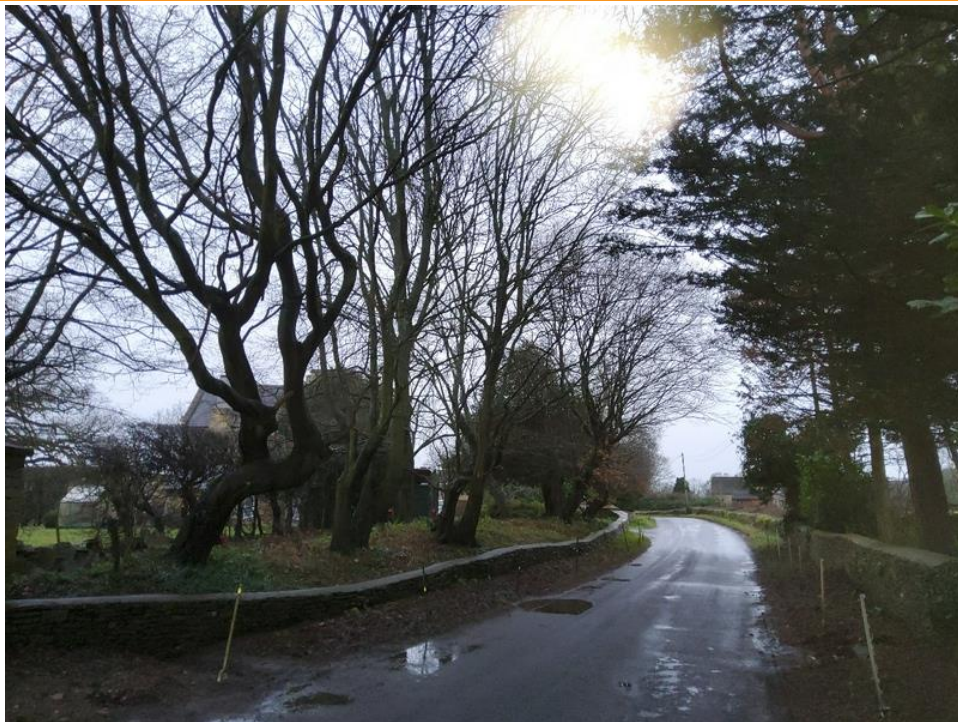
Further vegetation observed to front of property however outside expected influencing distance at point of survey.

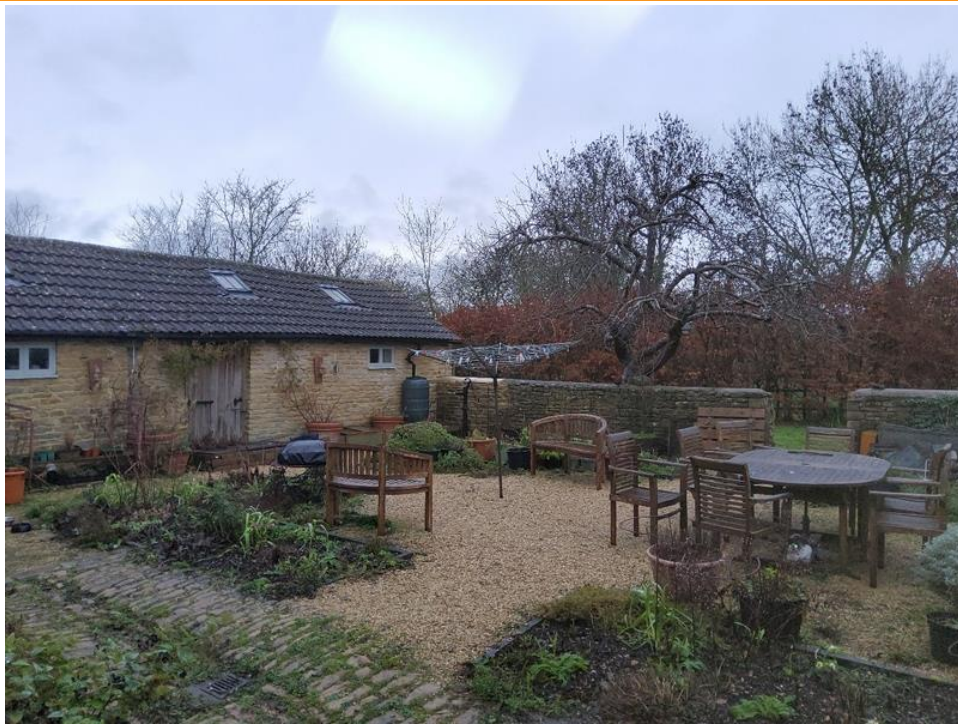
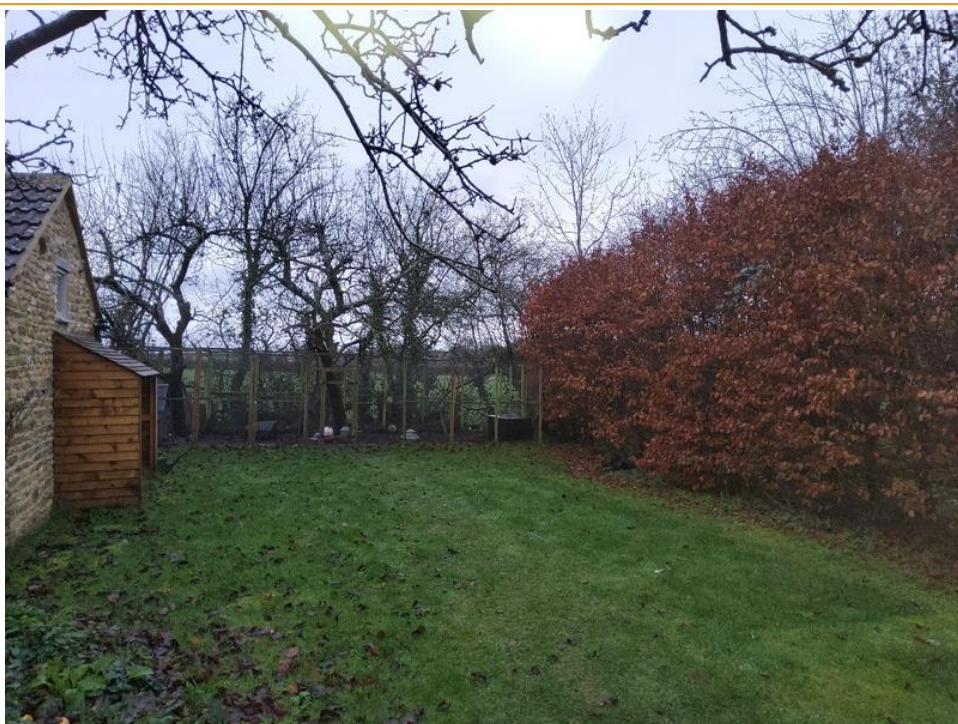
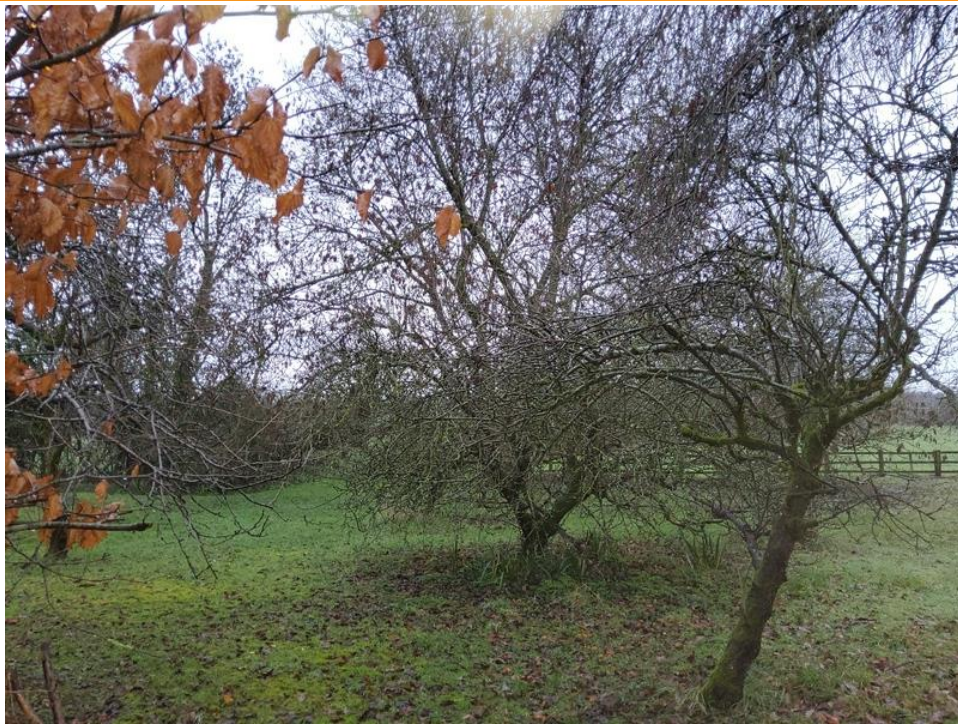
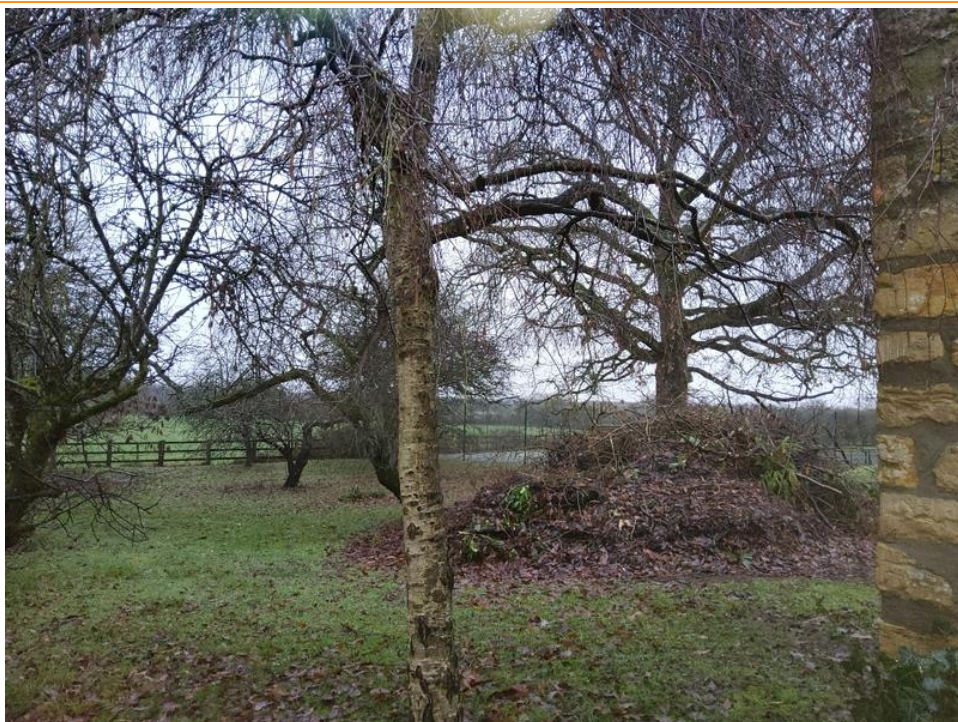
Further vegetation observed to rear of property however outside expected influencing distance for observed damage but greater management going forwards is advised.

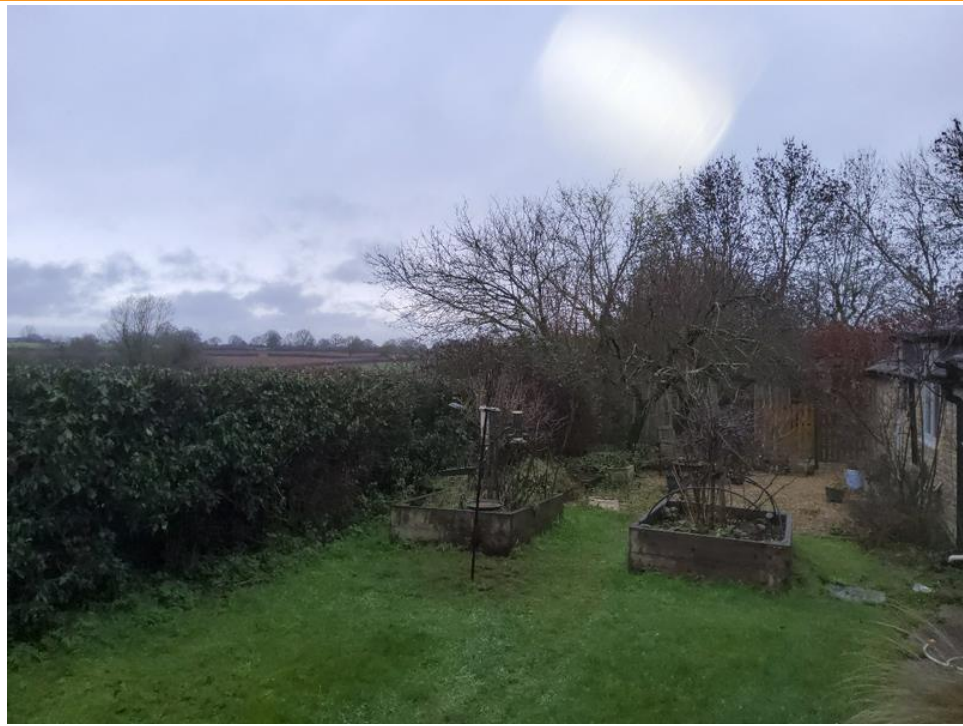
Minimal vegetation observed to LHS of property however considered outside expected influencing distance for observed damage at point of survey.
