**INSURANCE CLAIM: ENGINEERING APPRAISAL REPORT**

Situation of Damage: Meadow View, Vicarage Lane, Charlton, MALMESBURY, Wiltshire, SN16 9DW

Our Ref: 10857916

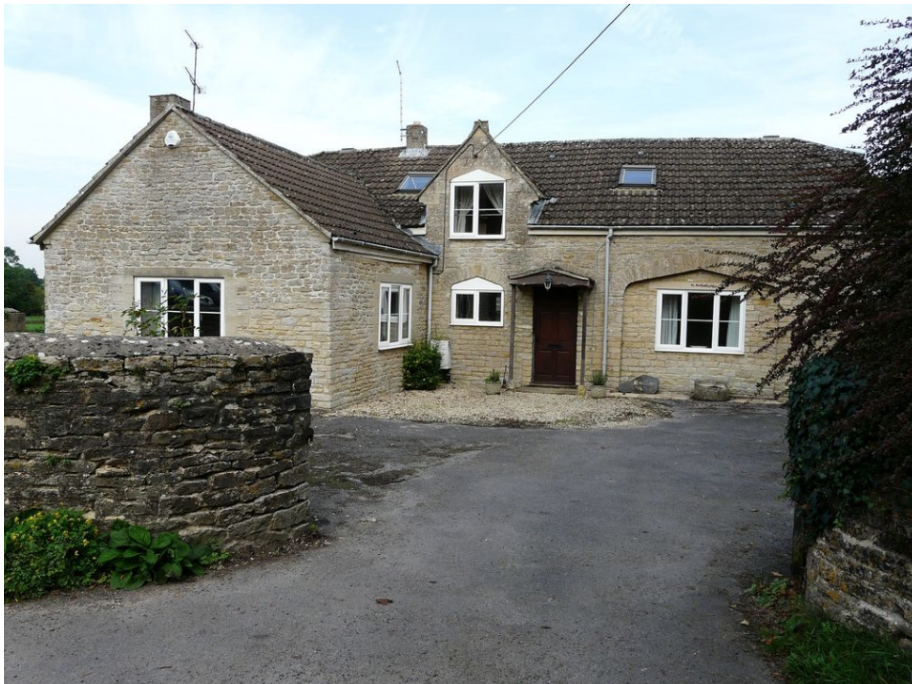
| Description and Mechanism | The main area of damage is to the front left-hand corner and takes the form of Stepped cracking to the external brick work which is reflected internally to the plastered walls and ceilings. |
| Significance | The level of damage is moderate, and is classified as category 3 in accordance with BRE Digest 251 - Assessment of damage in low-rise buildings. |

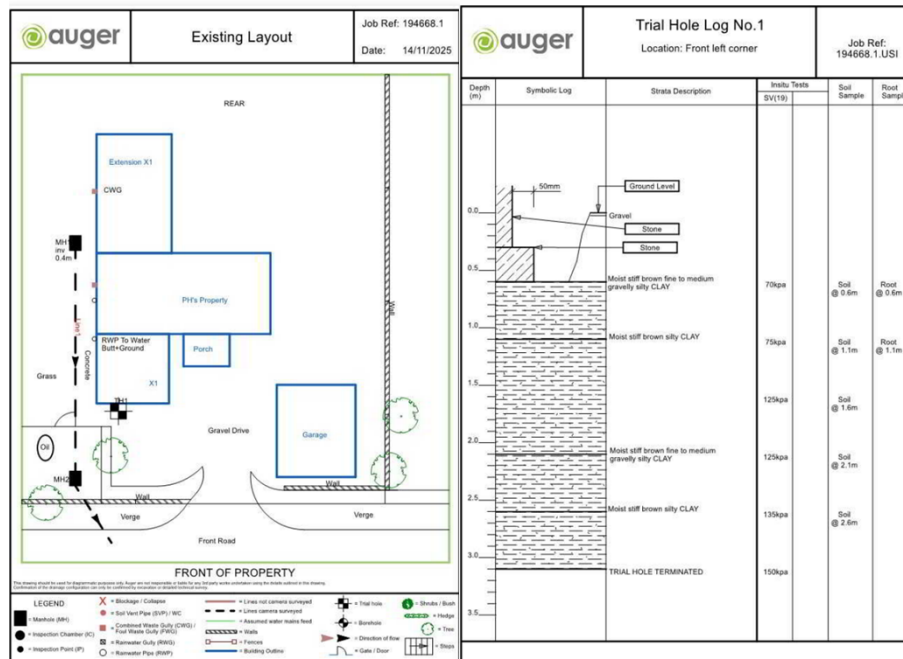
## SITE PLAN

A trial hole was excavated at the front left of the property to determine the foundation depth. The foundations comprise 300 mm of stonework which steps out a further 300 mm, giving a total foundation depth of 600 mm below ground level. The foundations bear onto moist, stiff, brown silty clay.

Root samples were collected at depths of 600 mm and 1100 mm. Laboratory analysis identified the roots as alive and attributable to ROSOIDEAE, HEDERA and FATSIA groups, which include common shrub and vine species such as brambles, roses, and ivy.

A CCTV survey was undertaken on the drainage system located to the left of the manhole. No defects were identified that could result in water escape or contribute to ground movement.
