# PRELIMINARY ARBORICULTURAL REPORT

Chafyns Boar Street, Mere, Warminster BA12 6DD

Client: Sedgwick International UK  
Insurer: Admiral Insurance

PRI Ref: 342114

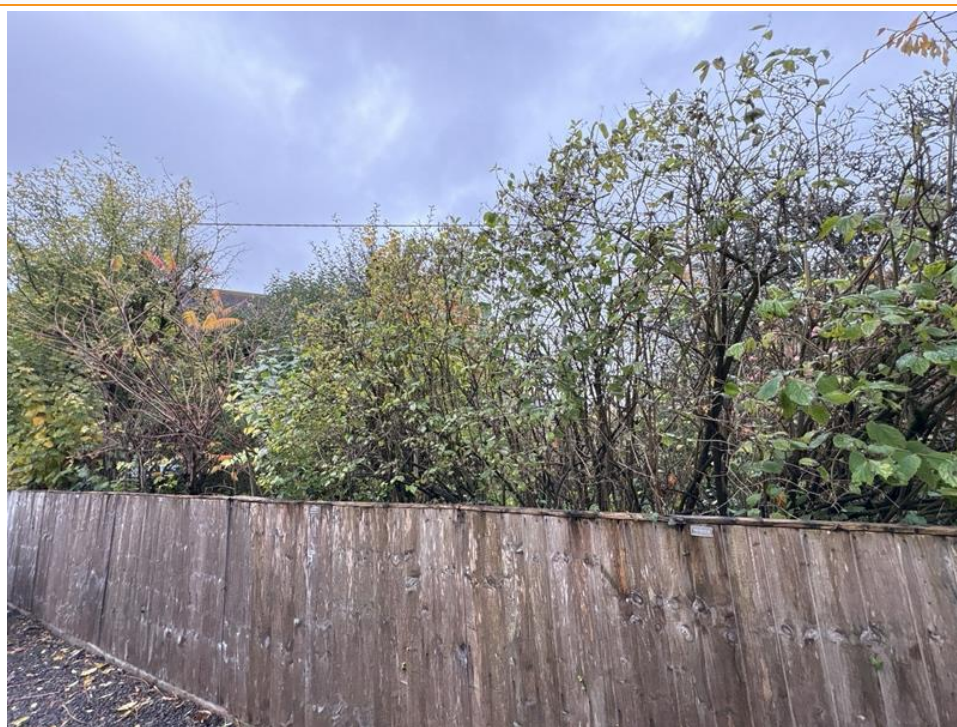
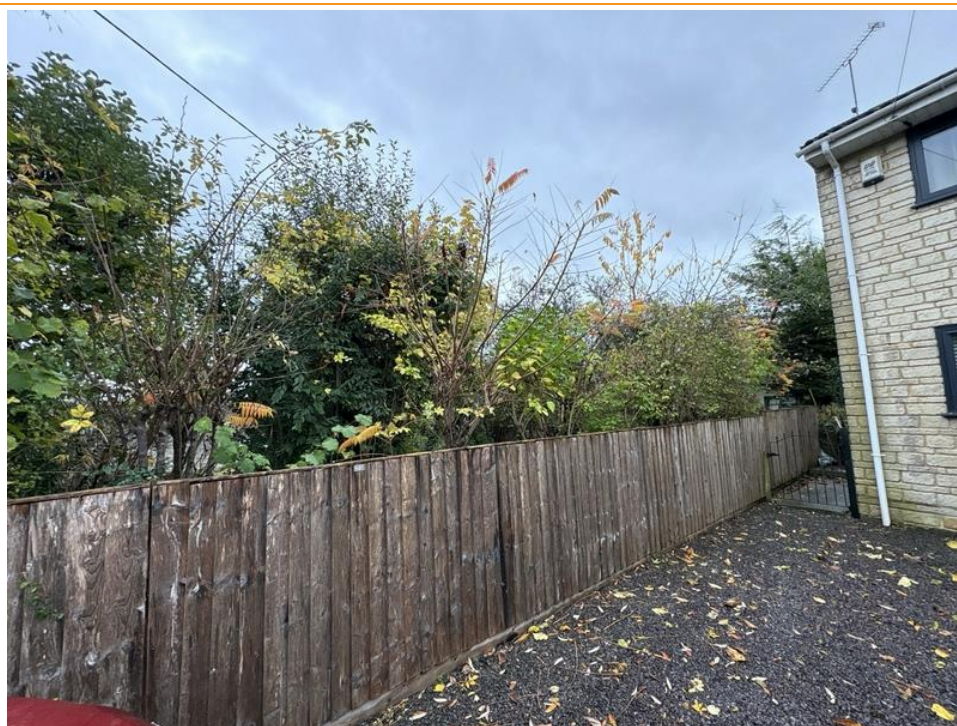
| Tree No: | Common Name | Age Class | Condition | Height (m) | Crown Spread (m) | Stem diam. (mm) | No. of Stems | Dist to bldg. (m) | Roots Implicated | Pruning History | Recommendation | Tree Work Constraints | Notes | Owner address | Owner |
|---|---|---|---|---|---|---|---|---|---|---|---|---|---|---|---|
| SG1 | Mixed species shrubs | Early Mature | Fair | 2.50 | 1.50 | 25 | 20 | 1.20 | Unavailable | Subject to historic crown reduction management. | Remove all vegetation within 3m of property. | The third party may be responsible for works. | Group includes Hazel, Rose, Sumac, Lilac, Mock Orange and Rowan. Stem count and diameter range from 5mm-100mm. | Haven Mere, Boar Street, Mere BA12 6DD | P3P |

SG1 Mixed species shrubs

| Tree No: | Species | Works Required | CA | TPO | Ownership |
|---|---|---|---|---|---|
| SG1 | Mixed species shrubs | Remove all vegetation within 3m of property. | Yes | No | P3P |

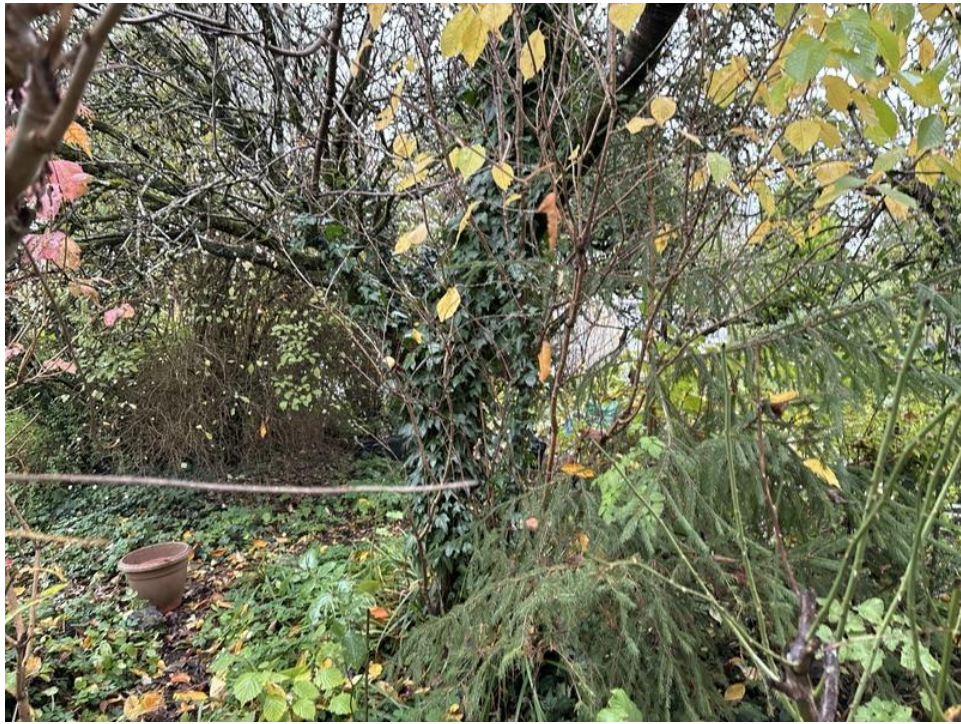
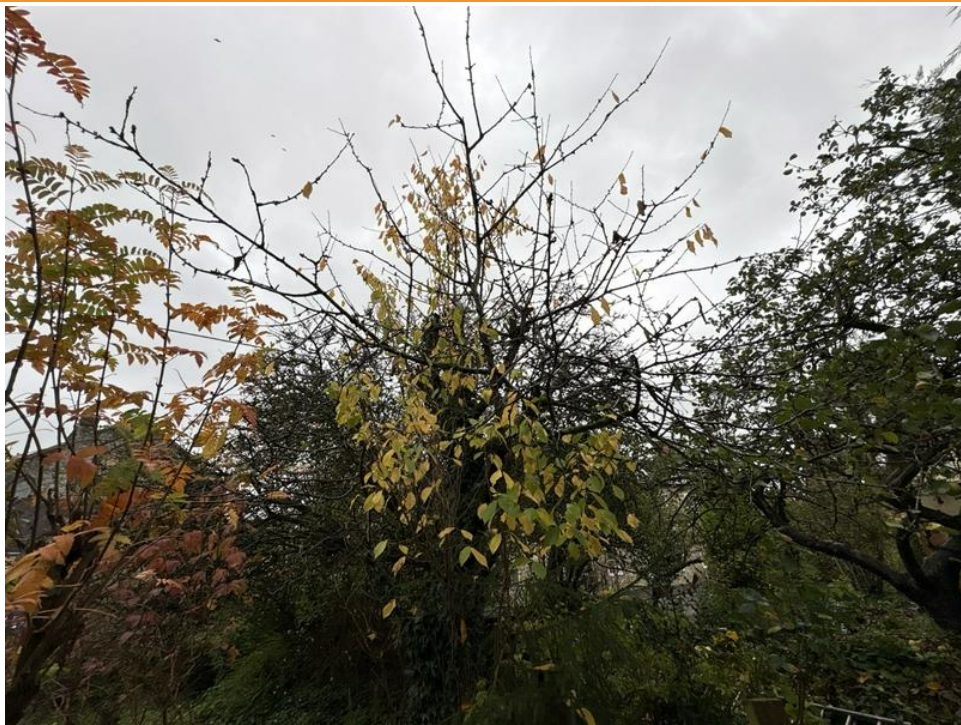
| Tree No: | Common Name | Age Class | Condition | Height (m) | Crown Spread (m) | Stem diam. (mm) | No. of Stems | Dist to bldg. (m) | Roots Implicated | Pruning History | Recommendation | Tree Work Constraints | Notes | Owner address | Owner |
|---|---|---|---|---|---|---|---|---|---|---|---|---|---|---|---|
| T3 | Cherry | Early Mature | Fair | 6.00 | 6.50 | 200 | 1 | 4.30 | Unavailable | Subject to historic crown reduction management. | Fell and treat stump with eco plugs (broadleaved). | The third party may be responsible for works. | Stem diameter estimated. | Haven Mere, Boar Street, Mere BA12 6DD | P3P |

T3 Cherry

| Tree No: | Species | Works Required | CA | TPO | Ownership |
|---|---|---|---|---|---|
| T3 | Cherry | Fell and treat stump with eco plugs (broadleaved). | Yes | No | P3P |

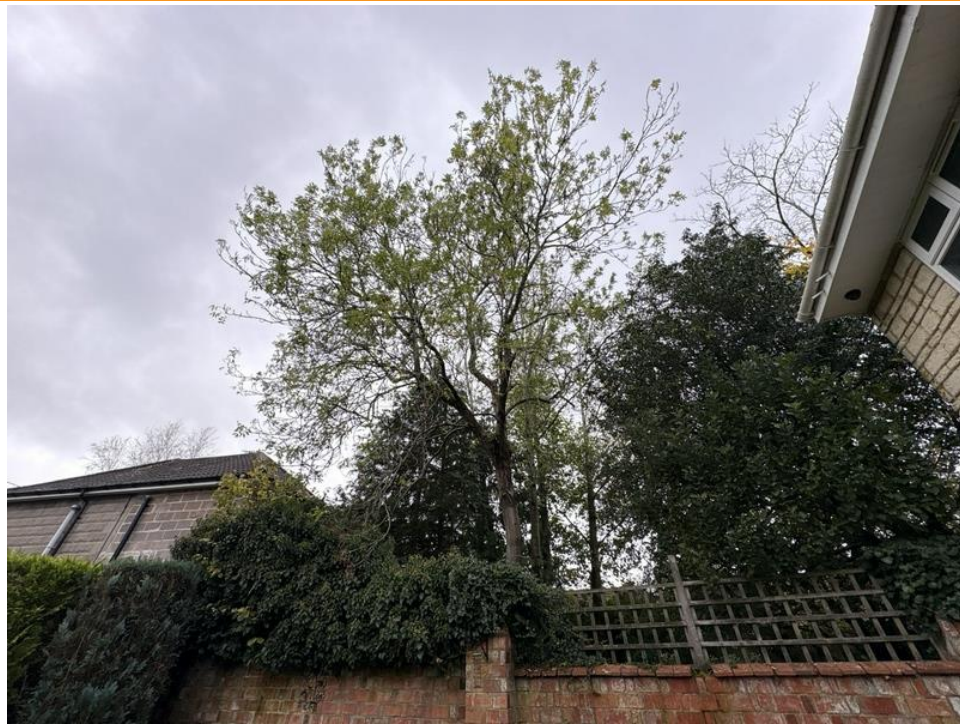
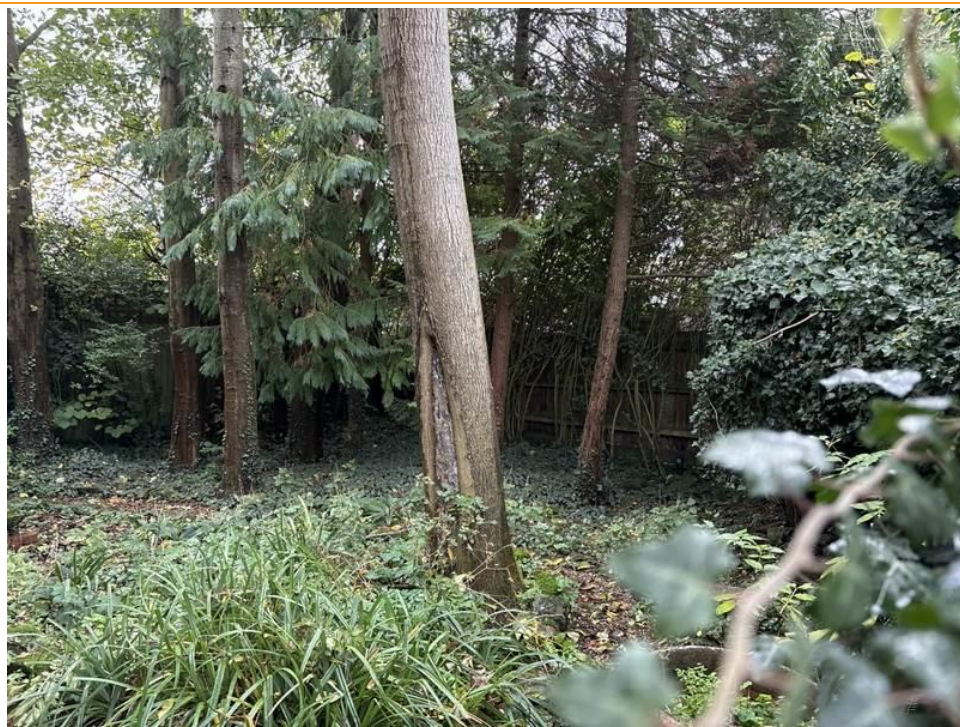
| Tree No: | Common Name | Age Class | Condition | Height (m) | Crown Spread (m) | Stem diam. (mm) | No. of Stems | Dist to bldg. (m) | Roots Implicated | Pruning History | Recommendation | Tree Work Constraints | Notes | Owner address | Owner |
|---|---|---|---|---|---|---|---|---|---|---|---|---|---|---|---|
| T9 | Ash | Mature | Fair | 15.00 | 12.00 | 400 | 1 | 7.50 | Unavailable | No significant past works. | Fell and treat stump with eco plugs (broadleaved). | The third party may be responsible for works. | Stem diameter estimated. Large wound to main stem from ground level to 1.5m. | Sportsman's Lodge, Boar Street, Mere BA12 6DD | P3P |

T9 Ash

| Tree No: | Species | Works Required | CA | TPO | Ownership |
|---|---|---|---|---|---|
| T9 | Ash | Fell and treat stump with eco plugs (broadleaved). | Yes | No | P3P |

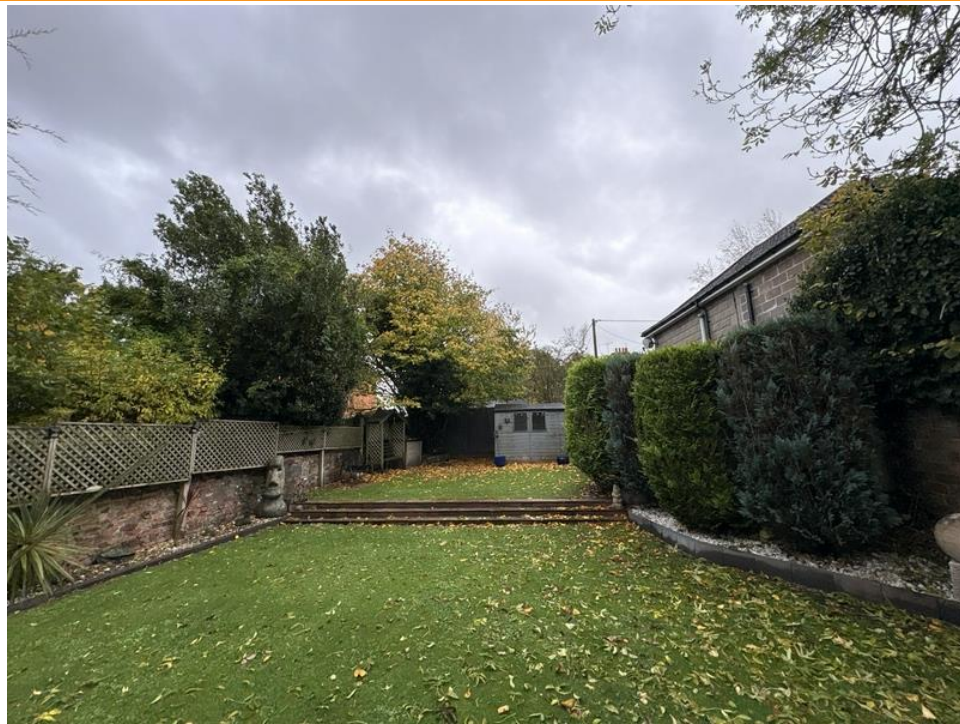
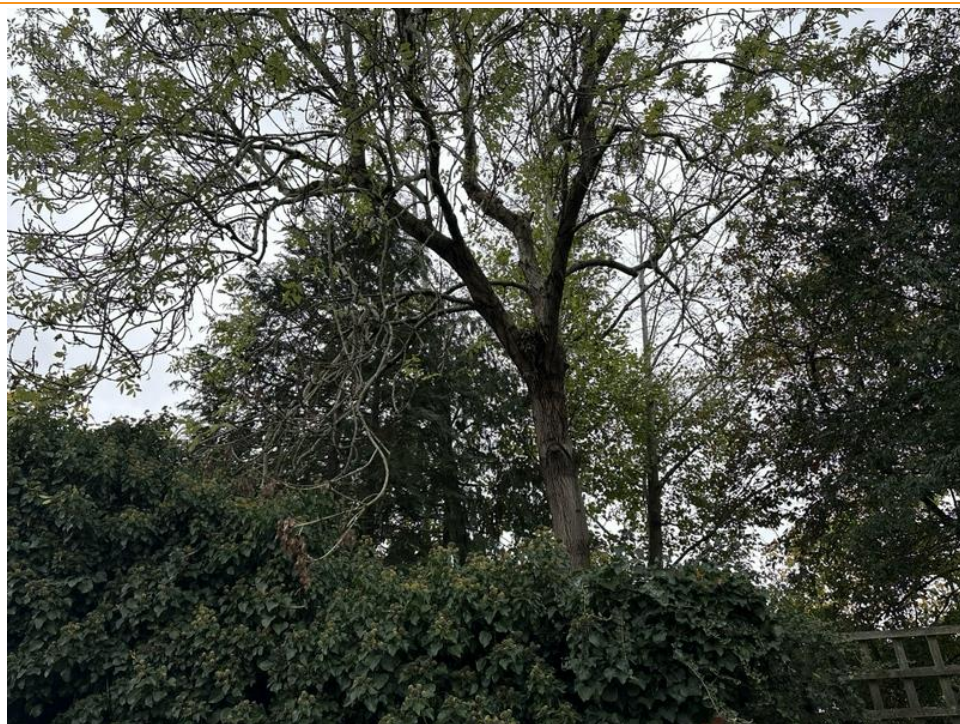
Further trees to rear outside of an expected influencing range

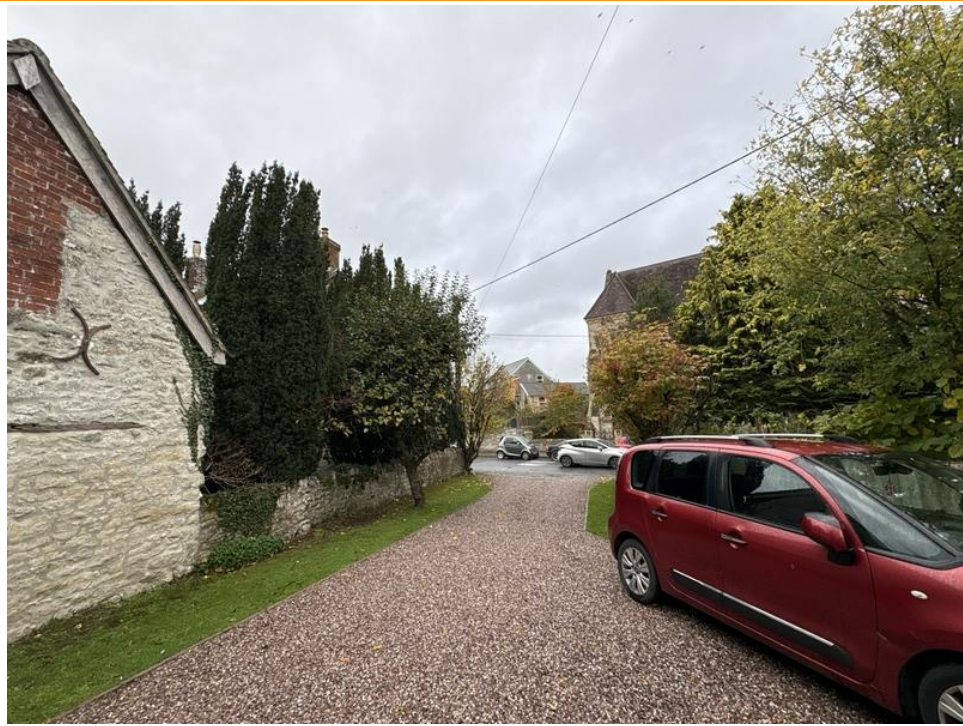
Further vegetation to front outside an expected influencing range

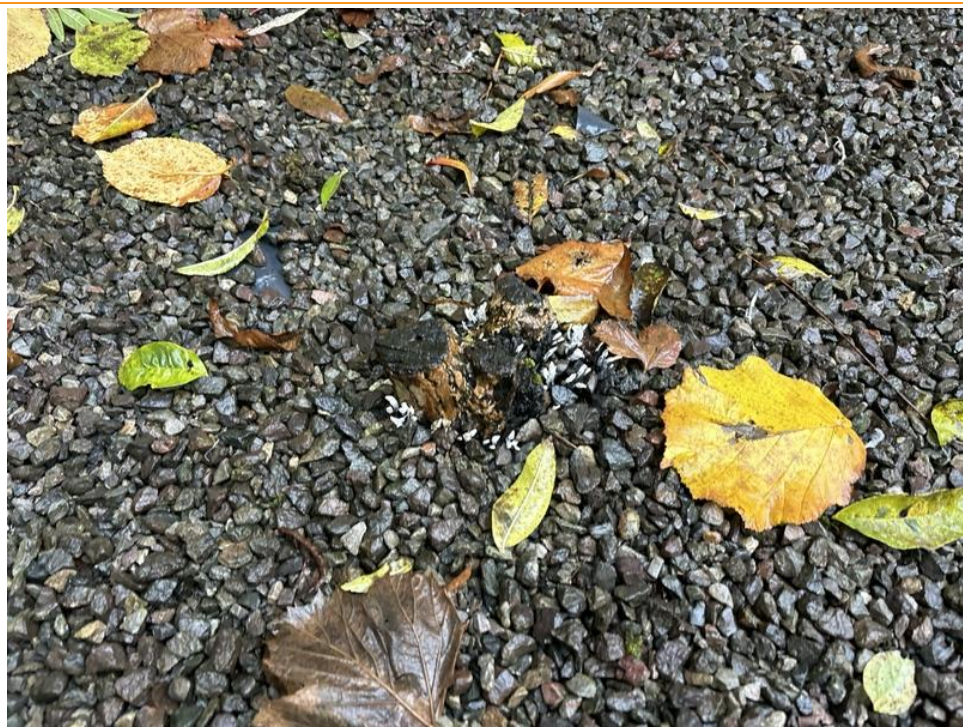
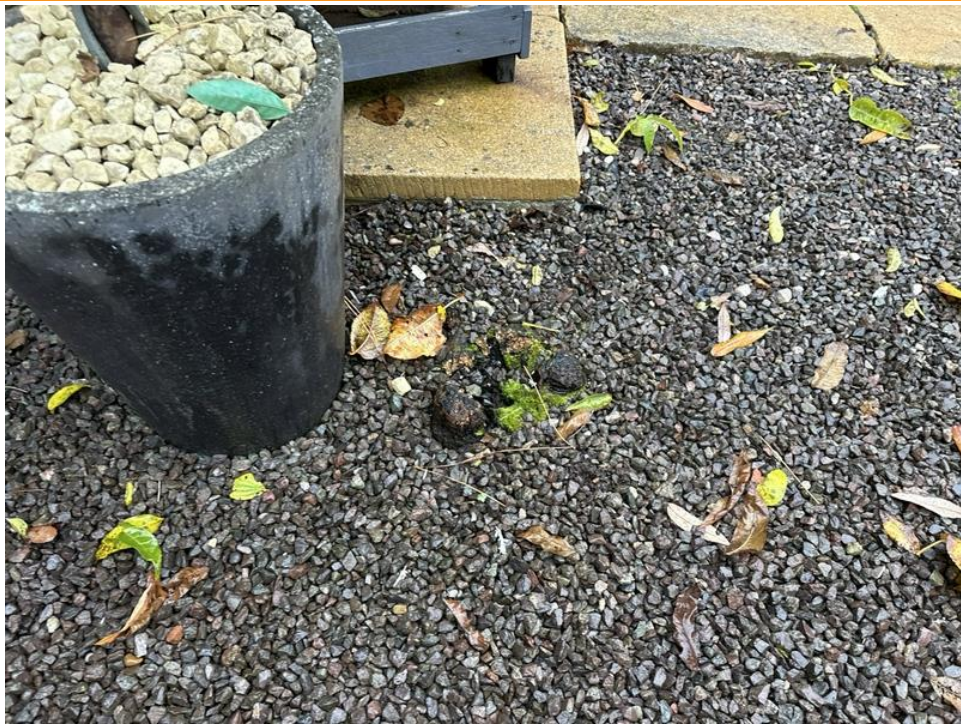
Small old, decayed stumps to front of property.
