# Arboricultural Consultancy for Aviva

| Insured | Mr & Mrs Stephen & Christina Wood | Address | 32 Amour Acre, Trowbridge, Wiltshire, BA14 7BU | | |
| ES Ref | SA-256416 | Consultant | Simon Nash | Contact No. | 0330 380 1036 |

**Scope of Report:** To survey the property and determine significant vegetation contributing to subsidence damage, make recommendation for remedial action and assess initial mitigation and recovery prospects. The survey does not make an assessment for decay or hazard evaluation.

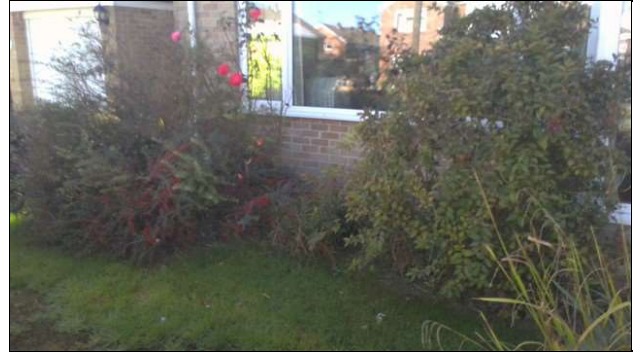
SG2 - Mixed species shrubs

Please note that the footing of the insured property fall within the anticipated rooting distance of additional vegetation which we believe presents a foreseeable risk of future damage and accordingly we have made recommendations in respect of this.

| Tree No. | Species | Age Cat | Approx. Height (m) | Distance to Building (m) * | Ownership | Action | Requirement |
|---|---|---|---|---|---|---|---|
| SG2 | Mixed species shrubs: broadly consisting of Rose, Spirea and Weigela | 1 | 2 | 1 | C - Insured | Action to avoid future risk | Maintain at broadly current dimensions by way of regular pruning. |

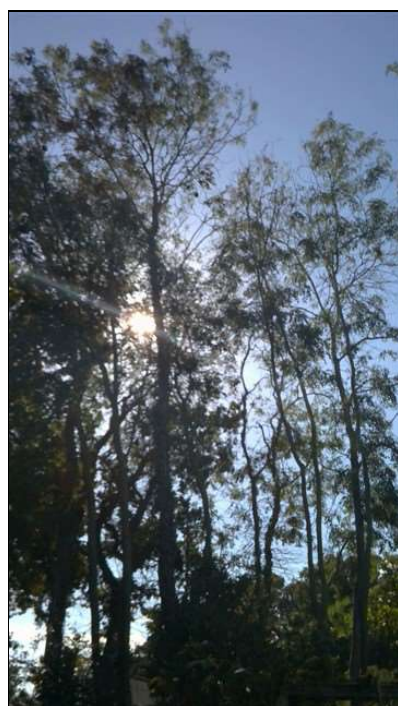
With due regards to species profile, size and proximity, the Ash group (TG2) is considered the dominant feature proximate to

the focal area(s) of movement and accordingly, where vegetation is confirmed as being causal, we have identified it as the primary cause of the current subsidence damage.

The size and proximity of the above vegetation is consistent with the advised location(s) of damage and it is our opinion, on balance of probability, that roots from the above vegetation will be in proximity to the footings of the insured property.

Consequently, we have advocated the complete removal of TG2 as it will offer the most certain arboricultural solution likely to restore long-term stability.

Whilst it is accepted that pruning in accordance with BRE IP7/06 (and if repeated on a 3-year (max) basis) can be an alternative to removal, it is one with a high residual risk of future movement; in the context of the current claim we consider the above vegetation is too large and/or close for pruning to be viable in this instance.

| Tree No. | Species | Age Cat | Approx. Height (m) | Distance to Building (m) * | Ownership | Action | Requirement |
|---|---|---|---|---|---|---|---|
| TG2 | Ash | 2 | 22 | 12 | A - Third Party | Remove | Remove close to ground level; do not treat stump(s) due to translocation risk. Where such a risk exists, we advise that any emergent regrowth is removed annually. |

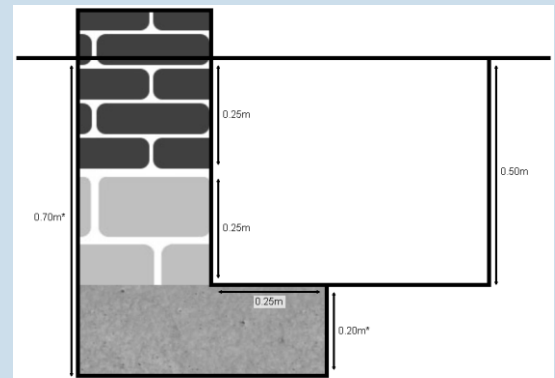
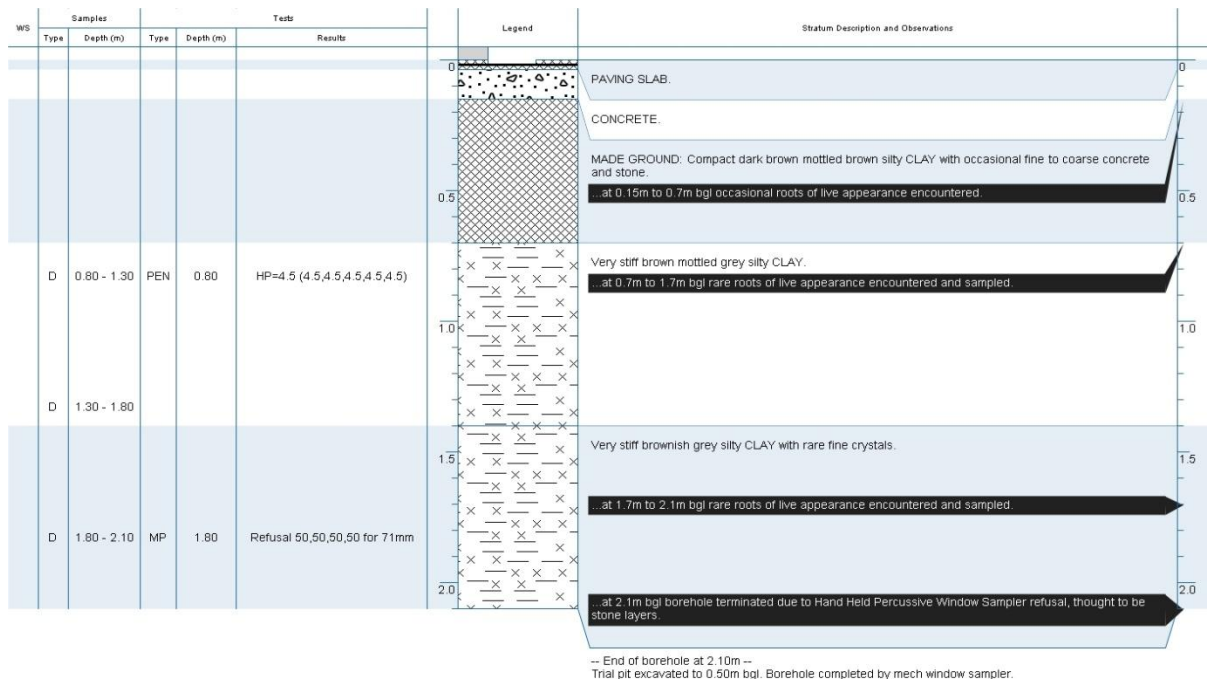
## TP/BH1 Foundation Detail and Borehole Log

House foundation comprised of blockwork wall to 500mm bgl, bearing on concrete to an estimated depth of 700mm bgl, with a total projection of 250mm from the elevation. Underside of foundation (USF) was estimated by pushing a probe, approximately 120mm back from the face of the foundation, at an angle with no apparent contact with the face of the foundation beyond the estimated depth.

At 2.1m bgl borehole terminated due to Hand Held Percussive Window Sampler refusal, thought to be stone layers in TP/BH1. At 2.2m bgl borehole terminated due to Hand Held Percussive Window Sampler refusal, thought to be stone layers in TP/BH2.

At 0.15m to 0.7m bgl occasional roots of live appearance encountered in TP/BH1. At 0.7m to 1.7m bgl rare roots of live appearance encountered and sampled in TP/BH1. At 1.7m to 2.1m bgl rare roots of live appearance encountered and sampled in TP/BH1. At 0.2m to 0.8m bgl occasional roots of live appearance encountered in TP/BH2. At 0.8m to 1.8m bgl rare roots of live appearance encountered and sampled in TP/BH2. At 1.8m to 2.2m bgl rare roots of live appearance encountered and sampled in TP/BH2.

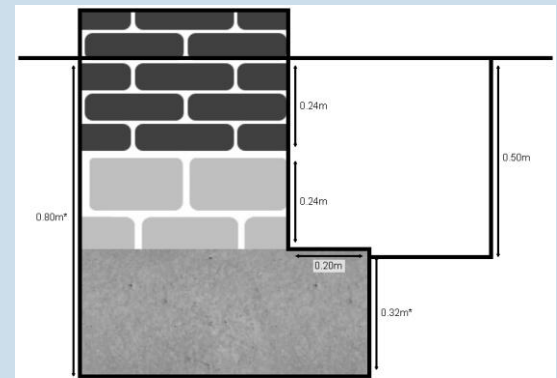
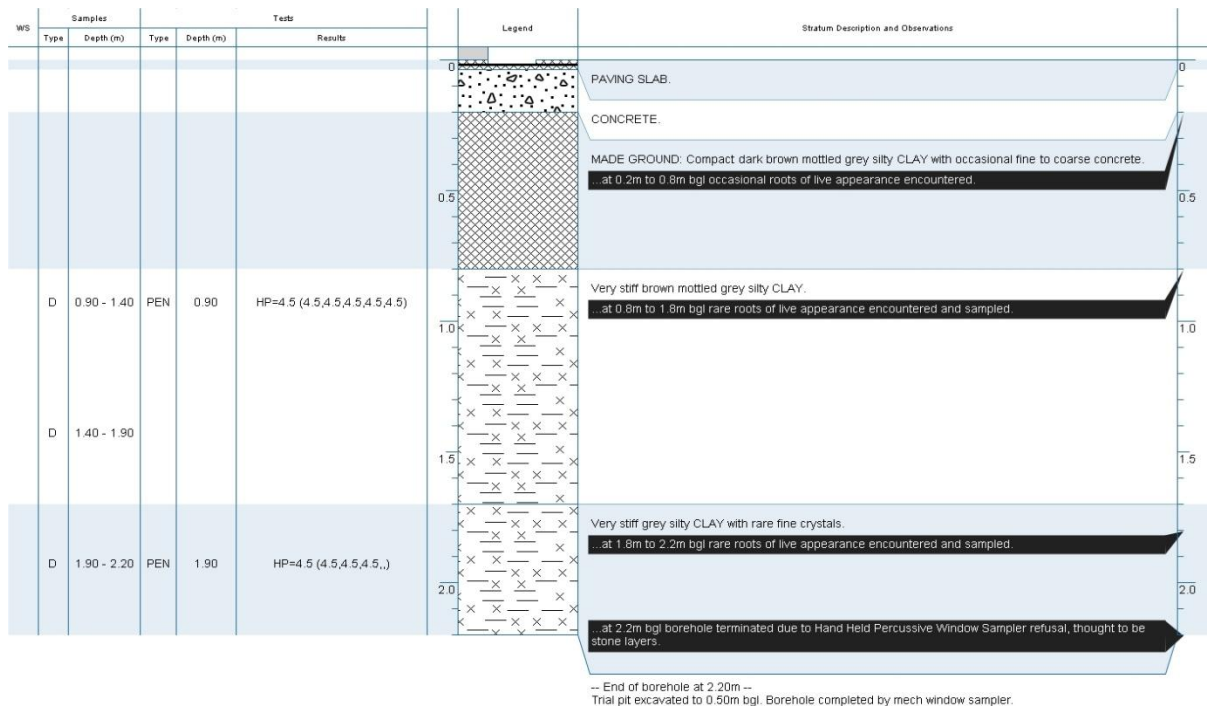
## TP/BH2 Foundation Detail and Borehole Log

House foundation comprised of blockwork wall to 500mm bgl, bearing on concrete to an estimated depth of 800mm bgl, with a total projection of 200mm from the elevation. Underside of foundation (USF) was estimated by pushing a probe, approximately 150mm back from the face of the foundation, at an angle with no apparent contact with the face of the foundation beyond the estimated depth.
