Our Ref: 18067/EO/RPT/02/01  
Date: July 2025

**Re: 18067 – Old Manor Farm, Wedhampton, SN10 3RR – Barn 2**

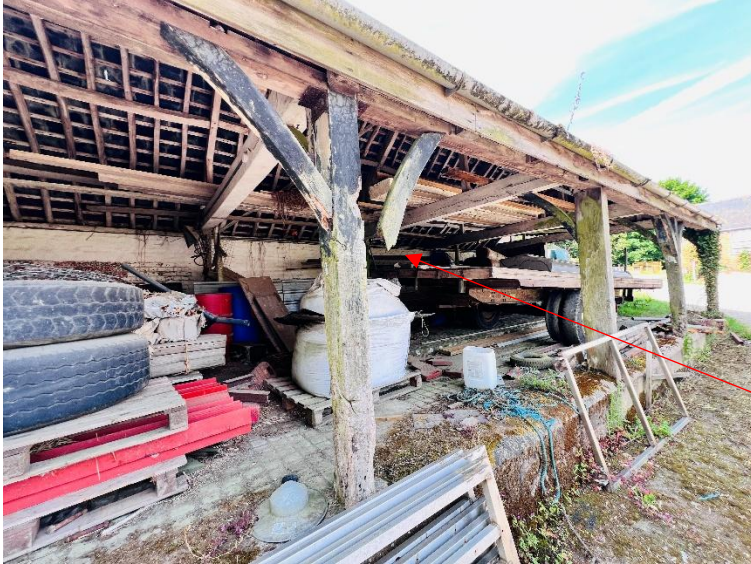
The knee-brace joint has failed at the front elevation and needs localised replacement of the timber braces at one joint.

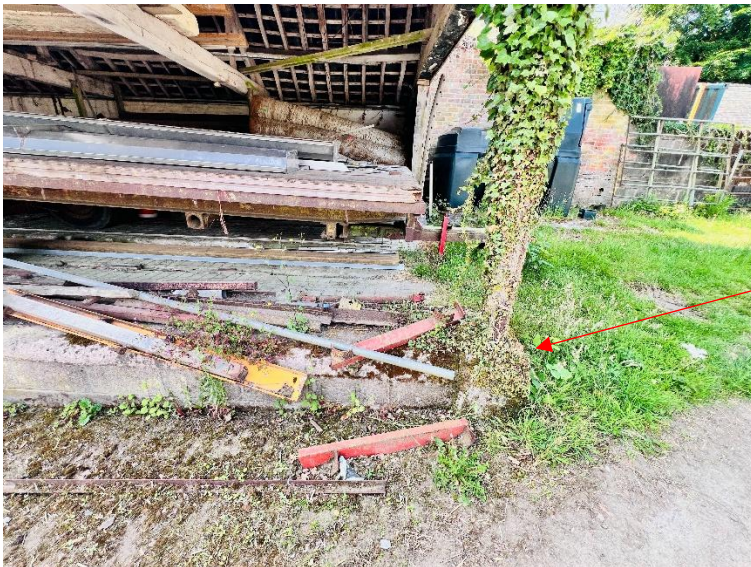
The corner post appears to have begun decaying at its base and should be replaced with a like-for-like upright element.
