Our Ref: 18067/EO/RPT/05/01  
Date: July 2025

**Re: 18067 – Old Manor Farm, Wedhampton, SN10 3RR – Barn 5**

### **Building 5:**

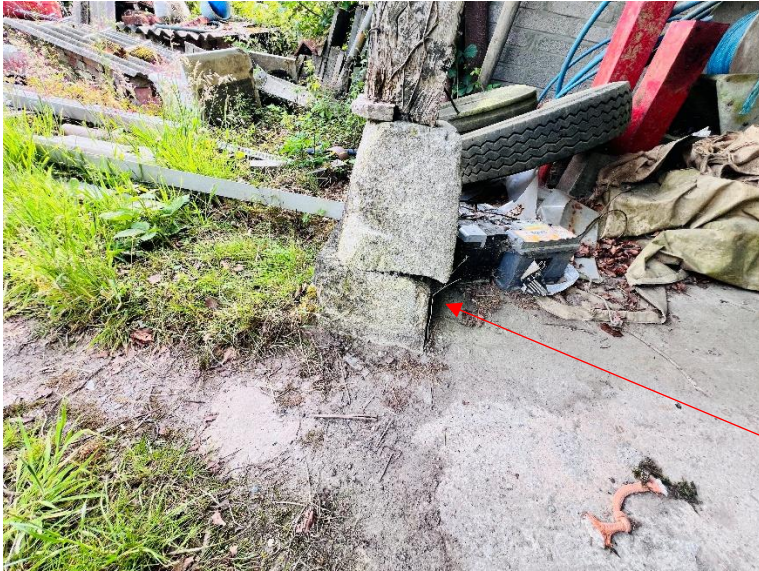
A supporting staddle stone at the front elevation was seen to be damaged and requires replacement.

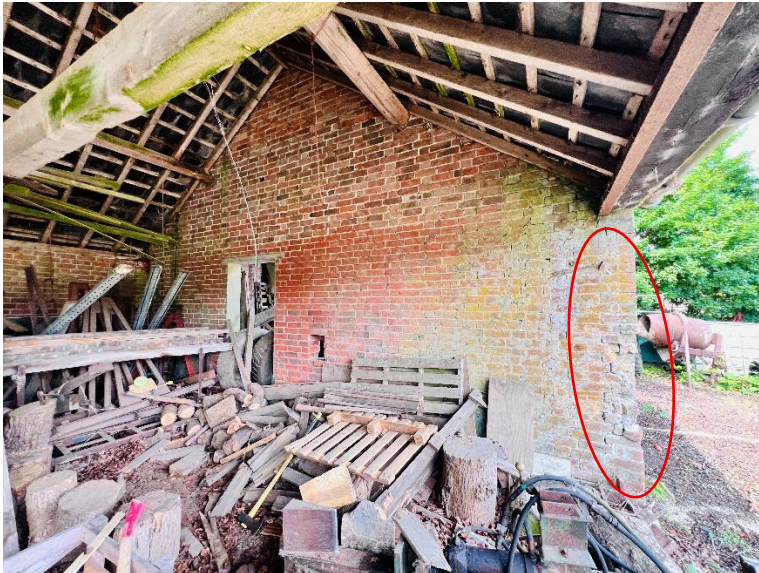
The brickwork at the gable end (front side) appears to be deteriorated and coming loose; this could do with localised replacement of the individual bricks and repointing in a bedding mortar of a suitable specification.
