# Arboricultural Consultancy for Aviva

| Insured | Mr & Mrs Stephen & Christina Wood | Address | 32 Amour Acre, Trowbridge, Wiltshire, BA14 7BU | | |
| ES Ref | SA-256416 | Consultant | Simon Nash | Contact No. | 0330 380 1036 |
| Report Date | 02/10/2025 | | | | |

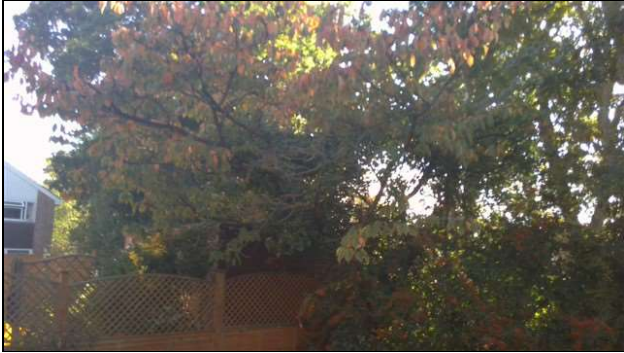
T1 - Cherry

| Tree No. | Species | Age Cat | Approx. Height (m) | Distance to Building (m) * | Ownership | Action | Requirement |
|---|---|---|---|---|---|---|---|
| T1 | Cherry | 1 | 4.5 | 7 | C - Insured | Action to avoid future risk | Maintain at, or below current dimensions by way of regular pruning. |

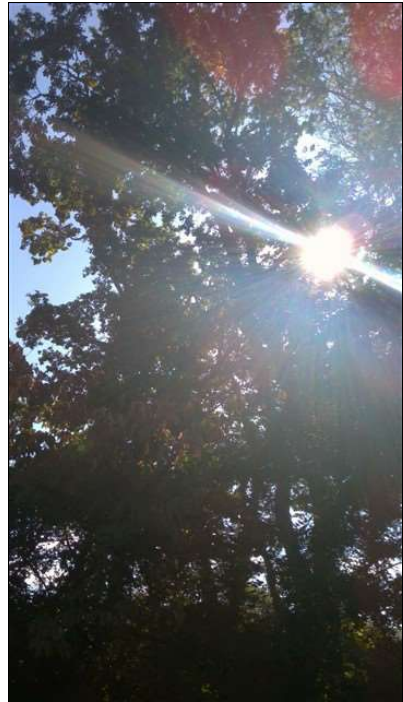
T5 - Oak

| Tree No. | Species | Age Cat | Approx. Height (m) | Distance to Building (m) * | Ownership | Action | Requirement |
|---|---|---|---|---|---|---|---|
| T5 | Oak | 2 | 18 | 15 | A - Third Party | Action to avoid future risk | Maintain at broadly current dimensions by way of regular pruning. |

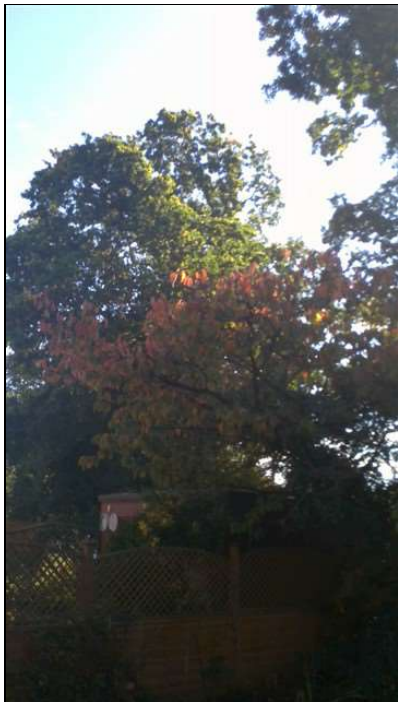
T6 - Oak

| Tree No. | Species | Age Cat | Approx. Height (m) | Distance to Building (m) * | Ownership | Action | Requirement |
|---|---|---|---|---|---|---|---|
| T6 | Oak | 3 | 18 | 21 | A - Third Party | Action to avoid future risk | Maintain at broadly current dimensions by way of regular pruning. |

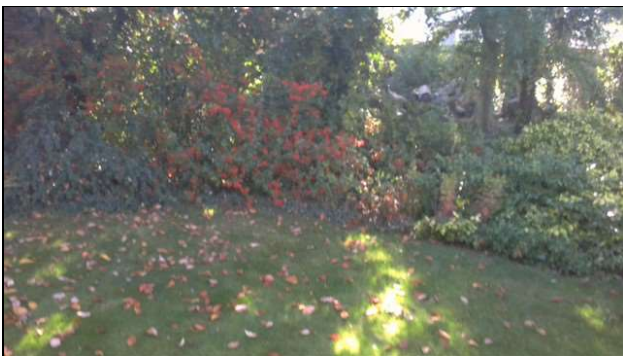
SG1 - Mixed species shrubs

| Tree No. | Species | Age Cat | Approx. Height (m) | Distance to Building (m) * | Ownership | Action | Requirement |
|---|---|---|---|---|---|---|---|
| SG1 | Mixed species shrubs: Pyracantha and Euonymus group | 1 | 1 | 7 | C - Insured | No action | No works. |

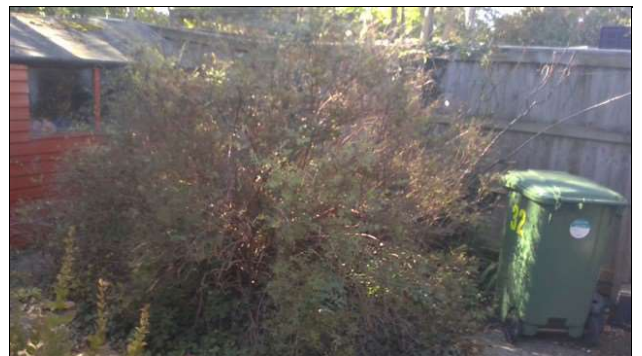
S1 - Shrub

| Tree No. | Species | Age Cat | Approx. Height (m) | Distance to Building (m) * | Ownership | Action | Requirement |
|---|---|---|---|---|---|---|---|
| S1 | Spirea | 1 | 1 | 4 | C - Insured | No action | No works. |

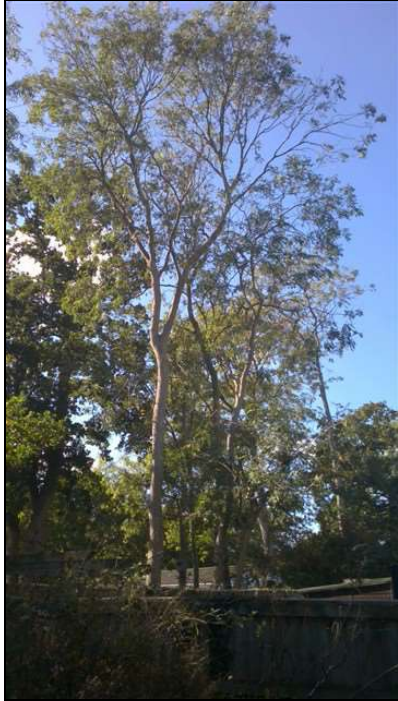
TG1 - Ash

| Tree No. | Species | Age Cat | Approx. Height (m) | Distance to Building (m) * | Ownership | Action | Requirement |
|---|---|---|---|---|---|---|---|
| TG1 | Ash | 2 | 22 | 18 | A - Third Party | Action to avoid future risk | Maintain at broadly current dimensions by way of regular pruning. |

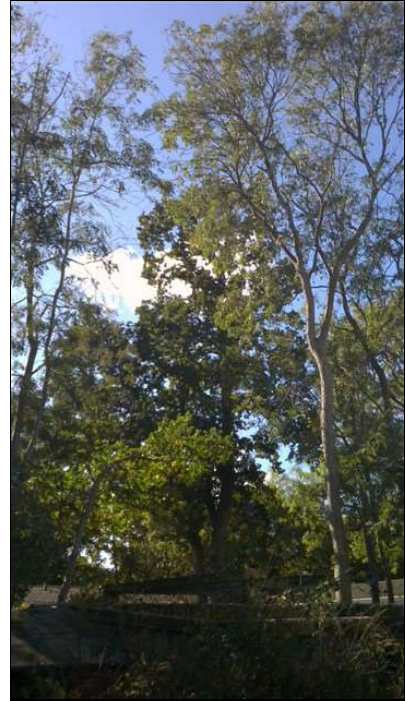
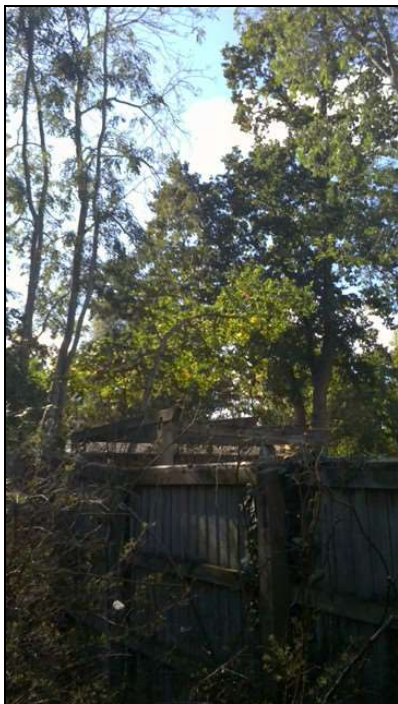
T2 - Oak

| Tree No. | Species | Age Cat | Approx. Height (m) | Distance to Building (m) * | Ownership | Action | Requirement |
|---|---|---|---|---|---|---|---|
| T2 | Oak | 3 | 22 | 25 | A - Third Party | Action to avoid future risk | Maintain at, or below current dimensions by way of regular pruning. |

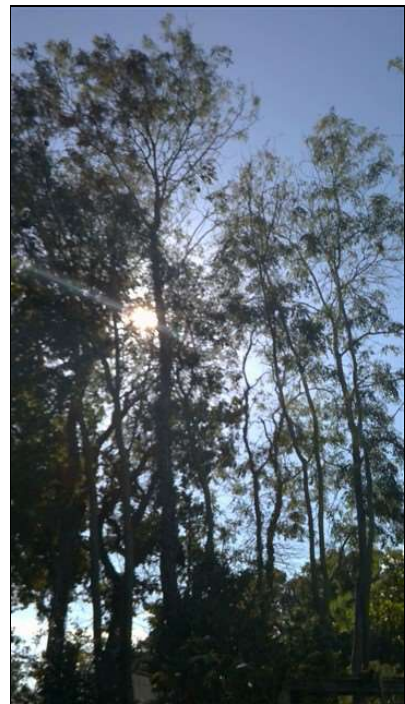
With due regards to species profile, size and proximity, the Ash group (TG2) is considered the dominant feature proximate to

the focal area(s) of movement and accordingly, where vegetation is confirmed as being causal, we have identified it as the primary cause of the current subsidence damage.

The size and proximity of the above vegetation is consistent with the advised location(s) of damage and it is our opinion, on balance of probability, that roots from the above vegetation will be in proximity to the footings of the insured property.

| Tree No. | Species | Age Cat | Approx. Height (m) | Distance to Building (m) * | Ownership | Action | Requirement |
|---|---|---|---|---|---|---|---|
| TG2 | Ash | 2 | 22 | 12 | A - Third Party | Remove | Remove close to ground level; do not treat stump(s) due to translocation risk. Where such a risk exists, we advise that any emergent regrowth is removed annually. |

Consequently, we have advocated the complete removal of TG2 as it will offer the most certain arboricultural solution likely to restore long-term stability.

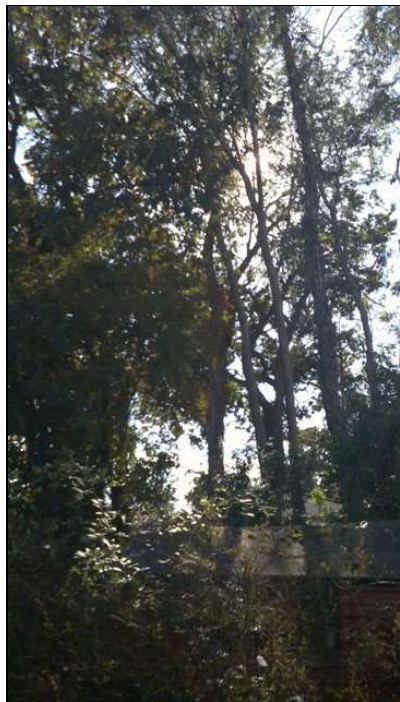
T3 - Oak

| Tree No. | Species | Age Cat | Approx. Height (m) | Distance to Building (m) * | Ownership | Action | Requirement |
|---|---|---|---|---|---|---|---|
| T3 | Oak | 2 | 11 | 16 | A - Third Party | Action to avoid future risk | Maintain at broadly current dimensions by way of regular pruning. |

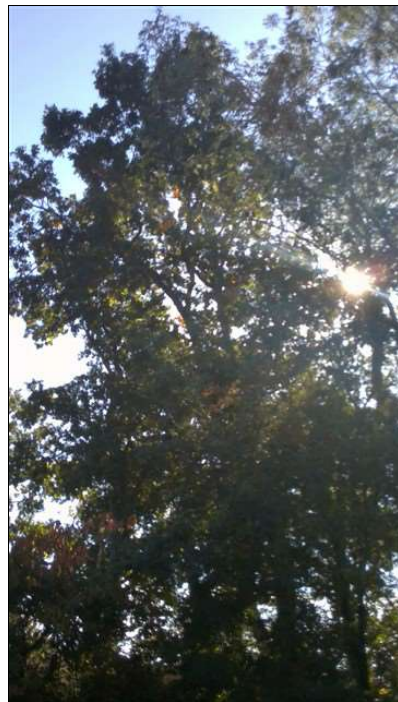
T4 - Oak

| Tree No. | Species | Age Cat | Approx. Height (m) | Distance to Building (m) * | Ownership | Action | Requirement |
|---|---|---|---|---|---|---|---|
| T4 | Oak | 2 | 14 | 15 | A - Third Party | Action to avoid future risk | Maintain at broadly current dimensions by way of regular pruning. |

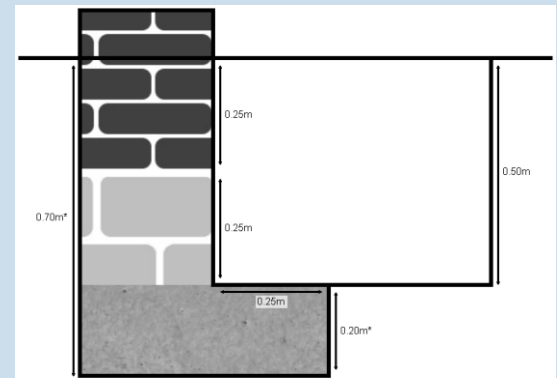
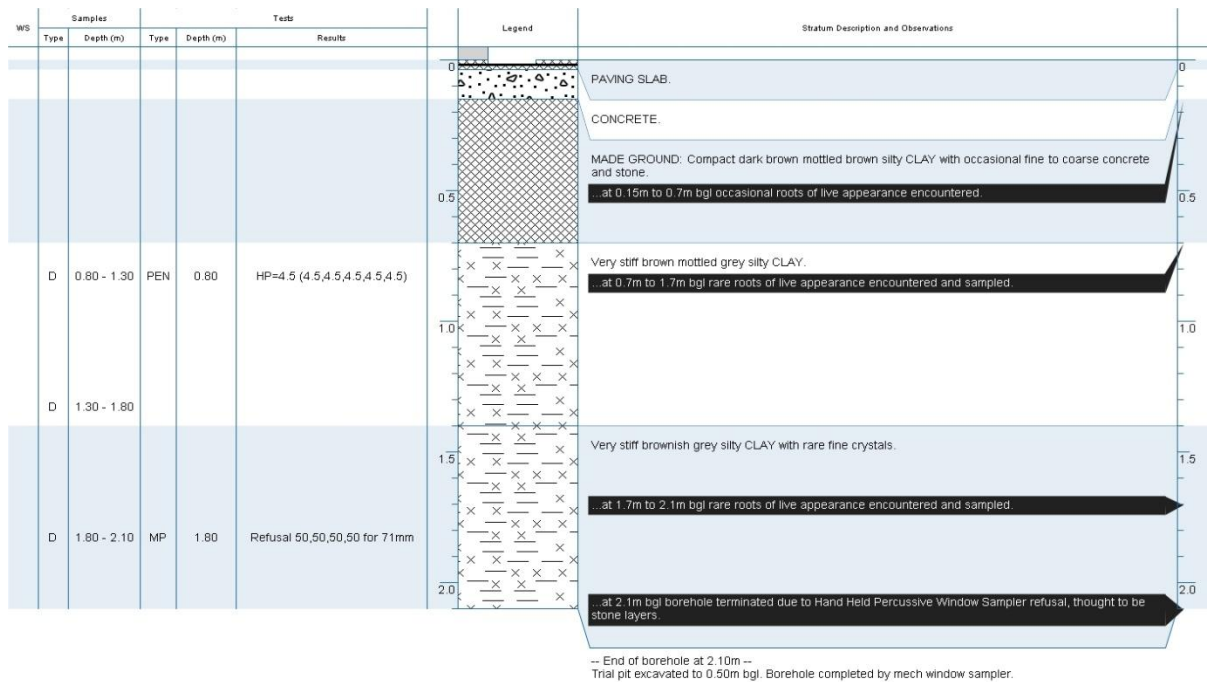
## TP/BH1 Foundation Detail and Borehole Log

House foundation comprised of blockwork wall to 500mm bgl, bearing on concrete to an estimated depth of 700mm bgl, with a total projection of 250mm from the elevation. Underside of foundation (USF) was estimated by pushing a probe, approximately 120mm back from the face of the foundation, at an angle with no apparent contact with the face of the foundation beyond the estimated depth.

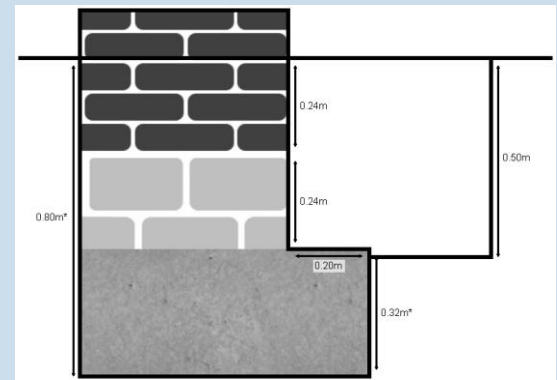
## TP/BH2 Foundation Detail and Borehole Log

House foundation comprised of blockwork wall to 500mm bgl, bearing on concrete to an estimated depth of 800mm bgl, with a total projection of 200mm from the elevation. Underside of foundation (USF) was estimated by pushing a probe, approximately 150mm back from the face of the foundation, at an angle with no apparent contact with the face of the foundation beyond the estimated depth.
