**76a Main Street,  
Keevil,  
BA14 6ND**

**Provisional Roost assessment  
(Phase 1 Bat survey)**

**17<sup>th</sup> January 2026**

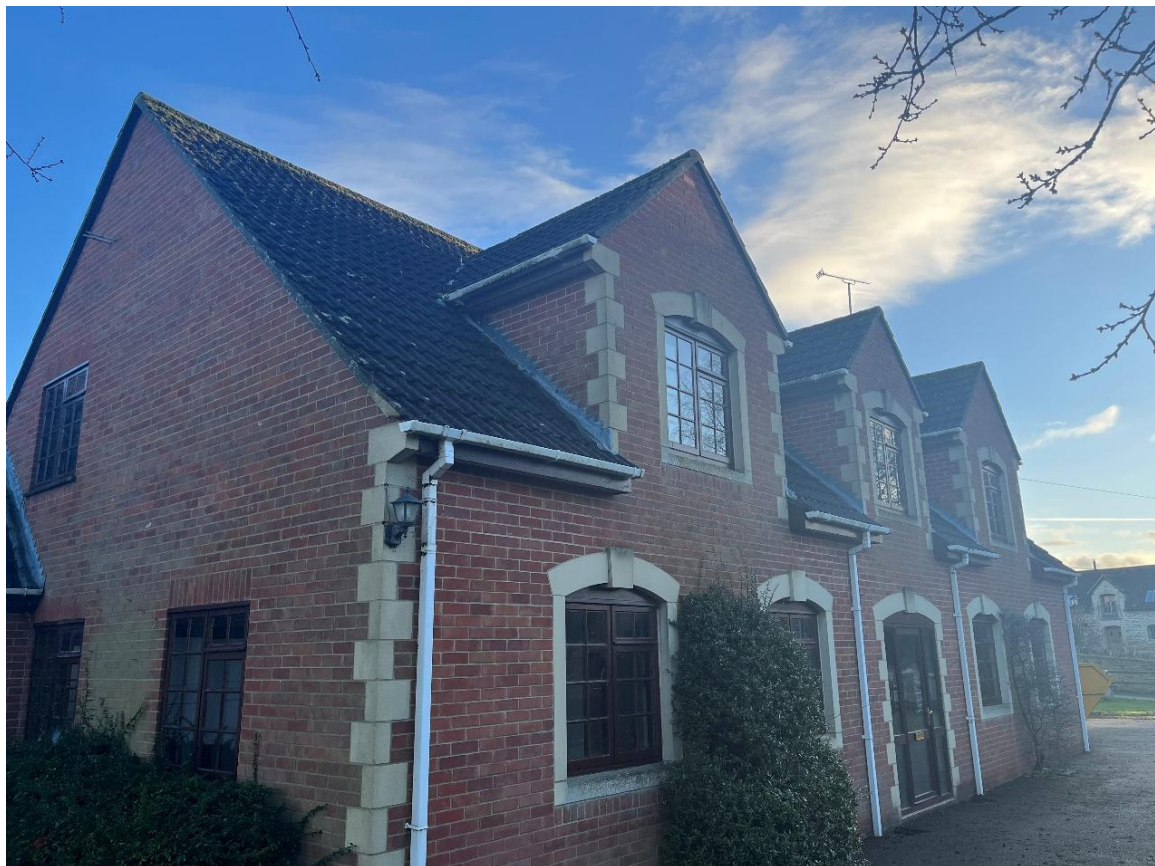
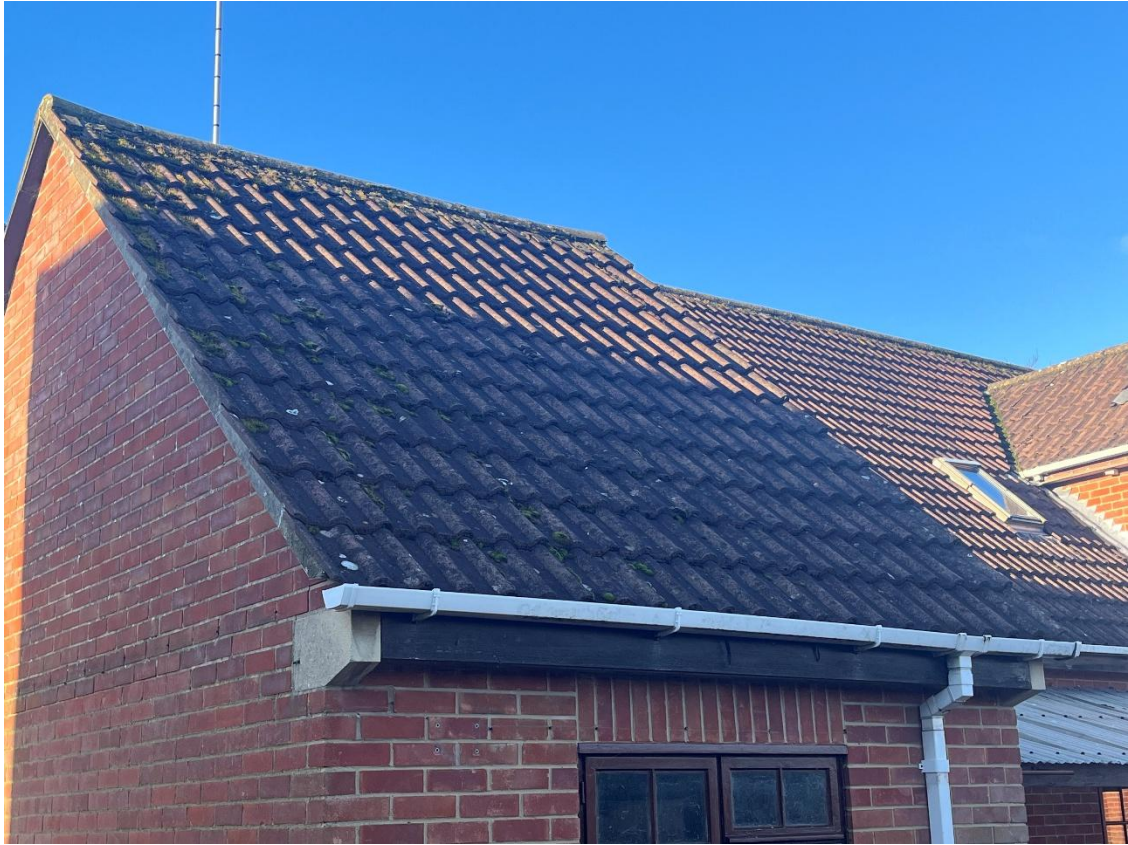
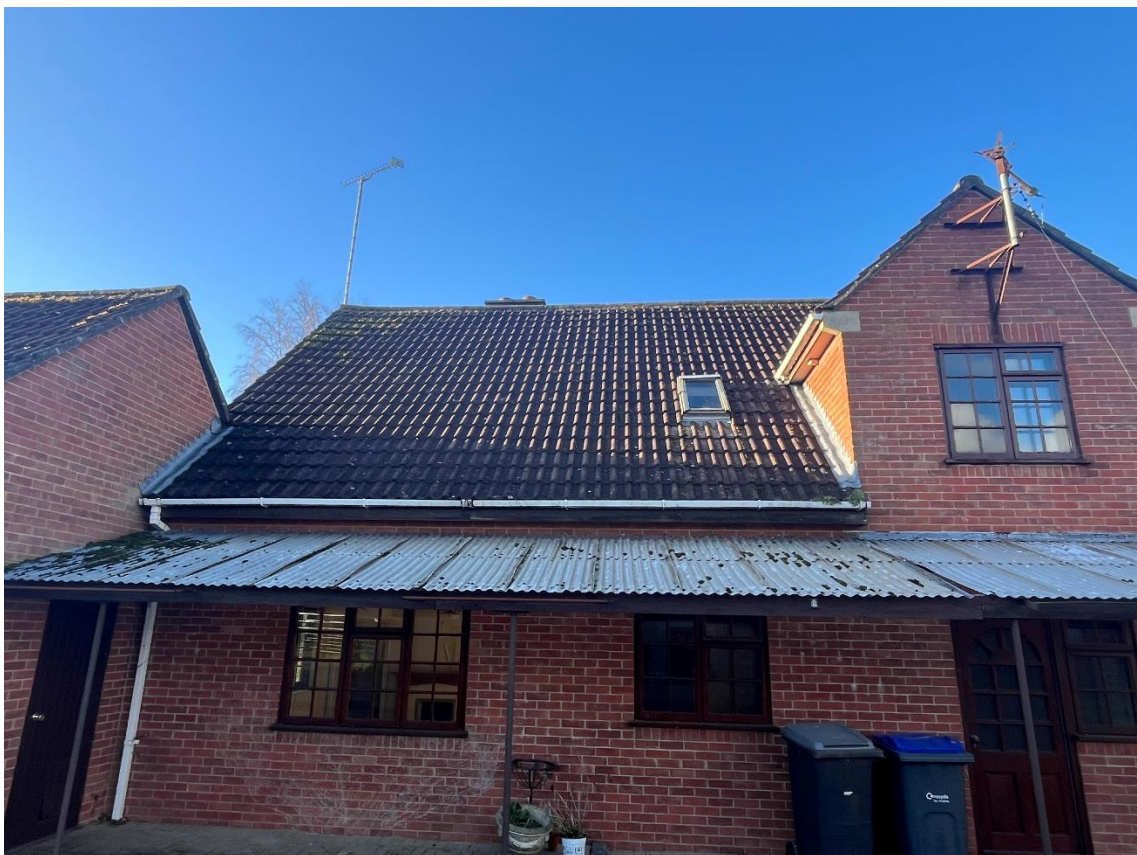
The house is a large dormer bungalow dating to the 1980s. It has plain brick and block walls and a roof faced with cement tiles which are in excellent order. The ridge tiles, leading, soffits and fascias are also all closed off with no openings (see figures 3-5).

**Figure 3. Eastern and northern elevations looking east**

**Figure 4. Western gable and western third of rear elevations looking north**

**Figure 5. Southern elevations looking northwest**

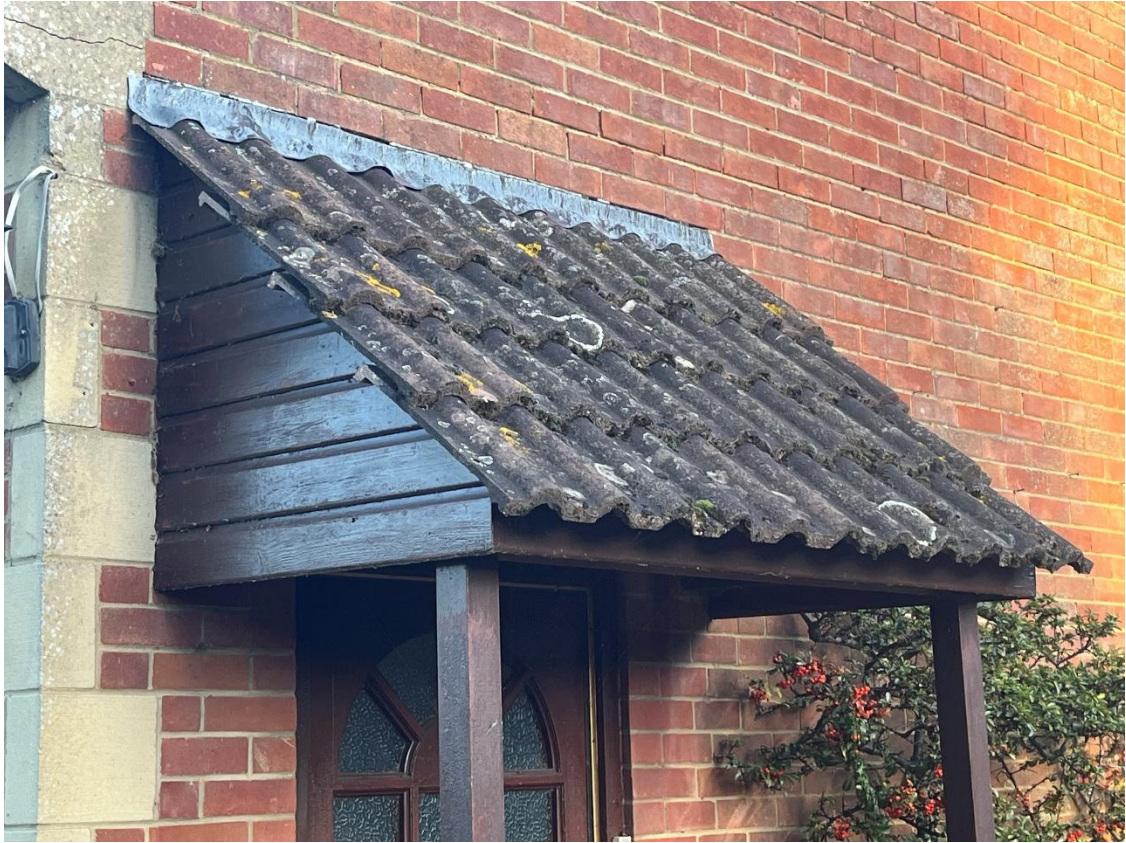
The side entrance has an open porch which is unlined and has negligible potential for bats (see figure 6).

**Figure 6. House west gable entrance porch area looking southeast**

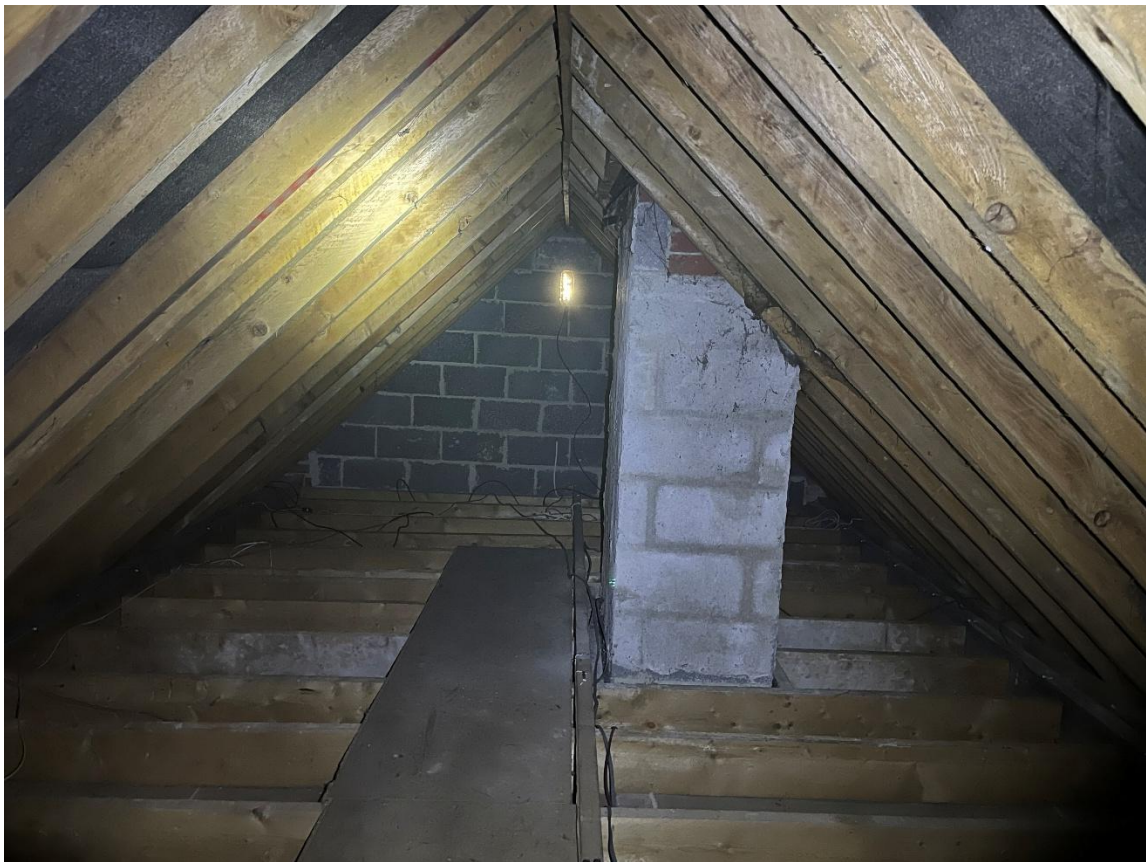
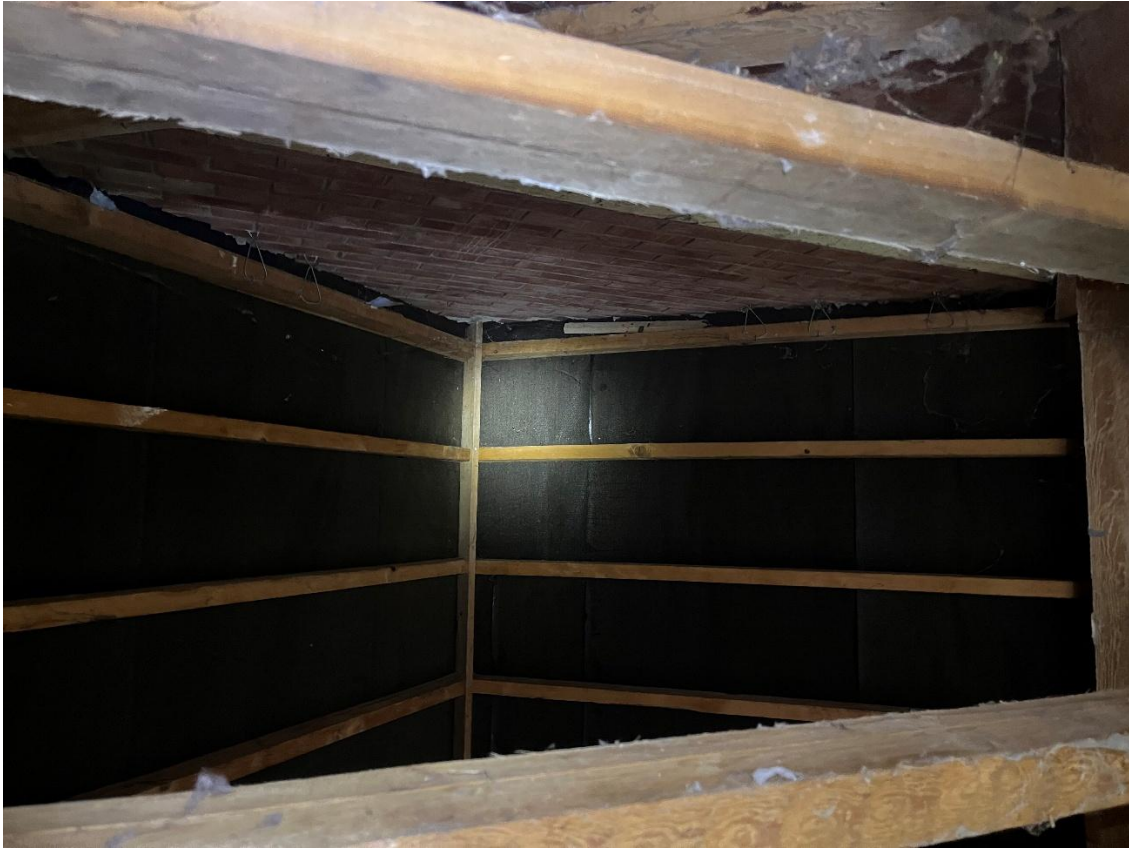
The loft was accessed via hatch in the hallway and is open with the dormer bay spaces connected and accessible from the main space. The roof is lined with felting which is in excellent condition with no external light visible from within and no sign of any bat activity (see figures 7-8).

**Figure 7. House loft looking southwest.**

**Figure 8. House loft below east gable.**

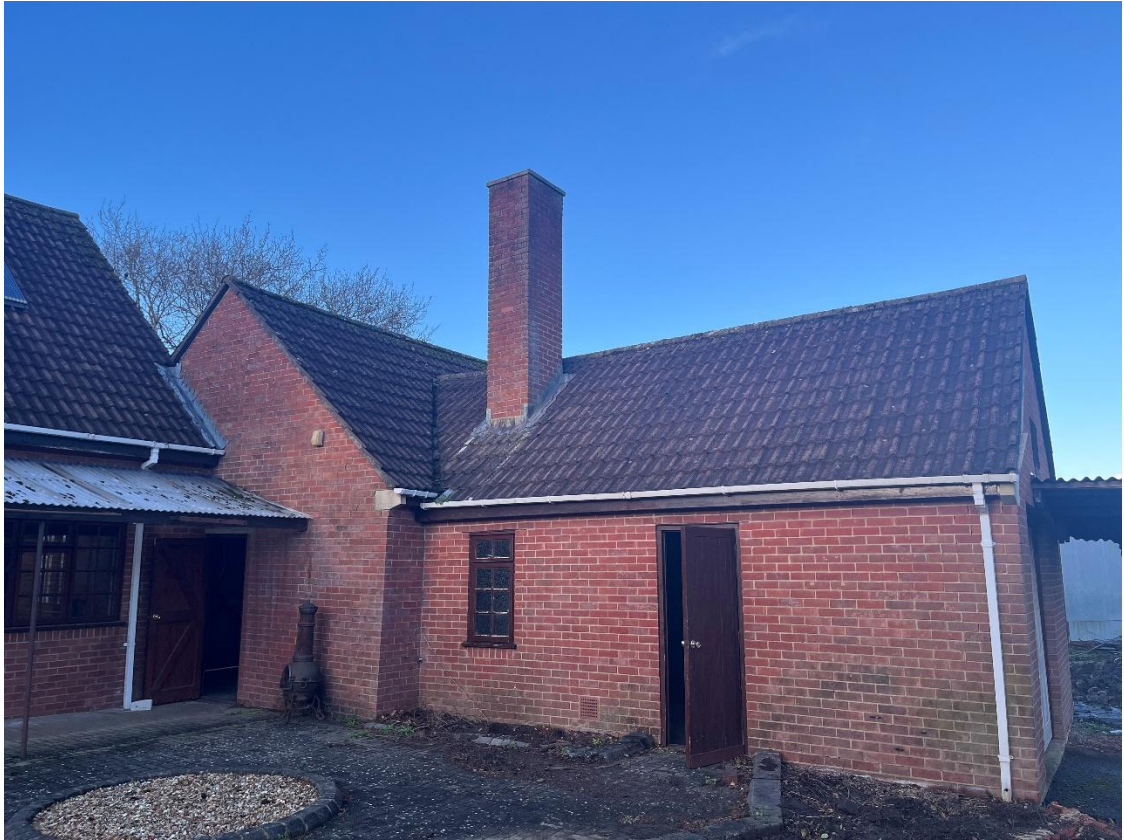
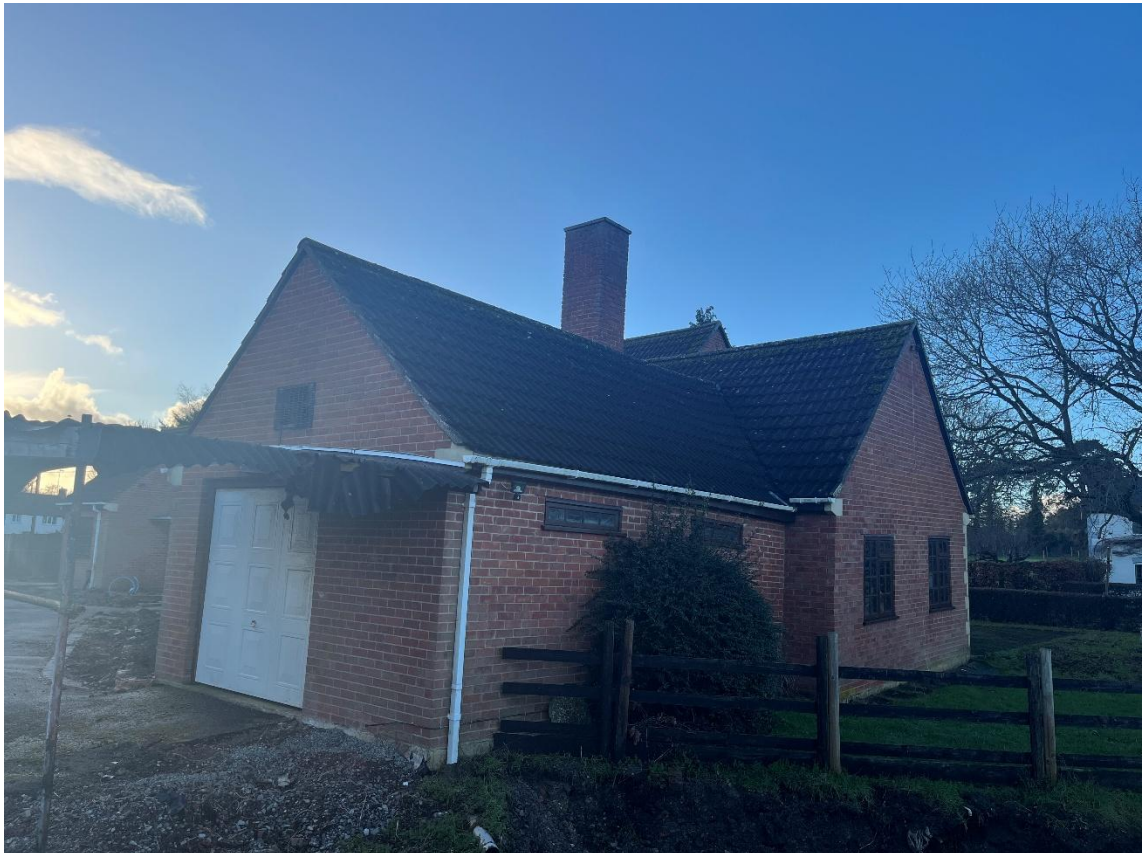
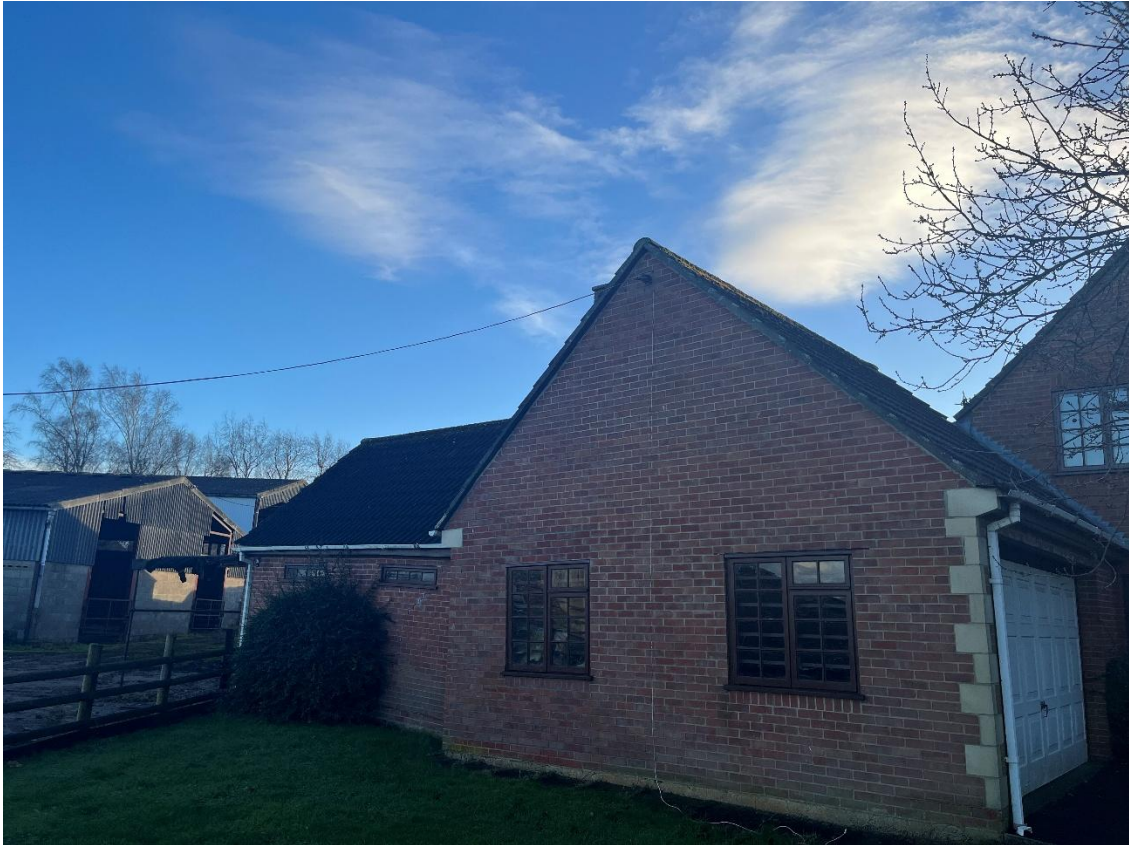
The garage is attached to the east gable of the house and has up and over doors to the north and south opening into two separate spaces (see figures 9-11). The south space was used as a furnace room with chimney venting through the loft space above the garage. The north bay roof space is open and permanently illuminated via side windows (see figures 12). There was no sign of any bat activity within the garage and the timber framing is nailed sawn softwood with no crevices or holes.

**Figure 9. Garage looking northeast**

**Figure 10. Garage looking northwest**

**Figure 11. Garage east gable looking southwest**

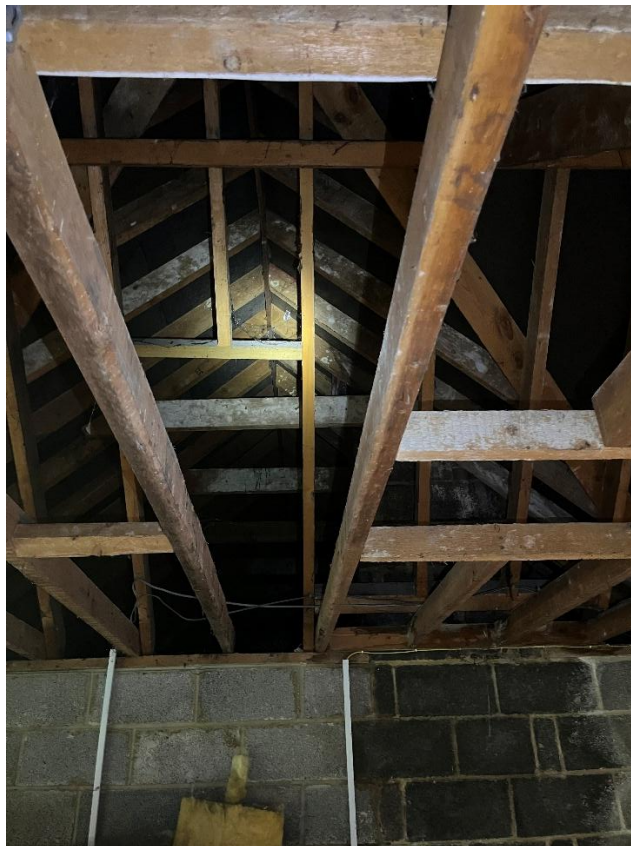
**Figure 12. Interior of garage looking southeast.**

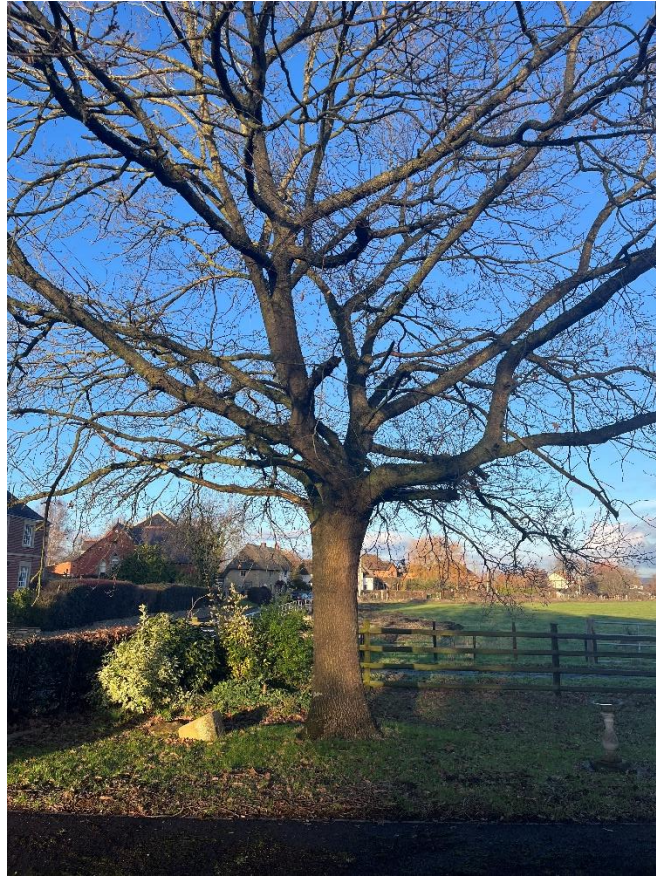
The only tree within 20m of the property is an oak circa 50 years old. This is in good health with no cavities or holes and no ivy. It has negligible potential for roosting bats (see figure 13).

**Figure 13. Oak tree at NE corner of plot looking east.**

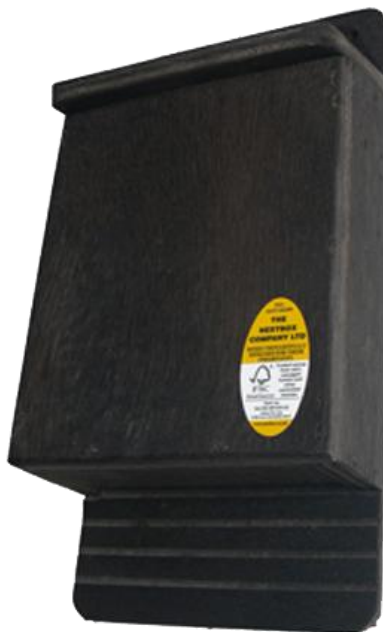
**Figure 14: The improved cavity box to be established on site**

An Improved Cavity Bat Box (shown in figure 14 below) should also be established on the replacement garage southeast facing gable. These are suitable for the smaller British bats, including pipistrelles.
