PROJECT: Bulford Manor Wall

DRAWING NO: V1013 - PRA - ZZ - XX - DR - A - 30006

SHEET: Condition Drawing E - Brick, Stone and Flintwork

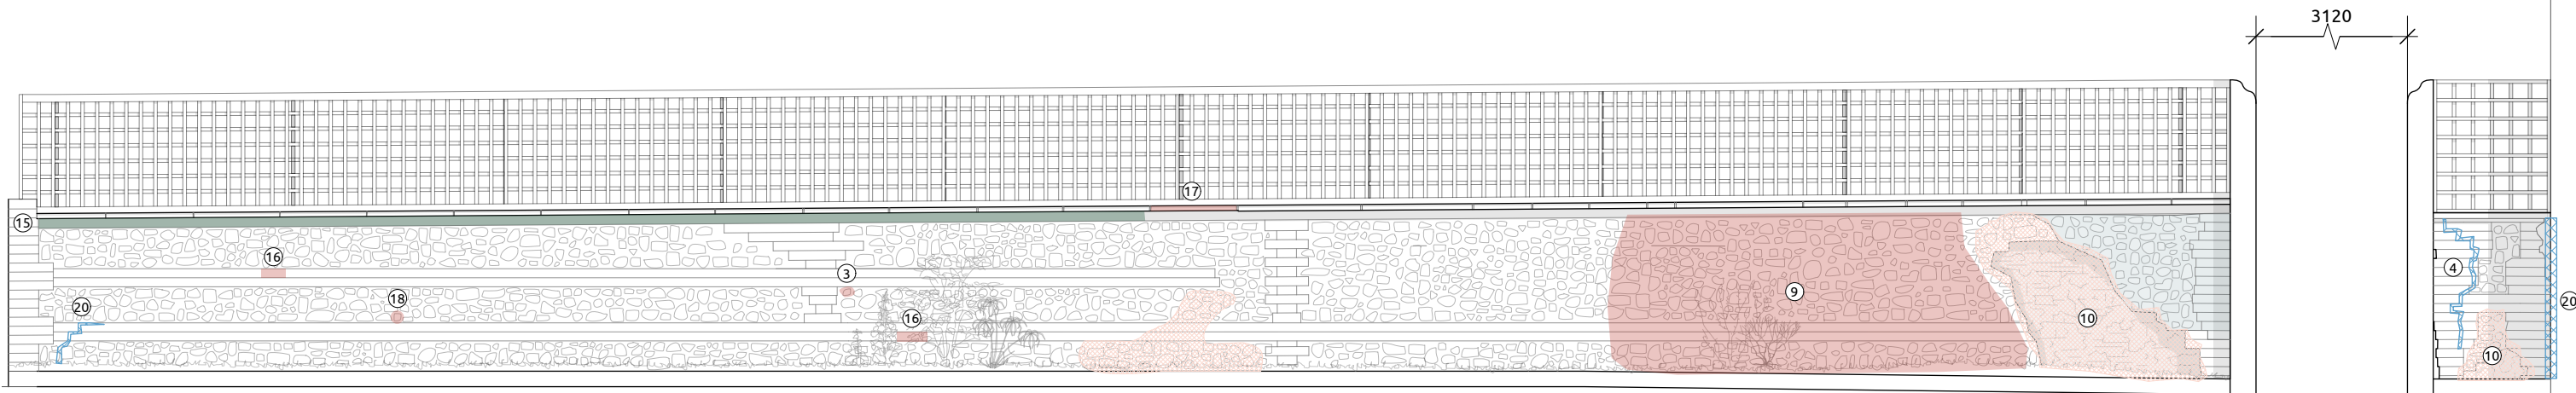
Front Elevation

| ① Severely failed. Stone coping not deep enough. | ⑧ Three missing flints. | ⑮ Heavily spalled modern brickwork. |
| ② Missing stone sections. Coping has poor overhang and no drip. | ⑨ Loose flintwork. | ⑯ Missing brick. |
| ③ Missing flint. | ⑩ Failed section of wall, partially collapsed. | ⑰ Concrete coping dislodged. |
| ④ Crack, less than 3mm. | ⑪ Missing flint. | ⑱ Plastic fixture to wall. |
| ⑤ Cracked brick. | ⑫ Cracked brick. | ⑳ Poor connection with brick slips. Cracking and open joints. |
| ⑥ Failed section of wall with severe lean inwards. Flintwork is loose. | ⑬ Crack, 5-10mm. | |
| ⑦ Failed buttress leaning towards road. | ⑭ Missing flint. | |
