PROJECT: Bulford Manor Wall

SHEET: Condition Drawing D - Joints and Pointing

DRAWING NO: V1013 - PRA - ZZ - XX - DR - A - 30005

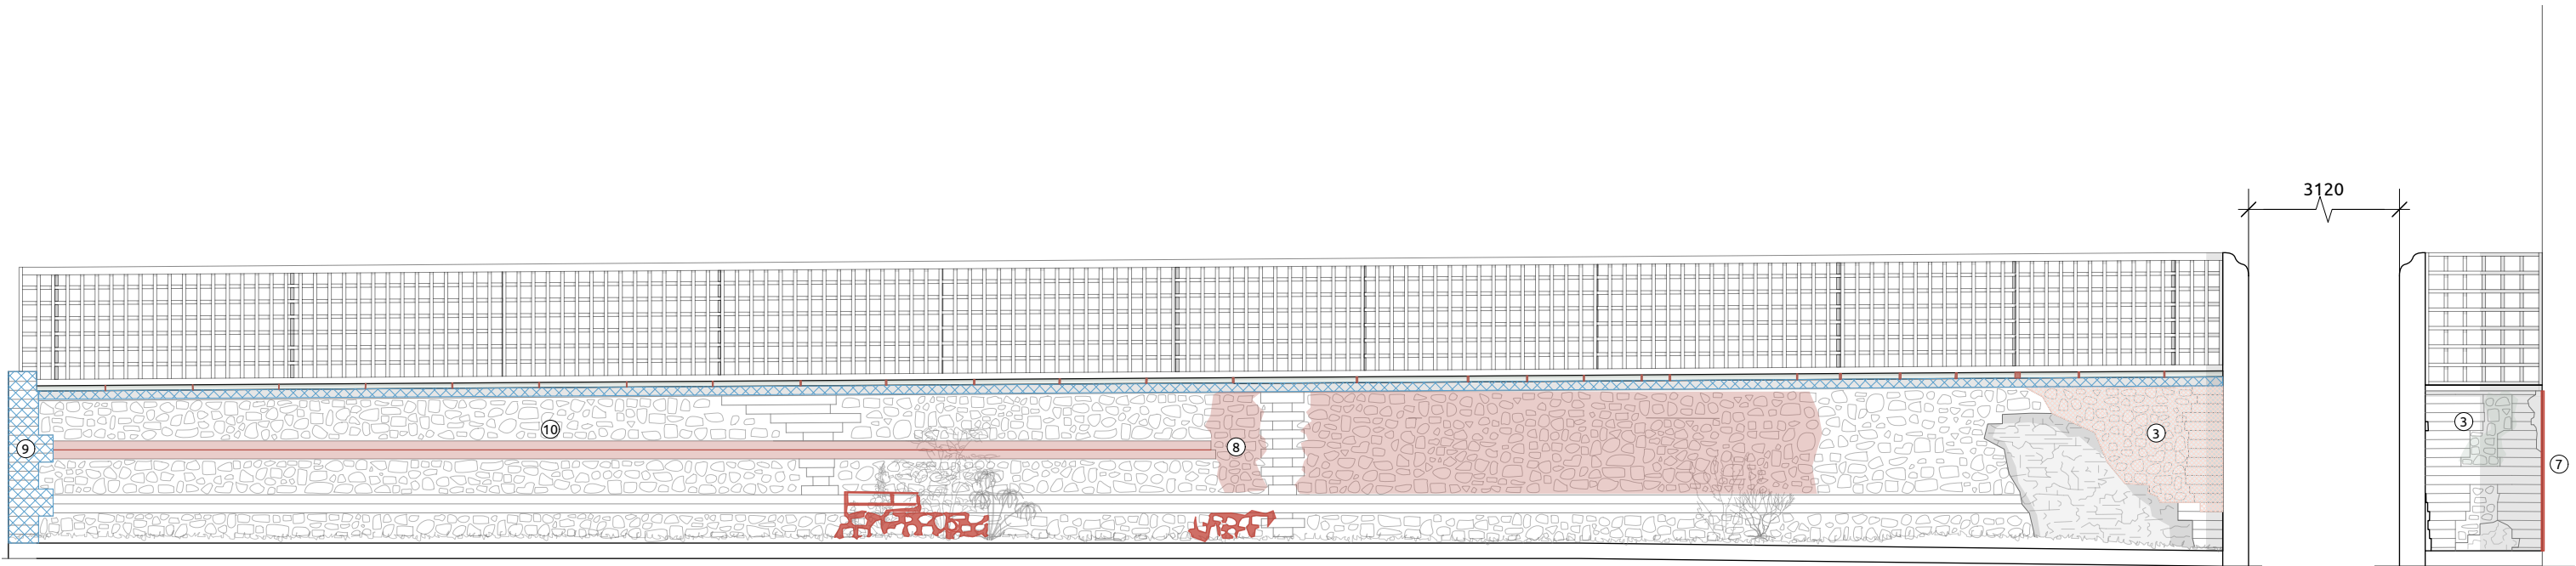
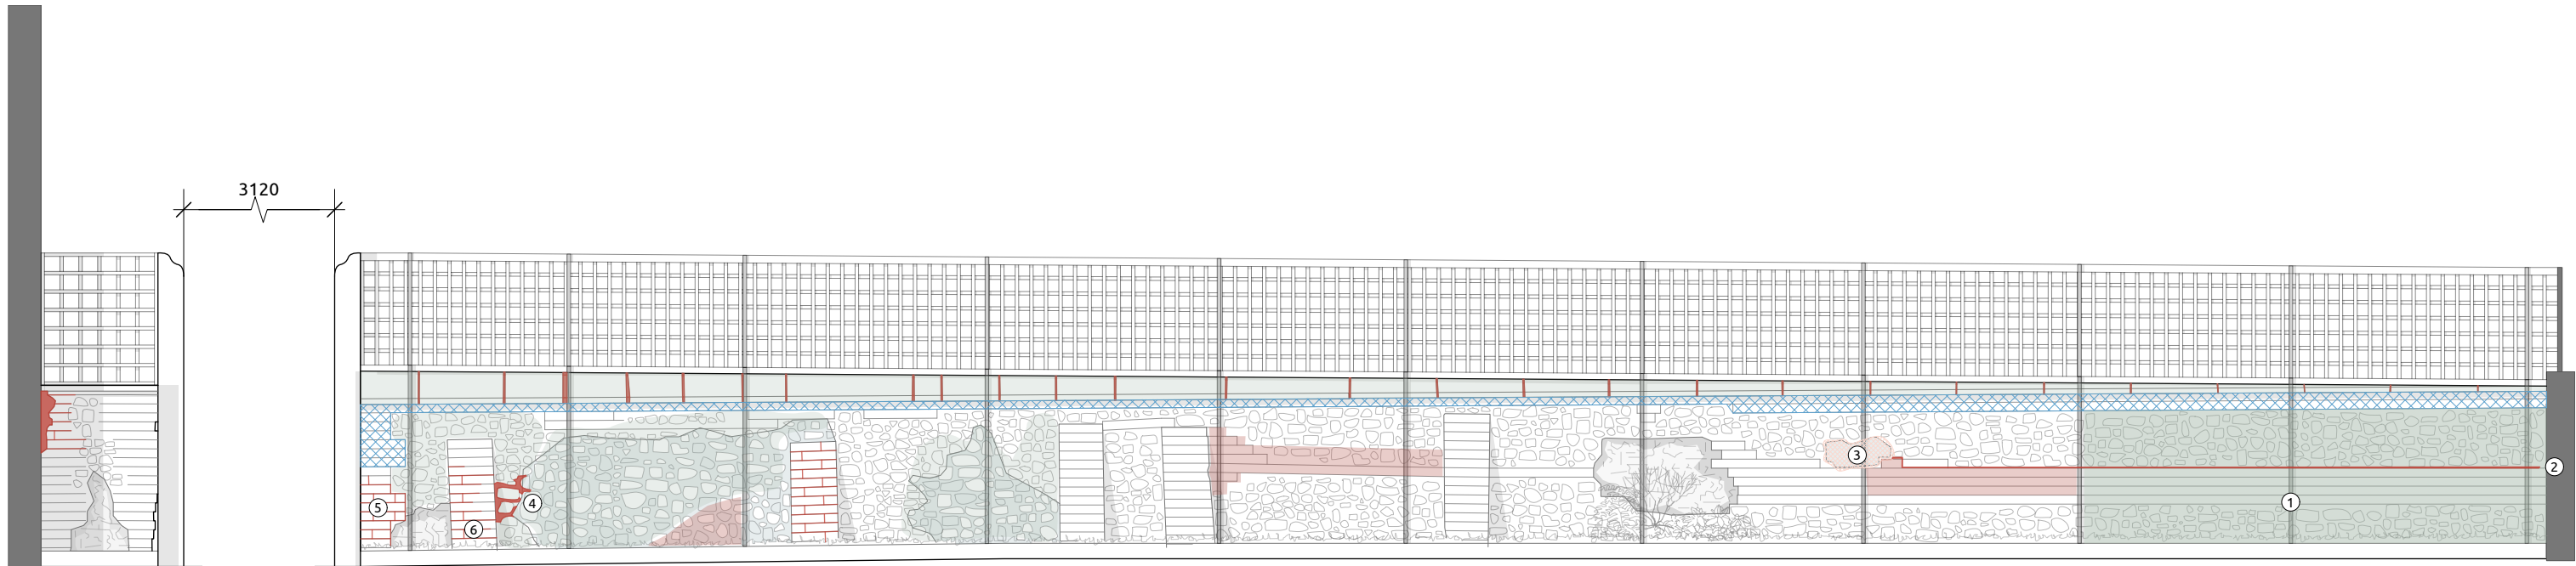
Front Elevation

- Cement render repairs
- Modern brickwork in cement
- Open joints/missing mortar
- Deeply recessed pointing
- Areas of cement pointing

- ① Flint and brickwork in very hard mortar. Likely contains Portland Cement.
- ② Open joint between brick and flint.
- ③ Poor cement render repair.
- ④ Missing mortar - daylight is visible through the wall.
- ⑤ Missing mortar to severely leaning wall end.
- ⑥ Open joints and movement to buttress.
- ⑦ Cracking and open joints, poor connection with brick slips.
- ⑧ Pointing loose/missing.
- ⑨ Modern end to wall.
- ⑩ Open pointing to central band of brick.
