# PRELIMINARY ARBORICULTURAL REPORT

Coombe Farm, Coombe Lane, Bratton, Westbury BA13 4SY

Client: Sedgwick International UK  
Insurer: NFU Mutual Insurance

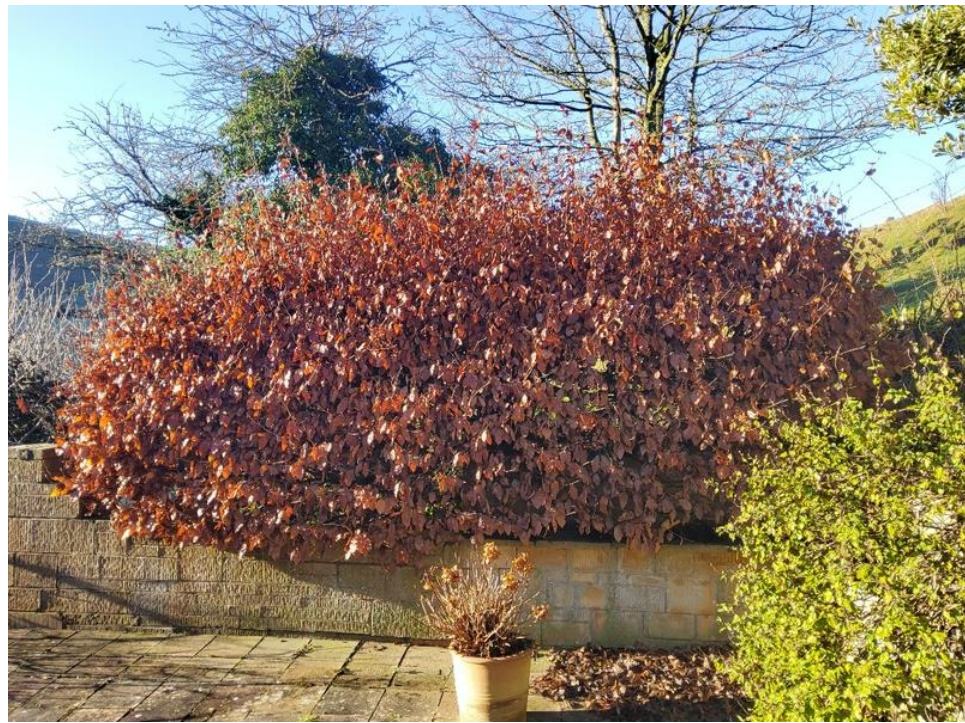
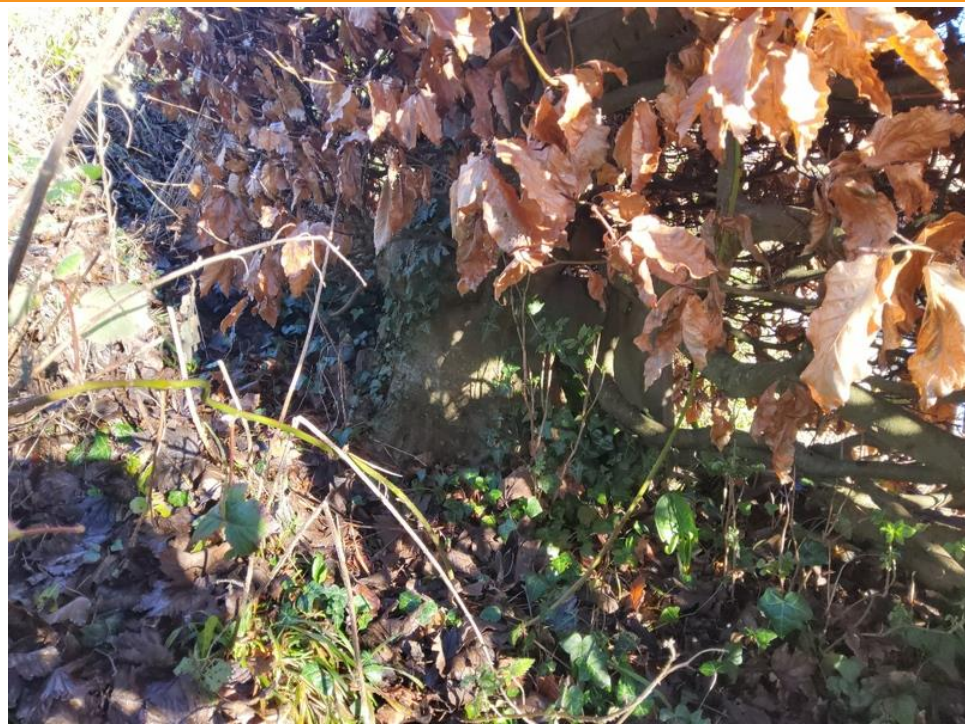
H1 Beech (Common)

| Tree No: | Common Name | Age Class | Condition | Height (m) | Crown Spread (m) | Stem diam. (mm) | No. of Stems | Dist to bldg. (m) | Roots Implicated | Pruning History | Recommendation | Tree Work Constraints | Notes | Owner address | Owner |
|---|---|---|---|---|---|---|---|---|---|---|---|---|---|---|---|
| H1 | Beech (Common) | Mature | Fair | 2.50 | 1.25 | 275 | 1 | 5.30 | No | Managed by regular pruning. | Fell and treat stump with eco plugs (broadleaved). | There are no restrictions to the site or to the tree - scheduled rates may apply. | Distance is to closest point to property. | Combe Farm, Coombe Lane, Bratton BA13 4SY | PH |

| Tree No: | Species | Works Required | CA | TPO | Ownership |
|---|---|---|---|---|---|
| H1 | Beech<br>(Common) | Fell and treat stump with eco plugs (broadleaved). | Yes | No | PH |

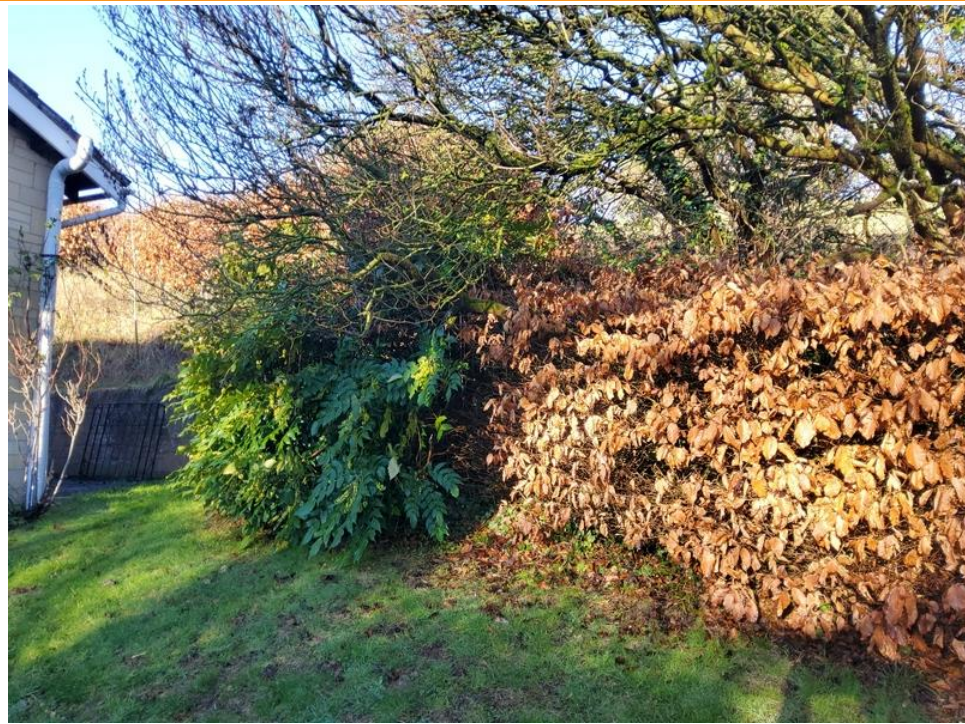
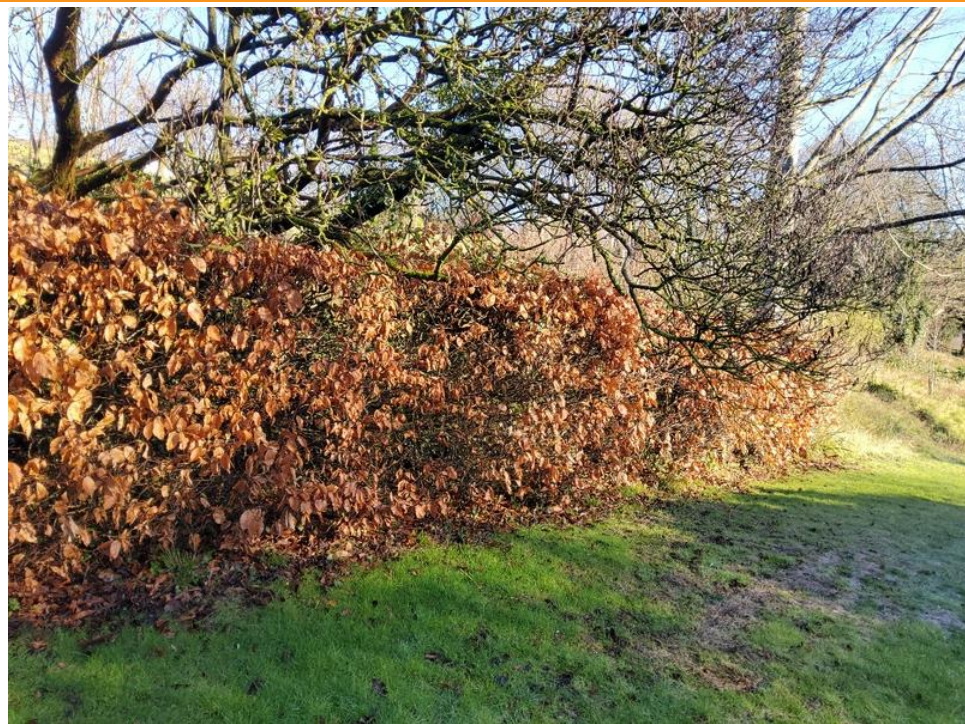
HG3 Mixed species group

| Tree No: | Common Name | Age Class | Condition | Height (m) | Crown Spread (m) | Stem diam. (mm) | No. of Stems | Dist to bldg. (m) | Roots Implicated | Pruning History | Recommendation | Tree Work Constraints | Notes | Owner address | Owner |
|---|---|---|---|---|---|---|---|---|---|---|---|---|---|---|---|
| HG3 | Mixed species group | Mature | Fair | 2.00 | 1.75 | 50 | 20 | 3.50 | No | Managed by regular pruning. | Fell and treat stump with eco plugs (broadleaved). Removal of closest 3.5m section. No other works to remaining group. | There are no restrictions to the site or to the tree - scheduled rates may apply. | Distance is to closest point to property. Group consists of Mahonia, Beech, Forsythia, and Lilac with an approximate DBH range of 30mm - 75mm. | Combe Farm, Coombe Lane, Bratton BA13 4SY | PH |

| Tree No: | Species | Works Required | CA | TPO | Ownership |
|---|---|---|---|---|---|
| HG3 | Mixed<br>species<br>group | Fell and treat stump with eco plugs (broadleaved). Removal of closest 3.5m section. No other works to remaining group | No | No | PH |

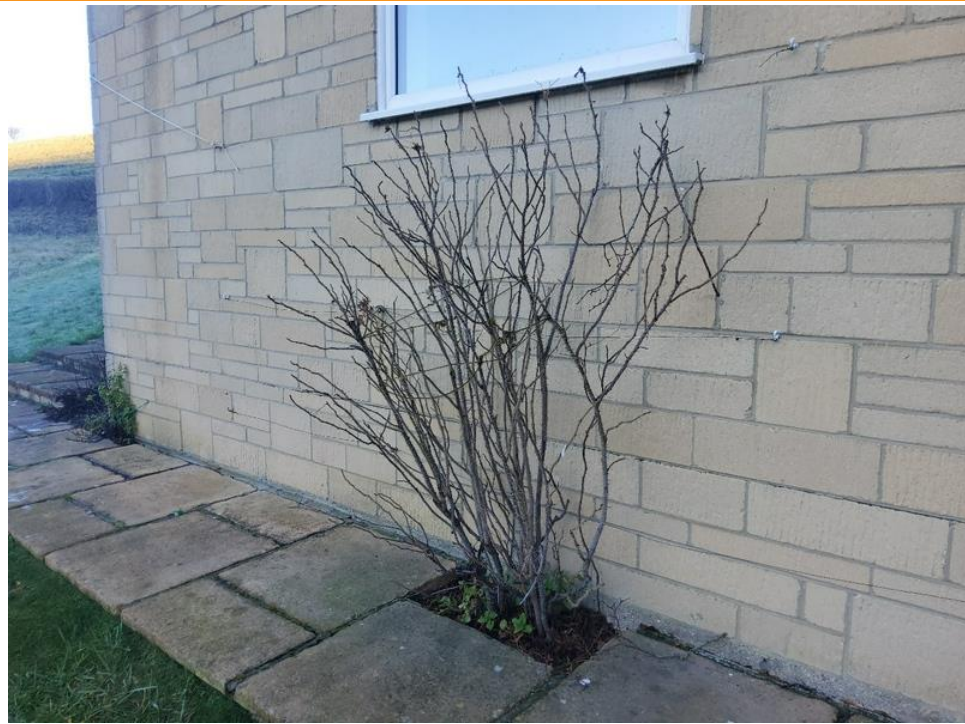
S1 Rose

| Tree No: | Common Name | Age Class | Condition | Height (m) | Crown Spread (m) | Stem diam. (mm) | No. of Stems | Dist to bldg. (m) | Roots Implicated | Pruning History | Recommendation | Tree Work Constraints | Notes | Owner address | Owner |
|---|---|---|---|---|---|---|---|---|---|---|---|---|---|---|---|
| S1 | Rose | Mature | Fair | 1.50 | 1.00 | 25 | 10 | 0.00 | No | Managed by regular pruning. | Fell and treat stump with eco plugs (broadleaved). | There are no restrictions to the site or to the tree - scheduled rates may apply. | Distance is to closest point to property. Approximate DBH range of 5mm - 20mm. | Combe Farm, Coombe Lane, Bratton BA13 4SY | PH |

| Tree No: | Species | Works Required | CA | TPO | Ownership |
|---|---|---|---|---|---|
| S1 | Rose | Fell and treat stump with eco plugs (broadleaved). | No | No | PH |

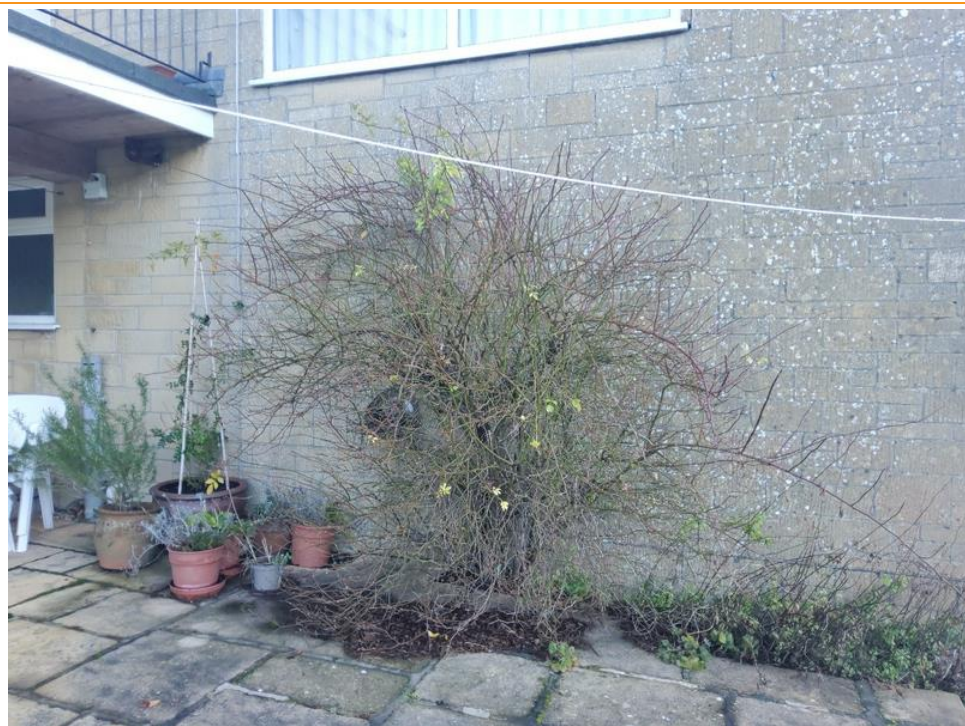
S2 Rose

| Tree No: | Common Name | Age Class | Condition | Height (m) | Crown Spread (m) | Stem diam. (mm) | No. of Stems | Dist to bldg. (m) | Roots Implicated | Pruning History | Recommendation | Tree Work Constraints | Notes | Owner address | Owner |
|---|---|---|---|---|---|---|---|---|---|---|---|---|---|---|---|
| S2 | Rose | Mature | Fair | 2.00 | 2.00 | 25 | 10 | 0.00 | No | Managed by regular pruning. | Fell and treat stump with eco plugs (broadleaved). | There are no restrictions to the site or to the tree - scheduled rates may apply. | Distance is to closest point to property. Approximate DBH range of 10mm - 25mm. Crown lopsided to the west. | Combe Farm, Coombe Lane, Bratton BA13 4SY | PH |

| Tree No: | Species | Works Required | CA | TPO | Ownership |
|---|---|---|---|---|---|
| S2 | Rose | Fell and treat stump with eco plugs (broadleaved). | No | No | PH |

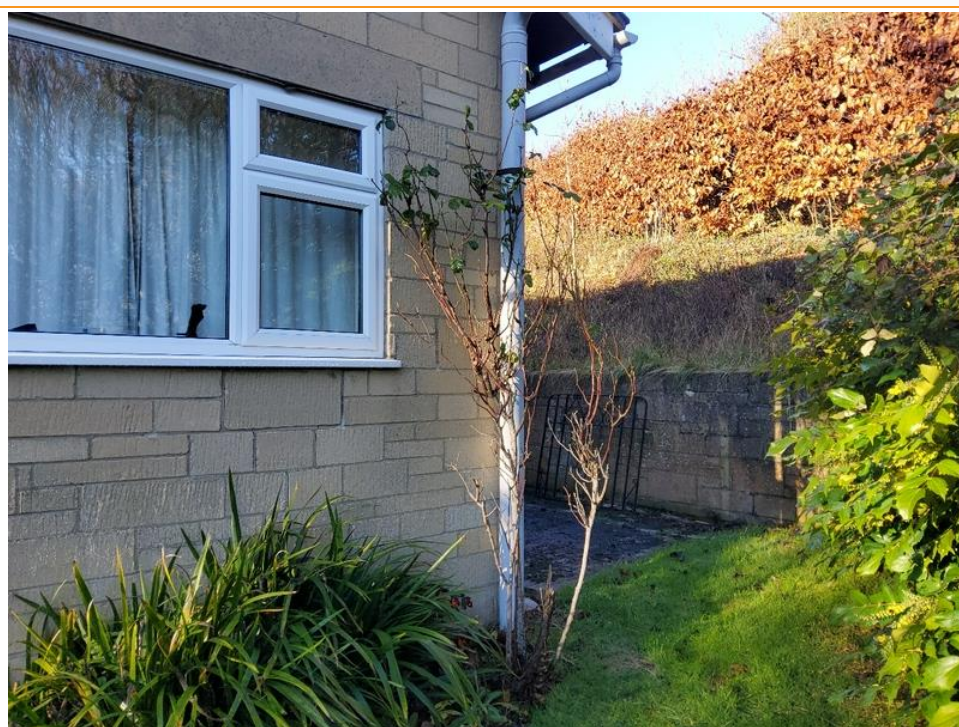
S4 Rose

| Tree No: | Common Name | Age Class | Condition | Height (m) | Crown Spread (m) | Stem diam. (mm) | No. of Stems | Dist to bldg. (m) | Roots Implicated | Pruning History | Recommendation | Tree Work Constraints | Notes | Owner address | Owner |
|---|---|---|---|---|---|---|---|---|---|---|---|---|---|---|---|
| S4 | Rose | Mature | Fair | 2.50 | 1.00 | 25 | 4 | 0.40 | No | Managed by regular pruning. | Fell and treat stump with eco plugs (broadleaved). | There are no restrictions to the site or to the tree - scheduled rates may apply. | Distance is to closest point to property. Approximate DBH range of 10mm - 30mm. | Combe Farm, Coombe Lane, Bratton BA13 4SY | PH |

| Tree No: | Species | Works Required | CA | TPO | Ownership |
|---|---|---|---|---|---|
| S4 | Rose | Fell and treat stump with eco plugs (broadleaved). | No | No | PH |

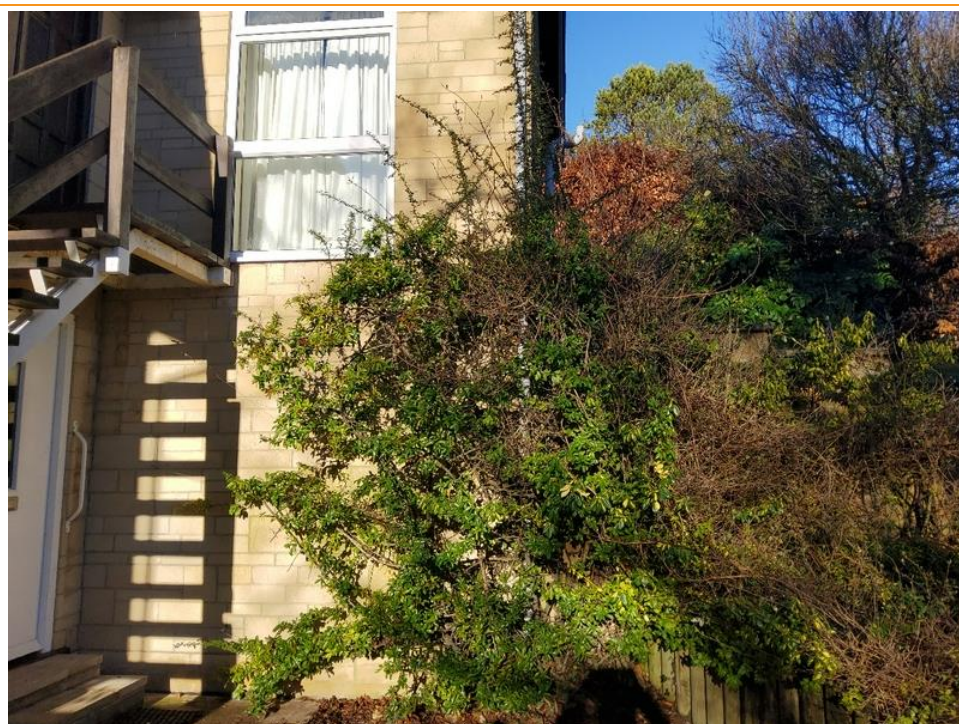
S6 Pyracantha

| Tree No: | Common Name | Age Class | Condition | Height (m) | Crown Spread (m) | Stem diam. (mm) | No. of Stems | Dist to bldg. (m) | Roots Implicated | Pruning History | Recommendation | Tree Work Constraints | Notes | Owner address | Owner |
|---|---|---|---|---|---|---|---|---|---|---|---|---|---|---|---|
| S6 | Pyracantha | Mature | Fair | 4.50 | 2.50 | 25 | 8 | 0.00 | Yes | Managed by regular pruning. | Fell and treat stump with eco plugs (broadleaved). | There are no restrictions to the site or to the tree - scheduled rates may apply. | Distance is to closest point to property. Approximate DBH range of 10mm - 40mm. | Combe Farm, Coombe Lane, Bratton BA13 4SY | PH |

| Tree No: | Species | Works Required | CA | TPO | Ownership |
|---|---|---|---|---|---|
| S6 | Pyracantha | Fell and treat stump with eco plugs (broadleaved). | No | No | PH |

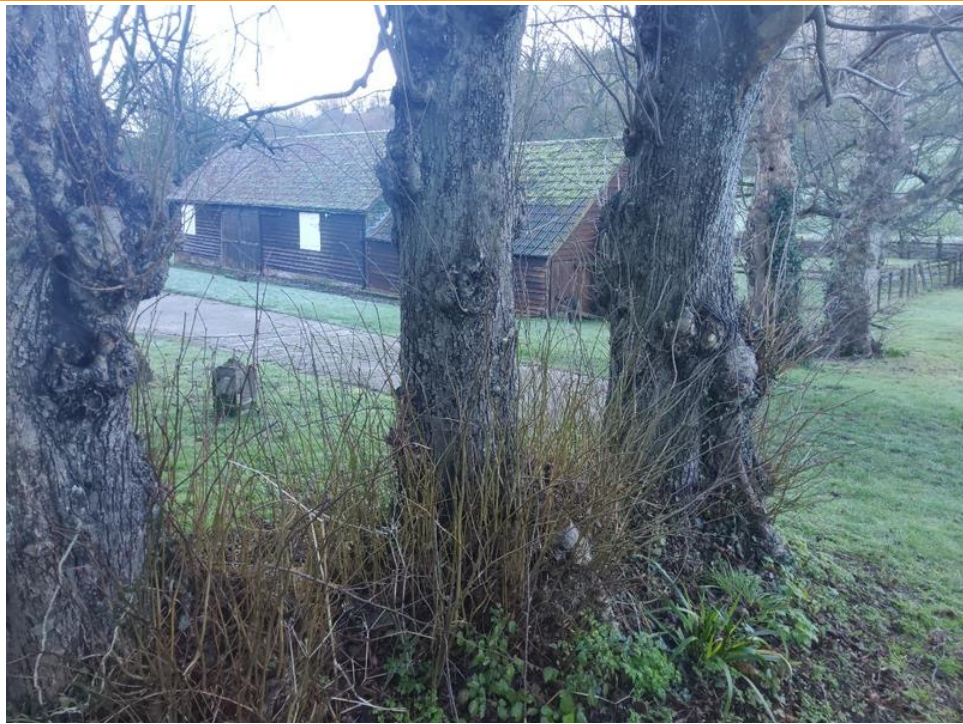
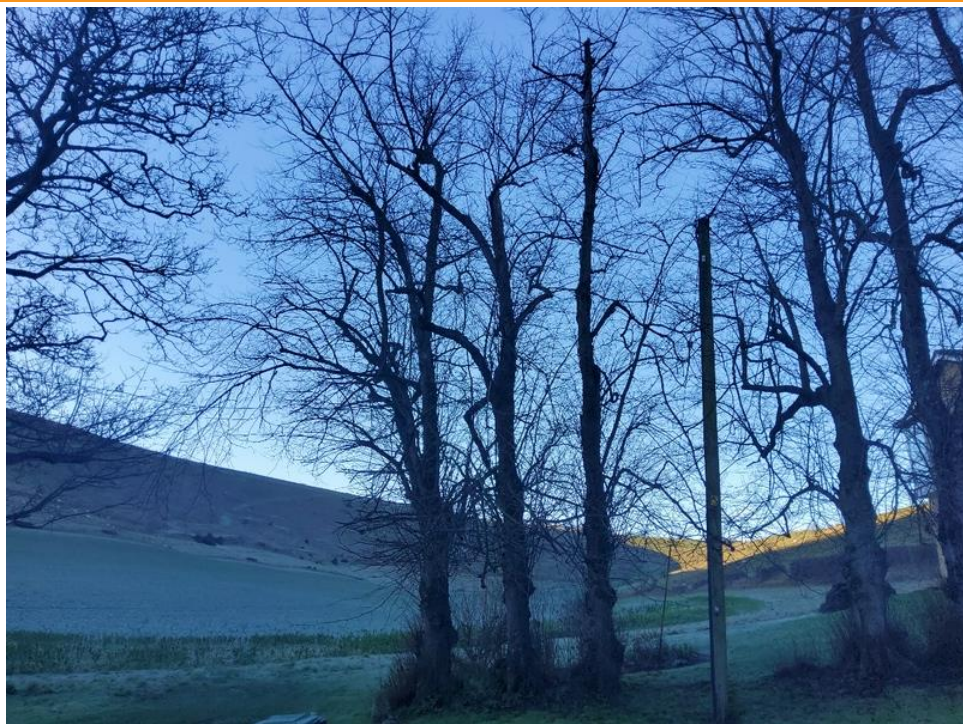
T2 Lime (Common)

| Tree No: | Common Name | Age Class | Condition | Height (m) | Crown Spread (m) | Stem diam. (mm) | No. of Stems | Dist to bldg. (m) | Roots Implicated | Pruning History | Recommendation | Tree Work Constraints | Notes | Owner address | Owner |
|---|---|---|---|---|---|---|---|---|---|---|---|---|---|---|---|
| T2 | Lime (Common) | Mature | Poor | 13.00 | 10.00 | 575 | 1 | 12.40 | No | Subject to historic crown reduction management. | Fell and grind stump. | There are restrictions to the site or to the tree - contractor should quote. Adjacent to power lines. | Distance is to closest point to property. Large amounts of epicormic growth throughout and up the tree. Crown lopsided to the east and west. Large amounts of dead wood within crown and upper crown has begun to die off and snap out. Grinding advised to minimise cross contamination. | Combe Farm, Coombe Lane, Bratton BA13 4SY | PH |

| Tree No: | Species | Works Required | CA | TPO | Ownership |
|---|---|---|---|---|---|
| T2 | Lime (Common) | Fell and grind stump | Yes | No | PH |

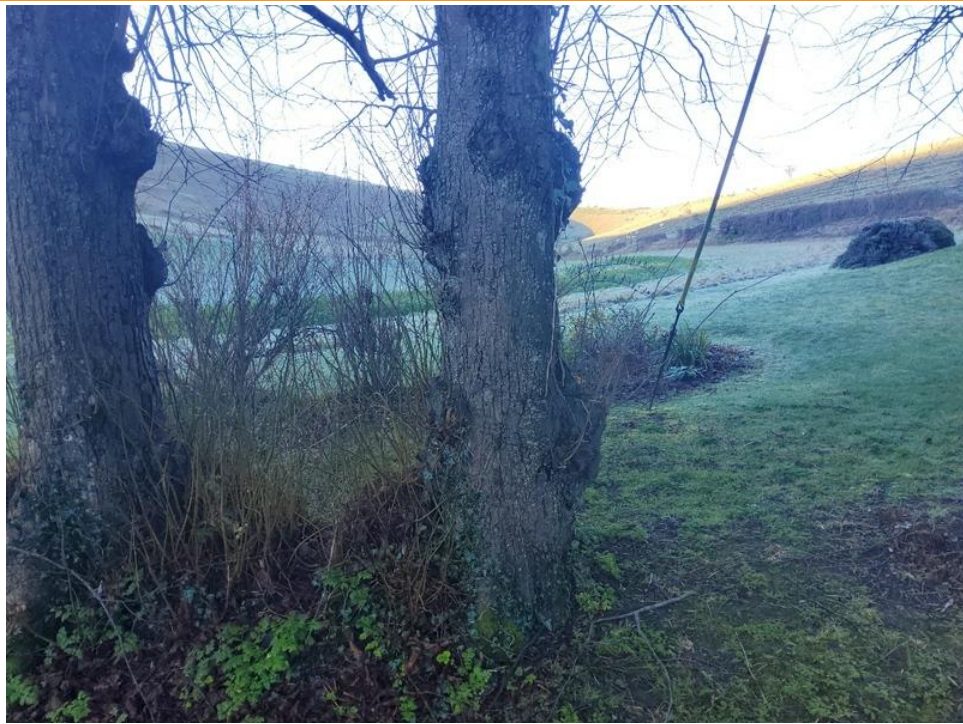
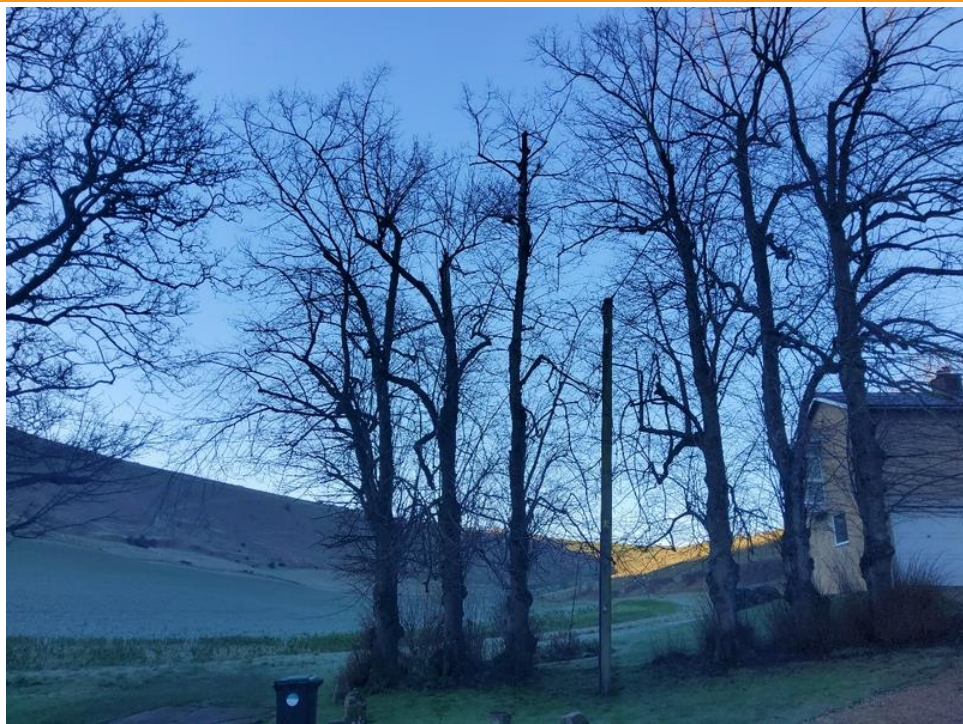
T3 Lime (Common)

| Tree No: | Common Name | Age Class | Condition | Height (m) | Crown Spread (m) | Stem diam. (mm) | No. of Stems | Dist to bldg. (m) | Roots Implicated | Pruning History | Recommendation | Tree Work Constraints | Notes | Owner address | Owner |
|---|---|---|---|---|---|---|---|---|---|---|---|---|---|---|---|
| T3 | Lime (Common) | Mature | Poor | 13.00 | 10.00 | 550 | 1 | 11.60 | No | Subject to historic crown reduction management. | Fell and grind stump. | There are restrictions to the site or to the tree - contractor should quote. Power lines running through crown. | Distance is to closest point to property. Large amounts of epicormic growth throughout and up the tree. Crown lopsided to the east and west. Large amounts of dead wood within crown and upper crown has begun to die off and snap out. Grinding advised to minimise cross contamination. | Combe Farm, Coombe Lane, Bratton BA13 4SY | PH |

| Tree No: | Species | Works Required | CA | TPO | Ownership |
|---|---|---|---|---|---|
| T3 | Lime (Common) | Fell and grind stump | Yes | No | PH |

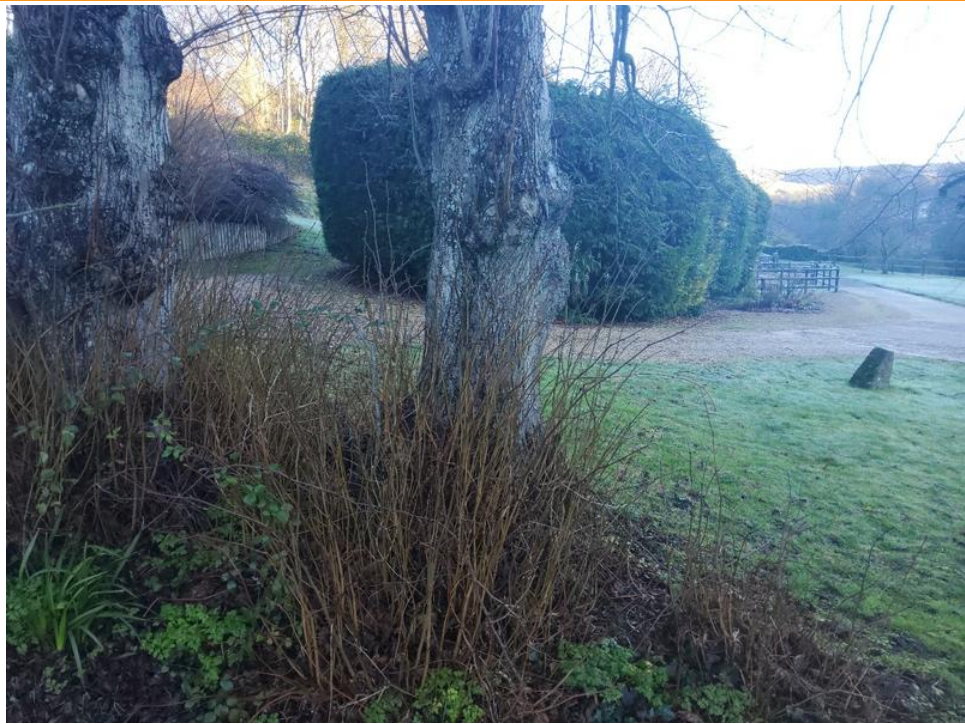
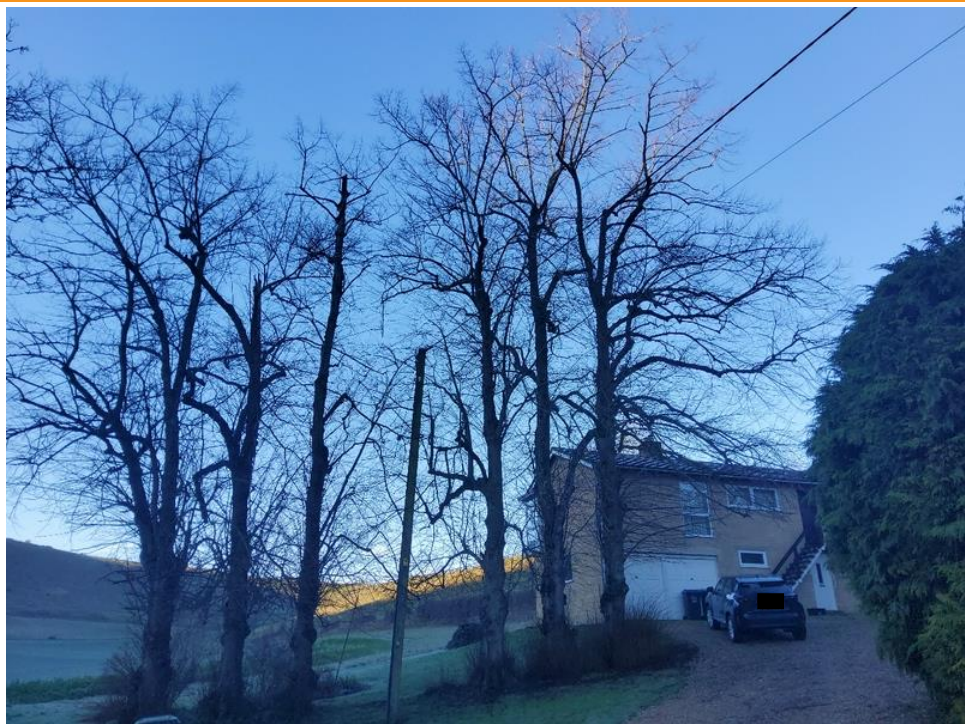
T4 Lime (Common)

| Tree No: | Common Name | Age Class | Condition | Height (m) | Crown Spread (m) | Stem diam. (mm) | No. of Stems | Dist to bldg. (m) | Roots Implicated | Pruning History | Recommendation | Tree Work Constraints | Notes | Owner address | Owner |
|---|---|---|---|---|---|---|---|---|---|---|---|---|---|---|---|
| T4 | Lime (Common) | Mature | Fair | 15.00 | 12.00 | 650 | 1 | 7.80 | No | Subject to historic crown reduction management. | Fell and treat stump with eco plugs (broadleaved). | There are restrictions to the site or to the tree - contractor should quote. Power lines running through crown. | Distance is to closest point to property. Large amounts of epicormic growth throughout and up the tree. Crown lopsided to the east and west. | Combe Farm, Coombe Lane, Bratton BA13 4SY | PH |

| Tree No: | Species | Works Required | CA | TPO | Ownership |
|---|---|---|---|---|---|
| T4 | Lime<br>(Common) | Fell and treat stump with eco plugs (broadleaved). | Yes | No | PH |

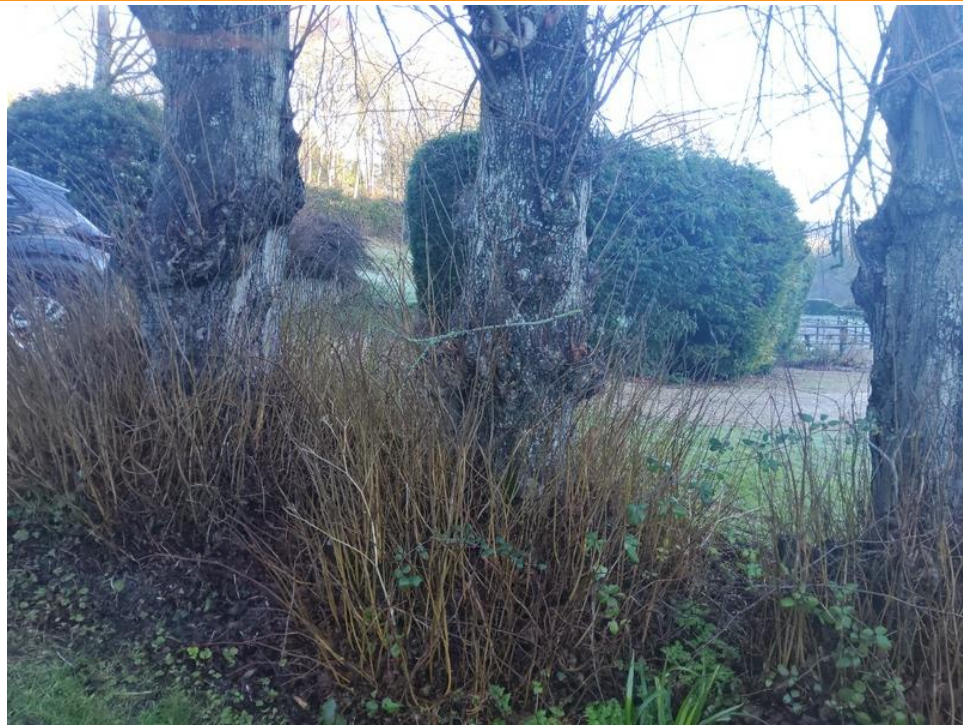
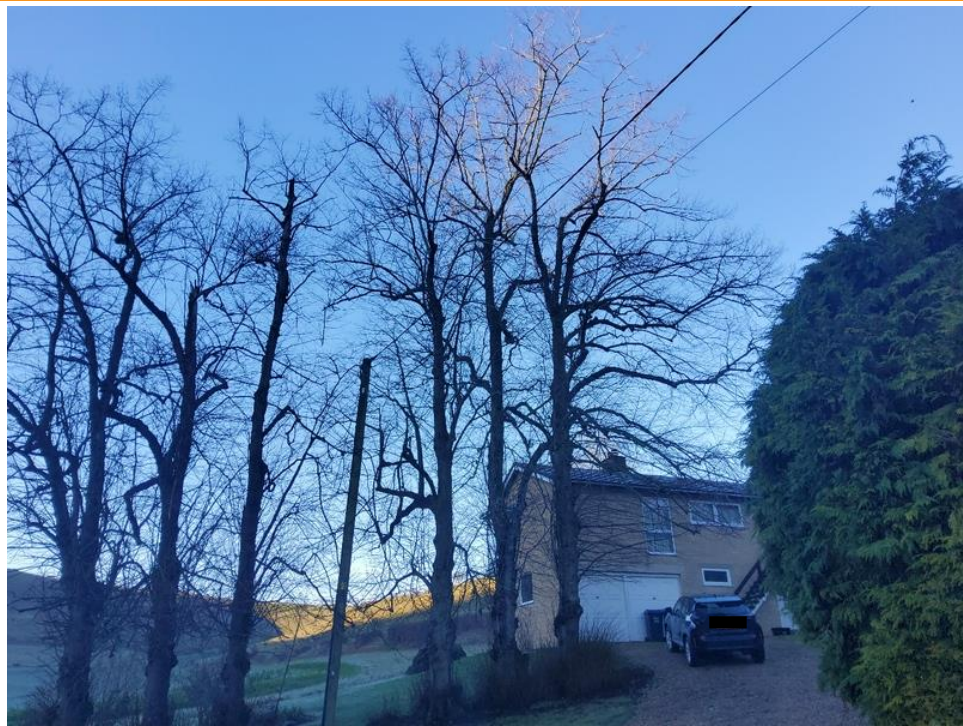
T5 Lime (Common)

| Tree No: | Common Name | Age Class | Condition | Height (m) | Crown Spread (m) | Stem diam. (mm) | No. of Stems | Dist to bldg. (m) | Roots Implicated | Pruning History | Recommendation | Tree Work Constraints | Notes | Owner address | Owner |
|---|---|---|---|---|---|---|---|---|---|---|---|---|---|---|---|
| T5 | Lime (Common) | Mature | Fair | 16.00 | 12.00 | 700 | 1 | 6.40 | No | Subject to historic crown reduction management. | Fell and treat stump with eco plugs (broadleaved). | There are restrictions to the site or to the tree - contractor should quote. Power lines running adjacent to crown. | Distance is to closest point to property. Large amounts of epicormic growth throughout and up the tree. Crown lopsided to the east and west. | Combe Farm, Coombe Lane, Bratton BA13 4SY | PH |

| Tree No: | Species | Works Required | CA | TPO | Ownership |
|---|---|---|---|---|---|
| T5 | Lime<br>(Common) | Fell and treat stump with eco plugs (broadleaved). | Yes | No | PH |

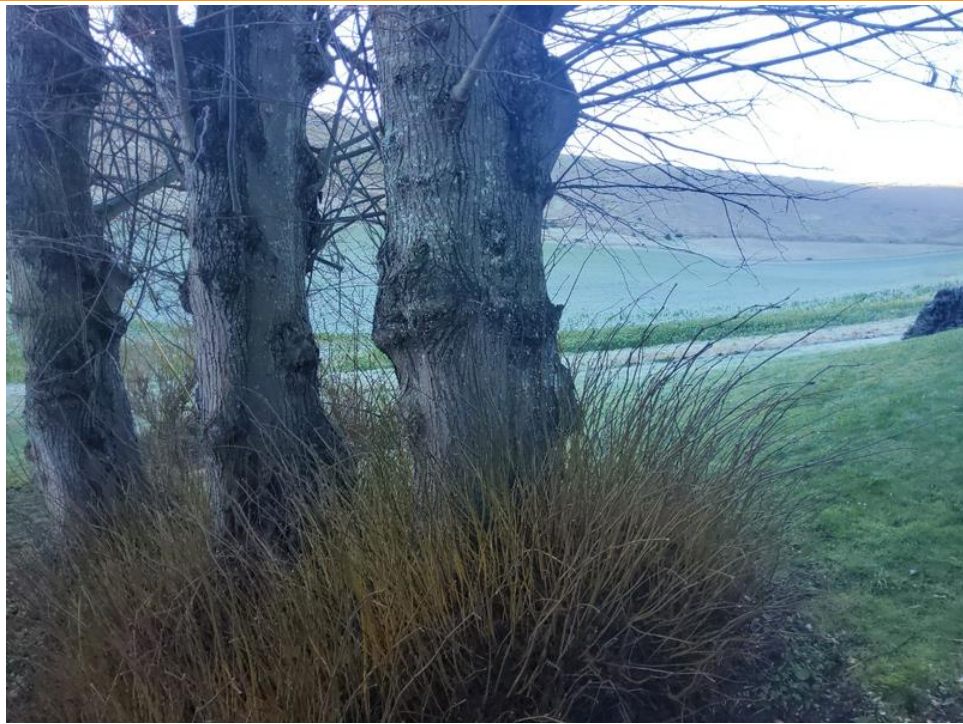
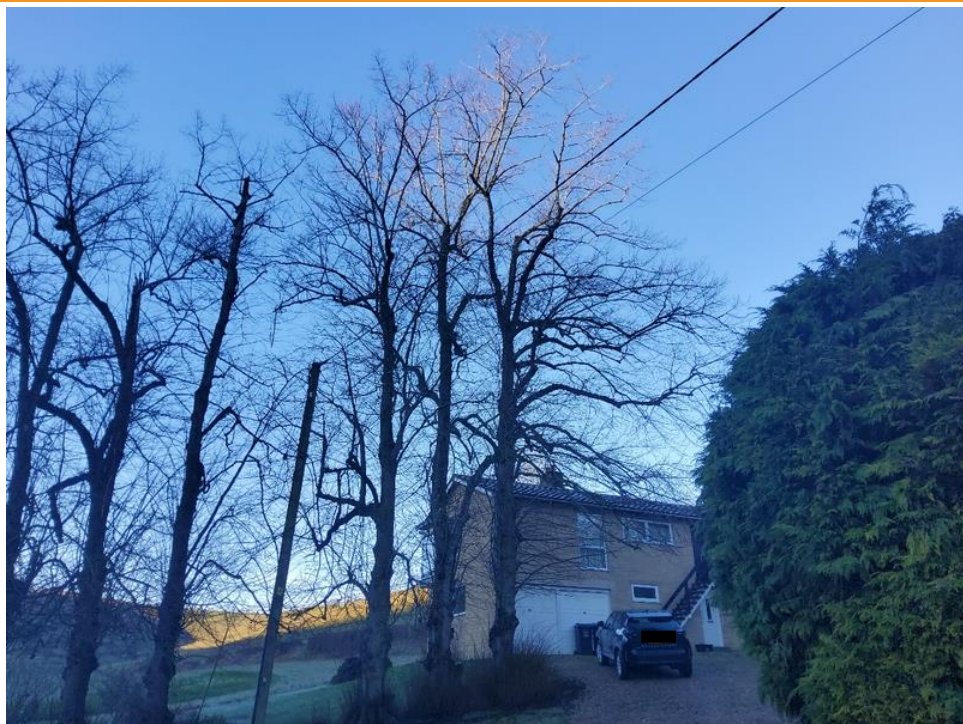
T6 Lime (Common)

| Tree No: | Common Name | Age Class | Condition | Height (m) | Crown Spread (m) | Stem diam. (mm) | No. of Stems | Dist to bldg. (m) | Roots Implicated | Pruning History | Recommendation | Tree Work Constraints | Notes | Owner address | Owner |
|---|---|---|---|---|---|---|---|---|---|---|---|---|---|---|---|
| T6 | Lime (Common) | Mature | Fair | 16.00 | 12.00 | 750 | 1 | 6.00 | No | Subject to historic crown reduction management. | Fell and treat stump with eco plugs (broadleaved). | There are restrictions to the site or to the tree - contractor should quote. Power lines running adjacent to crown. | Distance is to closest point to property. Large amounts of epicormic growth throughout and up the tree. Crown lopsided to the north. | Combe Farm, Coombe Lane, Bratton BA13 4SY | PH |

| Tree No: | Species | Works Required | CA | TPO | Ownership |
|---|---|---|---|---|---|
| T6 | Lime<br>(Common) | Fell and treat stump with eco plugs (broadleaved). | Yes | No | PH |

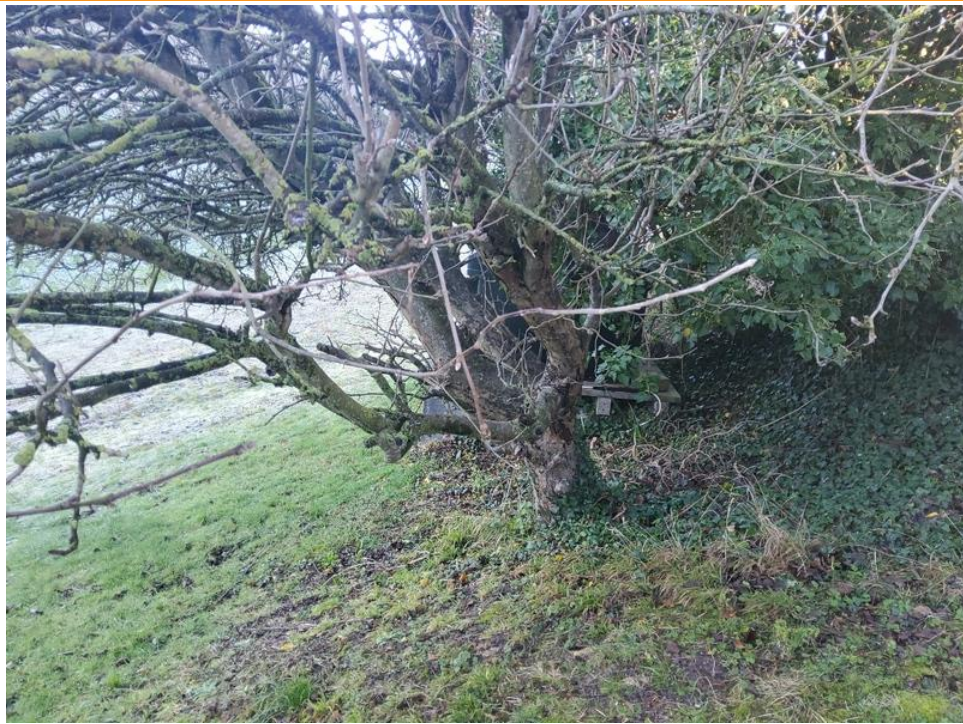
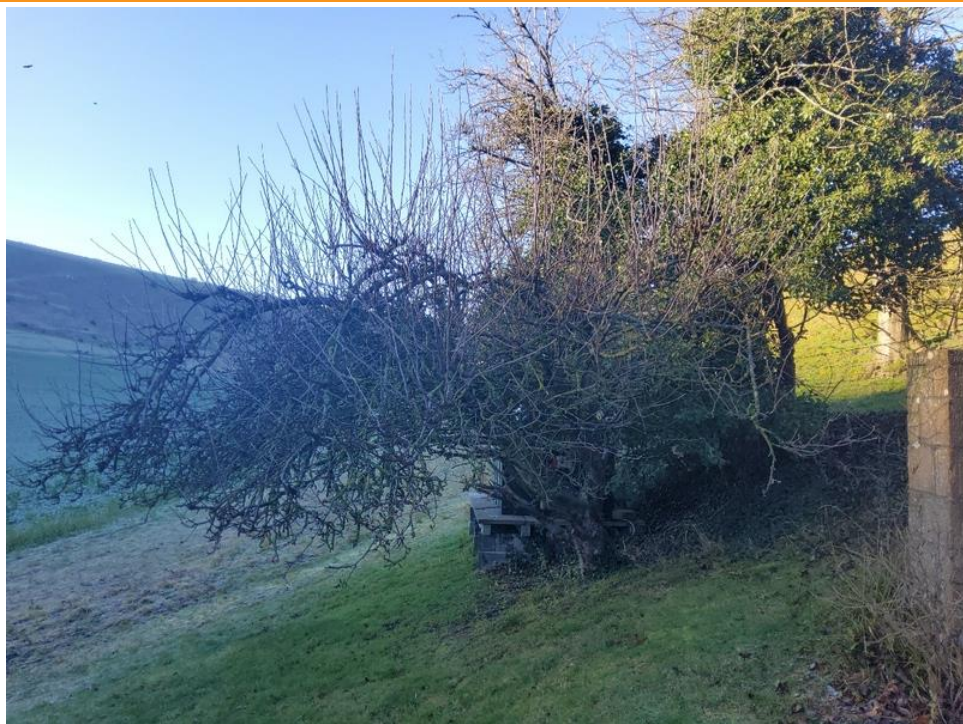
T7 Apple

| Tree No: | Common Name | Age Class | Condition | Height (m) | Crown Spread (m) | Stem diam. (mm) | No. of Stems | Dist to bldg. (m) | Roots Implicated | Pruning History | Recommendation | Tree Work Constraints | Notes | Owner address | Owner |
|---|---|---|---|---|---|---|---|---|---|---|---|---|---|---|---|
| T7 | Apple | Mature | Fair | 3.50 | 7.00 | 225 | 4 | 8.60 | Yes | Subject to historic crown reduction management. | Fell and treat stump with eco plugs (broadleaved). | There are restrictions to the site or to the tree - contractor should quote. Overhanging oil tank. | Distance is to closest point to property. Crown lopsided to the southeast. Approximate DBH range of 110mm - 240mm. | Combe Farm, Coombe Lane, Bratton BA13 4SY | PH |

| Tree No: | Species | Works Required | CA | TPO | Ownership |
|---|---|---|---|---|---|
| T7 | Apple | Fell and treat stump with eco plugs (broadleaved). | Yes | No | PH |

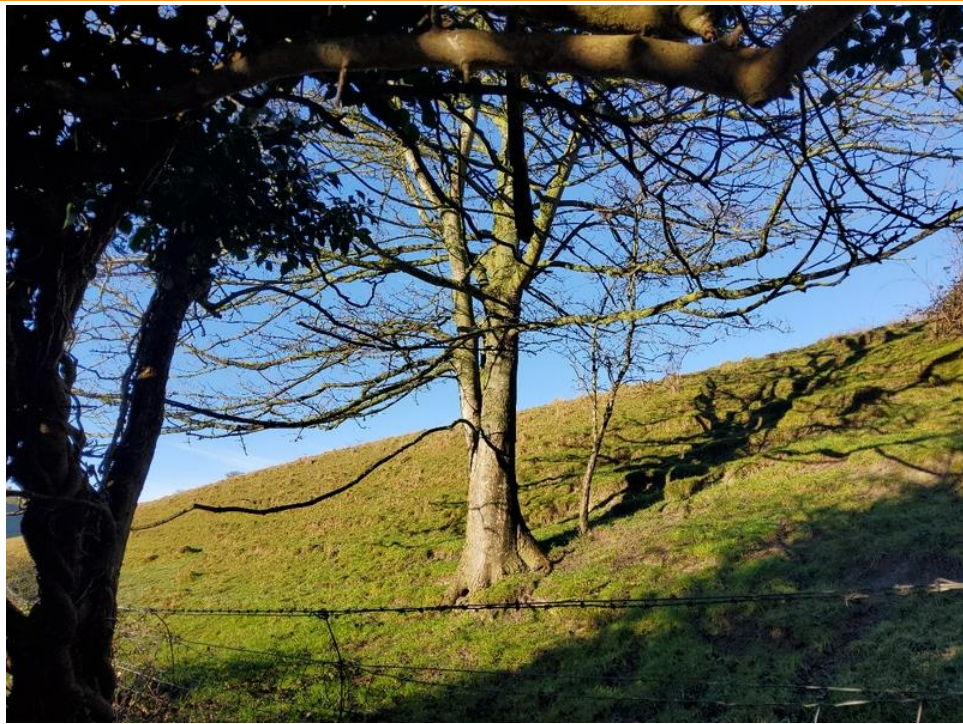
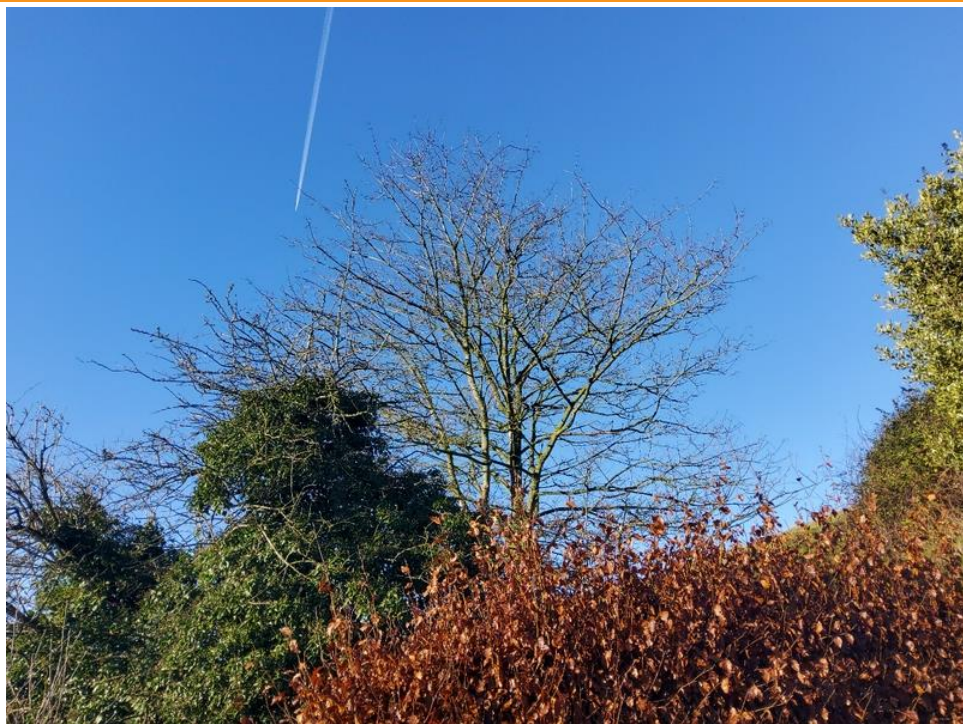
T9 Sycamore

| Tree No: | Common Name | Age Class | Condition | Height (m) | Crown Spread (m) | Stem diam. (mm) | No. of Stems | Dist to bldg. (m) | Roots Implicated | Pruning History | Recommendation | Tree Work Constraints | Notes | Owner address | Owner |
|---|---|---|---|---|---|---|---|---|---|---|---|---|---|---|---|
| T9 | Sycamore | Mature | Fair | 11.00 | 10.00 | 475 | 1 | 14.50 | No | No significant past works. | Fell and treat stump with eco plugs (broadleaved). | The commercial third party will be responsible for works. | All measurements estimated due to lack of access. | Combe Farm, Coombe Lane, Bratton BA13 4SY | PH |

| T9 | Sycamore | Fell and treat stump with eco plugs (broadleaved). | Yes | No | PH |

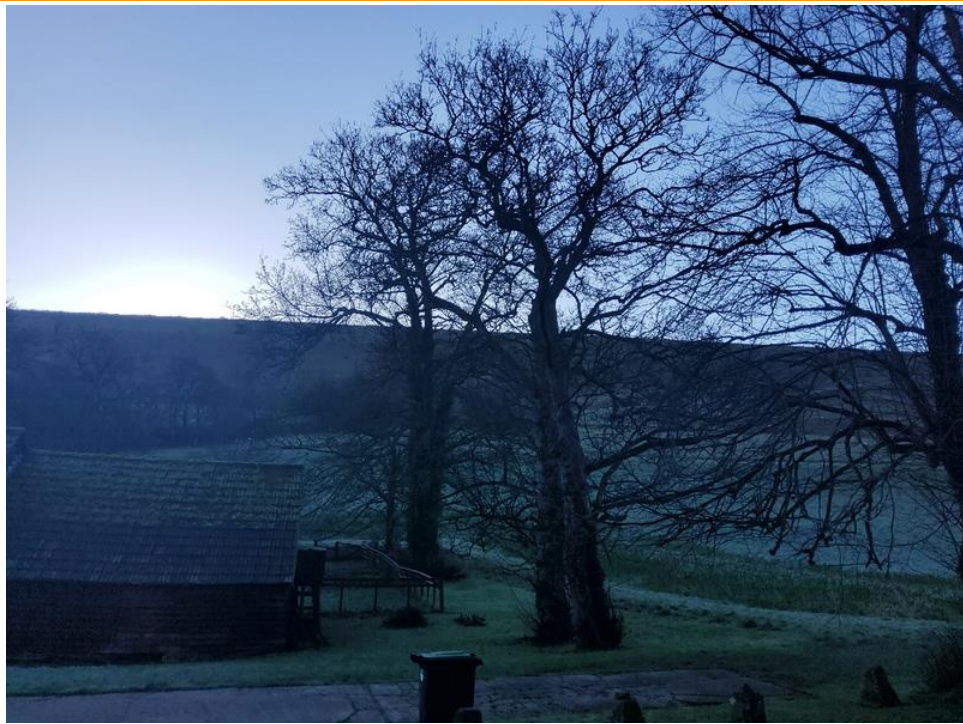
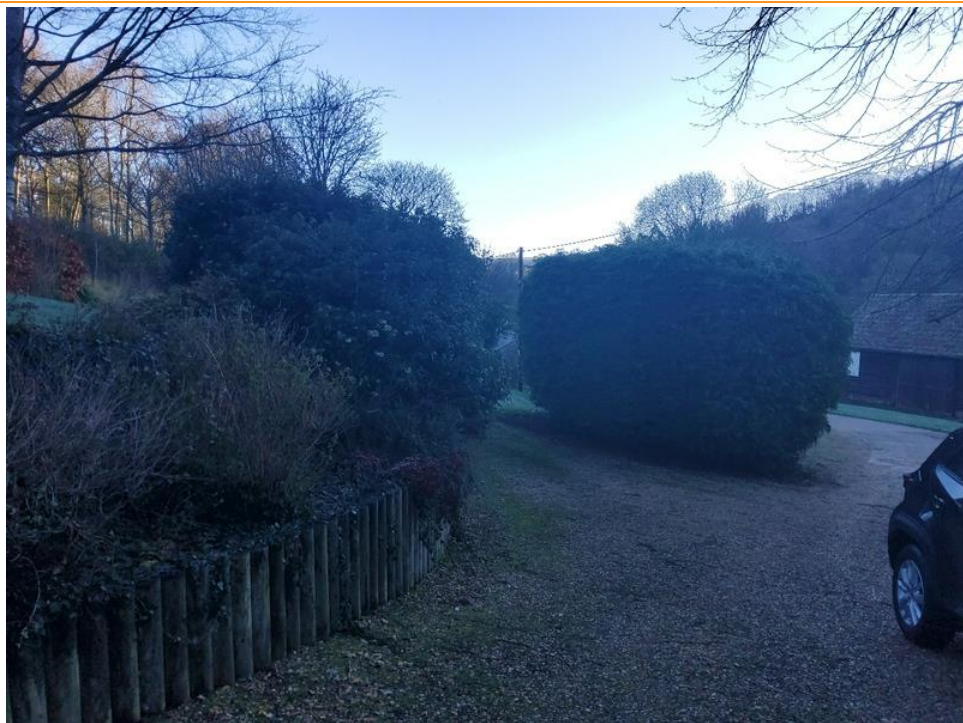
Further vegetation observed to front of property however considered outside expected influencing distance at point of.

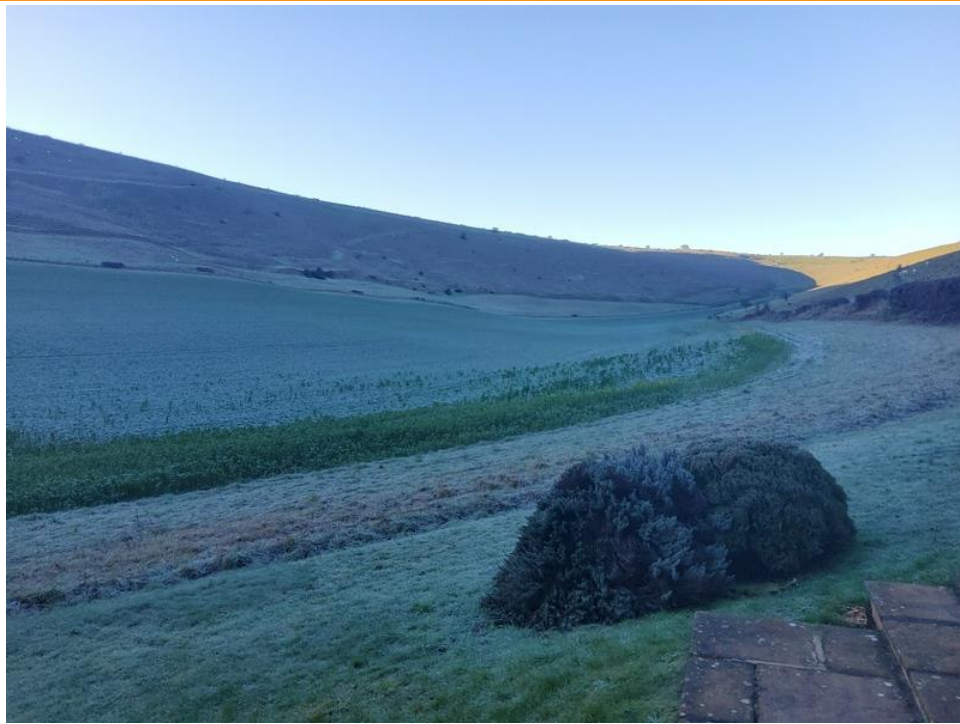
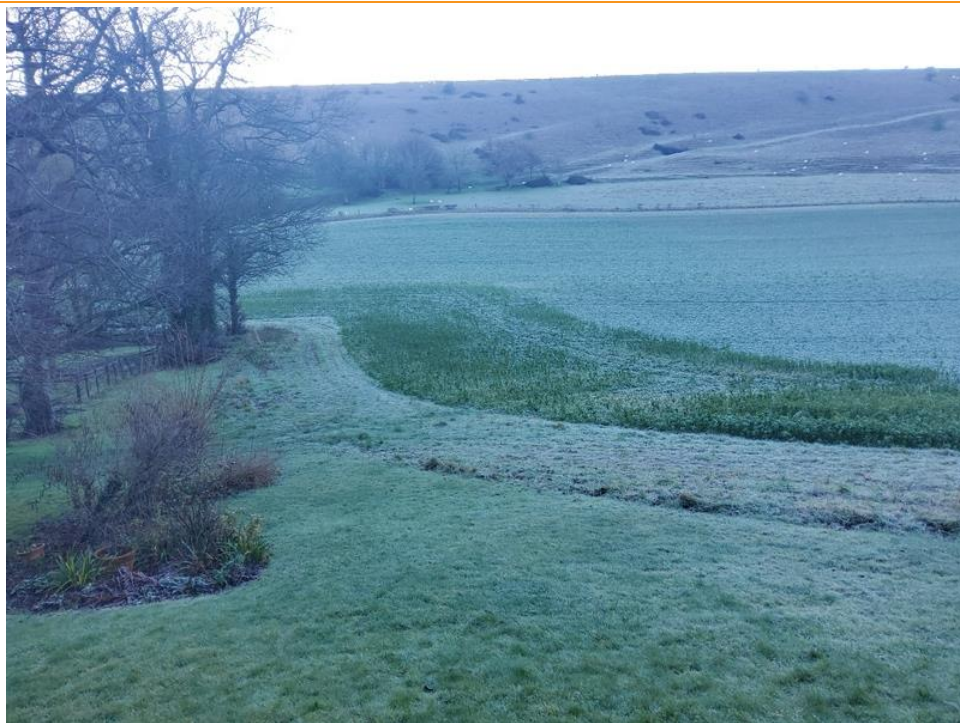
Limited to no vegetation to rear LHS of property within an influencing distance or size.
