# PRELIMINARY ARBORICULTURAL REPORT

Coombe Farm, Coombe Lane, Bratton, Westbury BA13 4SY

Client: Sedgwick International UK  
Insurer: NFU Mutual Insurance

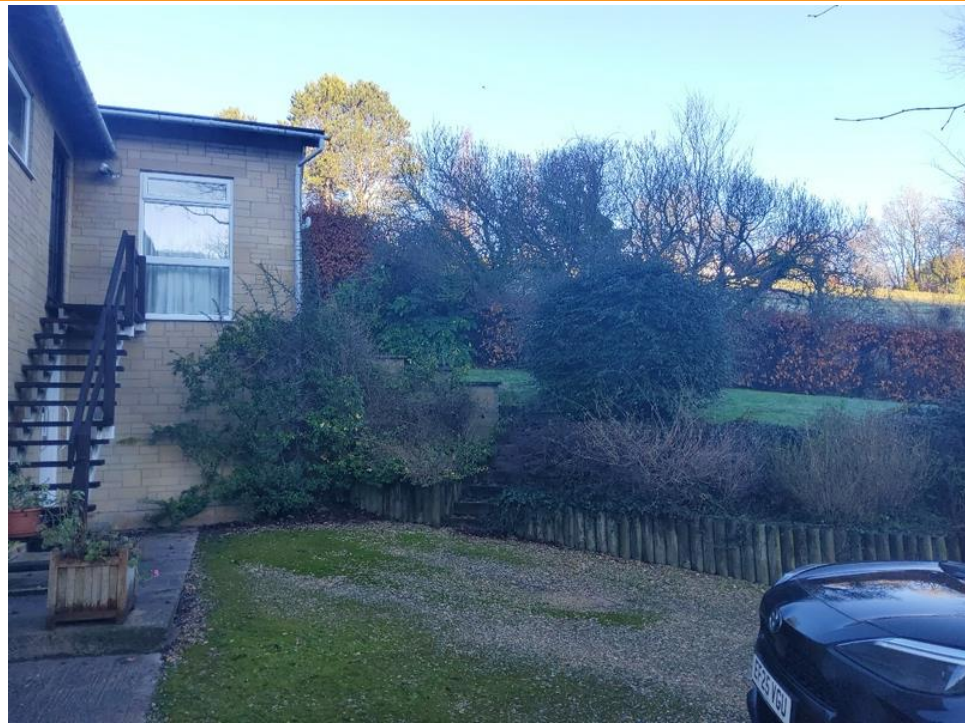
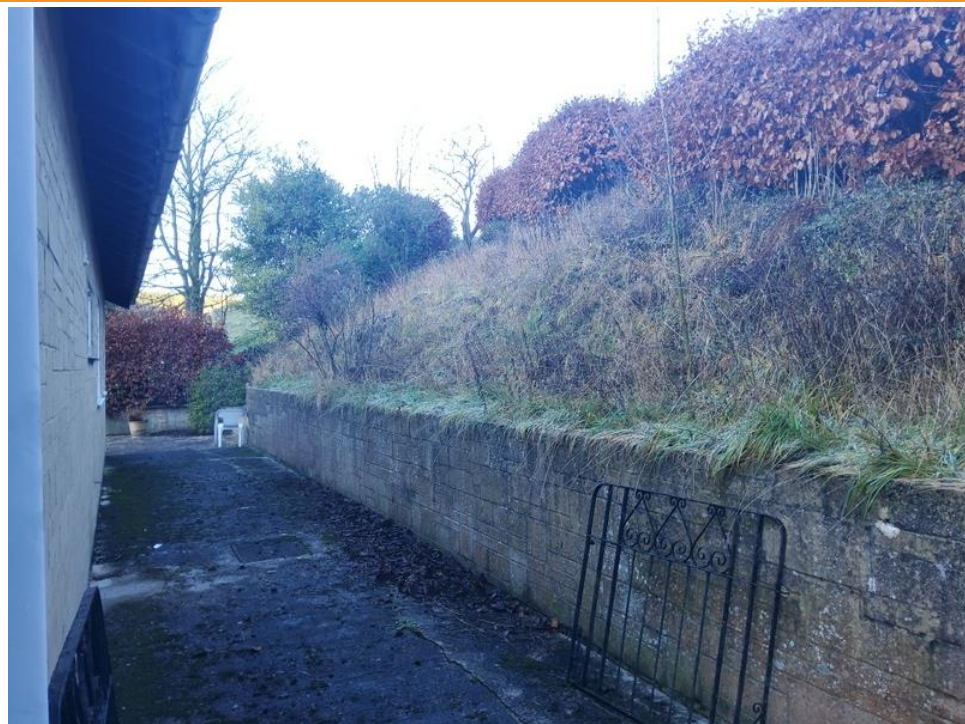
RHS of property located on raised ground.
