Coombe Farm  
Coombe Lane  
Bratton  
Westbury  
BA13 4SY

**INSURANCE CLAIM**

**CONCERNING SUSPECTED SUBSIDENCE**

**ENGINEERING APPRAISAL REPORT**

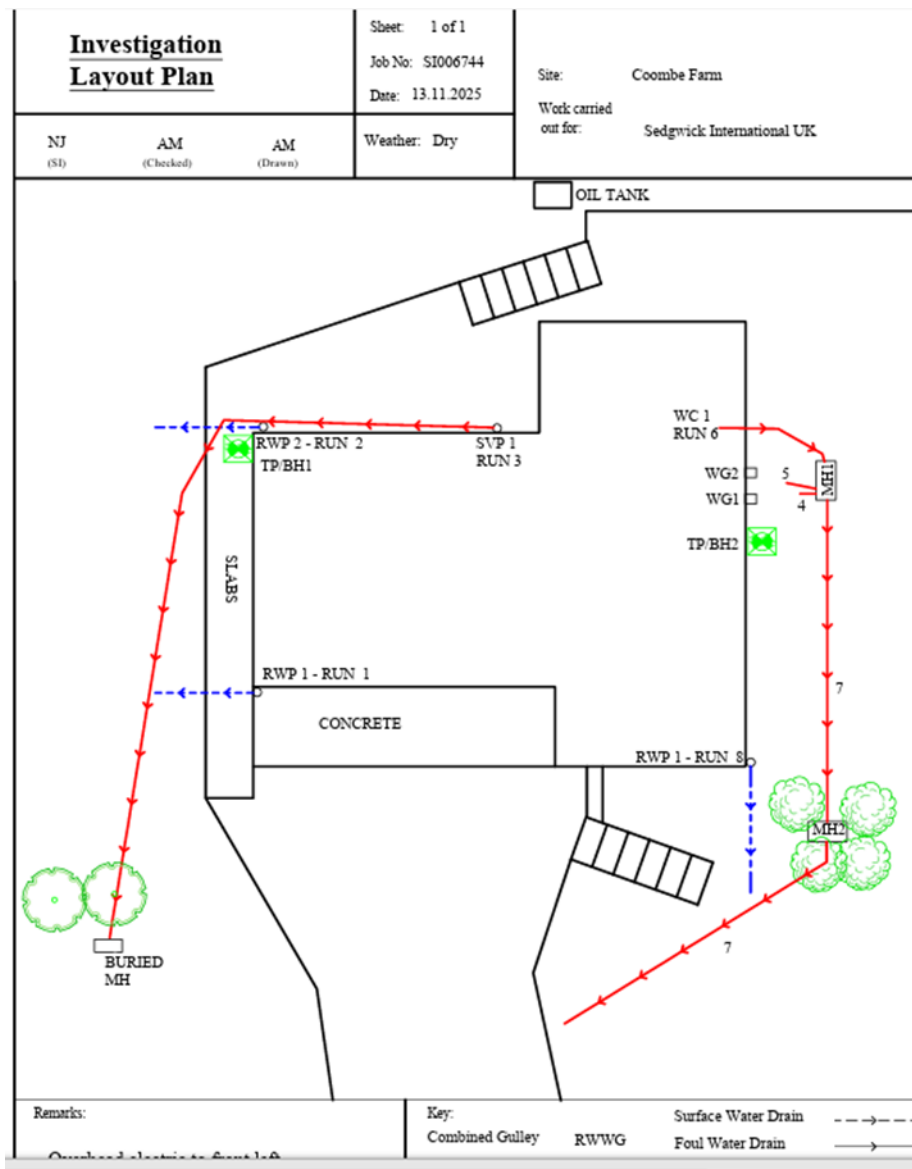
Following the recent site investigation at Coombe Farm, two trial pits and boreholes (TP/BH1 and TP/BH2) were examined to determine the cause of structural movement and a CCTV of the drainage as per the plan noted below:

Roots identified down to approximately 2.0 m, including Hebe species and Pomoideae group (apple, cotoneaster, hawthorn).

Subsoil comprises firm silty clay with moderate plasticity ( $PI \sim 23-24\%$ ) and suction values up to 200 kPa, indicating shrink-swell potential.

Movement in this area is consistent with vegetation-induced desiccation, compounded by seasonal moisture variation.

No roots were observed or recovered for identification.

Subsoil is stiff silty clay with chalk nodules, moderate plasticity (PI ~21–23%) and suction values up to 205 kPa. Significant drainage defects were recorded nearby, including joint displacement, cracking, debris, and root ingress within pipes (Runs 2, 5, and 8).

Movement here is primarily attributed to drainage leakage and structural defects, with seasonal clay shrink–swell as a secondary factor.

CCTV survey confirmed multiple unserviceable runs (1, 2, 5, and 8) with displaced joints, cracks, and root intrusion.

These defects can lead to localized softening and differential settlement, increasing subsidence risk when combined with shrink–swell clay.

Remove or prune moisture-demanding shrubs near TP/BH1.

No root action required at TP/BH2.
