## SITE INVESTIGATION FACTUAL REPORT

Report No: 006744

Client: Sedgwick International UK

Site Address: Coombe Farm, BA13 4SY

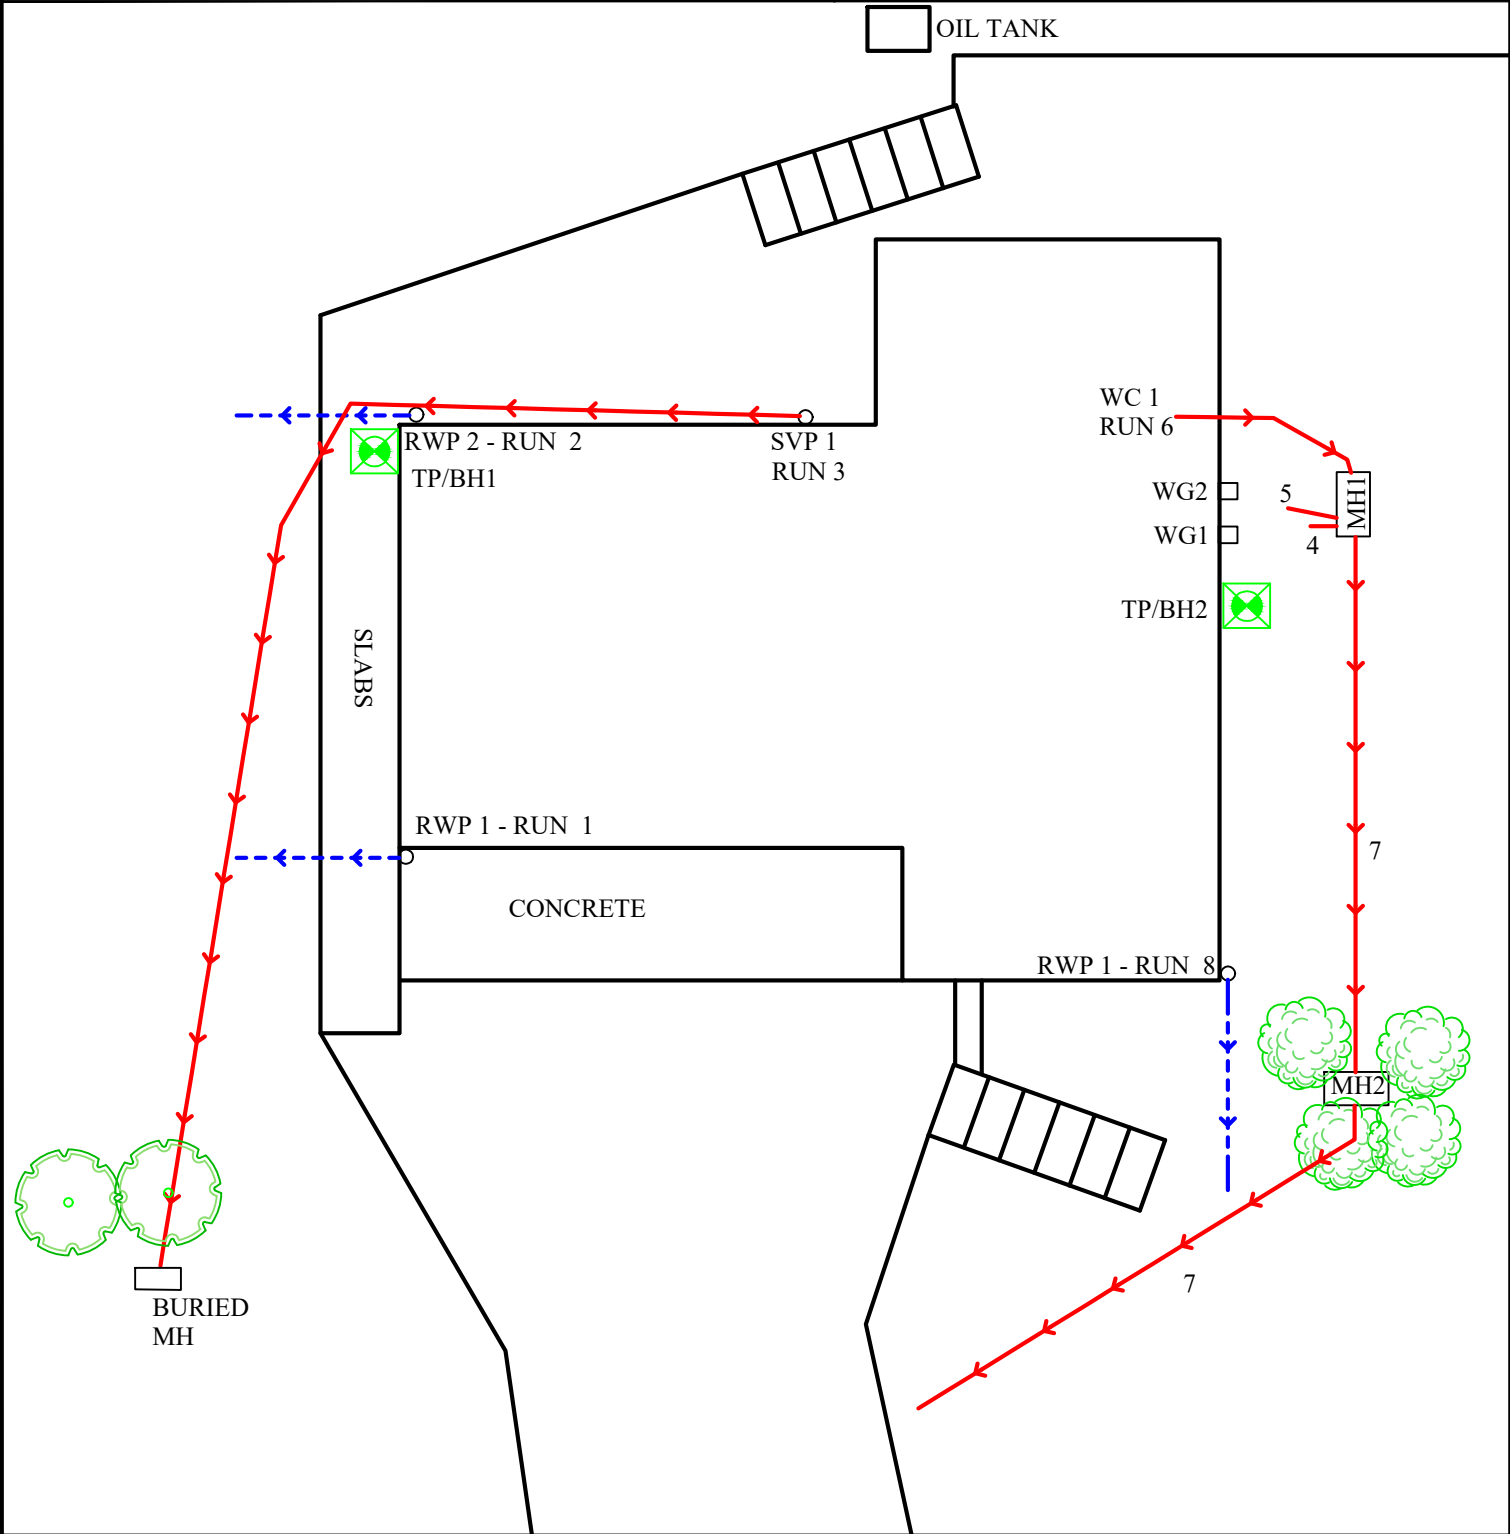
REPORT NUMBER: C5016281 / 380732.1.1.1  
TRIAL PIT REF: TP1  
CLIENT: Sedgwick International UK  
JOB NO: SI006744  
EXCAVATION METHOD: Hand tools

For Strata below 1000mm see Bore Hole log
