# BUCKLEAZE FARMHOUSE, PEWSEY, WILTSHIRE

## Heritage Statement

February 2026

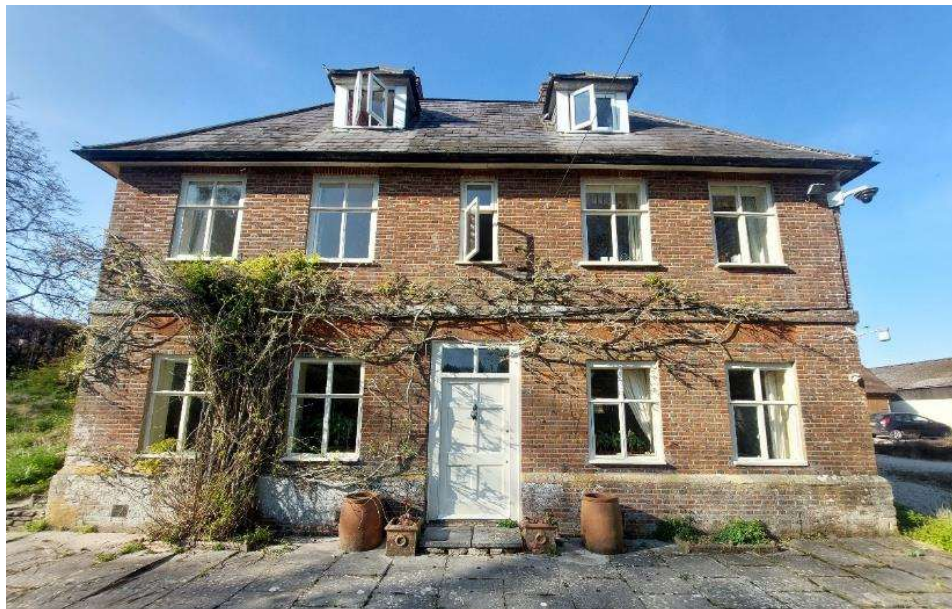
- 3.1 Buckleaze Farmhouse is a two-storey and attic house constructed in brick laid in Flemish bond with a regular use of burnt headers – this is not ‘diaper brick’ as mentioned in the list description (Figure 4). The front elevation is of five bays with a smaller central first floor window, the larger windows being mullion and transom windows which are set in adapted openings – at ground floor level the upper part of the original openings have been bricked up to the gauged brick arches over. The proportions of the original openings suggest that the windows would have been sashes, typical for a house of this period and character.

Figure 4 Front, south elevation.

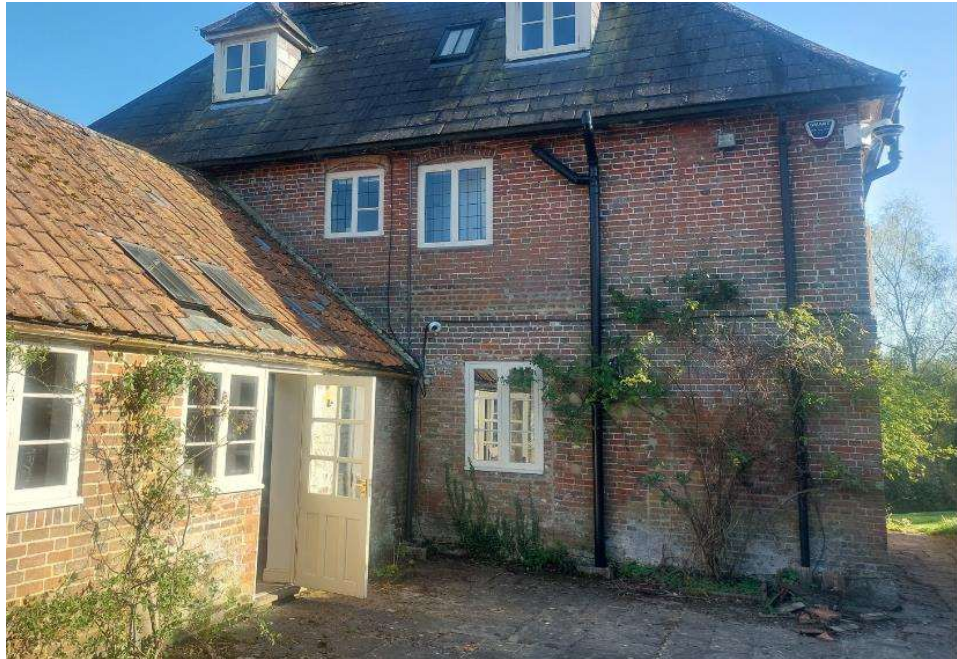
- 3.2 The rear elevation is considerably less formal in its appearance: the brickwork is laid in English bond which, without the pattern created by regular use of burnt headers on the front elevation, creates a relatively plain appearance (Figure 5). Also, the fenestration to this elevation is irregular, having two casement windows of different sizes at first floor level and a single casement window at ground floor level which is set within an area of brickwork that has clearly been altered. There are straight joints in the brickwork to the right of this window suggesting the presence of a blocked door.

Figure 5 Rear elevation.

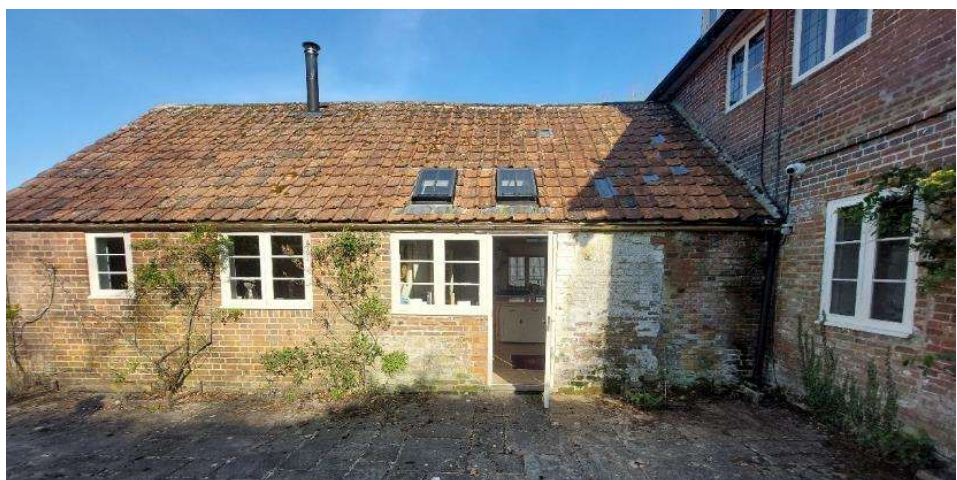
- 3.3 Attached to the east side of the rear elevation is a single-storey range that has been extended to the north (1996). On the west elevation, the earlier brickwork is partly white-washed although the section that was within the small lean-to in the angle between the rear elevation and the range is unpainted (Figure 6). The section beneath the window to the left of the door has been partly rebuilt beneath the window. There is a straight joint to the brickwork of the extension. The east elevation has a three-light casement to the historic element near the house (Figure 7).

Figure 6 The west elevation of the rear range.

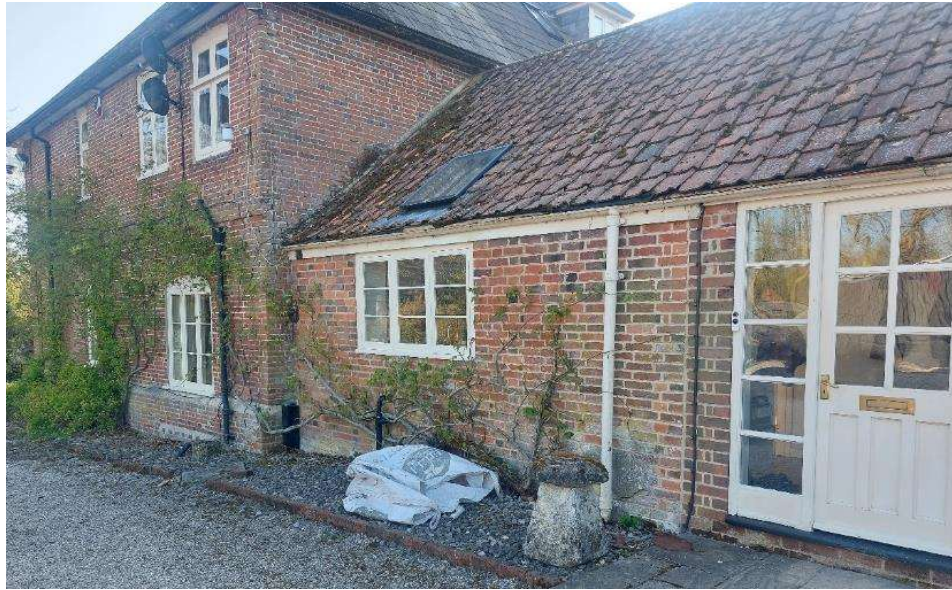
Figure 7 The southern part of the east elevation of the rear range.
