## Heritage Statement & Impact Assessment

**THE OLD RECTORY, CHURCH LANE, WINGFIELD, WILTSHIRE, BA14 9LW**

### **ROOF STRUCTURE & ASSOCIATED REPAIRS**

Job Ref: 20250307

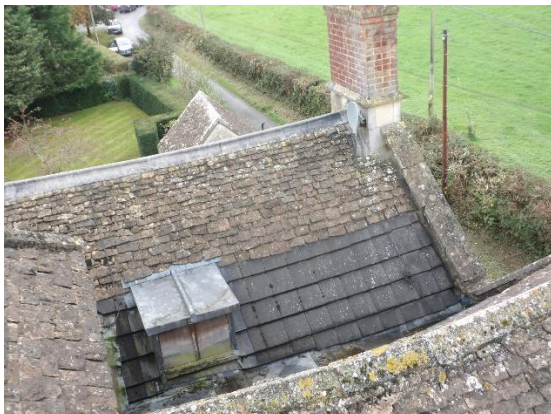
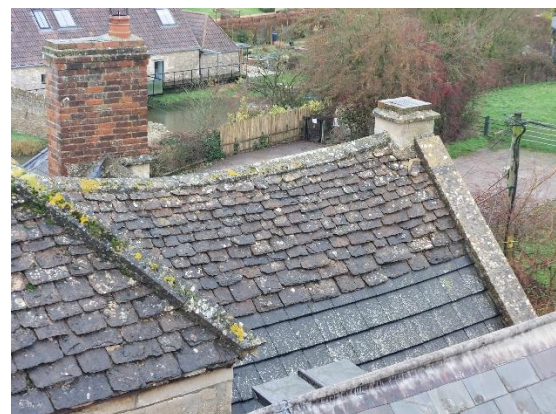
(North west roadside gables elevation roof coverings with a mixture of old stone and replacement concrete tiled covering and boarded up dormer window)

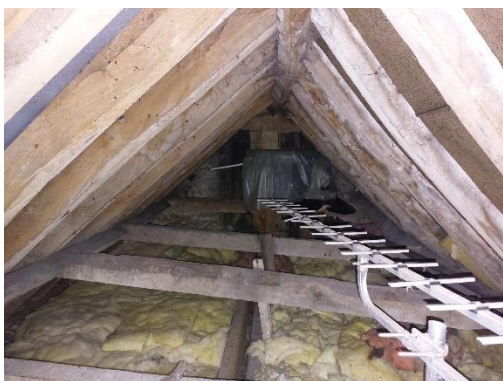
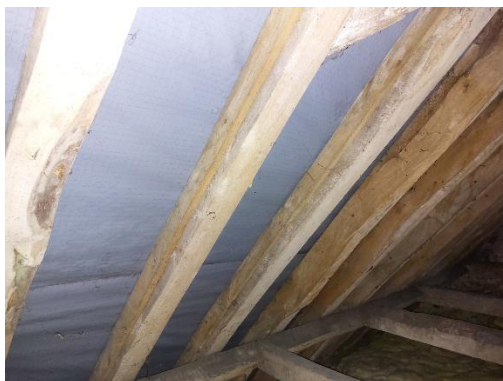
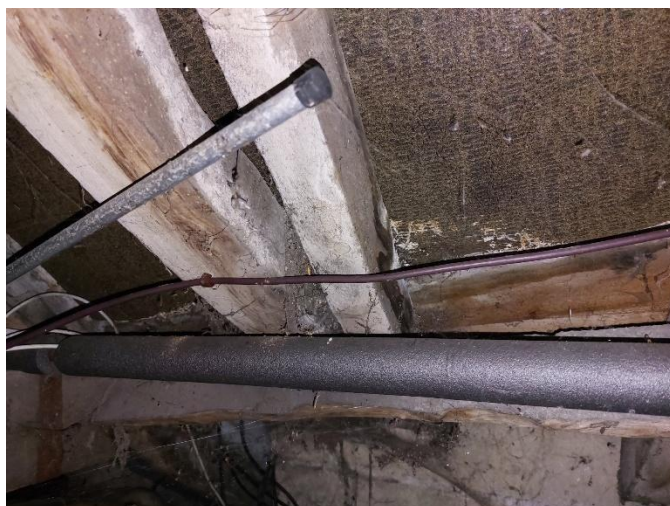
(Roof void from main attic office accommodation with replacement reinforced polythene sheet and older style 1F bitumen felts over old roof structure with some replacement rafters noted, some timber decay noted from water penetration)

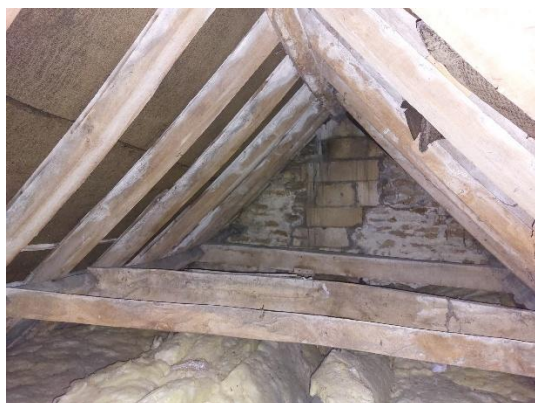
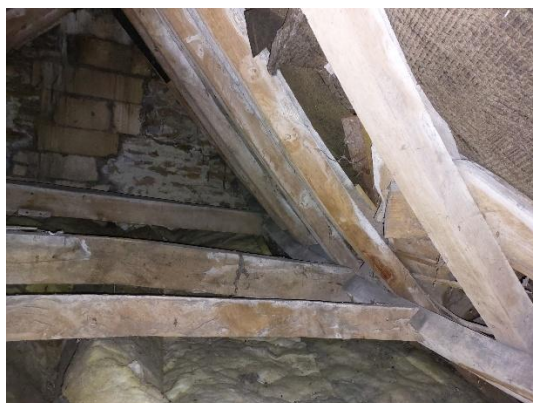
(Roof void from bedroom, with older style and deteriorating 1F bitumen felt, some timber decay noted from water penetration)

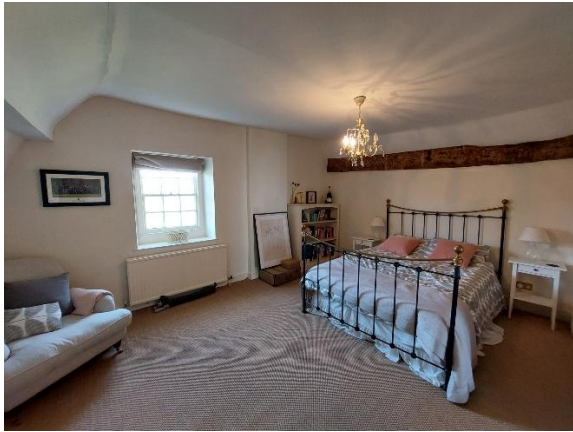
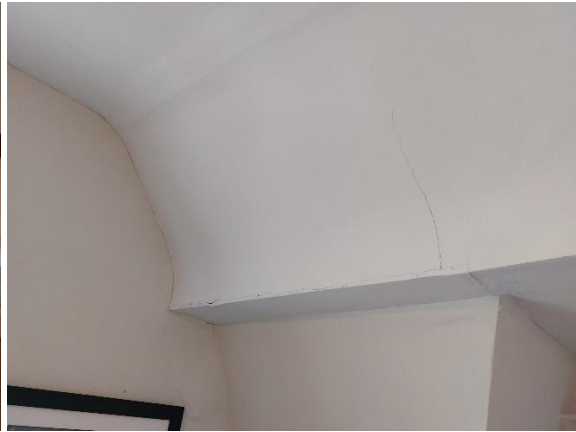
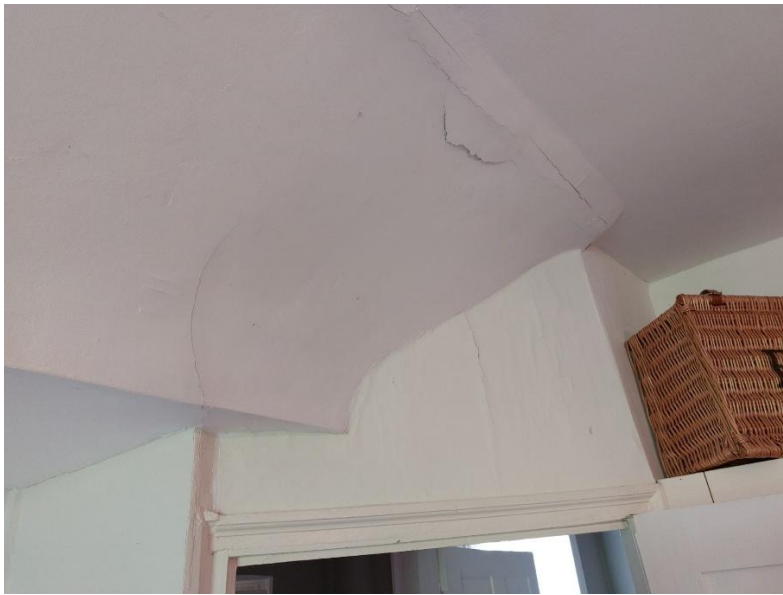
(2<sup>nd</sup> floor north west main bedroom, structural movement cracking noted beneath north west gabled roof structure)

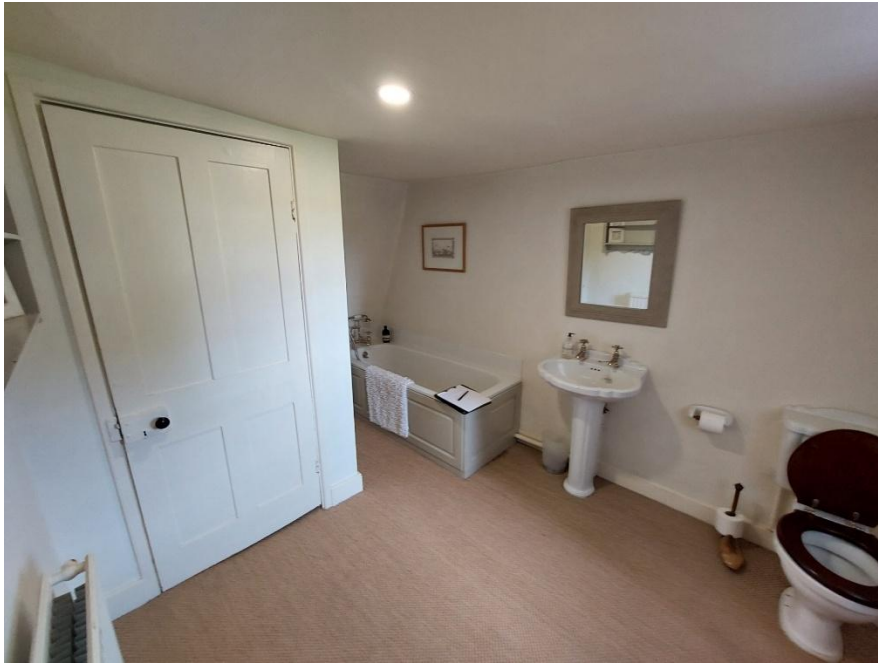
(2<sup>nd</sup> floor bathroom, below north west gables, no roof access, new roof hatch to be positioned within airing cupboard to inspect and access roof void and structure)

The introduction of a new roof hatch to the bathroom will enable the inspection and future maintenance of the roof structure and void over the bathroom. The new roof hatch to be positioned discretely within the bathroom.

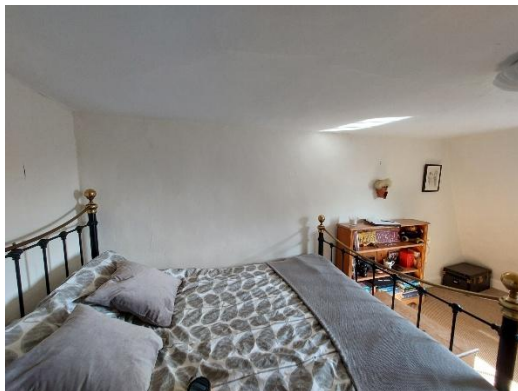
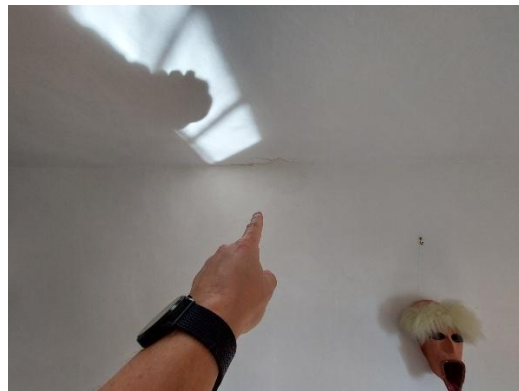
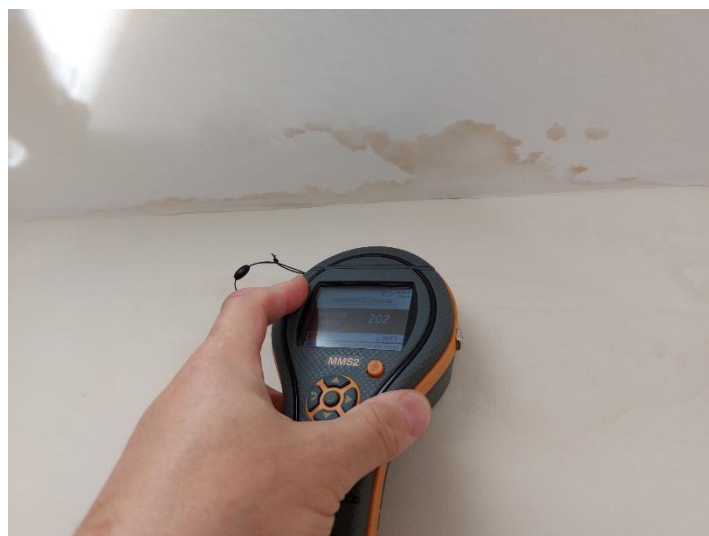
(2<sup>nd</sup> floor south east bedroom, cracking and water penetration noted)

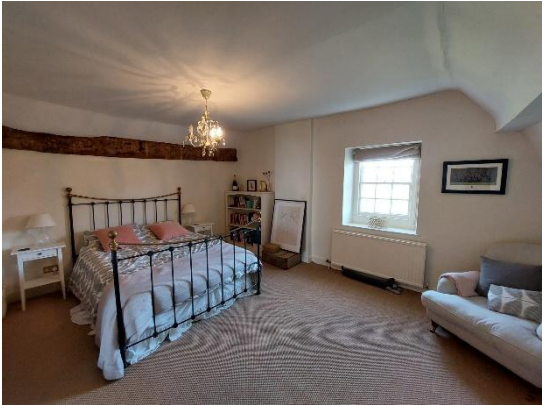
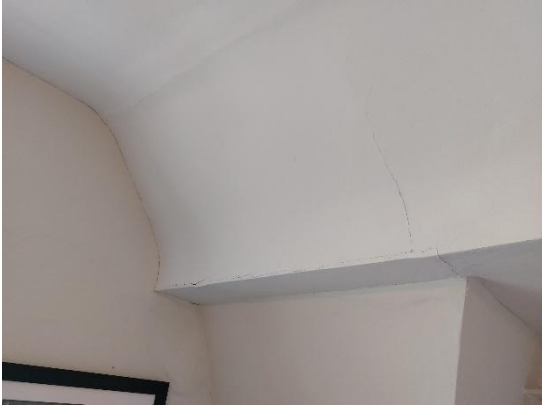
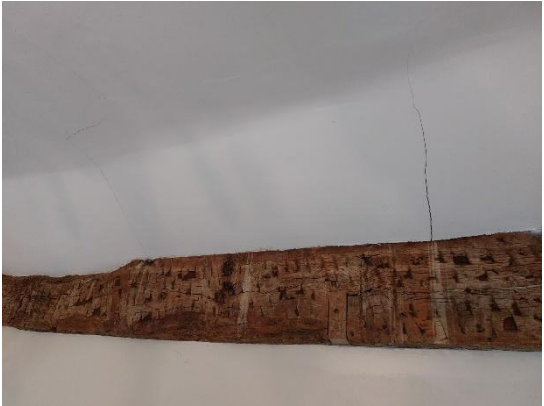
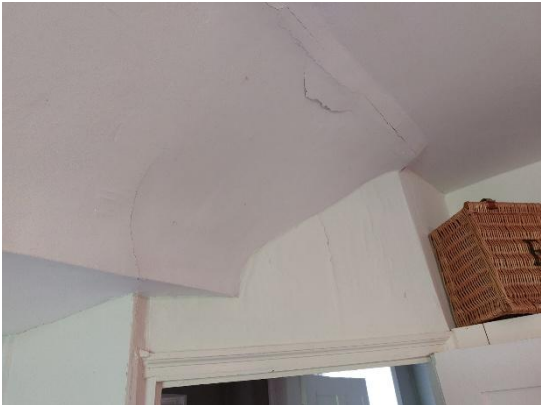
| 2. | Master bedroom set under north west gable roof range, daughter's bedroom, significant cracking to ceiling and wall plaster under roof structure | |

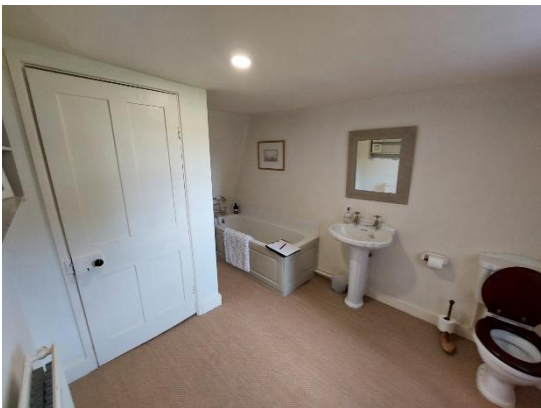
| 5. | Ditto. | |
|---|---|---|
| 6. | Bathroom set under north west gabled roof range, without roof access hatch to inspect roof structure and void, access hatch required | |

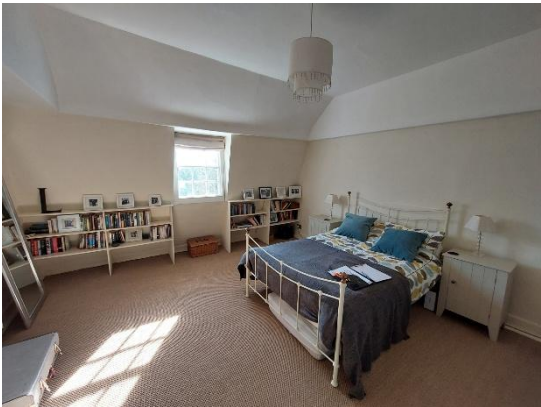
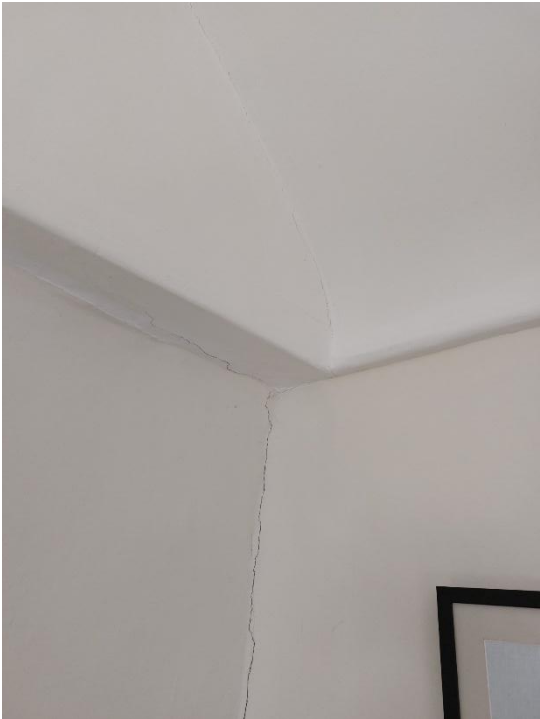
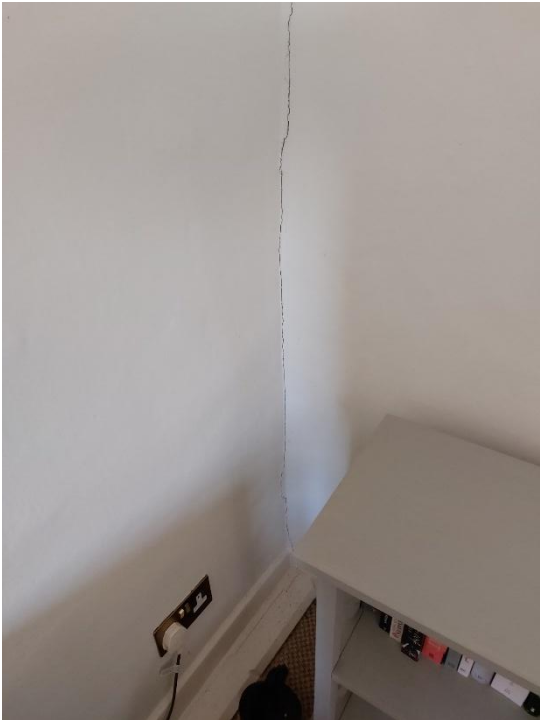
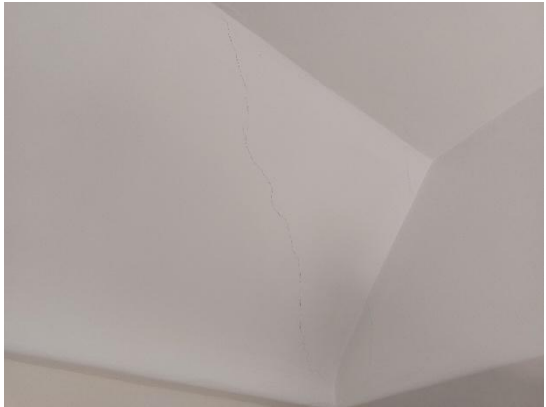
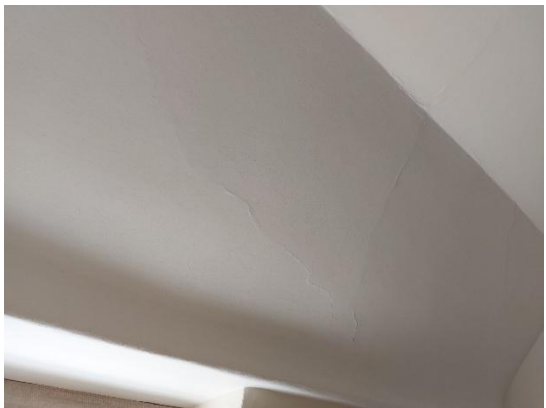
| 5. | Ditto. | |
|---|---|---|
| 7. | 2nd floor bedroom set under south east gable roof range, cracked ceiling and water penetration noted | |

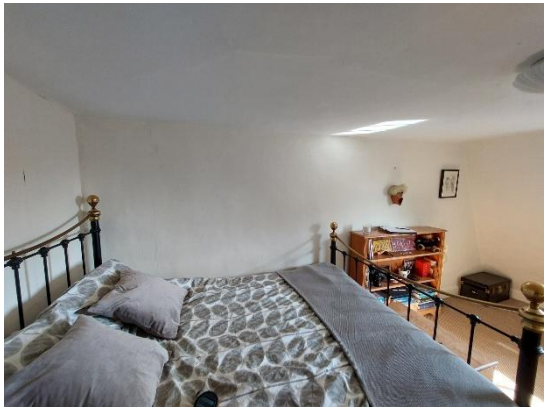
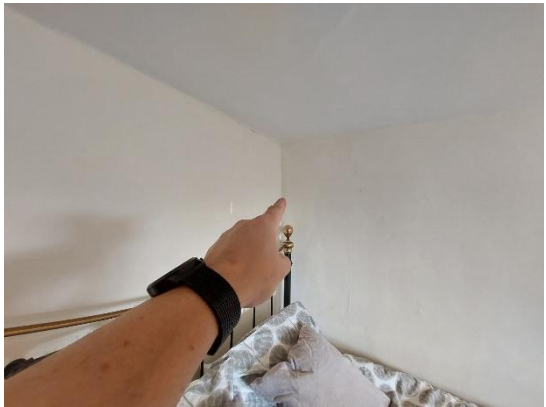
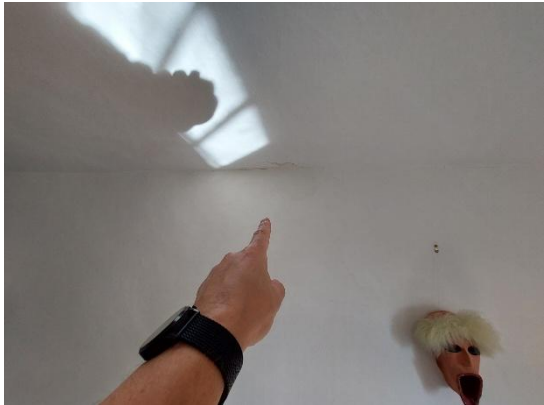
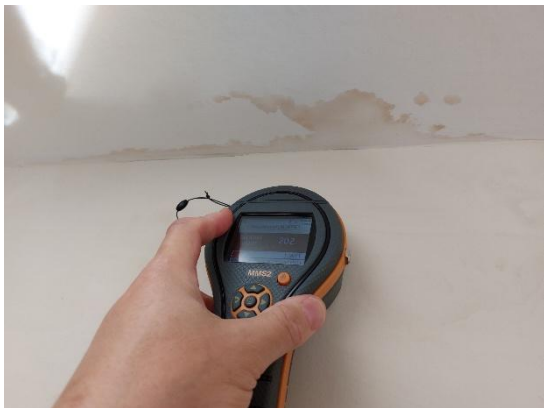
| 10. | Ditto. | |
|---|---|---|
| 12. | Secondary bedroom accommodation under south east roof range, cracking and water penetration noted to ceiling and wall plaster | |

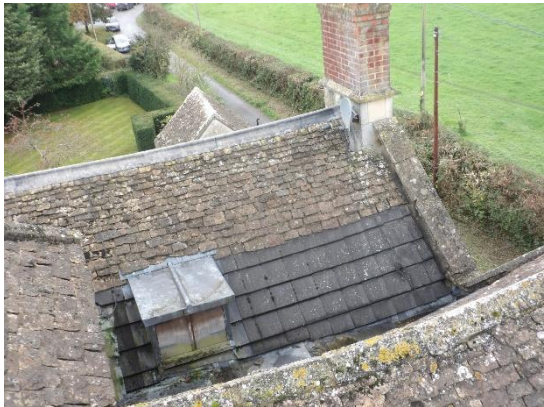
| 14. | Ditto. | |
|---|---|---|
| 17. | Ditto. concrete tiles used to lower half of hidden roof slop, old dormer window boarded up | |

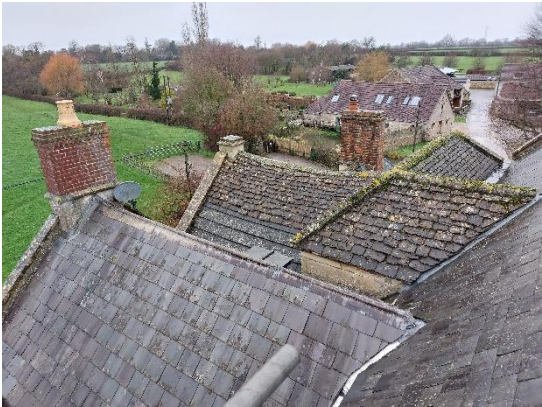
| 18. | Ditto. roof covering in mid-ground, ridge and main roof structure subject to structural movement with some decay noted | |

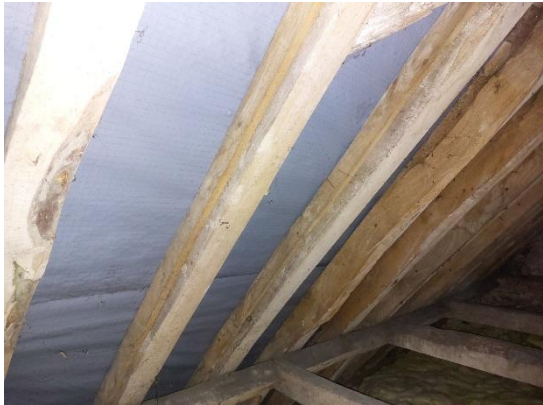
| 21. | Ditto. modern reinforced polythene sheeted sarking felt | |

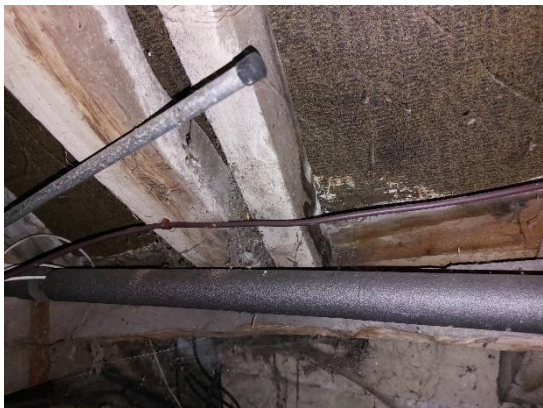
| 22. | Ditto. older style felt now being to rot and water penetration noted | |

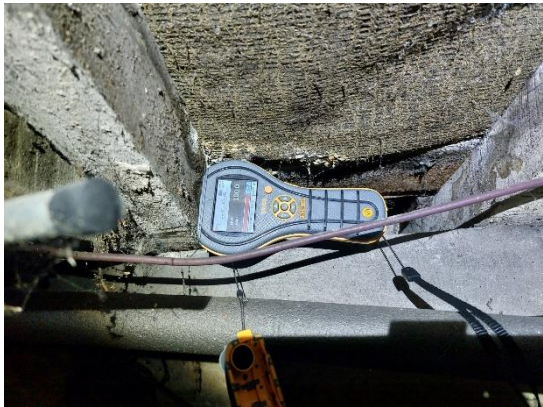
| 23. | Ditto. water penetration, high moisture content to old rafters and timber decay noted | |

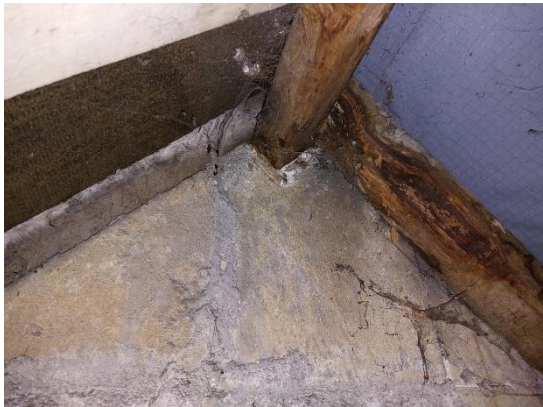
| 24. | Past rot and repairs noted to ridge | |

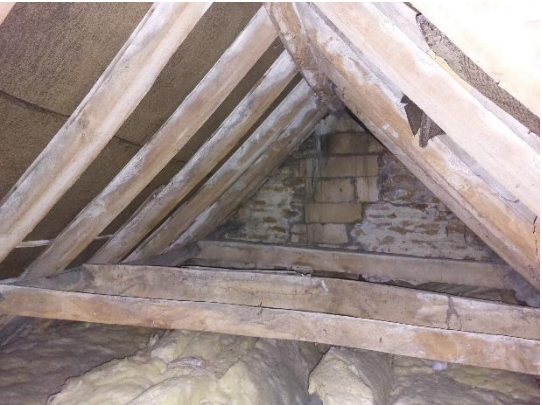
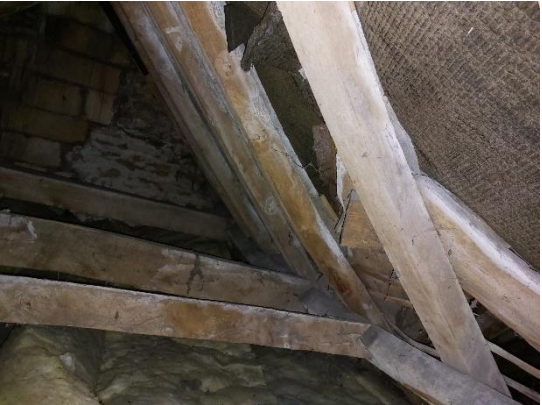
| 26. | Ditto. roof void with older style 1F bitumen sarking felt, with rotten section and water penetration noted, roof structure subject to movement | |

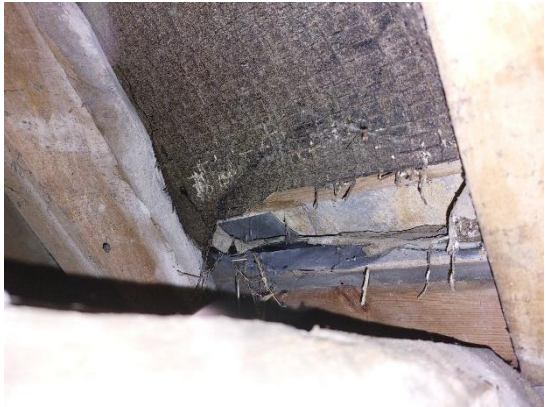
| 28. | Rotten roof felt noted | |

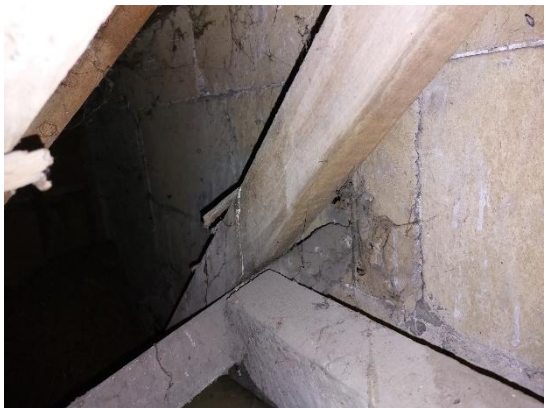
| 28. | Rotten roof felt noted | |
|---|---|---|
| 29. | Purling popped out of pocket, reinforcement required in accordance with Mann Williams details | |

*In roof space A, a new timber purlin member should be provided to prop the common rafters on the RHS. An allowance should be made for the purlin to be spliced to enable installation in the tight space. Softwood packing to the underside of the deflected rafters will be necessary to facilitate the varying levels. Steel bracketry will also be needed, to ensure the ends of the new purlin are secured on the masonry wall, mitigating the risk of new slippage due to the existing shallow pockets. New horseshow steel brackets should also be provided to secure the ends of the existing timber members where necessary. To ensure adequate robustness is reinstated, allowance should be made for providing new softwood noggins fixed with woodscrews between all existing common rafters, existing and new purlins.*

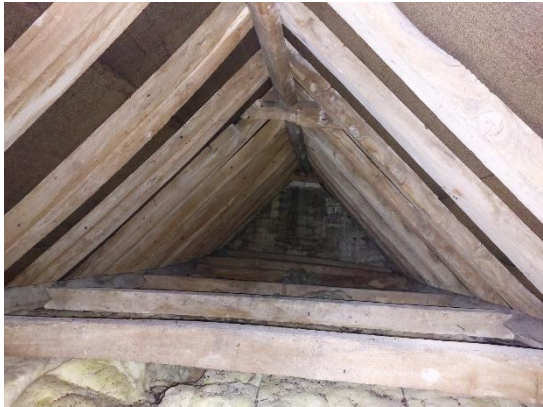
| 31. | Ditto. south east roof void with comparatively modern 1F bitumen felt | |
