# Hackthorne Cottage Durrington

## Inspection Report

Job Number: 12926

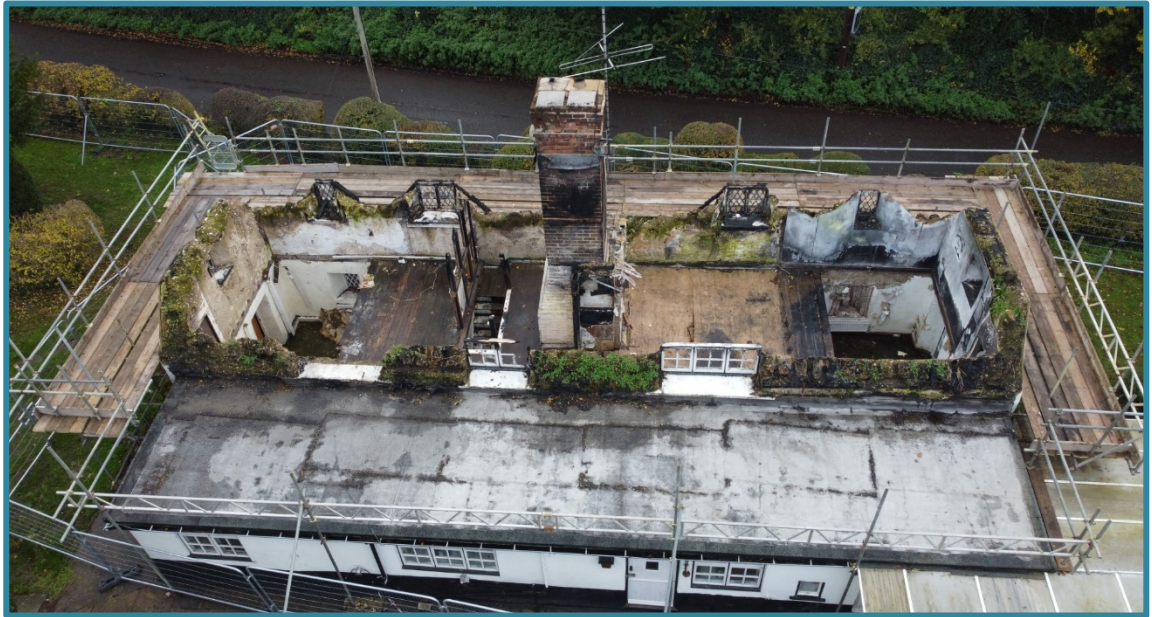
- 2.1.2 At the west end of the cottage a modern winding staircase remains giving access to the upper floor. The first floor though has collapsed due to failure in the timber floor beam bearing onto the rear cob wall. The beam has collapsed through the cob suggesting the integrity of the cob in this location has been compromised.

Figure 1 Aerial View Looking South

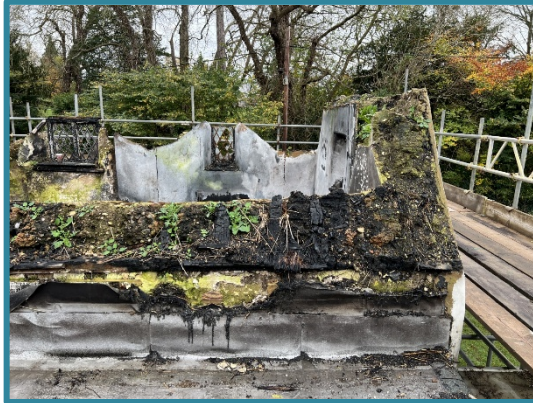
- 2.1.1 The roof of the cottage and all roof timbers as well as the first floor internal walls and partitions have been completely destroyed by the fire. Around the perimeter there are the remains of the rafters ends in place giving some evidence re roof rafter timber sizes, but no other evidence re the former roof configuration remains. All timber window lintels at first floor level, except those in each gable, have been destroyed. No remains of timber structures are present on site and the debris from the fire was presumably cleared as part of the post fire clean up and site protection works.

Figure 2 – Charred Remains Roof Timbers

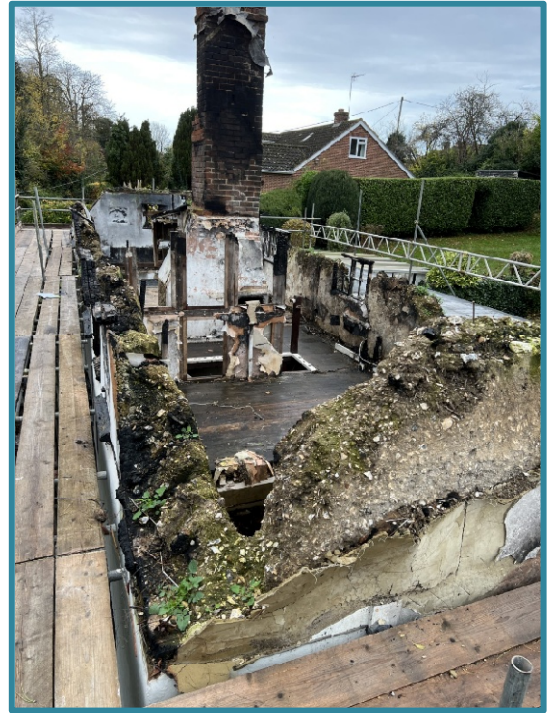
Figure 3 – Southeast Corner

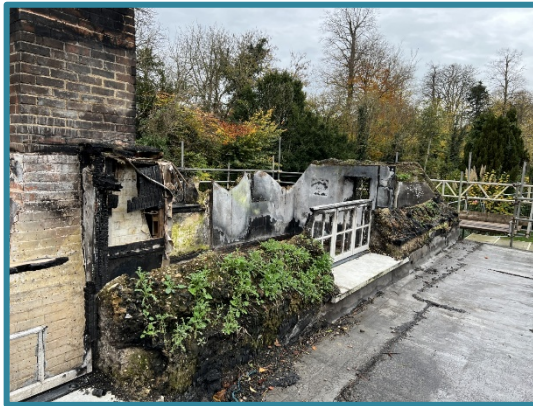
- 2.1.3 The cob walls have suffered considerably from the fire and the fire brigade dousing of the fire. The head of the walls are badly damaged and likely to be saturated. The walls have also been exposed to the weather since the fire in April and remain unprotected on site. Vegetation is starting to grow in the exposed top section of cob to the walls and no protection is currently in place. The condition of the cob will therefore continue to deteriorate whilst exposed to the weather

Figure 4 – Vegetation Head of Wall

- 3.1.7 The main area of immediate concern is the exposed wall heads and areas where the cob is failing. Protection whilst the building future is being discussed should be put in place.

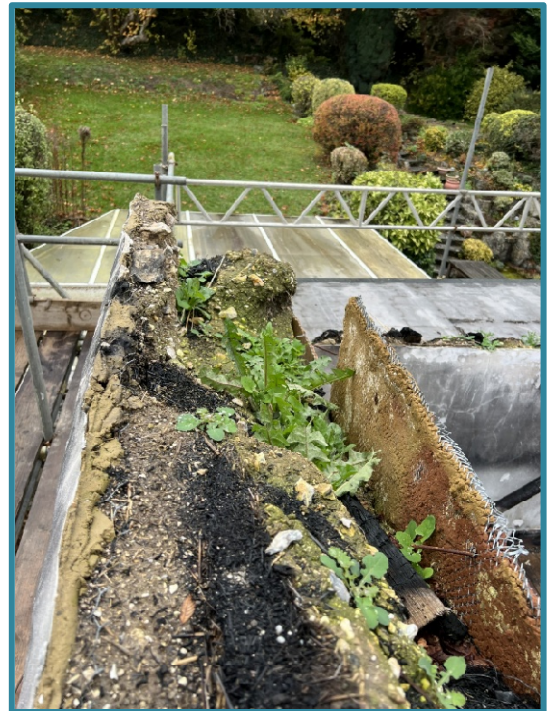
Figure 5 – Gypsum Internal Plaster & Cement Render Externally

- 2.1.7 In effect therefore, the finishes to the cob walls on outside and inside are trapping moisture in the core of the wall. We would therefore have strong concerns re the condition of the cob wall having both been exposed to the deluge from the fire fighting, and subsequently from the weather since the roof was destroyed in April 2025. Water will have permeated the wall from the top and, being trapped by the two impermeable surfaces, this could lead to instability in the walls as a whole.

- 3.1.8 The fractures present in the cob walls could be indicative of structural problems manifesting themselves.
- 3.1.9 The inappropriate plaster and render should also be removed in areas so that the cob can be inspected by a specialist to test if it remains competent or not. The results of testing would provide a guide as to whether the cob needs to be; a) fully demolished and removed as proven to be an incompetent material, b) carefully removed and reworked for use in a reconstructed cottage, or c) retained in position as part of the building re-construction.

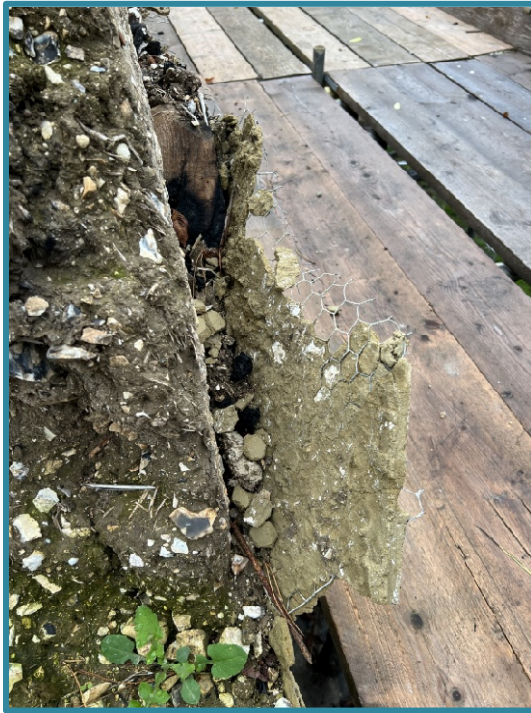
- 2.1.6 The external render on the cottage as a whole appears to be a cement based render which has been reinforced with galvanised chicken wire (Figure 6). The original render would have been lime (possibly earth) based which would have allowed the wall to breathe. The cement render is impermeable and therefore traps moisture in the core of the wall.

Figure 6 – Reinforced Cement Render

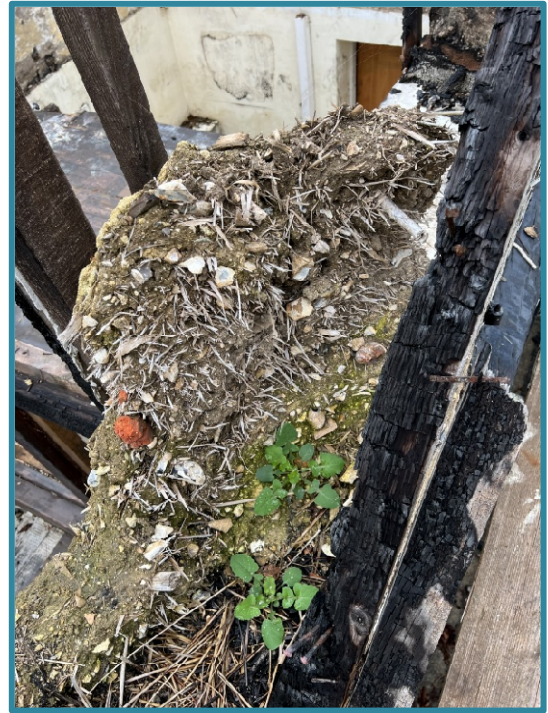
Figure 7 – Badly Weathered Cob

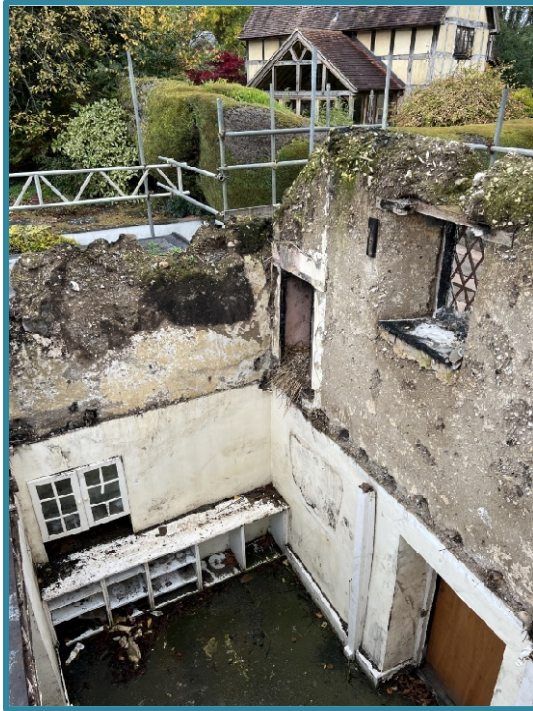
- 2.1.8 The plaster on the upper internal face of the east gable and part of the north wall has fallen off. The core of the cob is now exposed and vulnerable to degradation from the effects of the weather. This situation also exists in other areas of the upper wall on all sides. The former timber joist post holes at first floor level provide a direct route for moisture to run into the core of the wall at that level.

Figure 8 – Exposed Cob to inside of East Gable and North upper Wall

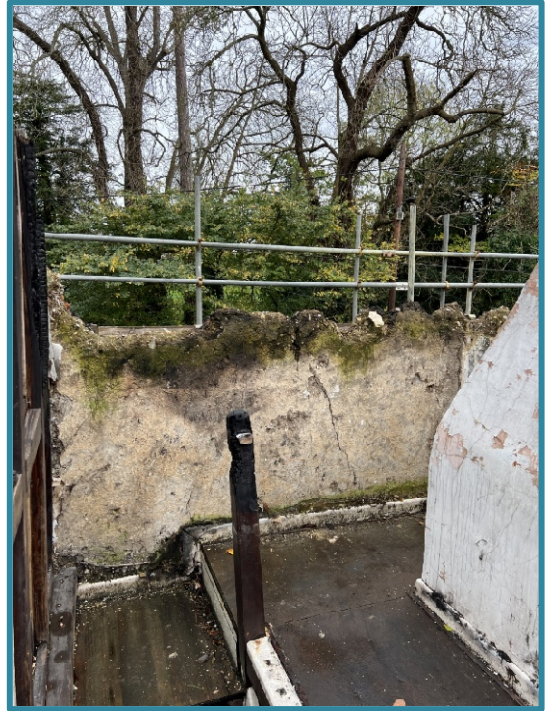
- 2.1.9 Part way along the upper south wall adjacent the main stair there is a fracture in the cob wall (Figure 9).
- 2.1.10 Similarly there are a couple of fractures in the north upper wall under the east window.

Figure 9 – Fracture to Cob Wall (South Side)

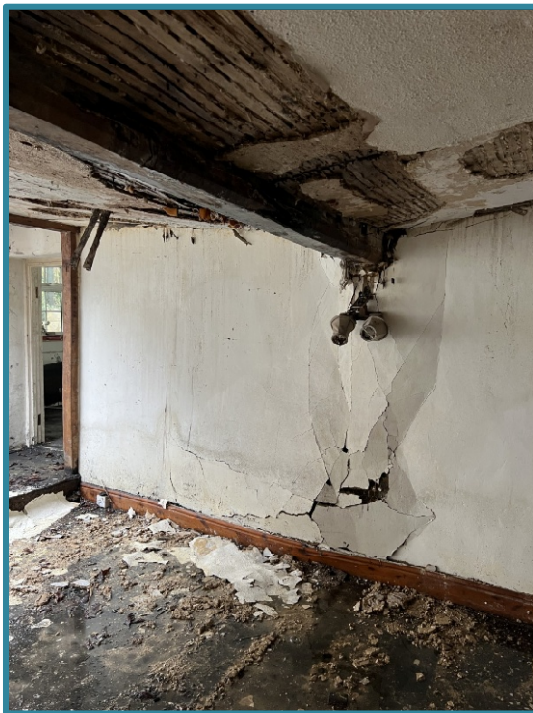
- 2.1.11 On the ground floor the timber supporting beam to the first floor has collapsed through the cob and it appears that the cob wall has failed in this location over the height of the ground floor (Figure 10).

- 2.1.12 Along the base of the wall here there is a damp stain and the plaster has bulged suggesting the plaster, and possibly the cob wall, has failed along a significant length (Figure 10).

- 2.1.13 The collapse of the beam has compromised the first floor, and whilst some timbers may be able to be salvaged the whole floor would need de-constructing first as the timber bearings generally will have been compromised. The lathe and plaster ceiling is beyond salvaging.

Figure 10 – Failed Bearing in Cob Wall

- 3.1.5 In the former living room, on the north wall, it can be seen that the cob has locally failed as the floor beam to the first floor has collapsed into the cob. It appears, by the staining on the plaster, that the base of this wall is very damp and the associated bulge in the plaster may suggest the cob has been compromised over a larger length in this area.

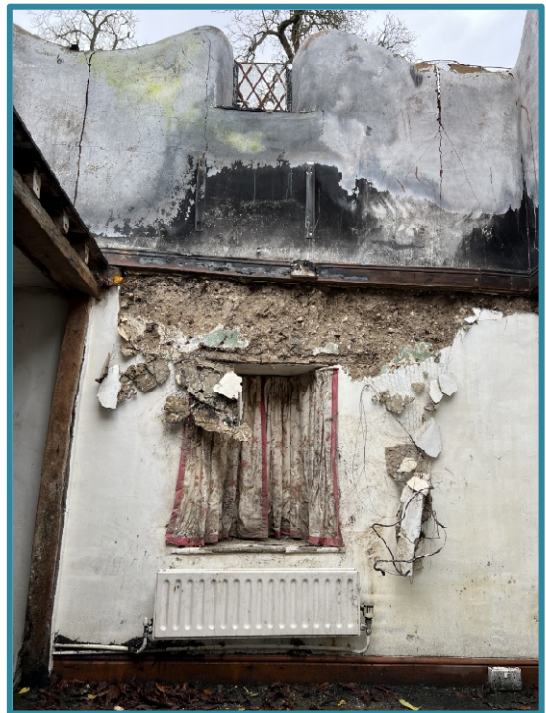
Figure 11 – Window Head South Elevation (West End)

- 2.1.14 The plaster above the western window in the southern elevation has been blown off in the fire exposing the cob wall and timber lintel. The lintel has a bow in it but this is probably a long standing issue.

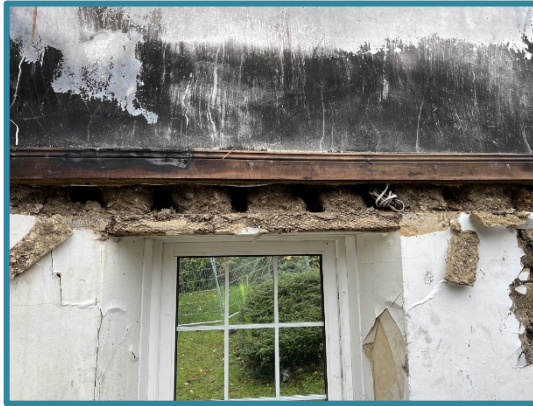
Figure 12 – Post Holes in Cob

- 2.1.15 There appears to be a shallow concrete lintel over the doorway in the west elevation suggesting the building has been altered in this location (Figure 12). A secondary concrete lintel appears to be present on the outside of the wall.
- 2.1.16 Post holes remain in the cob where the first floor presumably collapsed in the fire.

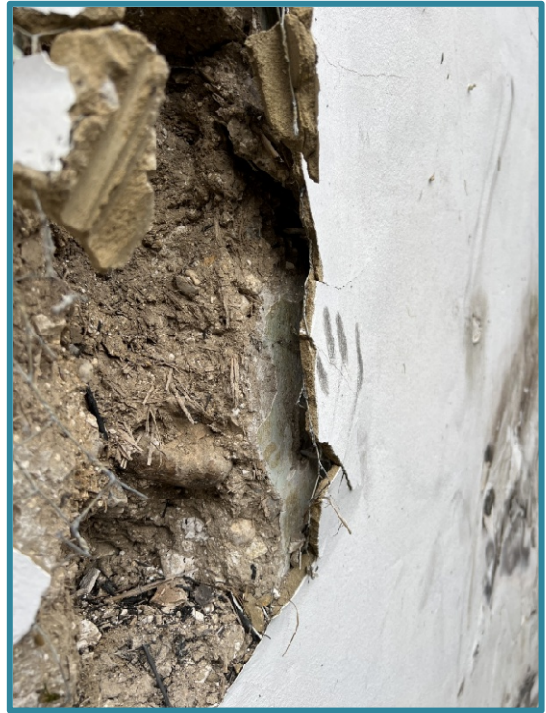
Figure 13 – Blown Render Showing Mesh

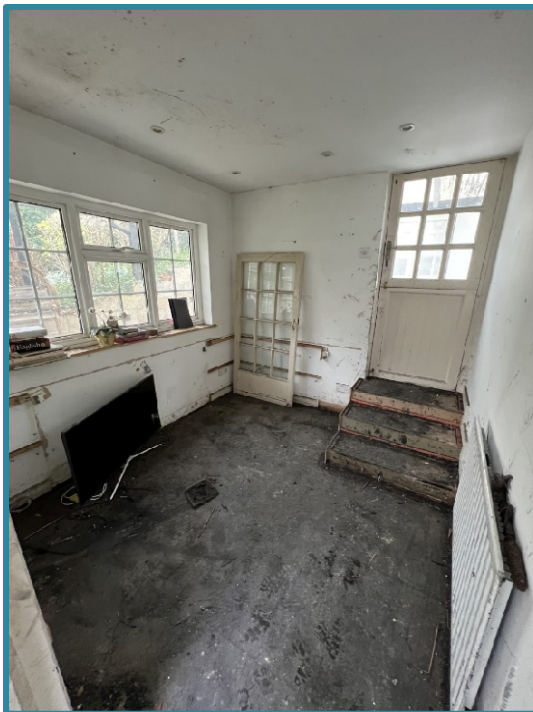
Figure 14 – Rear Appendage (Study)

- 2.1.17 We understand the modern rear appendage is built of masonry off a pre-existing flint plinth. The roof comprises a flat roof, probably timber joisted finished in a bitumastic felt flat roof system. The rear appendage appears largely untouched by the fire apart from smoke damage.

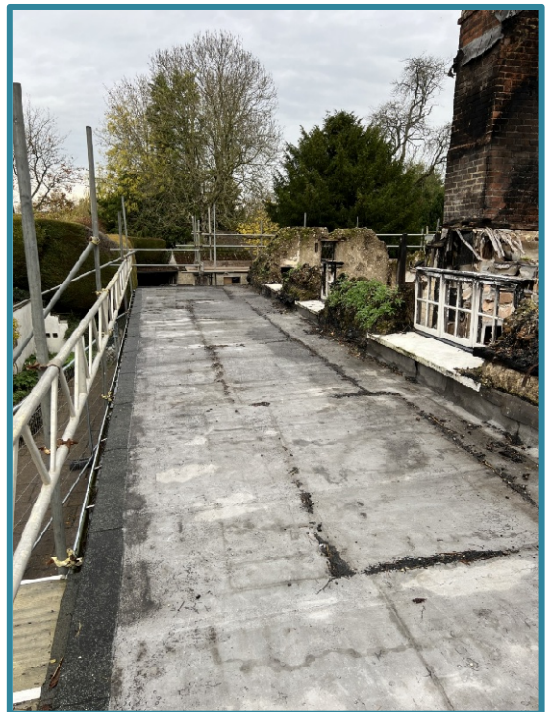
Figure 15 – North Appendage Roof

- 3.1.11 The flint plinth to the base of the walls appears to be intact and retains a good line.
- 3.1.12 The masonry and timber flat roof to the modern rear appendage appears largely unaffected by the fire but has suffered from smoke damage. It was not possible to inspect the bearing of the roof timbers onto the north cob wall. It is possible this detail has been compromised in the fire; opening up is required to establish the detail and condition of the bearing.

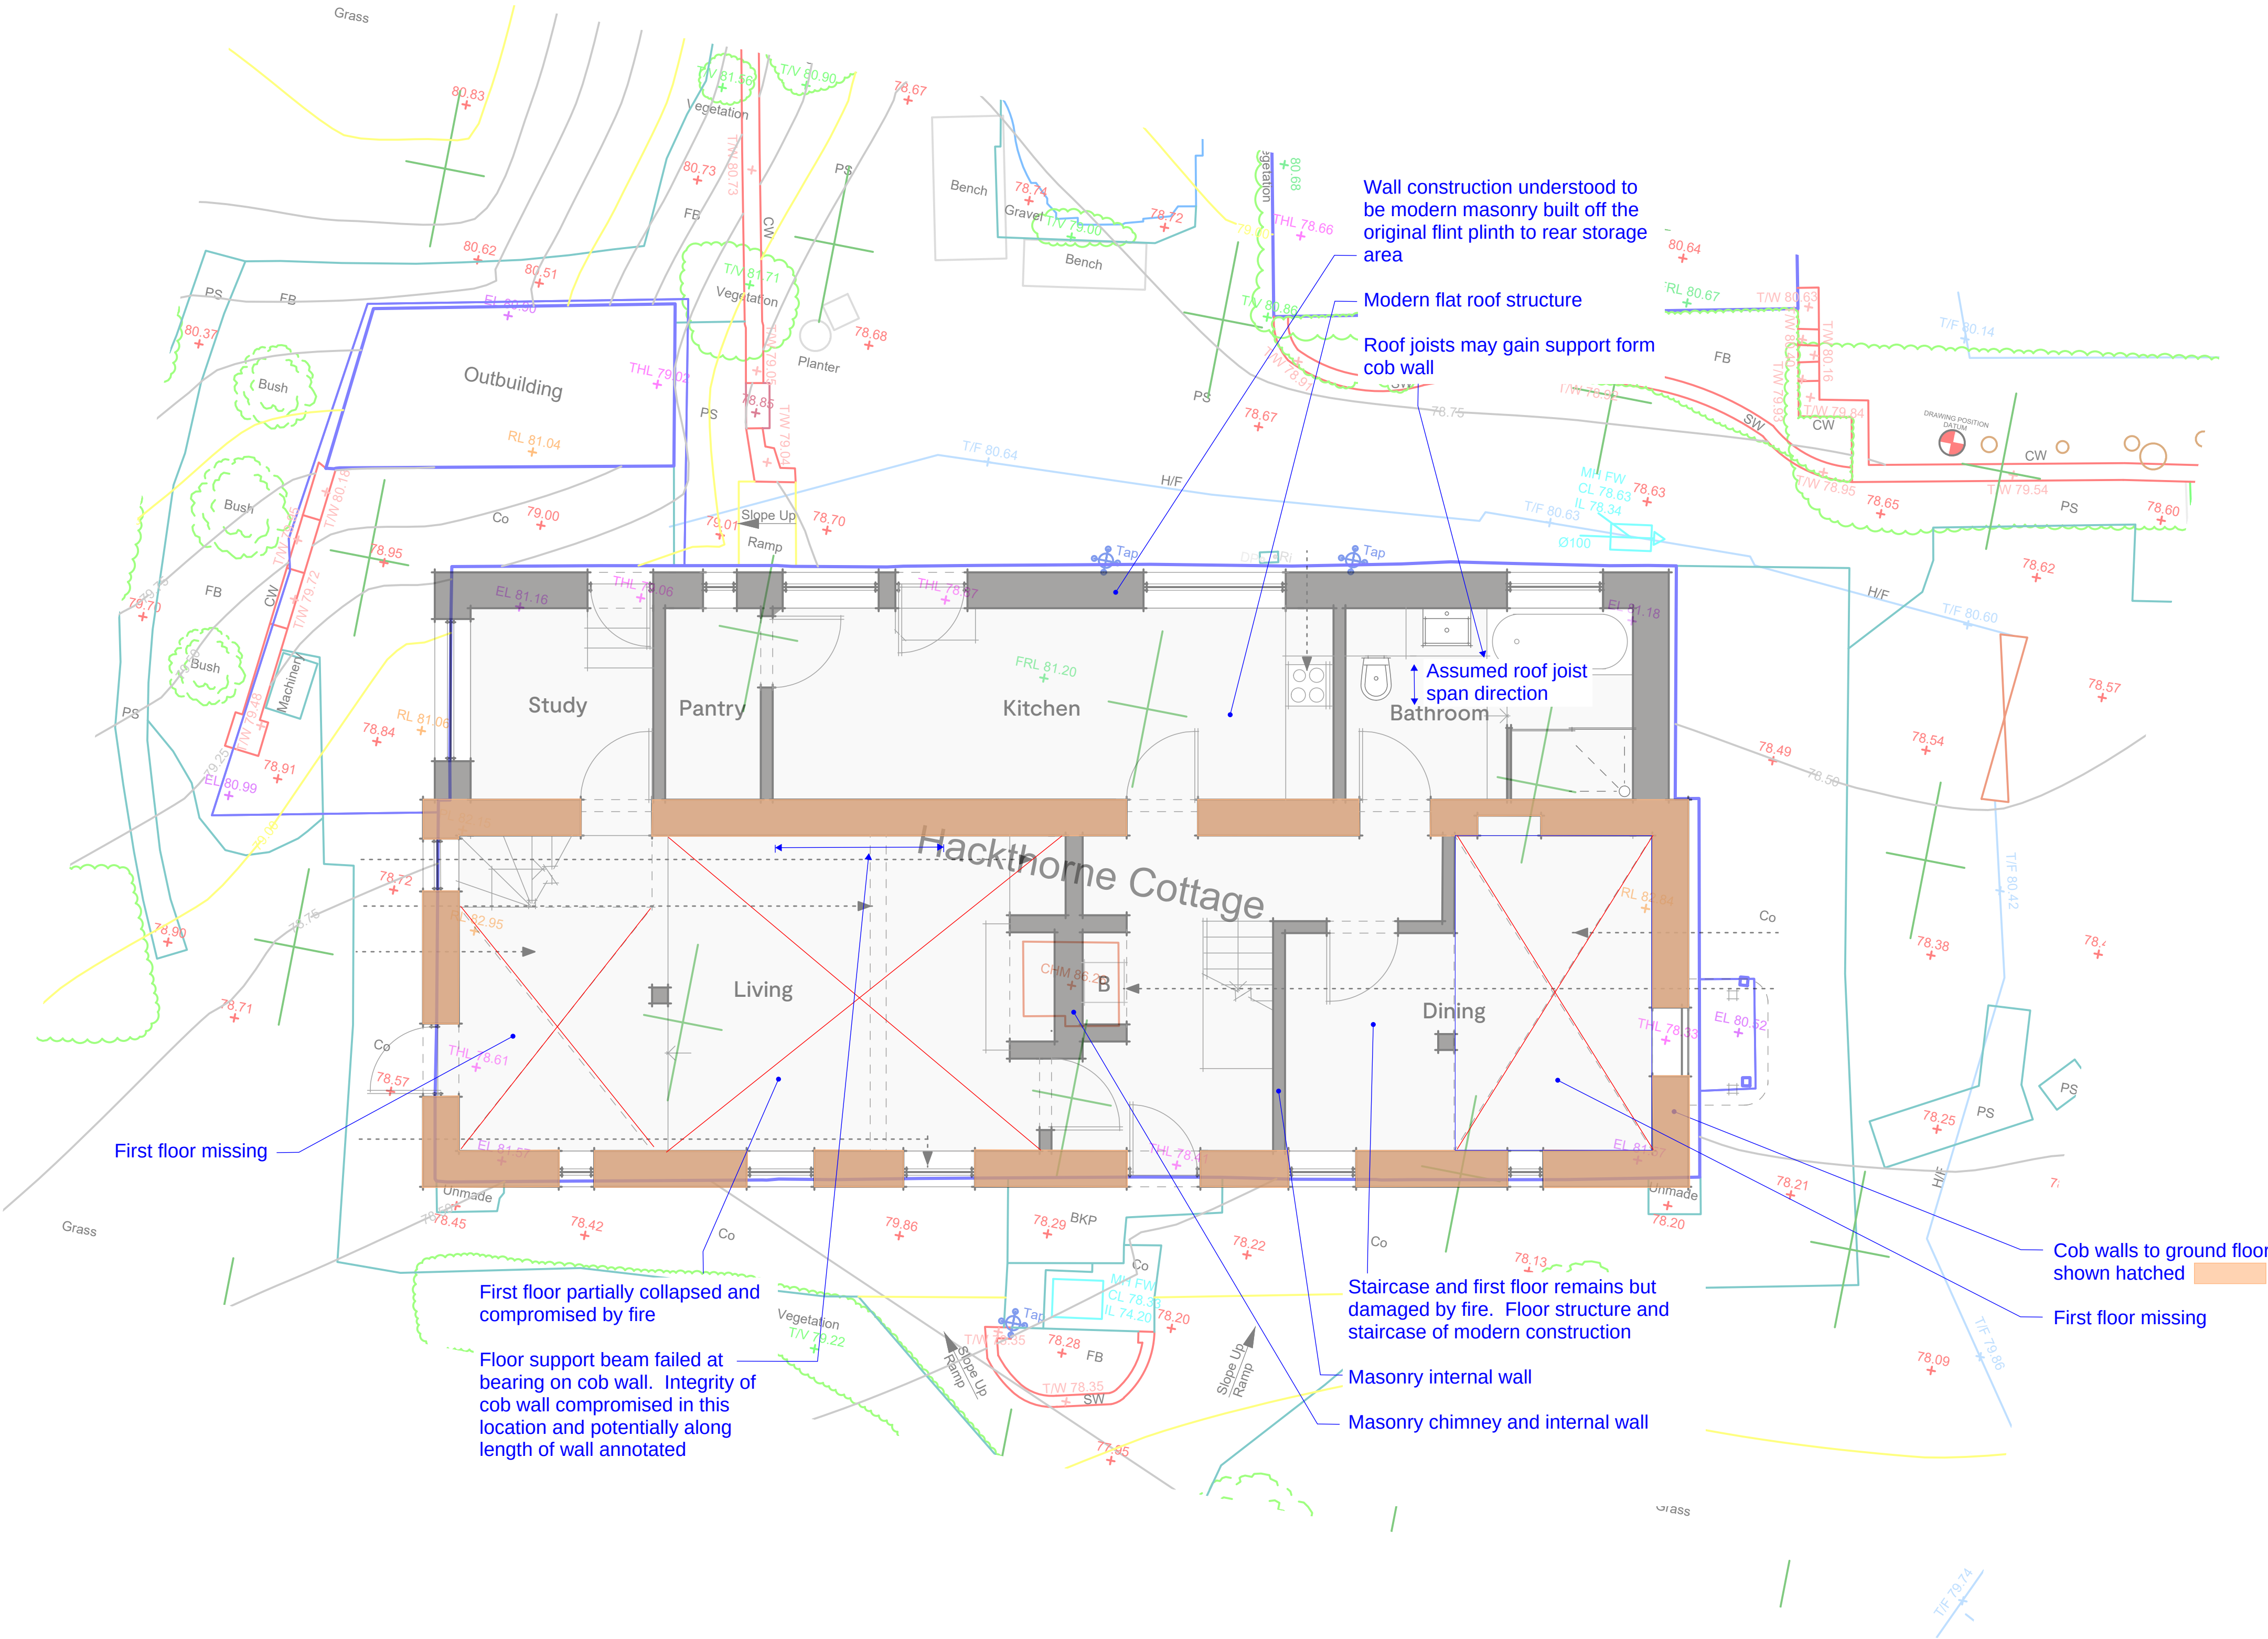
TITLE  
**EXISTING GROUND  
FLOOR PLAN**

Drawings showing survey notes
