# Huntenhull Farm Barn

## Inspection Report

Job Number: 13011

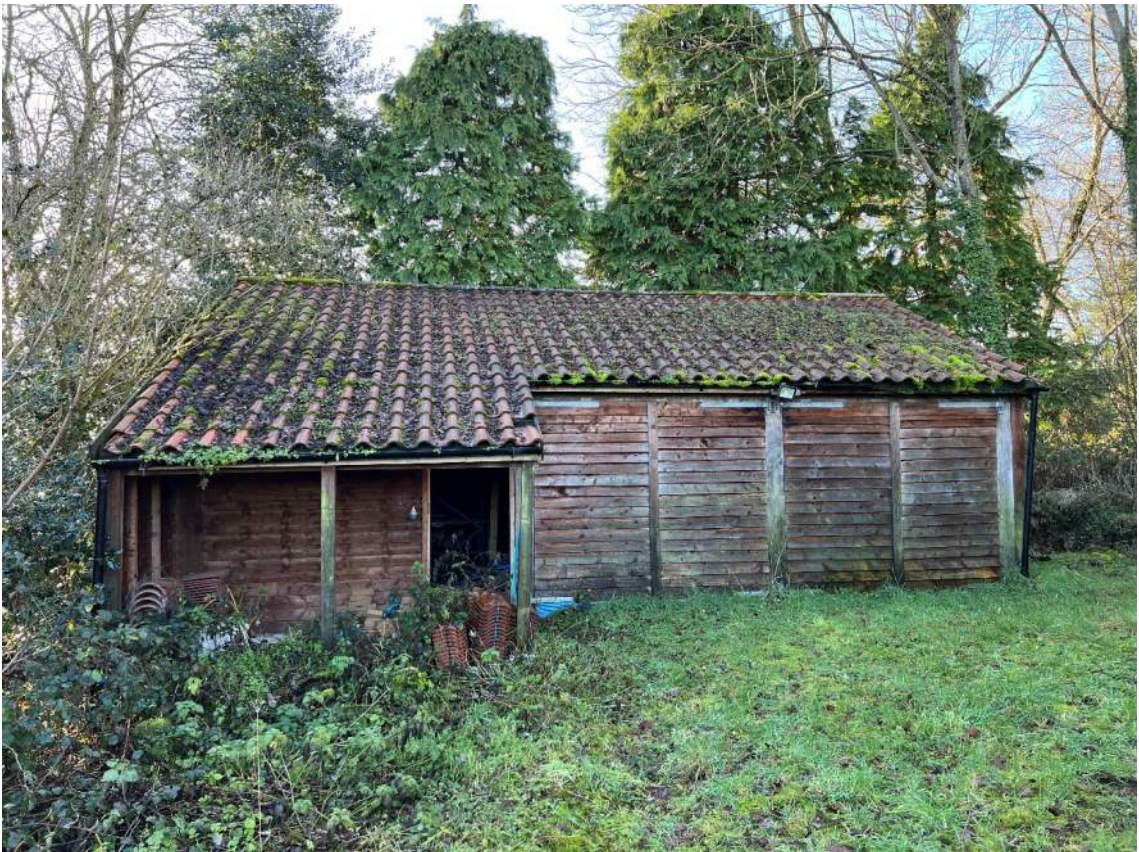
Figure 1 Northwest Elevation

- 2.1.1 The barn is set to the southeast of Huntenhull Farm adjacent the boundary of the property. The building has a number of trees growing near it the most significant of which are the evergreen conifers to the rear of the building.

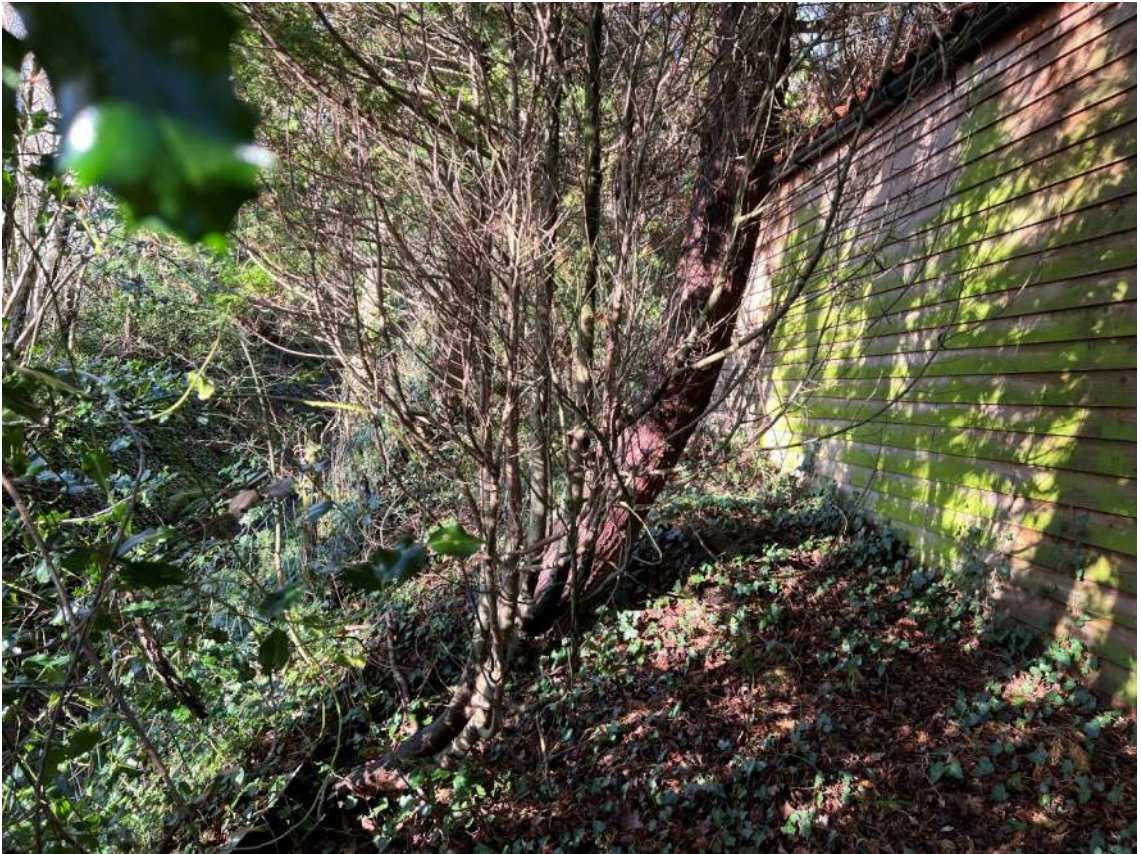
Figure 2 – Bank to 'Holloway'

- 2.1.2 One of these conifers in particular has a curve trunk taking it close to the rear of the barn and ideally should be removed before it causes structural issues with the building.

- 2.1.4 With reference to the British Geological Society (BGS) mapping the site is underlain by the Boyne Hollow Chert Sandstone member comprising interbedded sedimentary rock. This should form a good founding medium for the barn evidenced by the steep banks to the adjacent 'holloway' public footpath that suggest the material beneath the building stands up well.

- 3.1.3 There is a sunken public footpath to the west of the building but the building is set a distance from the top of the bank and the ground beneath the barn appears to be competent material. We see no issues from this aspect with the long term stability of the foundations.

- 3.1.4 Similarly whilst there are trees in the vicinity of the barn, the weathered sandstone ground beneath is not hugely susceptible to being affected by the action of tree roots and there are currently no signs of movement in the foundations. We would however recommend that the conifer immediately behind the barn be considered for removal as its bow is quite close to the rear of the barn and the branches overhang the building.

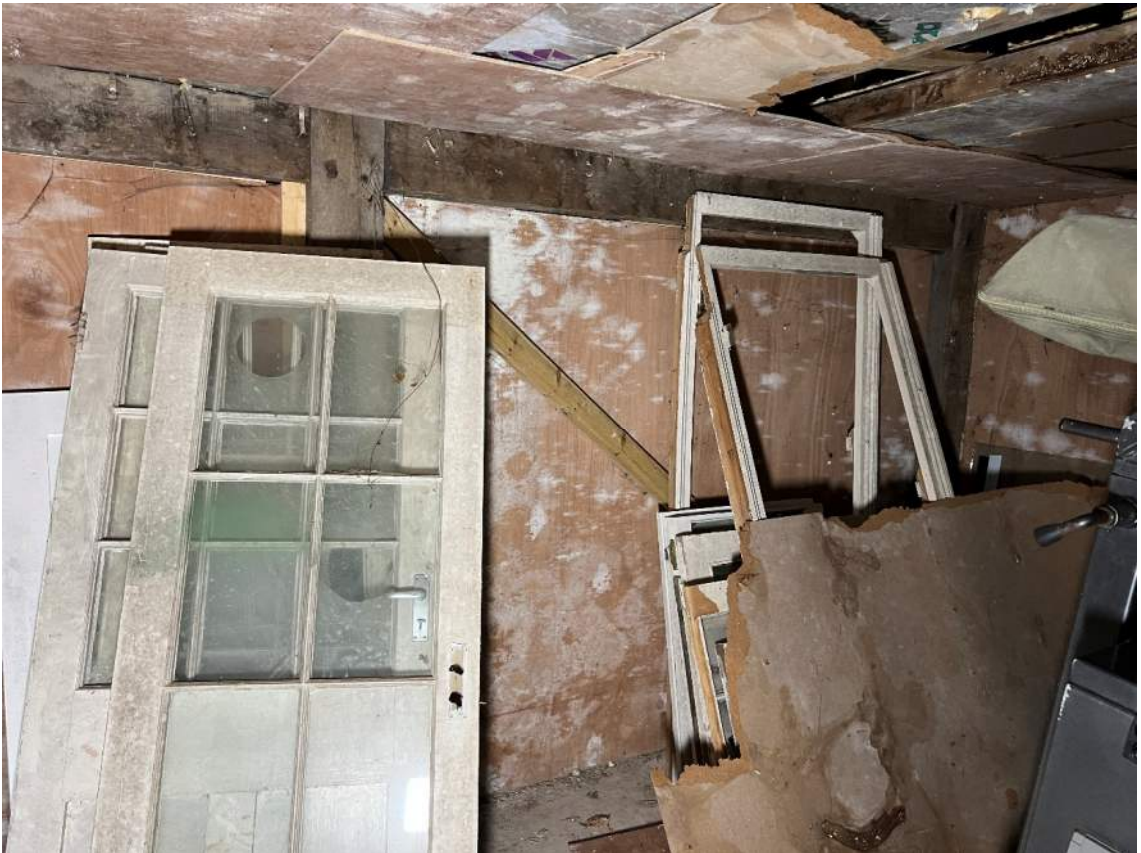
Figure 3 – Timber Frame

- 2.1.3 The barn comprises what appears to be an oak primary frame with infill timber walls sheathed in plywood which provides lateral stability to the frame and building overall. The timber walls appear to be supported on the edge of the concrete slab, but the principal posts to the oak frame appear to extend through the concrete slab and most likely extend through to the foundations beneath.

- 2.1.5 Where visible the upper timber frame appears in good condition and to have a good line and level. The roof is formed from pre-fabricated softwood timber trusses with insulation at truss cord / ceiling level.

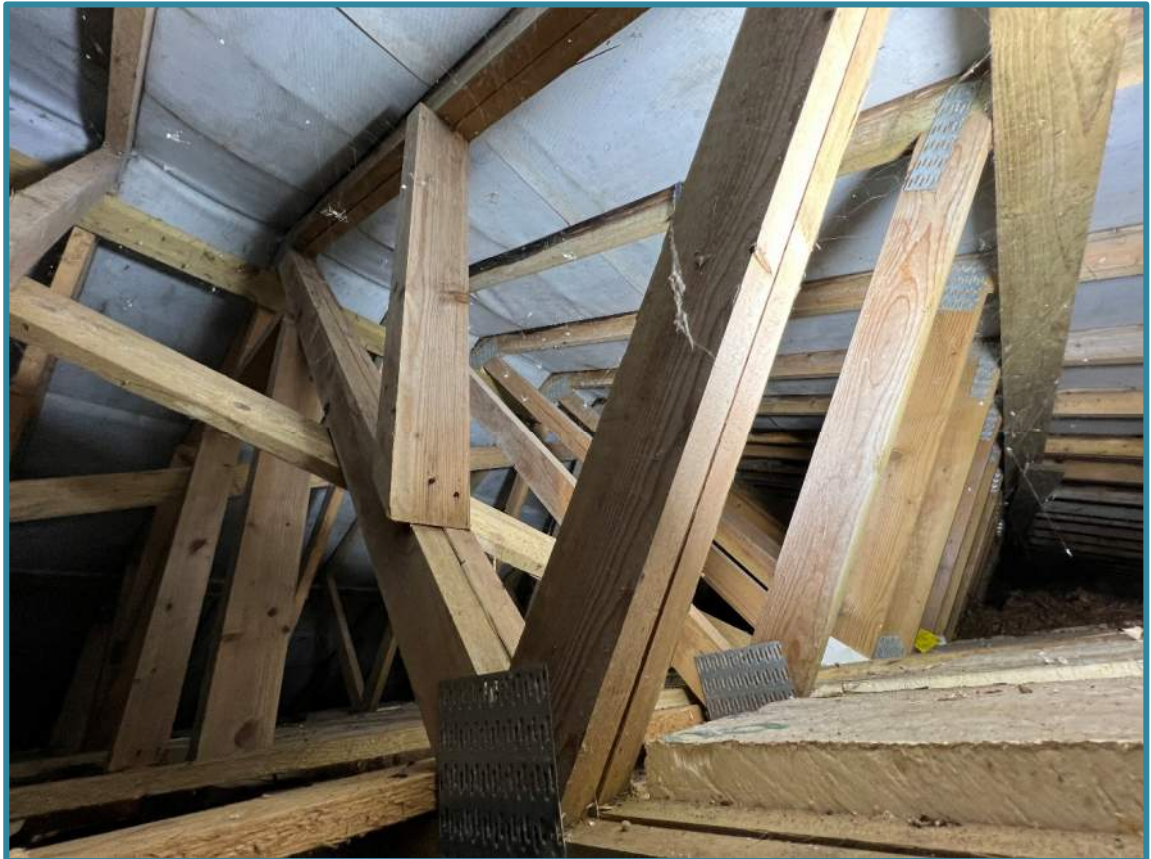
Figure 4 – Trussed Rafters

- 2.1.6 From our cursory inspection, the trussed rafters appear in good condition and well configured with cross and longitudinal bracing in place. There is a modern breathable membrane present under the clay tiled roof. Rigid insulation is present at ceiling tie level.
- 2.1.7 The main oak timber framing is visible on the northeast elevation. Where the posts meet the foundations the timber is vulnerable to decay from trapped water and soil. It can be seen on the post adjacent the door to the barn that the outer face of the timber is starting to decay slightly. This detail can be remedied with the introduction of new timber or a steel shoe and should be carried out prior to any general conversion works.
