| British Standard 5837-2012 Tree Categories Key | |

**G TREE LTD**  
**Tel: 01202 748967**  
**g.tree.c@outlook.com**

THIS PLAN MUST BE VIEWED IN CONJUNCTION WITH THE ARBORICULTURAL REPORT: GH23104

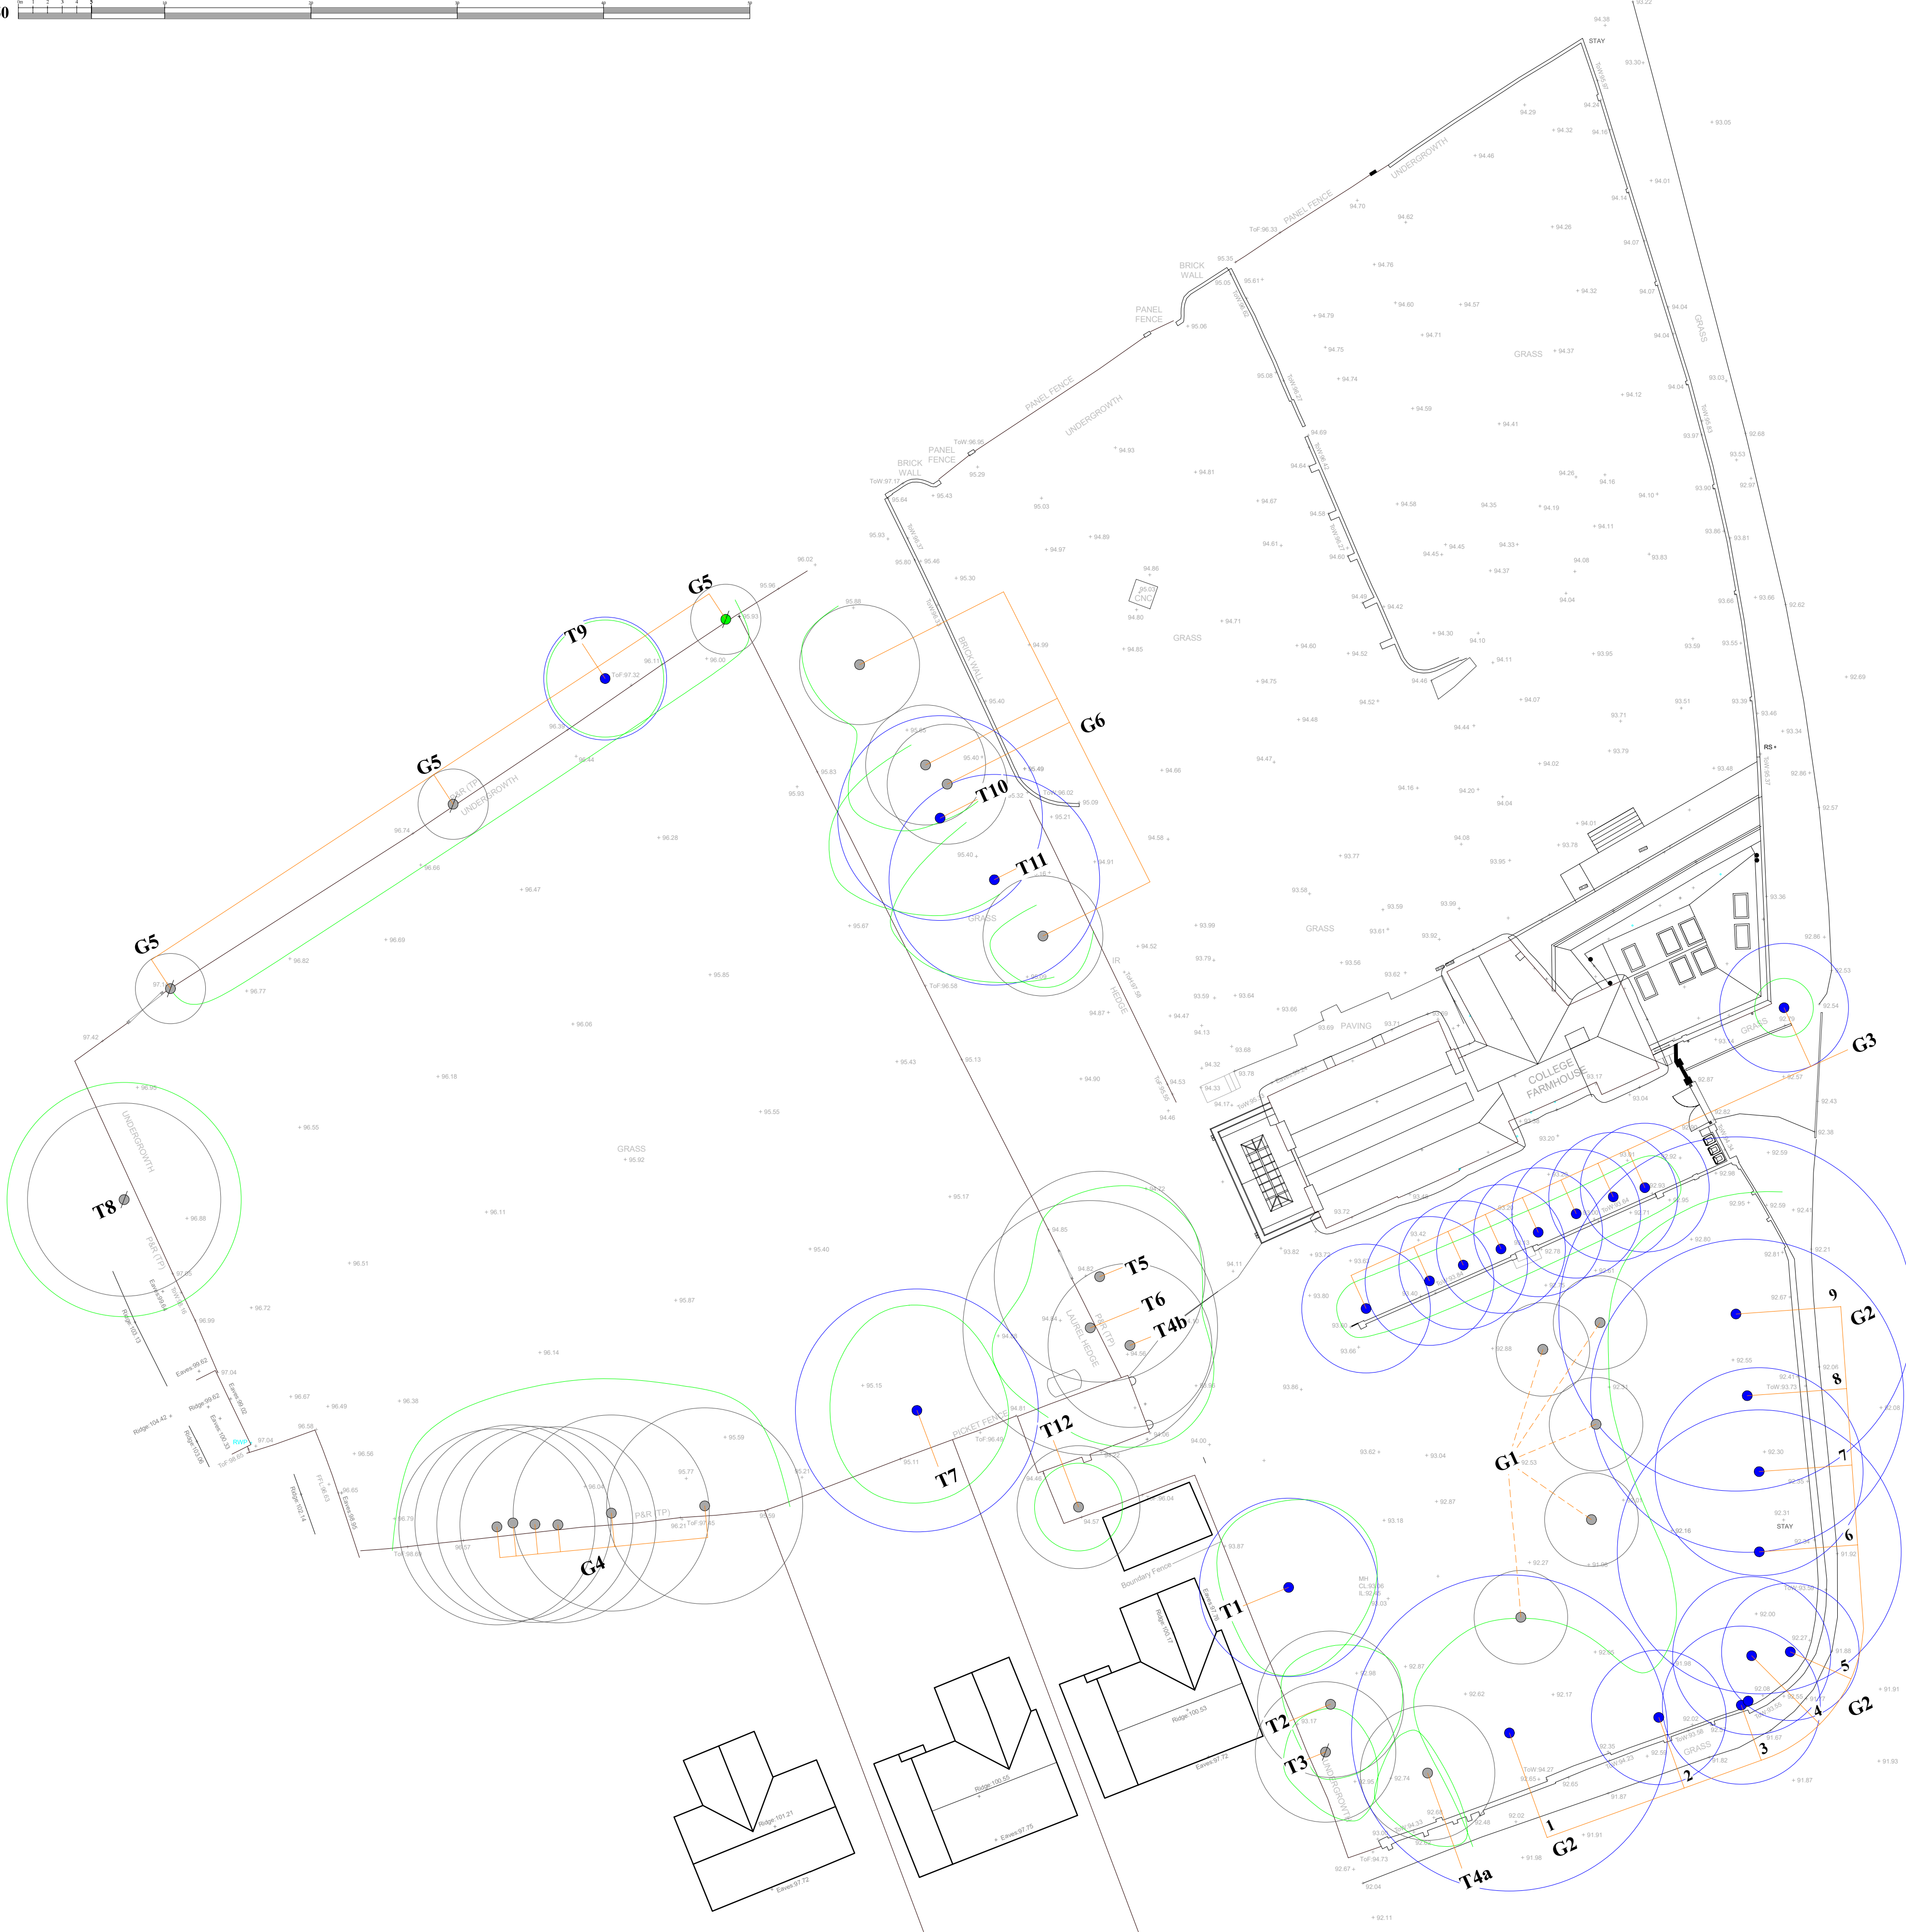
| T6 | Norway Maple | 17 | 43<br>51<br>18<br>21 | N<br>E<br>S<br>W | 7<br>3<br>3<br>3 | | 1 | M | <u>Poor</u><br>-growing from felled or damaged tree<br>-multi-stemmed at 0.3 m, included bark at stem unions<br>-open forming canopy | -due to included bark and shape of canopy, consider either crown-reduction by 3 m or removal | <20 | 8.7 | C2 | |
| T7 | Purple Hornbeam | 16 | 69 | N<br>E<br>S<br>W | 7<br>6<br>#6<br>6 | 7<br>3<br>3 | 1 | M | <u>Fair</u><br>-sap exudation main stem south at 1 m<br>-historic fence post embedded in tree south<br>-minor deadwood within canopy | -monitor for any increase in sap exudation, if increase occurs contact arborist | <30 | 8.3 | B1/2 | |
| G4 | Hornbeam x7 | <17 | <56 | N<br>E<br>S<br>W | 9<br>9<br>9<br>9 | 2+ | 1 | < M | <u>Poor</u><br>-linear planting<br>-large central tree ivy clad<br>-all trees extensive main stem bark damage, possible cause of heart rot<br>-few trees crying, trees unlikely to recover | -sever and band ivy<br>-further assessment required, consider possible crown-reduction to reduce loading upon weakened stems | <20 | <6.7 | C2 | |
| T8 | Ash | #20 | #55 | N<br>E<br>S<br>W | #8<br>#8<br>#8<br>#8 | #6 | 5 | M | <u>#Fair/Poor</u><br>-unable to completely assess, neighbours' tree<br>-minor canopy dieback | -monitor for any increased deadwood, if increase occurs contact tree owner | #2<br>0 | 6.6 | #B/C1 | |
| G5 | Privet<br>Ivy<br>Nettle<br>Bramble<br>Hazel<br>Eln<br>Elder<br>Hawthorn | <8 | #20 | S<br>W | <3 | 0 | 0 | M | <u>Poor</u><br>-poor diversity in woody species, Privet & Bramble dominant<br>-dead Elms within hedge | -remove dead trees<br>-consider producing hedgerow management plan to create more diverse hedgerow | <20 | 2.4 | C2 | |
| T9 | Hawthorn | 8 | #35 | N<br>E<br>S<br>W | <4<br>-4<br>-4<br>-4 | | | 0 | M | <u>Fair</u><br>-bifurcated main stem at 0.5 m<br>-Ivy clad<br>-unable to completely assess due to vegetation<br>-low canopy | -sever Ivy & resurvey | <30 | 4.2 | B/C2 |
| G6 | Horse Chestnut x 2<br>Cherry x 2 | <11 | <34 | W<br>W<br>W<br>W | 4<br>6<br>3<br>3 | 3 | 1 | E<br>M | <u>Poor</u><br>-Horse Chestnut main stem sap exudation<br><u>Poor/Fair</u><br>-Cherry growth suppressed | -consider removal of Horse Chestnut and replanting with different species<br>-prune branches back to 1 m past fence line to retain visual screen but clear paddock | <20 | 4.1 | C2 | |
| T10 | European Lime | 18 | 58 | N<br>E<br>S<br>W | 5<br>4<br>6<br>8 | | | S<br>M/<br>M | <u>Fair</u><br>-unable to completely assess due to epicormic growth and ivy on main stem<br>-slight growth suppression from adjacent trees | -remove epicormic and Ivy resurvey | #<3<br>0 | 7 | #B2 | |
| T11 | Robinia Acacia | 19 | 45<br>40 | N<br>E<br>S<br>W | 4<br>6<br>7<br>7 | 4 | | M | <u>Fair/Poor</u><br>-bifurcated main stem at 0.5 m, no evidence of movement<br>-growth slightly suppressed<br>-minor deadwood within canopy | -monitor bifurcation for sap exudation and excessive movement in windy conditions | <30 | 7.2 | B/C2 | |
| T12 | Ash | #11 | #35 | N<br>E<br>S<br>W | #3<br>3<br>#3<br>#3 | 3 | 3 | S<br>M | <u>Poor</u><br>-unable to completely assess, Ivy clad<br>-poor growing location | -consider removal | #2<br>0 | 4.2 | C1 | |
