**Our Ref: 12444/CH/B**

**11<sup>th</sup> January 2025**

### **Devizes Castle – Ladies Arch**

The area of concern is the arch leading from the terrace to the garden. This is highly decorative with carved columns and arch and was originally inspected in April 2022 and has subsequently been propped.

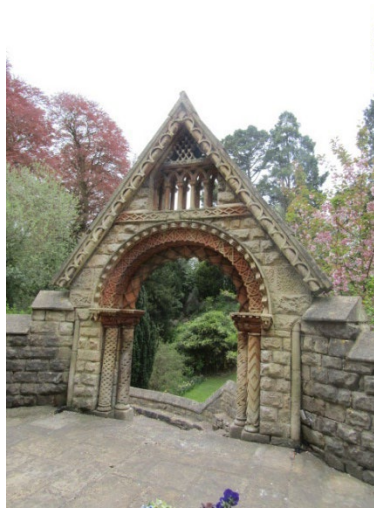
The structure is leaning to west (into the garden) and by a simple plumbob survey this is measured at 365mm over a height of 4.45m . As the width of the main stonework is approximately 615mm then it is considered that it is theoretically becoming unstable as the centre of gravity of the arch is outside the base (acceptable limit  $615/2 = 307.5\text{mm}$ ). Due to a potential slight inaccuracy in respect of taking measurements where the stone is quite decorative then a check dimension was taken to the lower stonework and this showed a lean of 100mm over 1.5m. This is of a similar magnitude and indicates the complete structure has rotated and not just the top section.

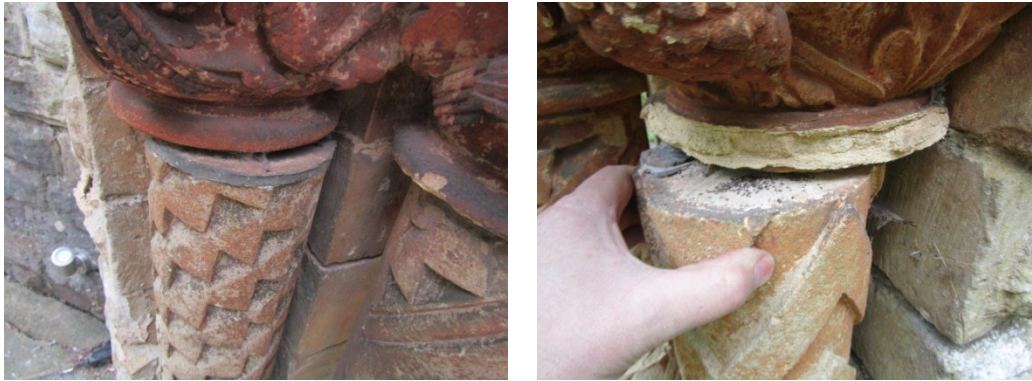
The degree of movement is clearly evident as the columns on the eastern face (nearest the house) are now detached.

As the total load is now being taken on the eastern columns, this is causing a compression failure with the stone splitting and cracking.

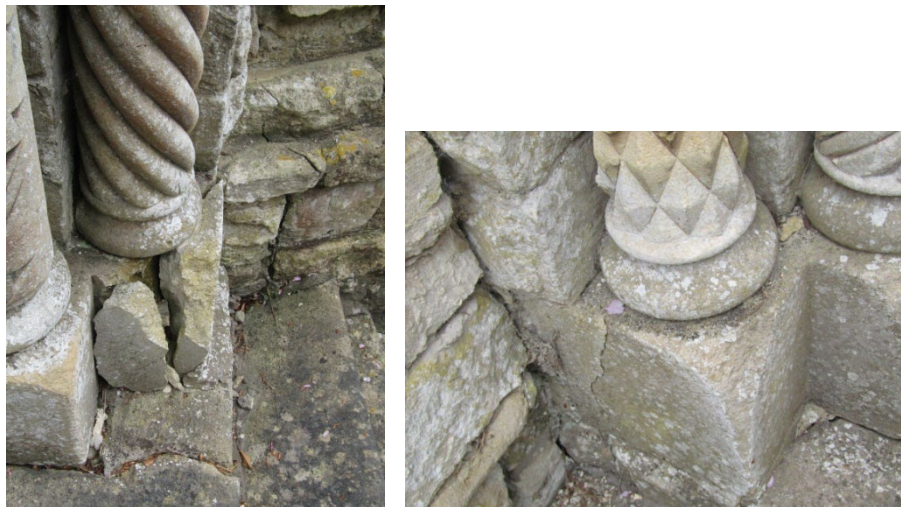
The movement has allowed the arch to spread and there is a distinct opening of the centre of the arch as the springing positions have released slightly.

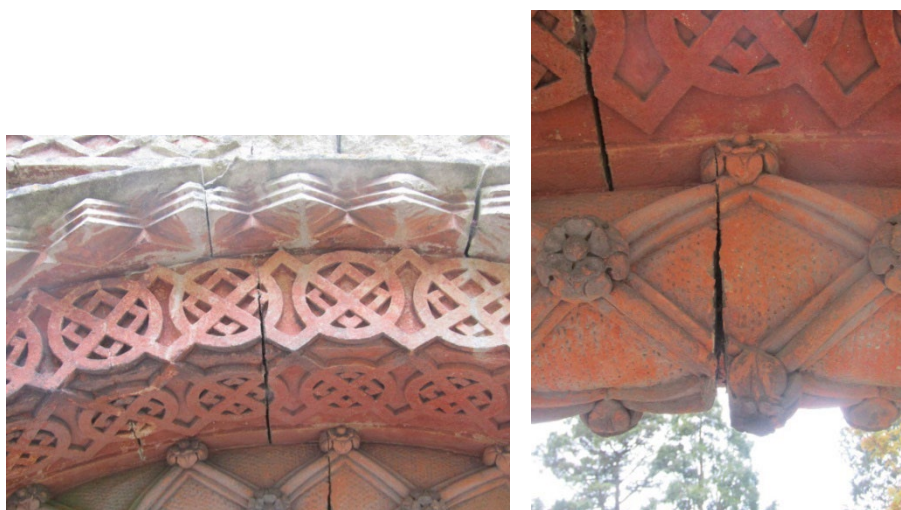
In the upper section the smaller decorative columns are also slightly loose.

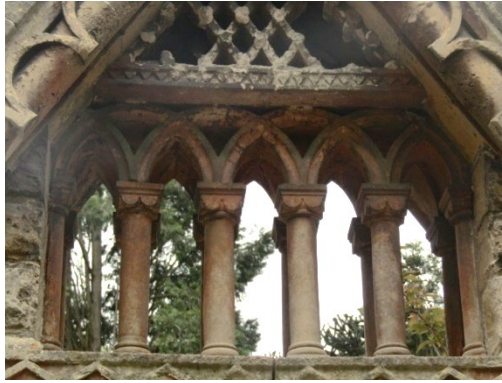
The western third of the arch is built off the steps, as exposed by the trial hole excavations and highlighted below and this is the reason why the arch has moved.

Although a very invasive option this is the lowest risk in protecting the historic feature. Conservation stone masons would take down the masonry and this would provide the best opportunity to keep all the decorative elements intact. Once taken down, new foundations would be cast and then the arch reconstructed with the failed plinth stone replaced. The main risk with this option is the potential damage to the decorative elements however by the selection of the correct conservators, then this is reduced.

Overall this option is considered the lowest risk of protecting the historic structure and also would allow the removal of the slightly crude later buttresses.

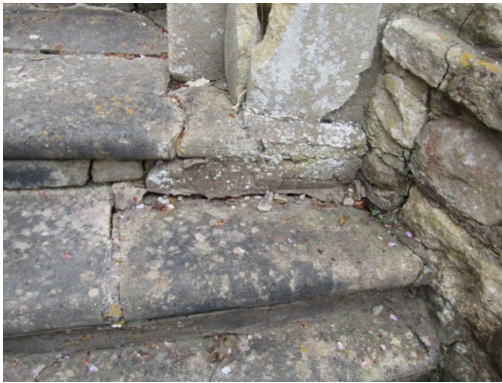
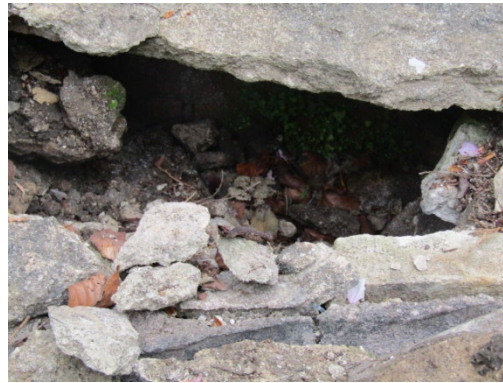
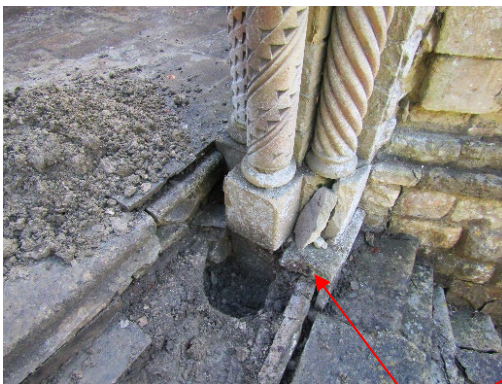
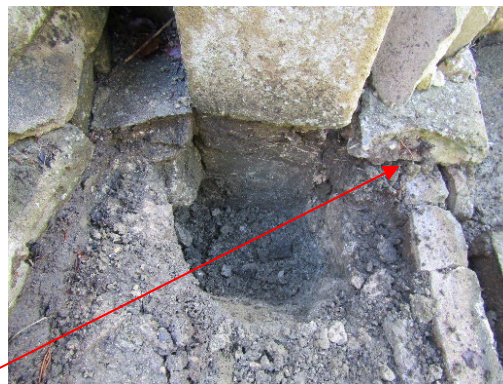
Column supported off riser of steps

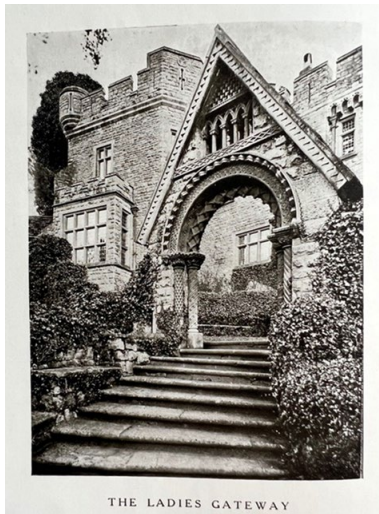
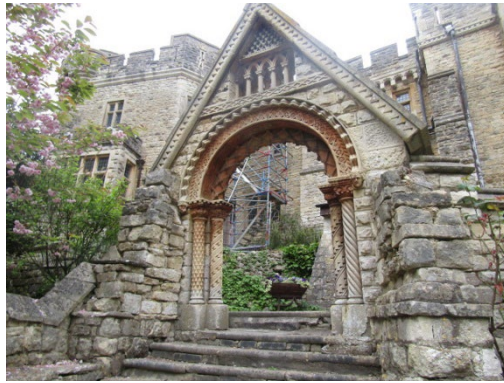
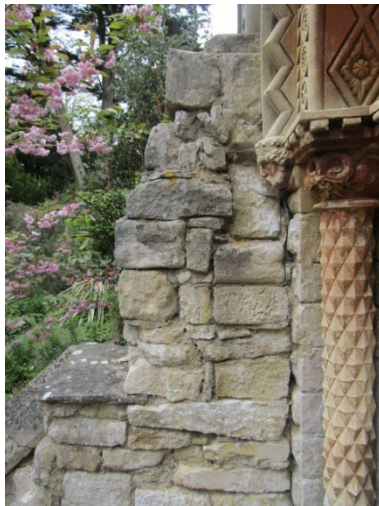
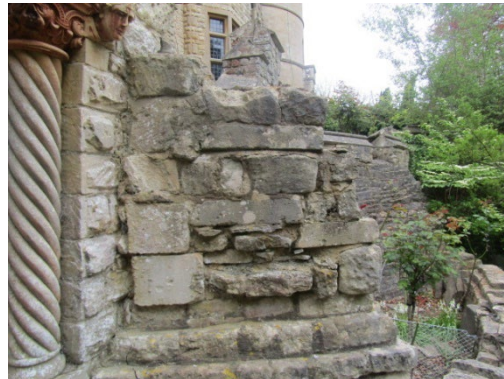
Historically an attempt to support the structure has been made with the introduction of a crude form of buttressing with stonework built off the side walls of the steps but this covers the rustication of the original stonework. This can be appreciated by comparing a photograph in the 1914 sales particulars (supplied by Justin Ayton) and the current view with the buttresses.
