# Inspection and report

43 Herd Street,  
Marlborough

| Document ref. | 14638.R01 |

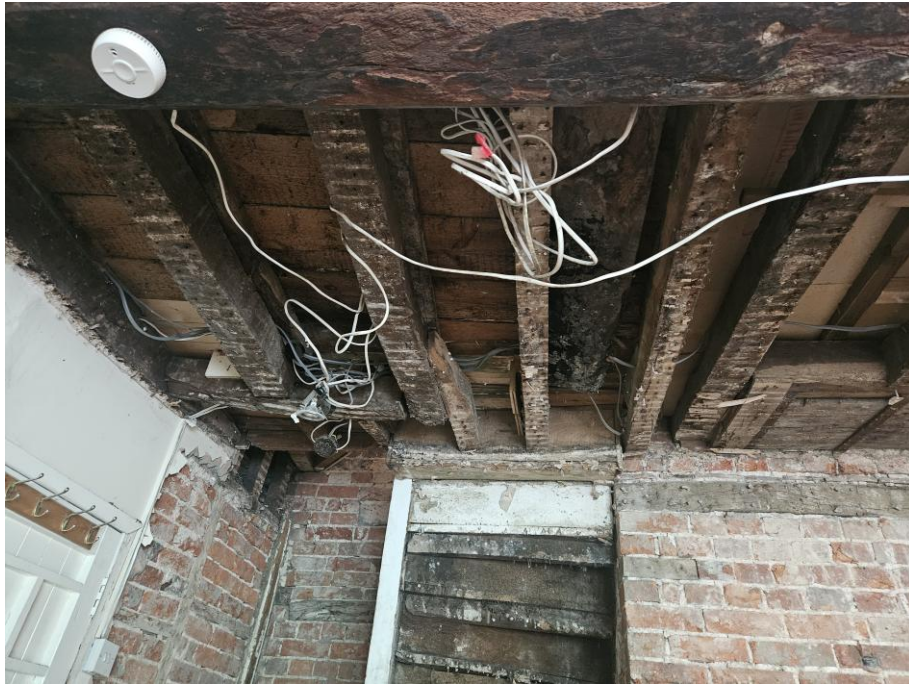
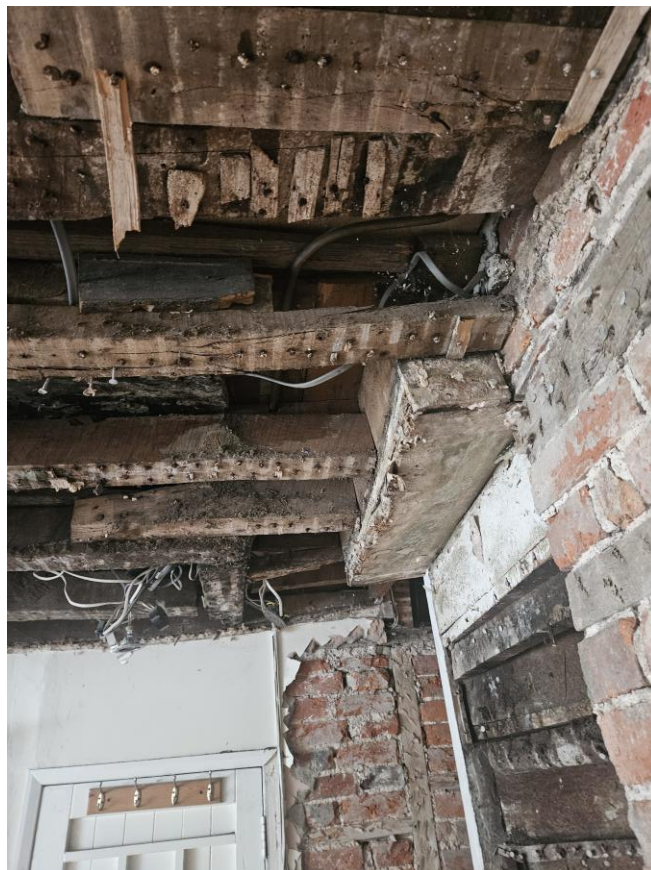
For example, two joists are nail fixed into end grain to the face of the top stair riser, which is itself unsupported, and others are floating in space with no coherent or effective load path. It is essential to locally strengthen this section of floor. The attached photographs show this floor area, and the annotated sketch illustrates the problems and the outline solutions.

Unsupported floor  
43 Herd Street

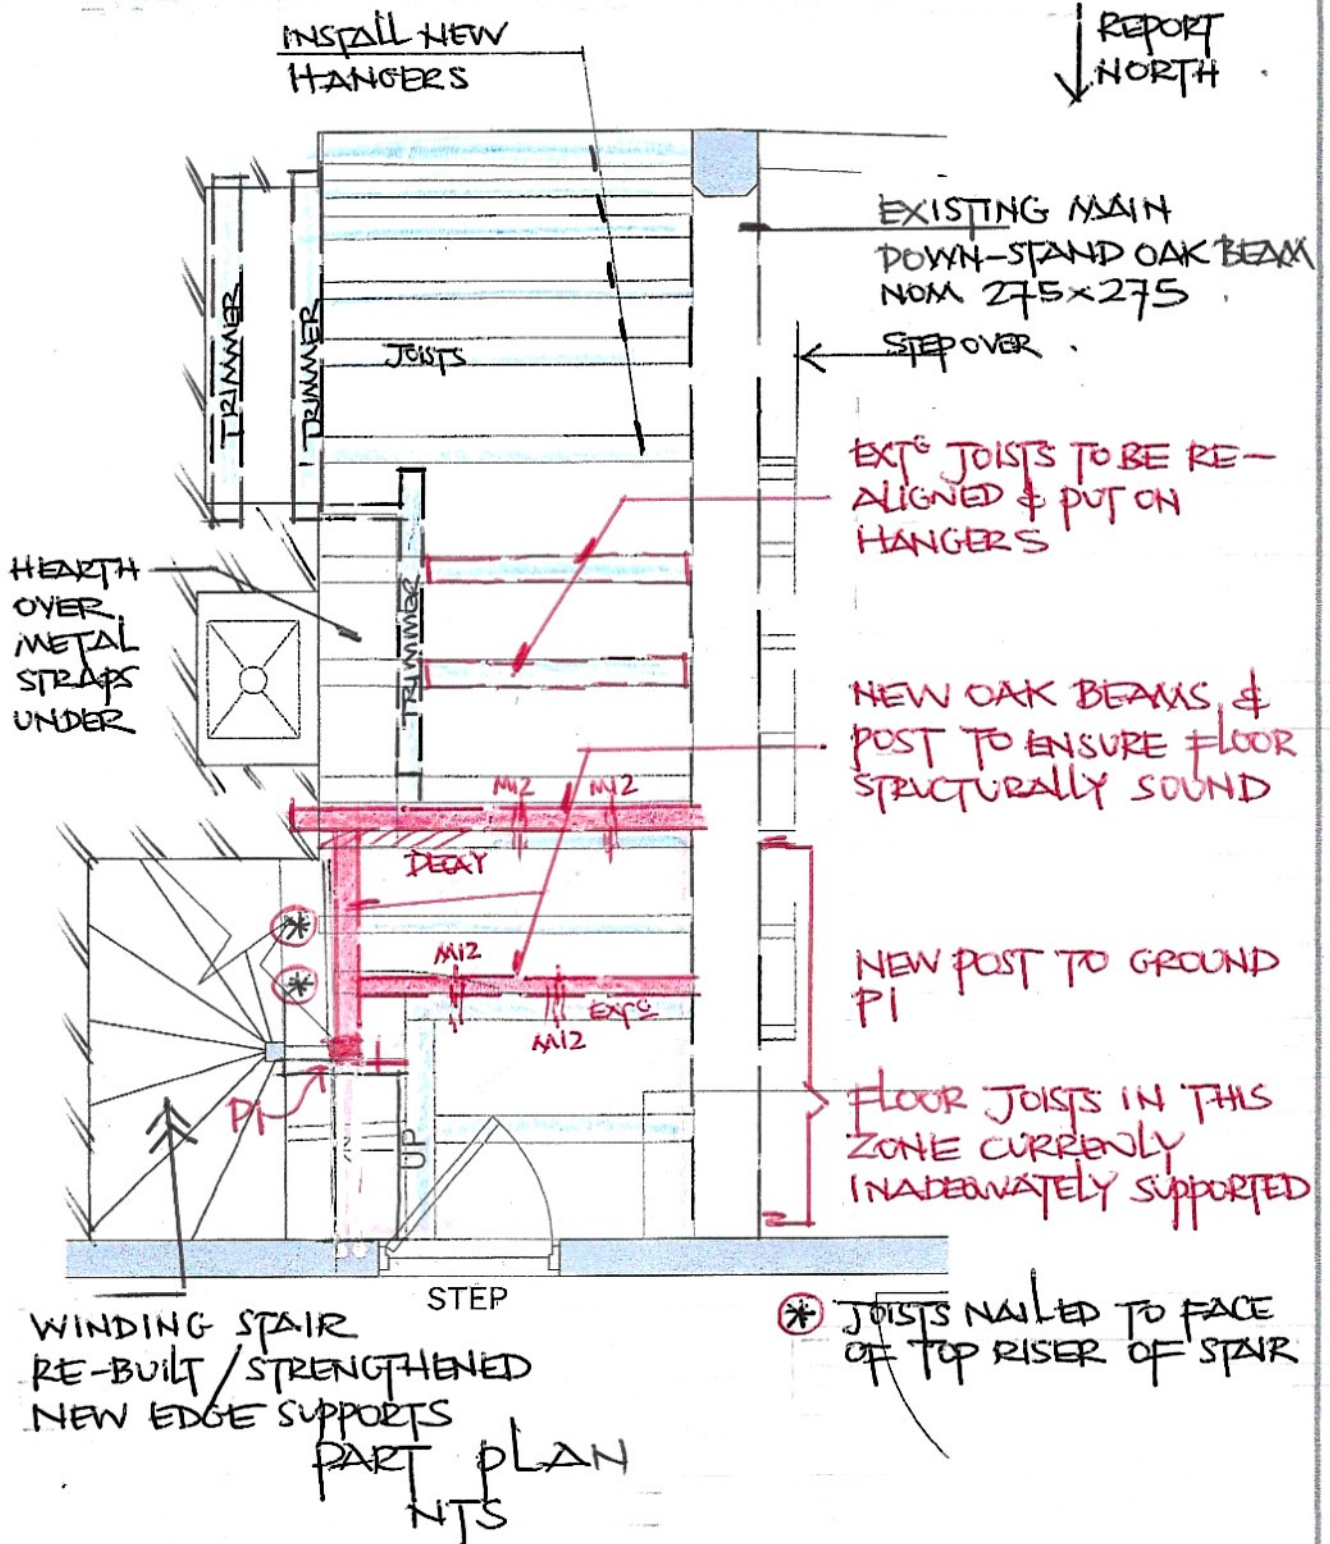
JOB TITLE 43, HERD STREET  
MARLBOROUGH  
DRG. TITLE FIRST FLOOR STRUCTURE

The exposed fabric of the building reveals alterations made in the life of the building and also a number of structural deficiencies. These are concentrated in the eastern side of the first-floor structure around the stair and adjacent to the chimney party wall. Some intervention is now essential to ensure the structural stability of the floor areas and stair flight from ground to first. The structural works are indicated on the appended sketch.
