# Arboricultural Consultancy for Lloyds Bank

| Insured | Mr & Mrs David John & Jacqueline Heather Pike | Address | 2B Lower Road, Edington, Westbury, BA13 4QN | | |

We understand that the current damage relates to the attached double garage, where cracking indicates downwards movement.

# GEOTECHNICAL

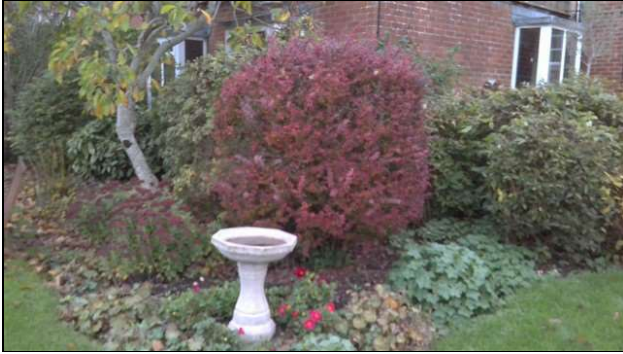
SG1 - Mixed species shrubs

| Tree No. | Species | Age Cat | Approx. Height (m) | Distance to Building (m) * | Ownership | Action | Requirement |
|---|---|---|---|---|---|---|---|
| SG1 | Mixed species shrubs: broadly consisting of weigelia, rose, berberis, kerria, dogwood and aucuba. | 1 | 1 | 0.5 | C - Insured | Action to avoid future risk | Subject to regular management; maintain at current dimensions by way of regular pruning. |

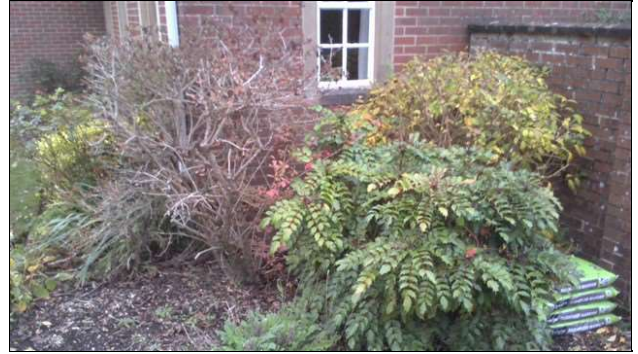
SG2 - Mixed species shrubs

| Tree No. | Species | Age Cat | Approx. Height (m) | Distance to Building (m) * | Ownership | Action | Requirement |
|---|---|---|---|---|---|---|---|
| SG2 | Mixed species shrubs | 1 | 1 | 0.5 | C - Insured | Action to avoid future risk | Maintain at broadly current dimensions by way of regular pruning. |

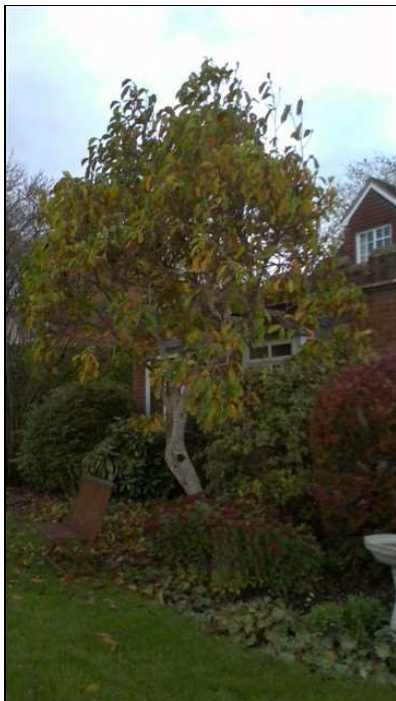
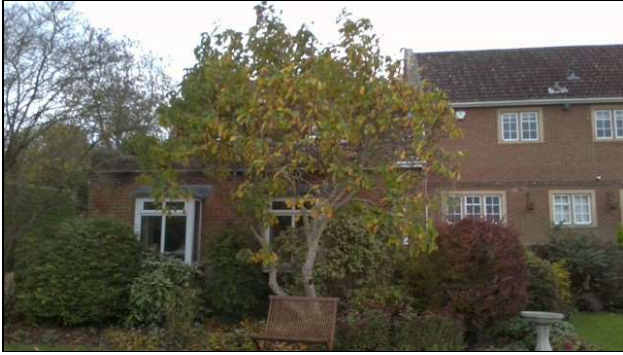
With due regards to species profile, size and proximity, T1 (Magnolia) is considered the dominant feature proximate to the focal area(s) of movement and accordingly, where vegetation is confirmed as being causal, we have identified it as the primary cause of the current subsidence damage.

T1 - Magnolia

Consequently, we have advocated the complete removal of T1 (as detailed) as it will offer the most certain arboricultural solution likely to restore long-term stability.

| Tree No. | Species | Age Cat | Approx. Height (m) | Distance to Building (m) * | Ownership | Action | Requirement |
|---|---|---|---|---|---|---|---|
| T1 | Magnolia | 2 | 5.4 | 1 | C - Insured | Remove | Remove close to ground level and treat stump to inhibit regrowth. |

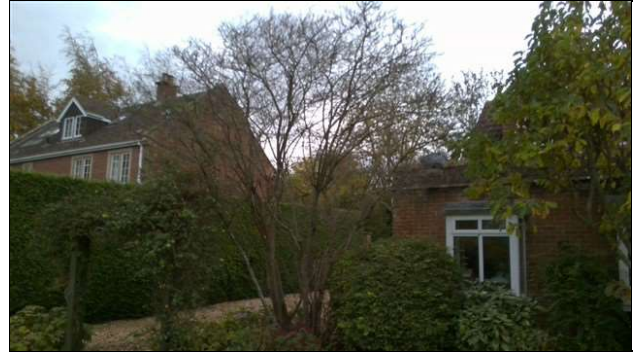
T2 - Other

| Tree No. | Species | Age Cat | Approx. Height (m) | Distance to Building (m) * | Ownership | Action | Requirement |
|---|---|---|---|---|---|---|---|
| T2 | Other | 2 | 5.4 | 1 | C - Insured | No action | No works (dead tree). |

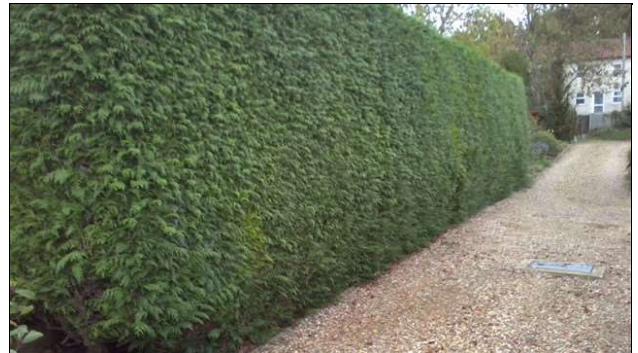
H1 - Cypress (Lawson)

| Tree No. | Species | Age Cat | Approx. Height (m) | Distance to Building (m) * | Ownership | Action | Requirement |
|---|---|---|---|---|---|---|---|
| H1 | Cypress (Lawson) | 2 | 2.6 | 5 | C - Insured | Action to avoid future risk | Subject to regular management; maintain at broadly current dimensions by way of regular pruning. |

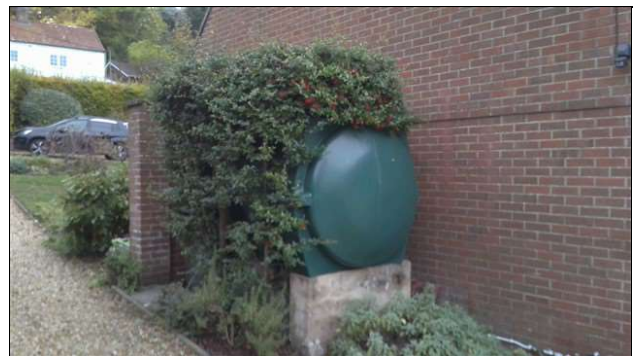
S1 - Pyracantha

| Tree No. | Species | Age Cat | Approx. Height (m) | Distance to Building (m) * | Ownership | Action | Requirement |
|---|---|---|---|---|---|---|---|
| S1 | Pyracantha | 2 | 2 | 1.5 | C - Insured | Action to avoid future risk | Maintain at broadly current dimensions by way of regular pruning. |

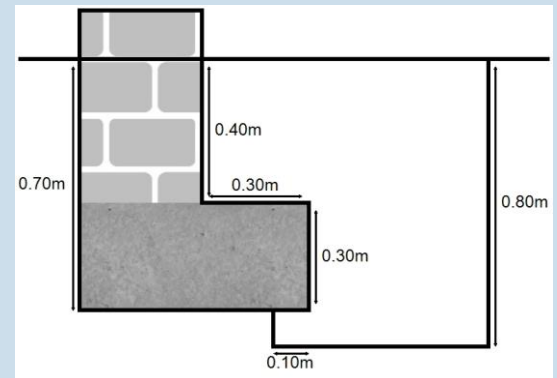
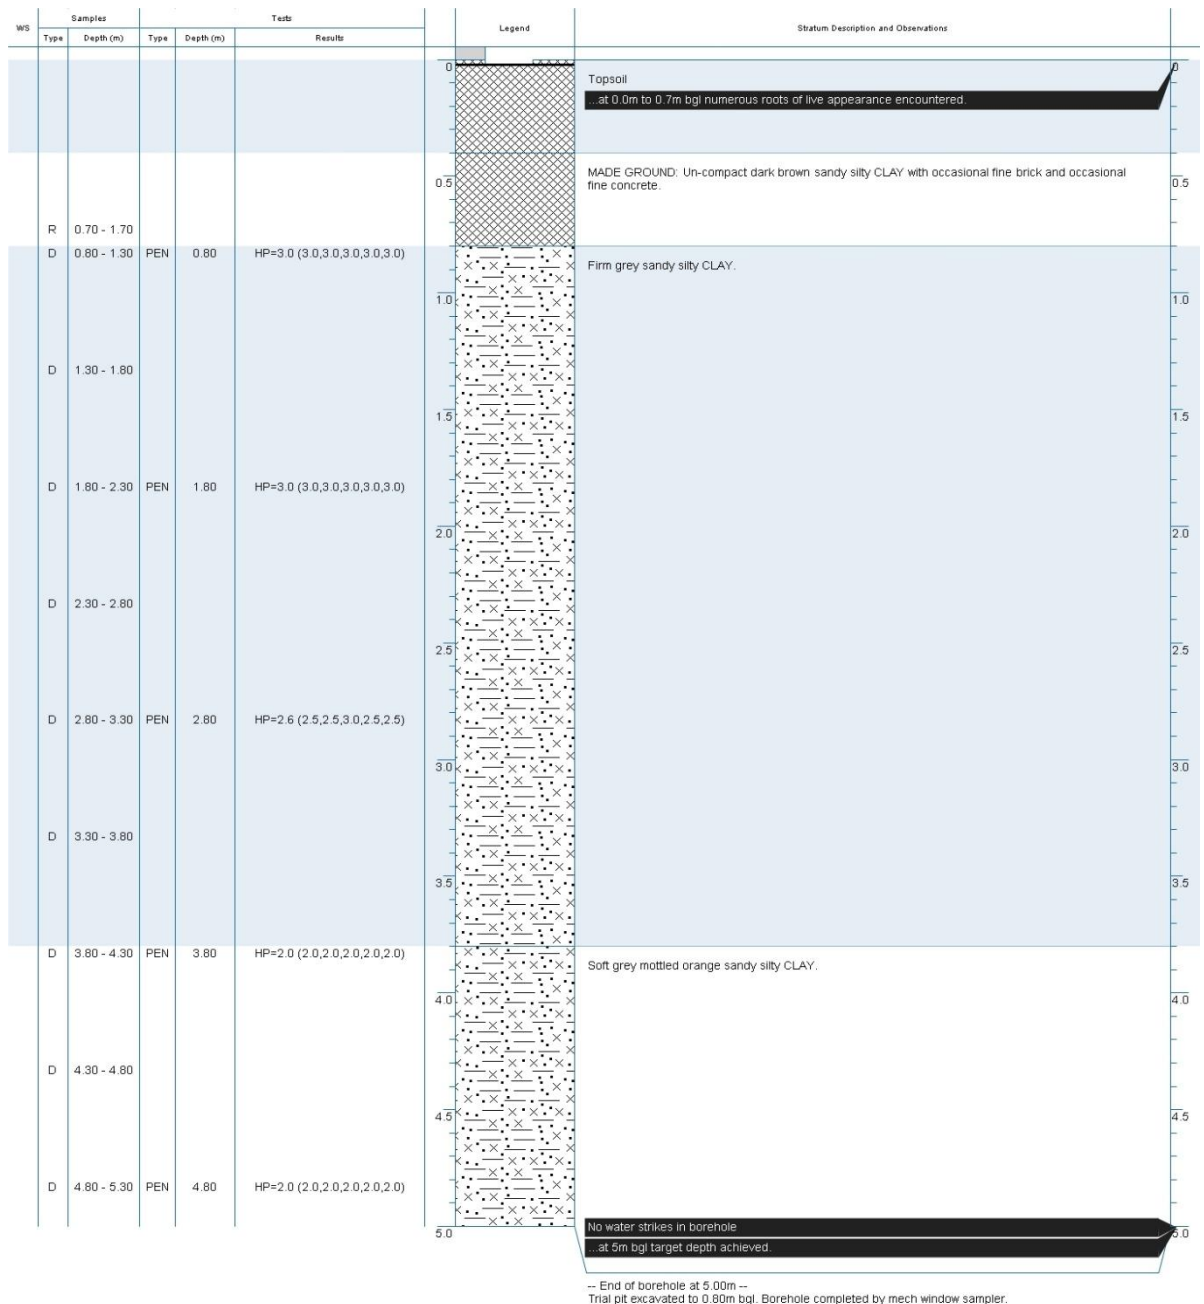
## TP/BH1 Foundation Detail and Borehole Log

Garage foundation comprised of blockwork wall to 400mm bgl, bearing on concrete to 700mm bgl, with a total projection of 300mm from the elevation. Underside of foundation (USF) was exposed to 100mm back from the face of the foundation and probed 450mm back from the face of the foundation.

At 0.0m to 0.7m bgl numerous roots of live appearance encountered in TP/BH1.
