Mr and Mrs M and J Mills  
Kew House, 23 Anchor Road, Calne, SN11 8DY  
08/12/2025  
Tree Surveyor : Stevyn Sargent

This tree and woodland survey was undertaken by a qualified inspector from ground level. It is advised that following any extreme weather conditions any damaged tree or tree movement that has occurred and noticed by persons on site or ground staff is reported to the surveyor for further advice or a revisit if required.

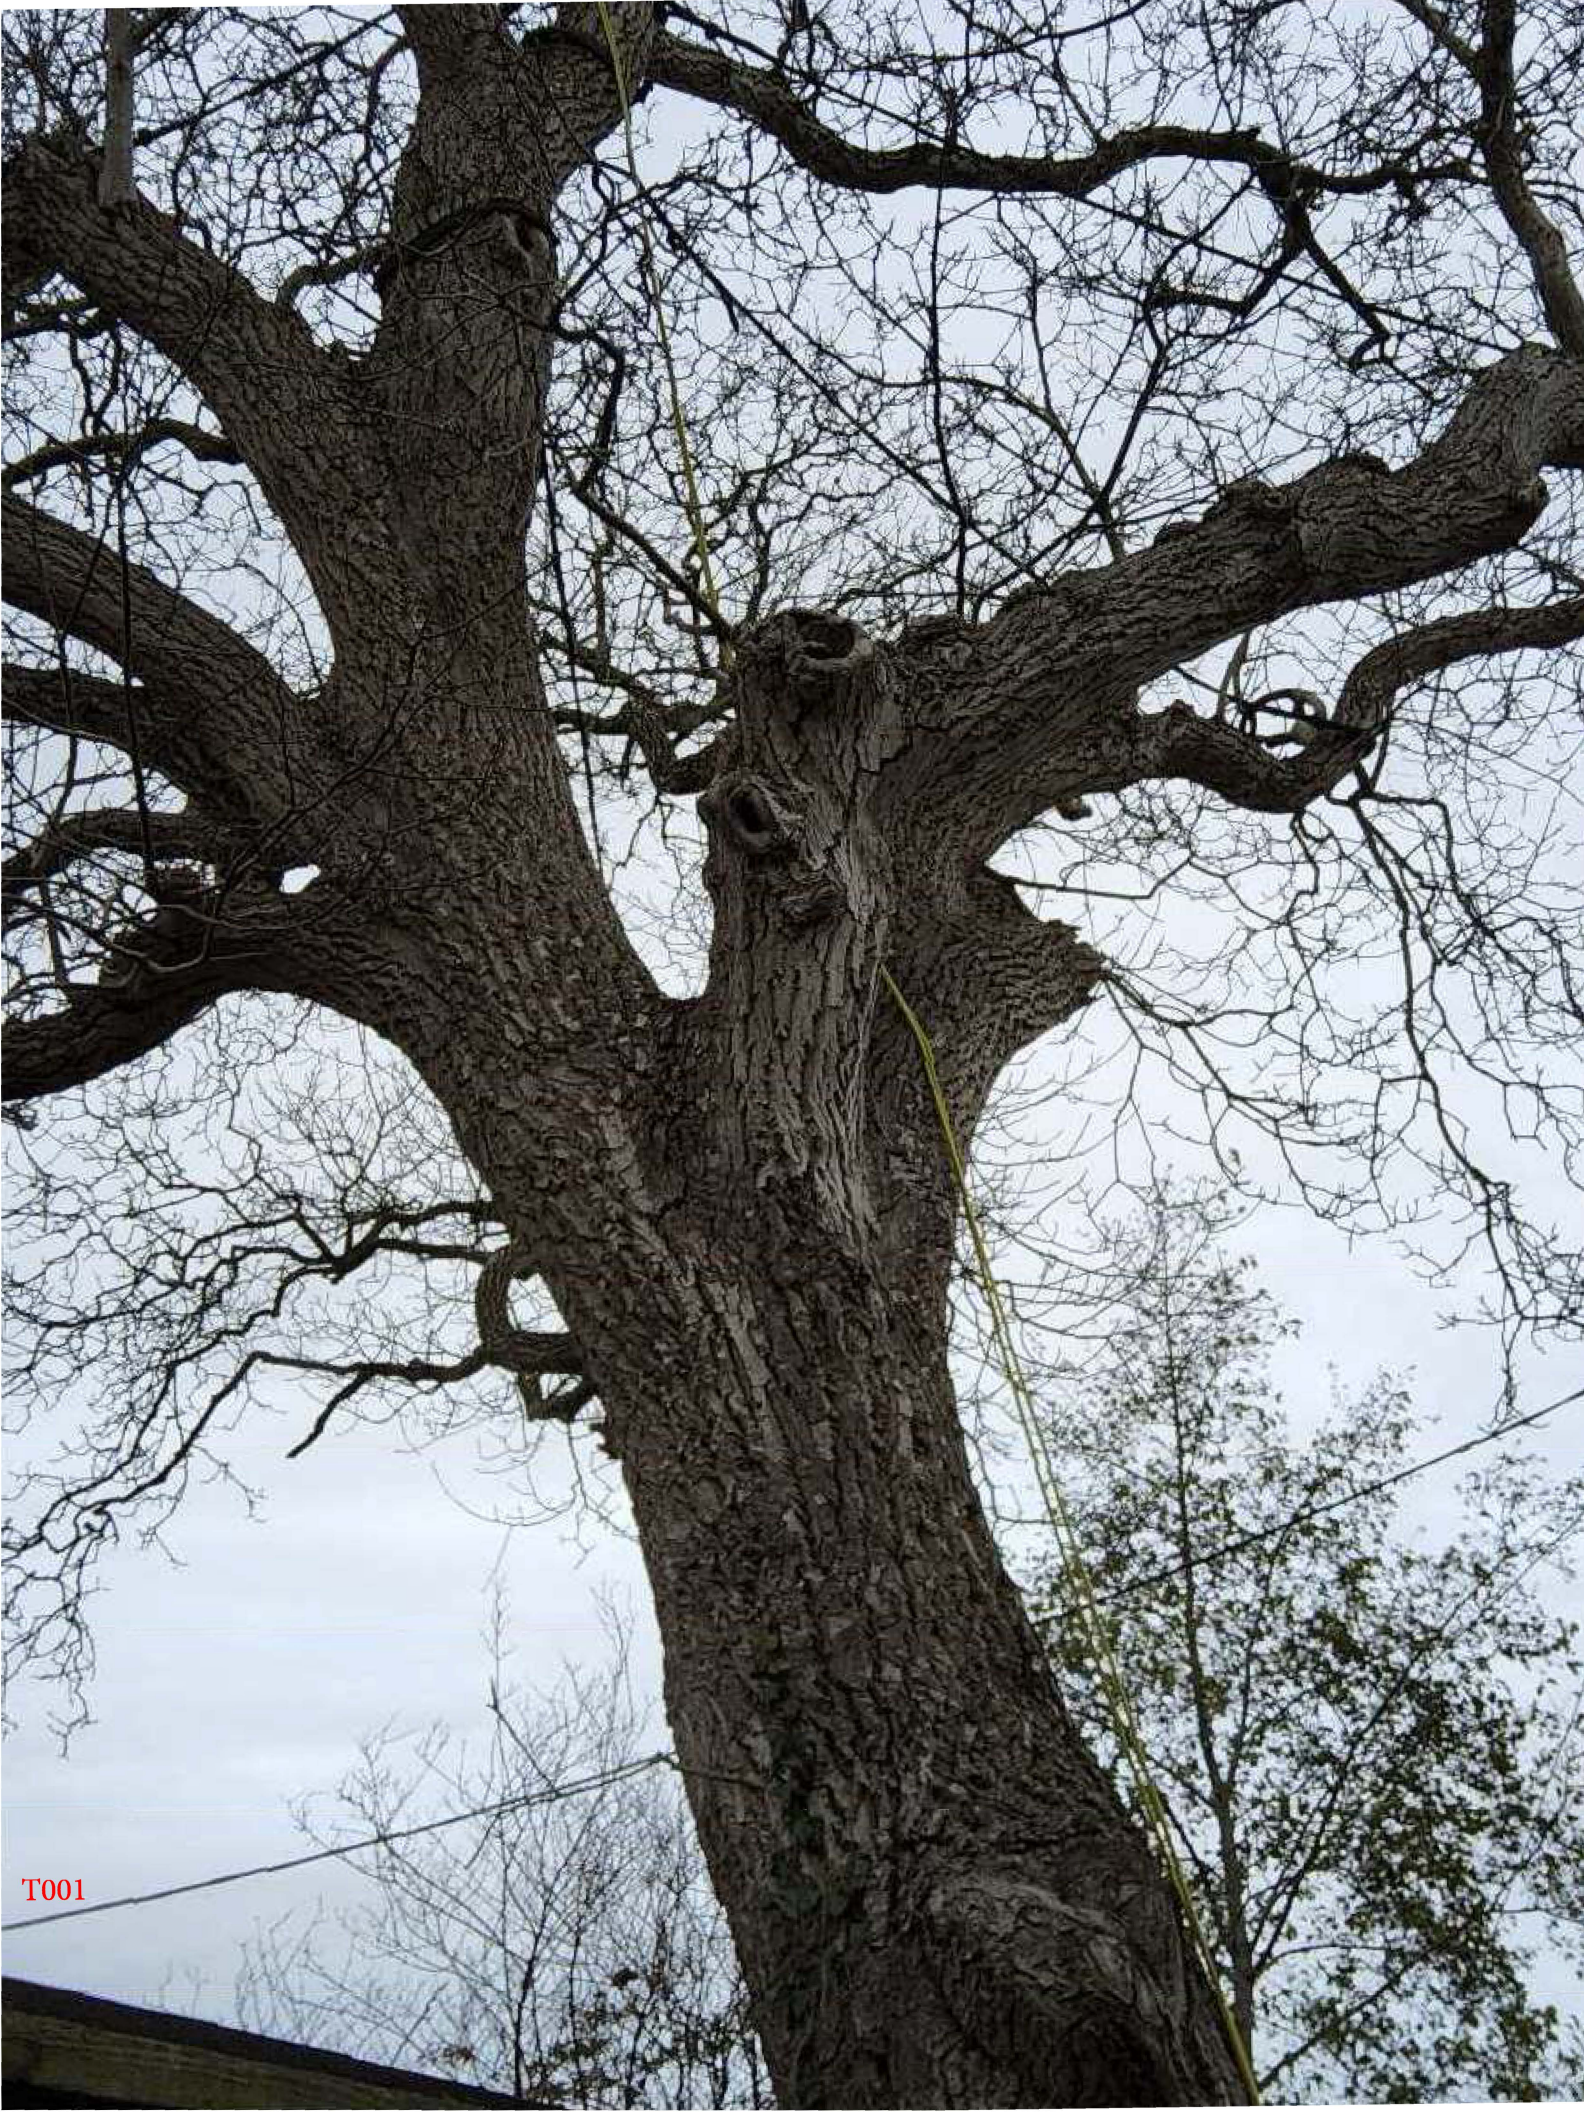
| Ref. | Species | What3Words | Measurements | Retention Category | Survey Notes | Recommendation | Estimated time for works | work priority | reinspection period | Photo |
|---|---|---|---|---|---|---|---|---|---|---|
| T001 | Black walnut<br>( <i>Juglans nigra</i> ) | ///warriors.oddly.pupils | Height (m): 16<br>Stem Diam(mm): 850<br>Life Stage: Mature<br>Rem. Contrib.: 10+ Years | U | <p>Tree is leaning and heavily weighted west facing towards neighbouring property and road. canopy east facing towards house has been heavily reduced in the past causing the heavily biased canopy west facing.</p> <p>South west facing at ground level cavity detected in stem. South facing at ground level gannoderma spp present, bracket fungus is at same location as hollow. Old cobra bracing in tree supporting 4 limbs west north and east facing, bracing system is loose and with out expansion loops or shock absorbers.</p> <p>Crack in main stem at 12m crack extends through stem cobra system is attached round stem at site of crack, see photo.</p> <p>Large wound in lateral limb North east facing 1m from stem. Old pruning wound on main stem at 10m approx 20cm deep. South west facing limb at 10m over neighbouring property has large wound on top of limb.</p> | Remove tree. Due to evidence obtained during climbing inspection, including crack in stem, cavity detected in main stem south west facing, and gannoderma fungal bracket and numerous cavities through out canopy. | | 6 Months | | |

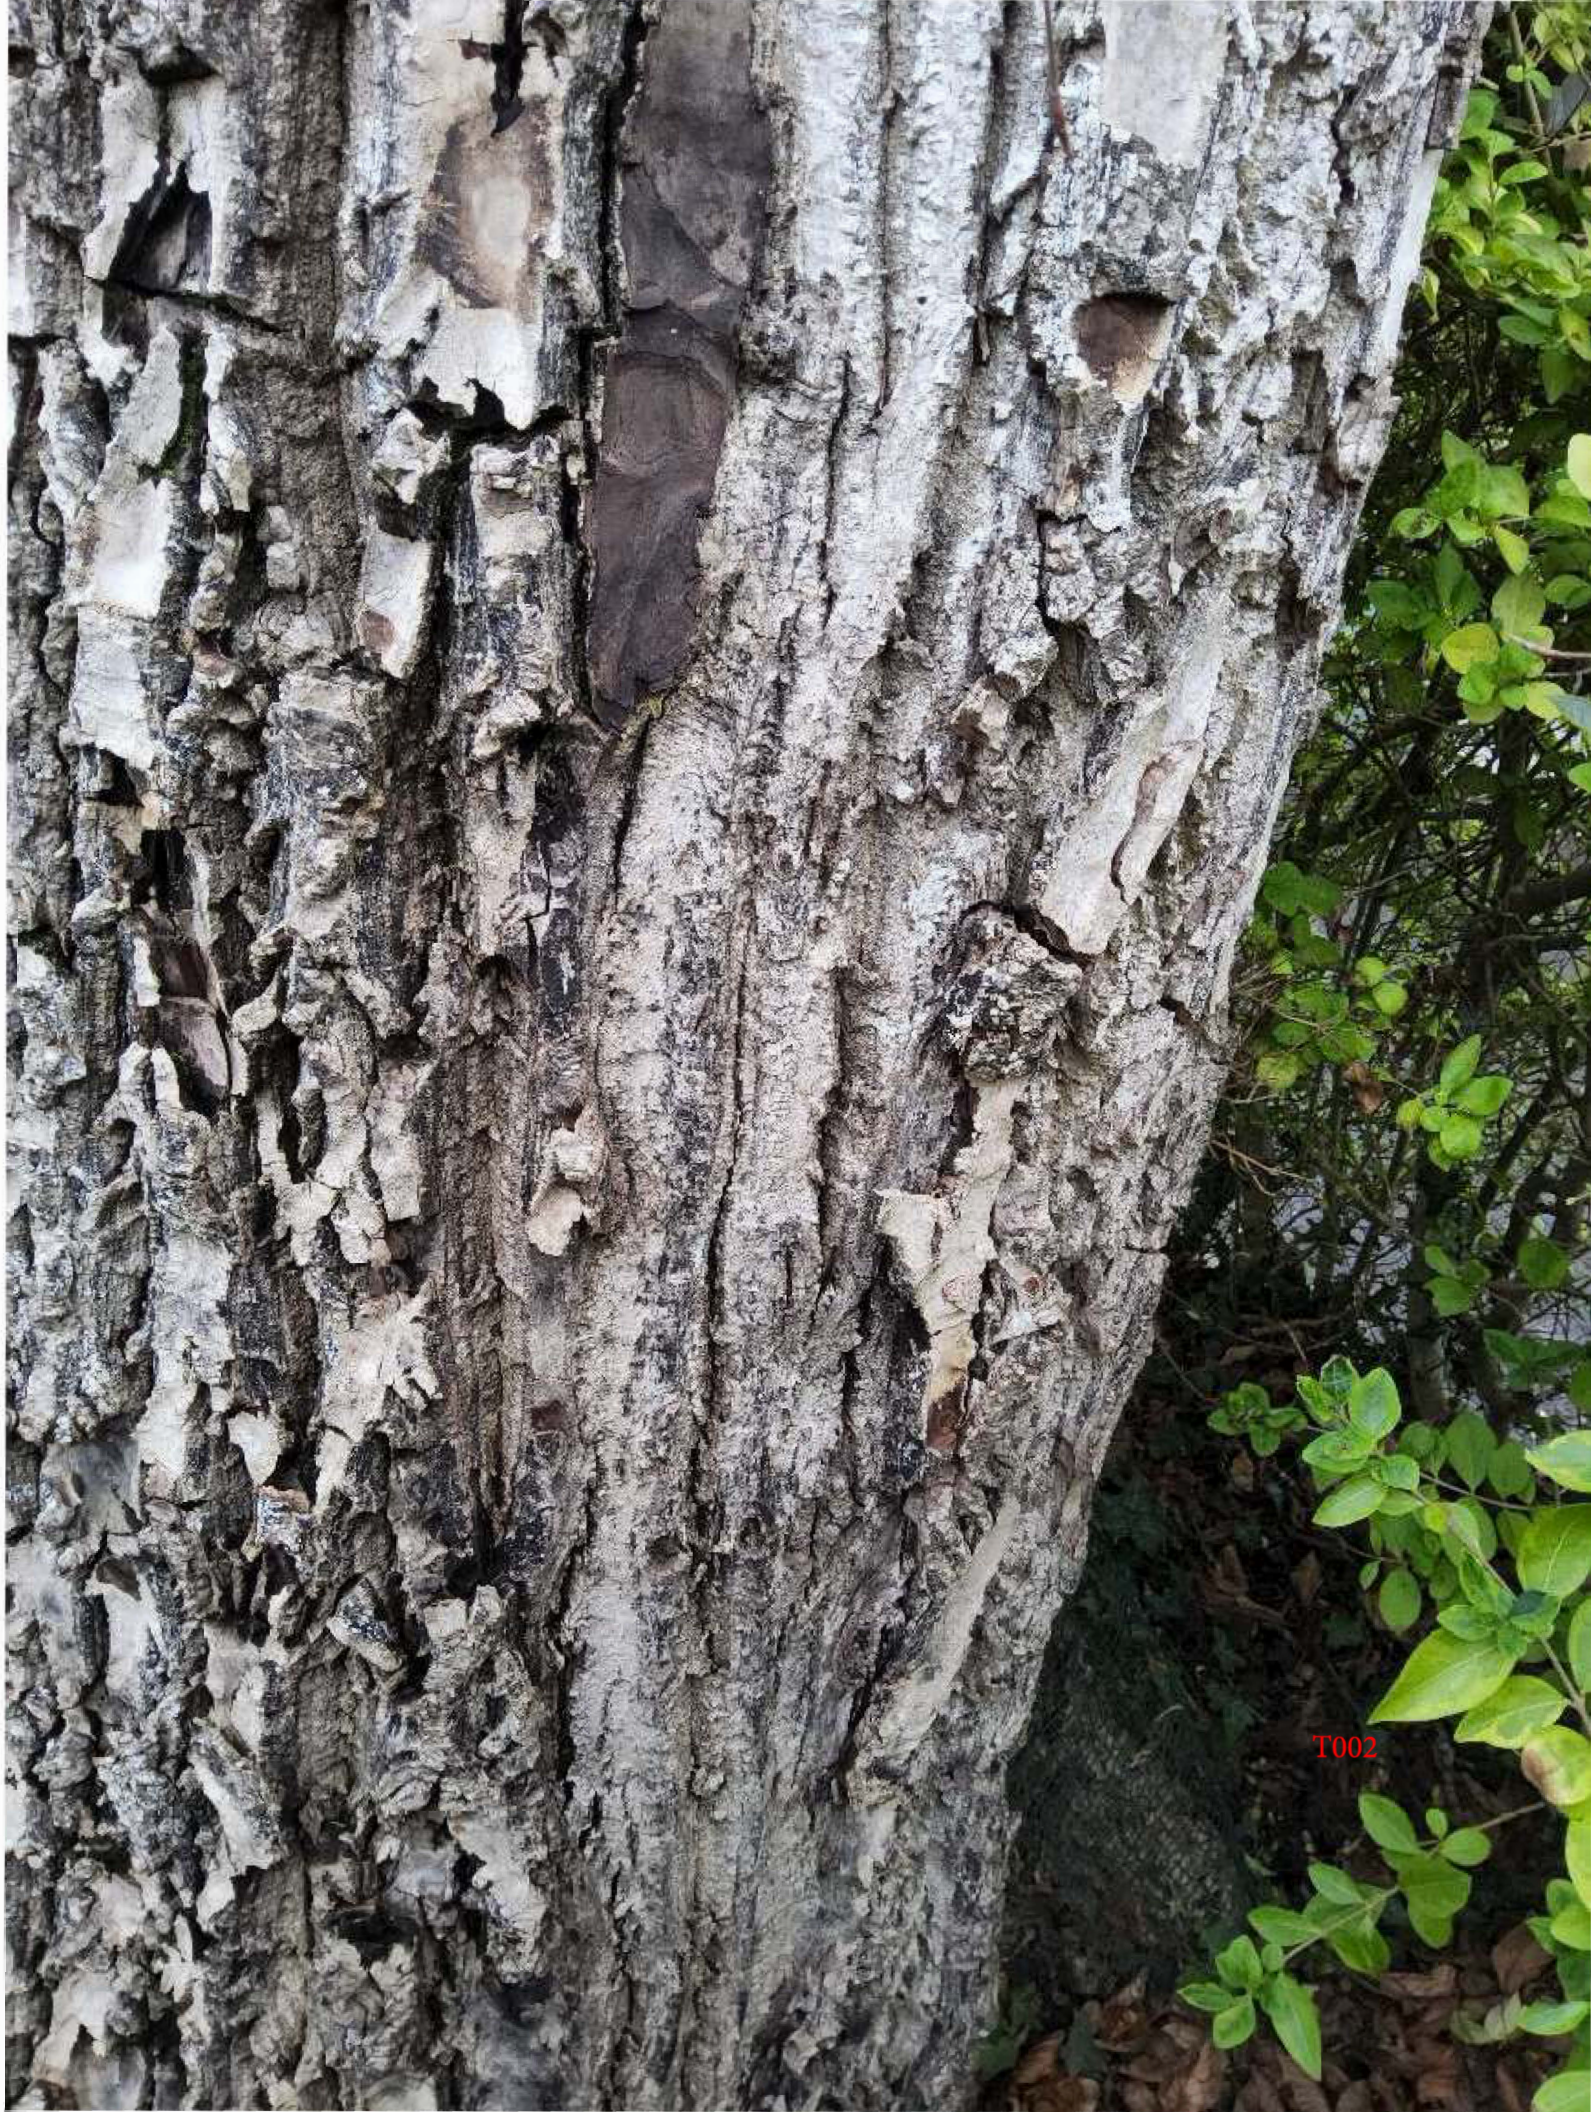
| Ref. | Species | What3Words | Measurements | Retention Category | Survey Notes | Recommendation | Estimated time for works | work priority | reinspection period | Photo |
|---|---|---|---|---|---|---|---|---|---|---|
| T002 | Black walnut<br>( <i>Juglans nigra</i> ) | ///sprouting.buckling.gardens | Height (m): 14<br>Stem Diam(mm): 650<br>Spread (m): 5N, 5E, 5S, 5W<br>Life Stage: Mature | C | <p>South east facing at 5m bracket fungus on main stem. Main stem south facing at 5m old pruning wound with decay present. South facing at 5m on main stem old pruning wound with decay behind.</p> <p>Large lateral limb east facing at 2m has possible hazard beam from union for 2m. North facing at 2m old pruning wound in main stem. Possible crack in stem at 1m South facing.</p> | Reduce canopy by 2m. Install COBRA system on lowest branch over driveway due to possible hazard beam | | 6 Months | | |
