TIMBERGLAZE

#### WINDOW CONDITION REPORT

In response to your request for a report on the condition and status of East facing 1<sup>st</sup> floor window at Your property at 11 Hill Street in Trowbridge.

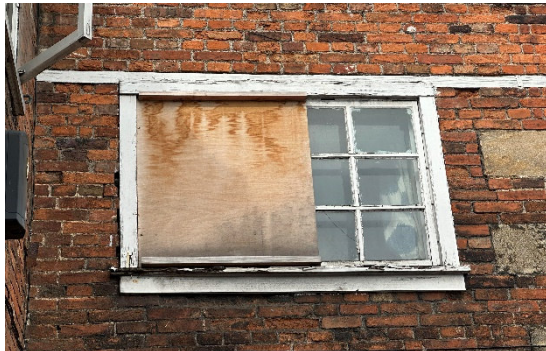
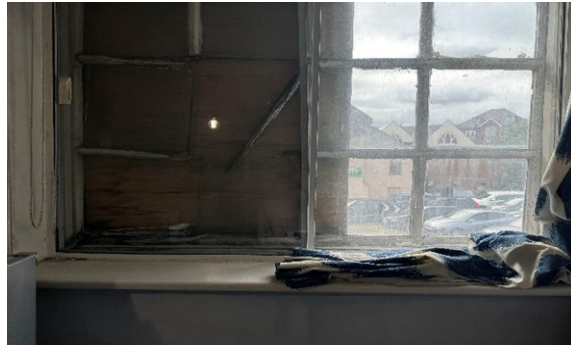
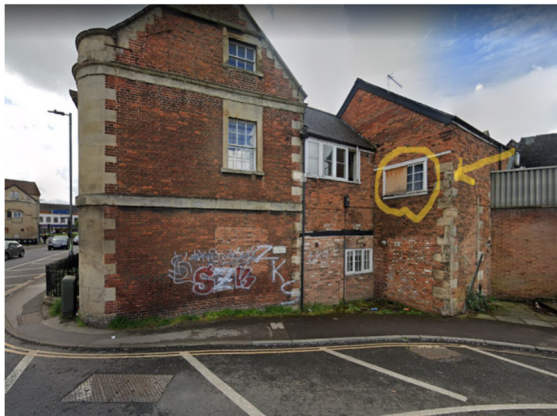
Please find an internal and external photos:

It is my opinion that the window is beyond economical repair, furthermore it is a late 20<sup>th</sup> century poor quality softwood window that is of no historical significance.

It is also my opinion that the current glazing bar format is badly proportioned and not in keeping with the age of the property, or with the surrounding windows. The current top hung casement has 12 panes (4 along and 3 up). This makes each pane more wide than tall.

I would suggest a window with two side hung casements, either with 1 horizontal glazing bar in each sash (to match the adjacent window) or two side hung casements with 4 panes in each sash, similar to the window below.

It would also provide significantly better sound and thermal insulation if the window were to be double glazed with slim profile insulating or glazed with vacuum glass. These would be glazed with a traditional overpainted putty line. The method of double glazing with a 6 or 8mm spacing between the inner and outer pane would have little double parallax reflection so would be difficult to discern from a single glazed window, the vacuum glazing option is only 8mm thick so is indistinguishable from single glazing.
