# Tree Risk Assessment 2025

For a single English oak at East Knoyle Playground

Instructed by Felltec Tree Services  
On behalf of East Knoyle Parish Council  
Church Road  
East Knoyle  
Salisbury  
SP3 6AE

Inspected and Prepared by Nick Baxter BSc(Hons) MArborA  
2<sup>nd</sup> December 2025

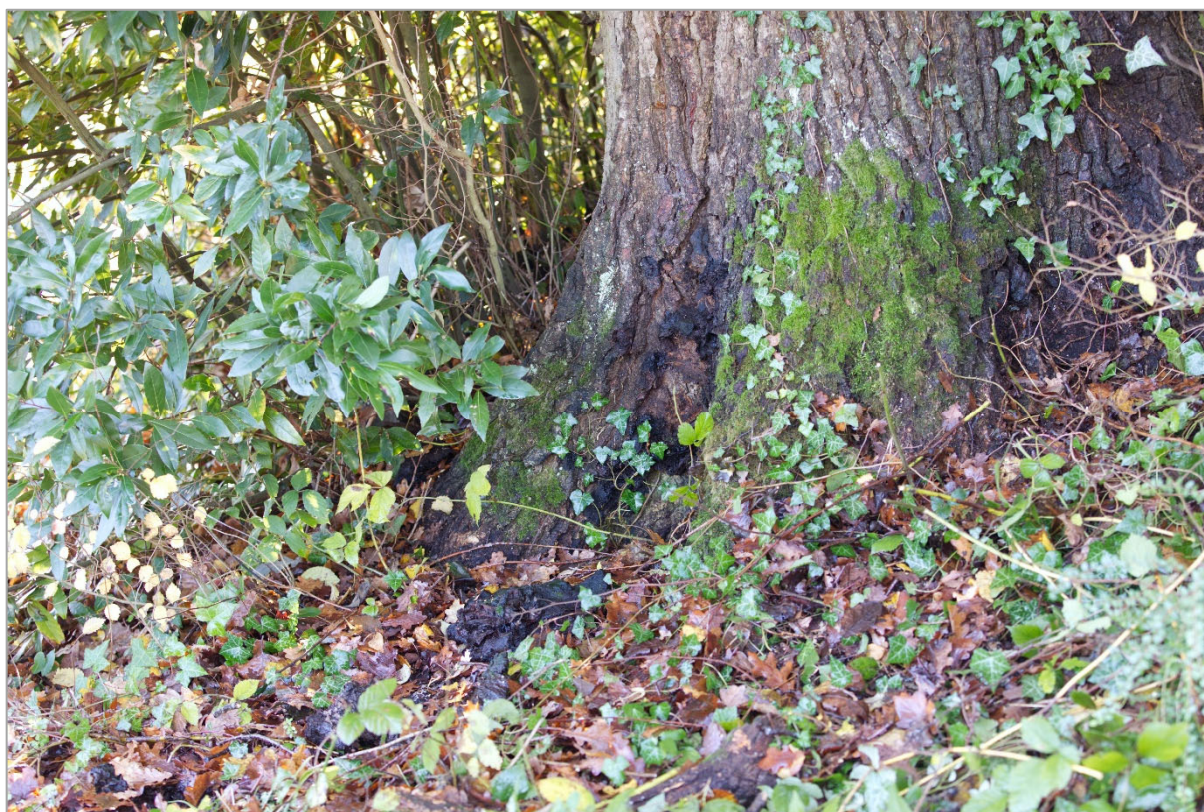
There are obvious fungal scars present from fruiting bodies between two large buttresses on the north side and two desiccated *Ganoderma* sp. brackets directly below, one further fungal scar is located on the south side. The use of a sounding hammer only indicates notable hollowing on the eastern side of the northern buttress and all other buttressing appears sound. Two live stubs at 6-7m on the south-western side, one is from a recent fracture and the other appears to have fractured many years ago. An old scar is located on the underside of a branch on the eastern side at 7m but has healthy wound wood present. The lower internal crown has good healthy leaf coverage but parts of the upper crown on the northern side shows signs of dieback with a slightly lower vitality. Minor deadwood over the playground and road.

**Figure 2:** *Fungal scars between northern buttresses and desiccated fruiting body on the ground.*

*“Reduce the crown periphery by no more than 1.0-1.5m whilst retaining all live growth below the pruning points. Remove the deadwood and stack close-by to retain some habitat.”*

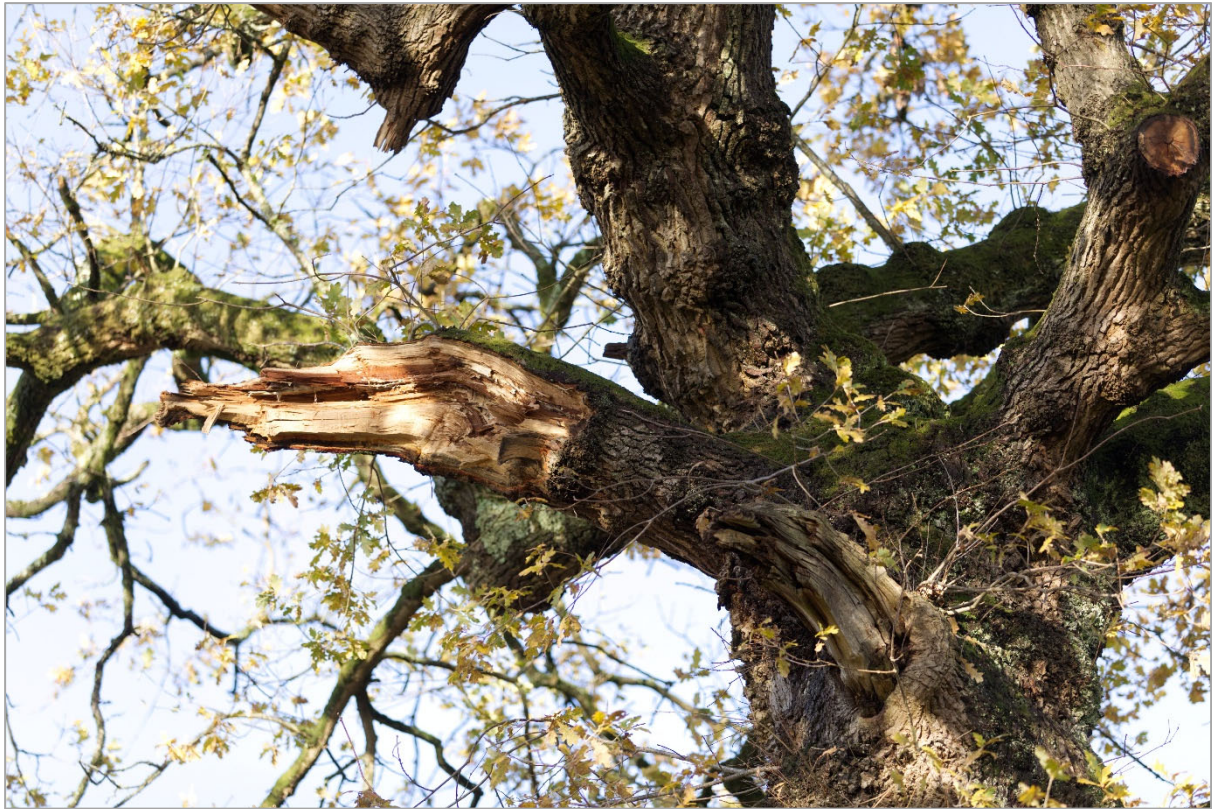
**Figure 3:** Two live stubs with associated scars. Recent scar above and old scar below.

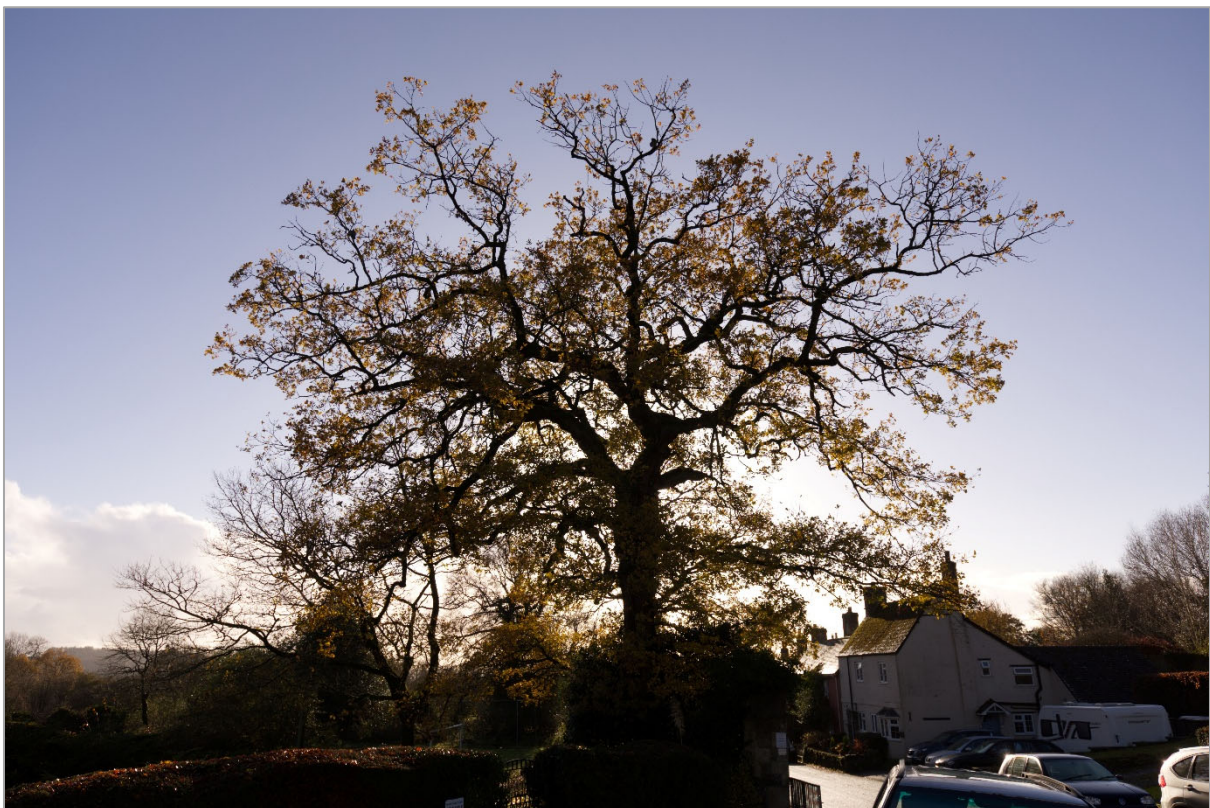
**Figure 4:** Patches of minor dieback in the upper canopy.

The pruning work is recommended as an ‘Advisory’ priority. There is no timescale for advisory works because it is not required for immediate risk management purposes, however it would be sensible for it to be carried out when the deadwood is removed.
