**TREES AT LAND ADJ TO TUDOR COTTAGE, PARK LANE, CHERHILL, CALNE, SN11 8QN.**

**Date of Inspection:** 09.07.25

**Inspected by:** Ivan Hinsley BSc

## TREE SURVEY FOR LAND ADJ TO TUDOR COTTAGE, PARK LANE, CHERHILL, CALNE, SN11 8XN.

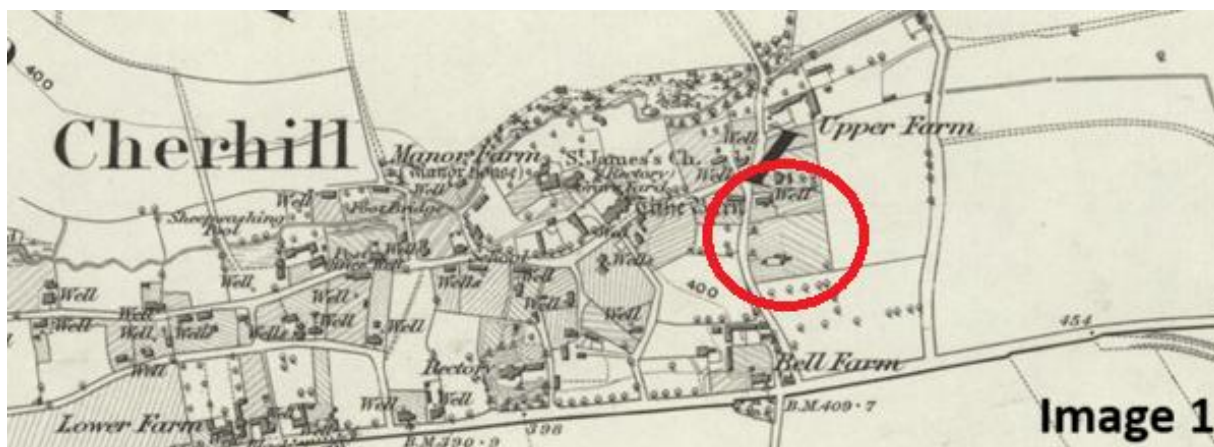
Image 1 is a segment of an 1889 map, Wiltshire Sheet XXVII. The red circle shows the area of the proposed development at Land Adj to Tudor Cottage, Cherhill, SN11 8QN. From this map it can be seen that there is a dwelling and an outbuilding in the area close to the proposed development. These buildings are not present on the 1922 edition of this map.

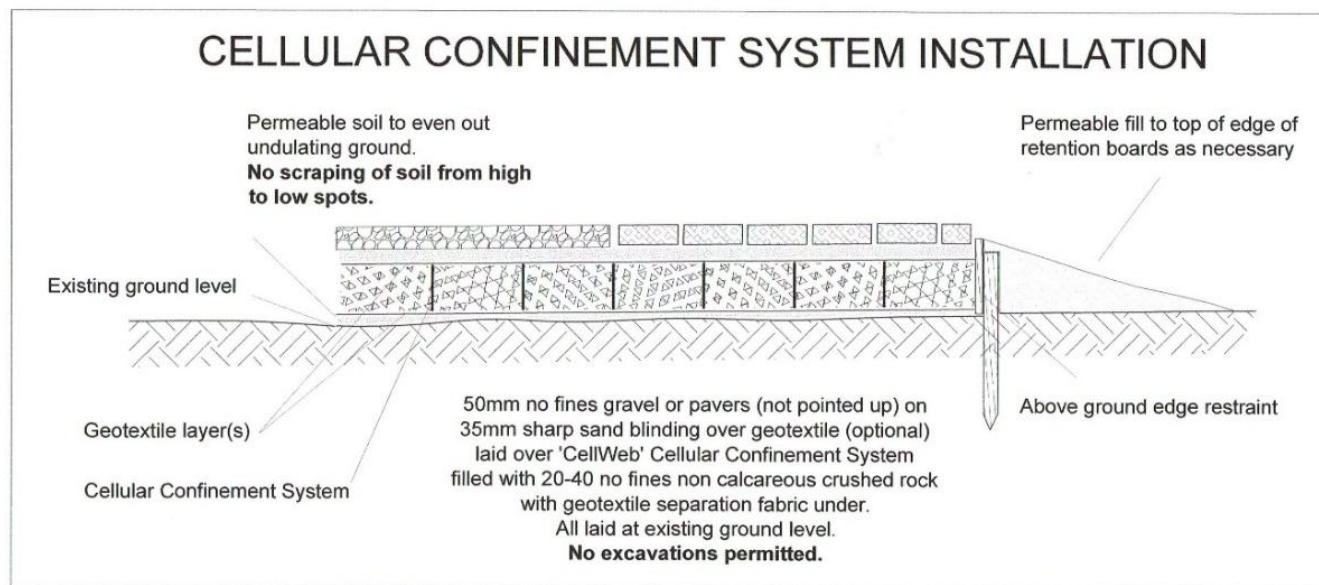
Diagram 1

Currently the site has a shared access with Tudor Cottage. In the plans provided there is a proposal for the site to have its own access driveway. The route of the driveway would be through part of the RPAs of T4, T14 and T15. To mitigate any impact on the trees from the proposed driveway there are a number of things that can be done to maintain the circumstances that the trees are currently used to. Firstly, we would state that the driveway cannot be constructed within 1 metre of the trunk of a tree. This protects the structural buttress roots of a tree and prevents damage to the driveway. If structures are constructed too close to trees as they grow and develop, the tree will exert pressure on the structure and deform it over time. The maximum changes in soil depth within the RPA are to be 100mm excavation or 150mm increase. 100mm would remove the top layer of turf without disturbing the tree's root system. 150mm increase would not detrimentally impact the penetration of moisture and gases to the tree's rooting system. Finally, a cellular confinement system, as shown in diagram 1, should be used. This type of cellular confinement system has been used for more than 20 years for the protection of tree roots. There are hundreds and thousands of examples where this system has been used and the trees have continued to be successful. We believe this can also be the case on this site. This method of protecting roots has been very successful because of its ability to spread load and protect against compaction within the rooting zones and when constructed with permeable materials the water that would normally be intercepted by the grass or other competitors is able to permeate down to the roots of the tree. As this water percolates through the cellular confinement system, it draws oxygen down with it making it available to the roots of the tree. This system also has the benefit of

being able to store water on a short-term basis, slowing down runoff and helping to prevent the drains being swamped. The wearing layer and sub-base layers will need to be permeable to enable moisture, nutrients and gases to be accessible for the roots and from a non-marine source. The permeable wearing layer will need to be constructed of a material that promotes easy maintenance. Being able to clear up easily the detritus that falls from a tree will promote a positive relationship between the trees and the residents of the proposed development.
