**REVIEW OF A STRUCTURE TO THE REAR OF  
THE CARPENTERS ARMS, LACOCK.**

**Carried out, 5<sup>th</sup> August 2025**

*An independent assessment of the historic relevance and authenticity  
of the structure bounding East Street, to the rear boundary of the curtilage for The Carpenters  
Arms (shown above) which faces Church Street, Lacock.*

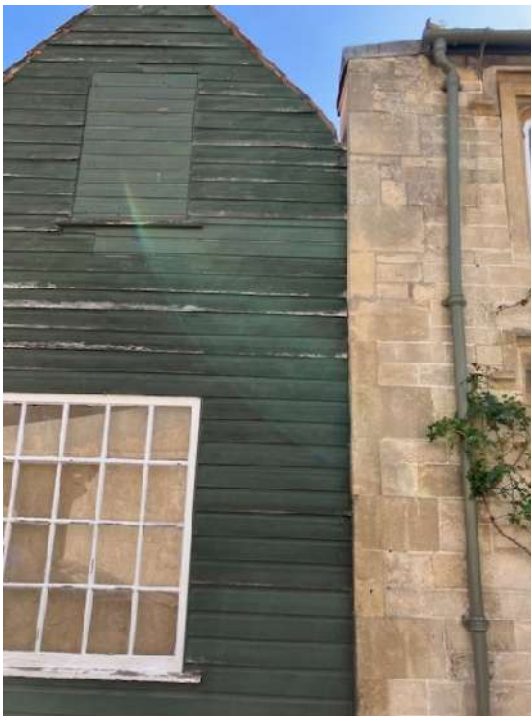
Fig. 2 timber clad street aspect

The general state of the building shows considerable rotting to both the cladding and structures at eaves level (see Figure 3). The state of the structure abutting the neighbouring property cannot be assessed as there is no visibility due to its proximity to the wall of the adjacent property as seen in Figure 2. Externally the current building presents as a horizontal timber clad structure two storey building that abuts the neighbouring property (see Figure 2 as viewed from East Street) with minimal or no air gap and may rely on the neighbouring structure for lateral support against collapse. The valley between the two buildings cannot be seen but is a potential trap that could be causing rot demonstrated on the exposed eave as shown in Figure 3. The visible side of the structure facing the “courtyard” (see Figure 3) is similarly timber clad with four, “2-over-2” glass paned window frames (three together as shown from the inside in Figure 4). To the upper storey (see Figure 1) there is a boarded-up access door/hatch, above a “6-over-4” window facing East Street.

10. The aspect this structure presents to East Street (see Figure 2) does not match or reflect any of the other buildings structures in this ancient part of Lacock Village, indicating that it was not a considered development.

Whatever is done to this structure, serious consideration should be given to removing any risk of potential deterioration of the adjacent building in East Street due to the lack of air gap between the buildings.

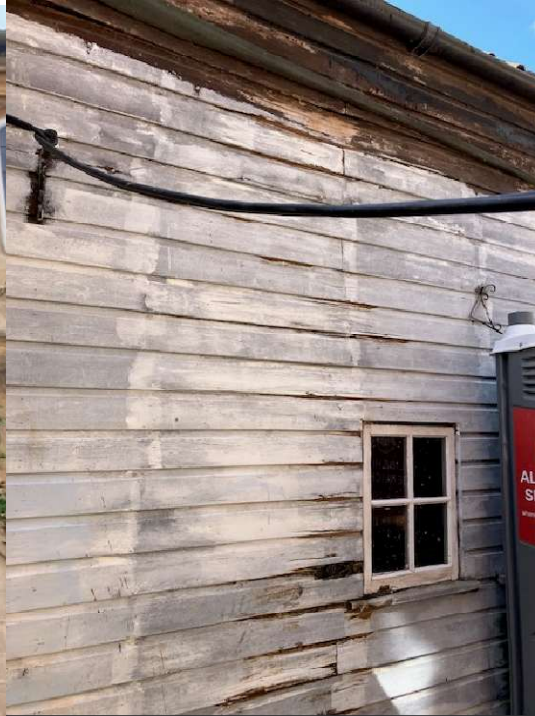
Fig 3 – inwards facing aspect

7. The windows let into the side wall facing the main building (Figures 3 and 4) are compatible with the 1980's, indicating that these were introduced during the circa 1985's pulling down and rebuild of the structure.

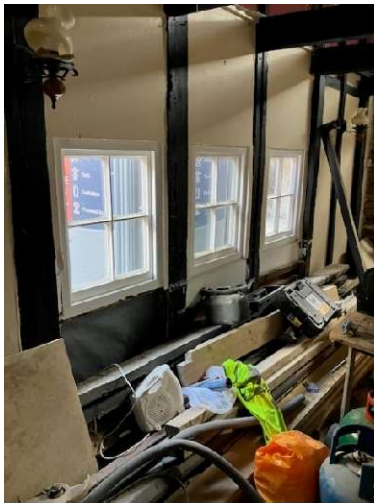
Figure 4 showing windows

Internally (see Figures 4 and 5) there are black painted horizontal beams with bolted extensions either resting or tied into vertical timber supports. The space above has recently been exposed by the removal of ceiling board revealing and empty “loft” space. The vertical wall timbers are accompanied by applied angled timbers but these do not appear to be tied in structurally to the vertical timbers and appear to mimic Tudor style cross-brace structures as shown in Figure 6.

1. The crossbeam timbers at ceiling height (Fig 4) have bolted extensions and are machine finished timbers, possibly to have been “recovered” from another source. The method of construction and support do not reflect any degree of craftsmanship or conventional structural method of any known period, with a crude attempt in places to replicate Tudor timber framing (chronologically not relevant).

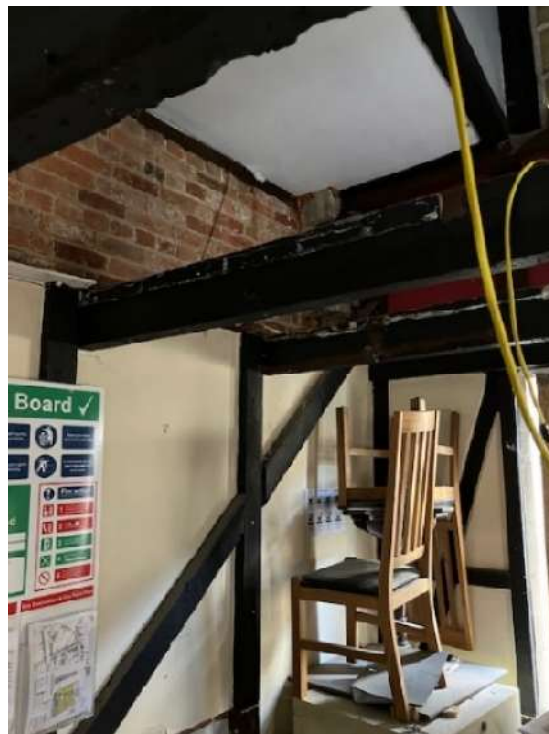
Figure 6

The wall infill between the black timbers is a combination of rendering and plasterboard concealing various brick and stone “wall” structures as shown in Figure 6. These appear to be using recovered stone and bricks using modern cement mortars.

4. The diagonal wall plates as shown in Fig 6 do not appear to be tied into the vertical struts and appear to be a cosmetic rather than functional structure.

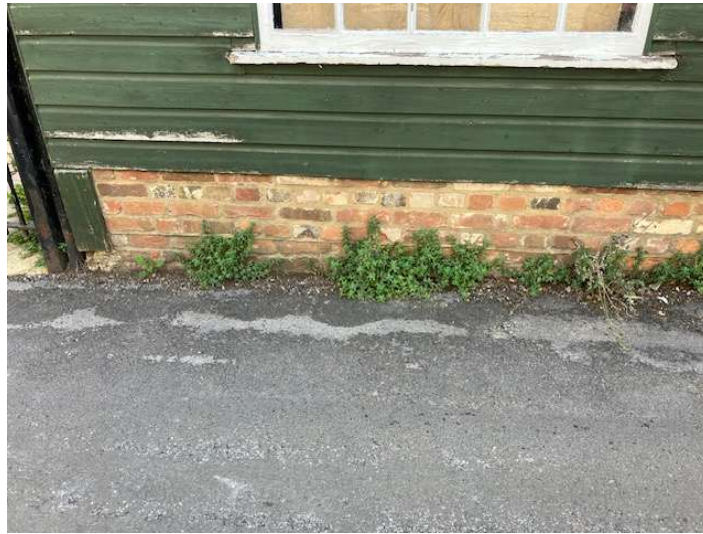
6. The wall facing onto East Street has modern bitumen DPC (damp proof course) with the use of recovered bricks abutting a stone remnant as shown to the lower left of the wall (see

Figure 6 below). This extends across the whole wall. This indicates a replacement/creation of the structure above this level and therefore is of little age archaeologically.

Figure 6 Modern DPC and recent brickwork.
