# Window Condition Survey Report

Linden Cottage,  
4 George Lane,  
Marlborough  
SN8 4BT

20 FEBRUARY 2026

Heritage Window Consultancy Ltd

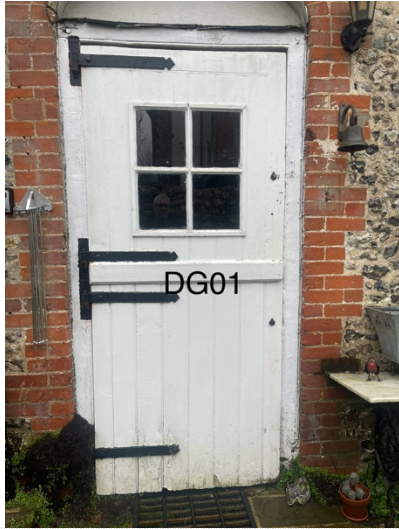
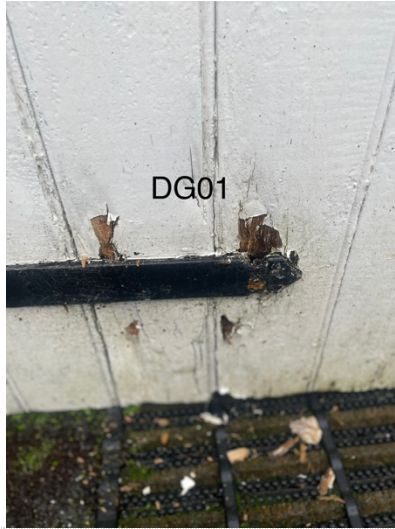
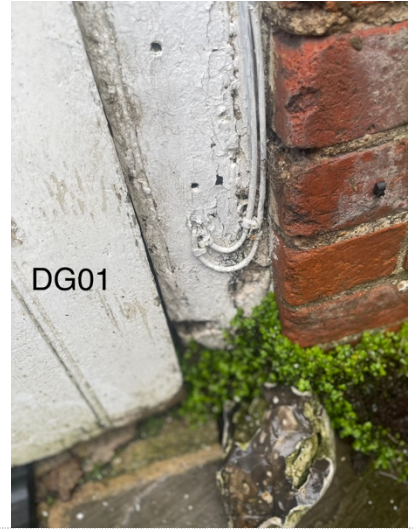
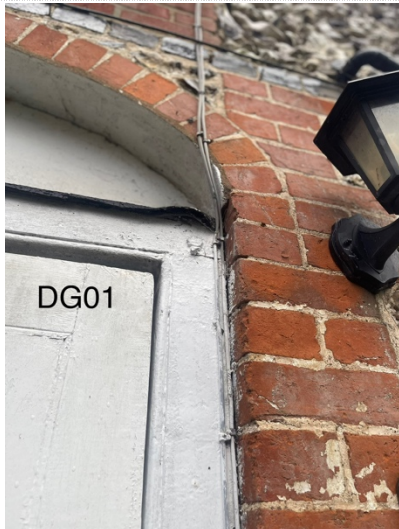
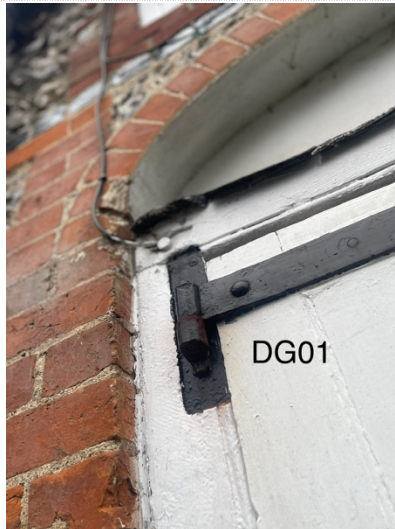
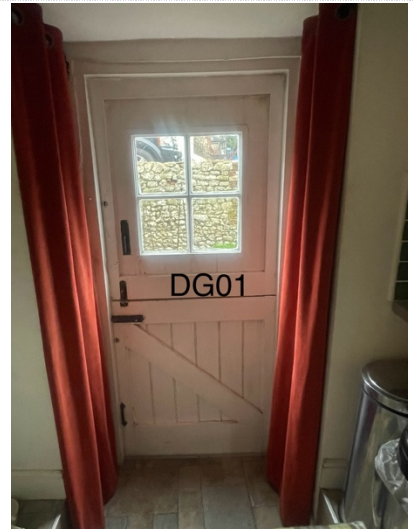
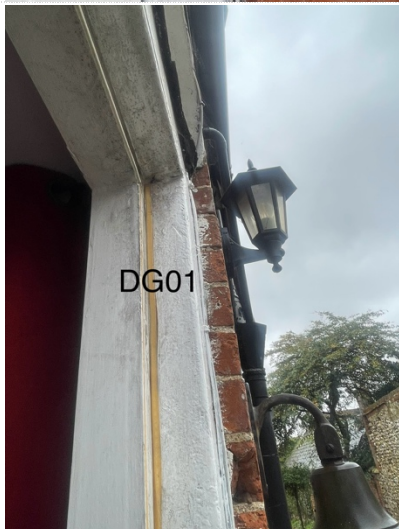
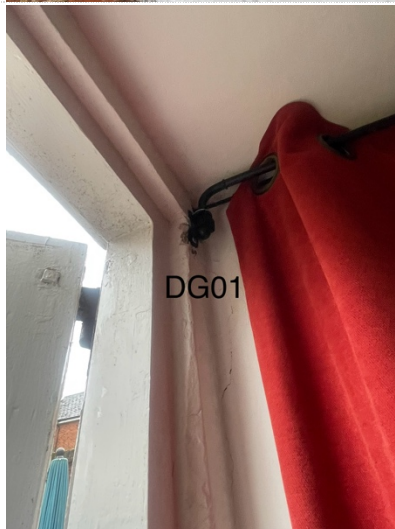
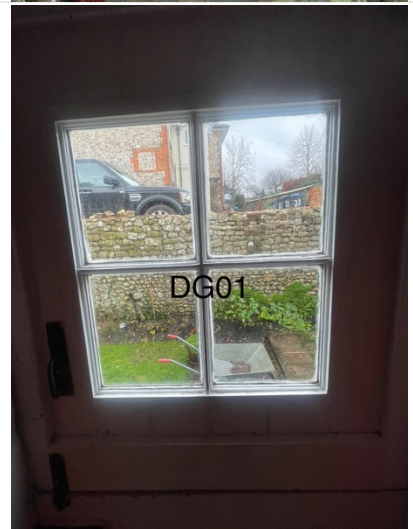
In this context, repairs to the door would not provide a durable or effective long term solution.

Replacement on a like for like basis in timber is therefore considered justified and proportionate. The proposed replacement would replicate the existing configuration, proportions and detailing, with glazing improvements addressed separately to minimise visual change whilst improving performance.

As such, it is proposed that the frame is repaired using traditional methods, involving the careful removal of decayed timber to the lower sections of both jambs and the scarfing in of a compatible, durable timber such as Sapele, thereby extending the serviceable life of the historic frame.

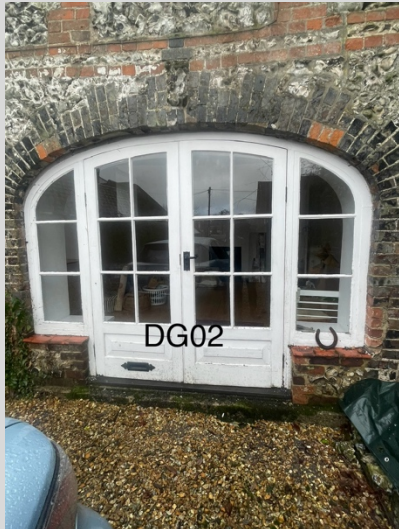
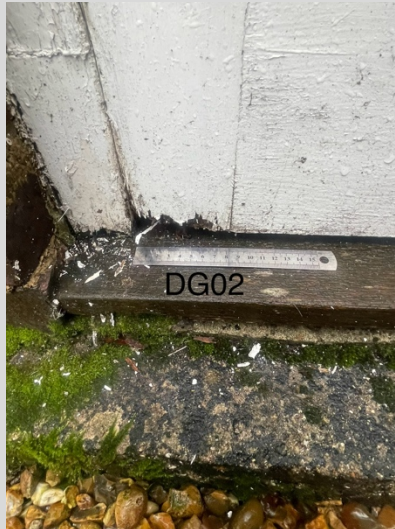
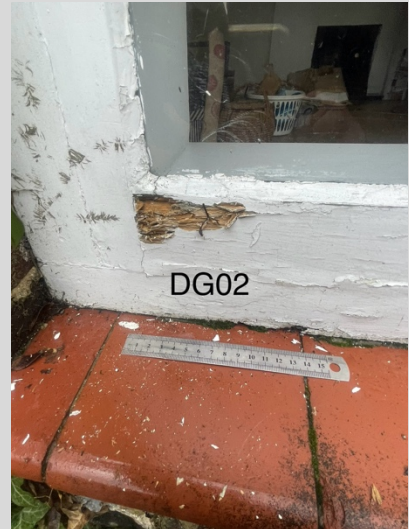
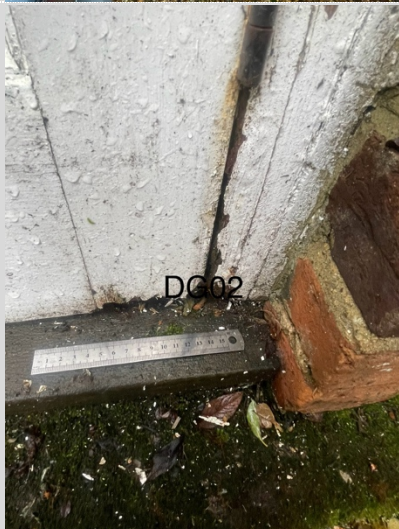
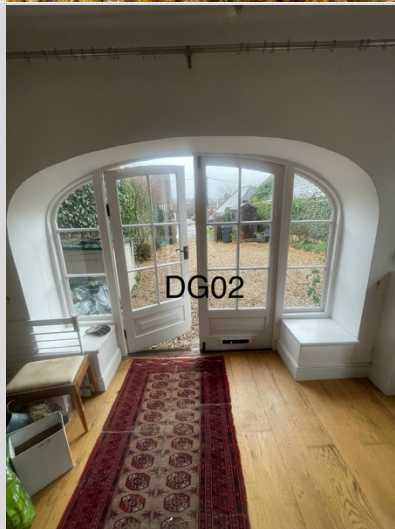
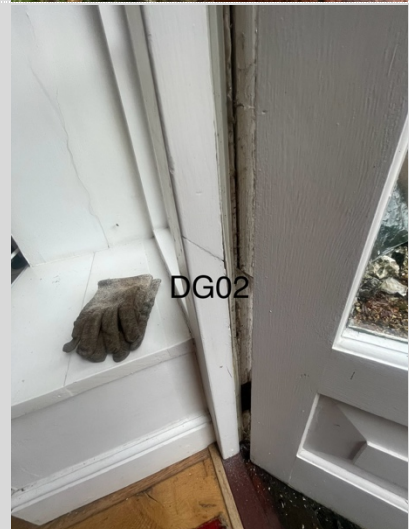
## DG.02

The existing door set exhibits widespread deterioration, including decay to both jambs, rot within the door stiles, and deterioration to the bottom rails of the fixed sidelights.

Evidence of previous localised repair and the use of inappropriate filler materials indicates an ongoing pattern of failure and moisture ingress.

The extent of decay affects multiple primary structural elements and is not confined to isolated areas capable of durable localised repair.

Any attempt at repair would necessitate extensive replacement of timber across the frame, door leaves and fixed elements, resulting in a level of intervention comparable to reconstruction rather than meaningful conservation.

In light of the absence of identified heritage significance, replacement on a like for like basis in timber is considered justified and proportionate.

The proposed replacement doors would replicate the existing configuration, arched heads, glazing pattern and joinery profiles.

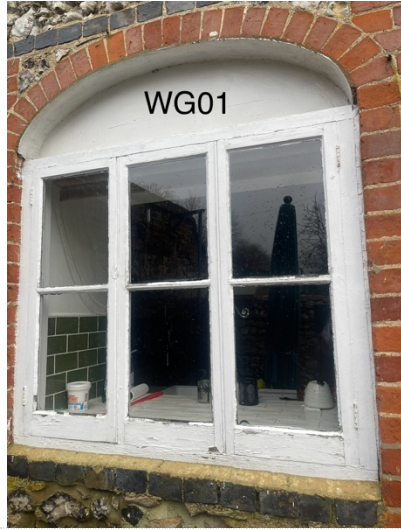
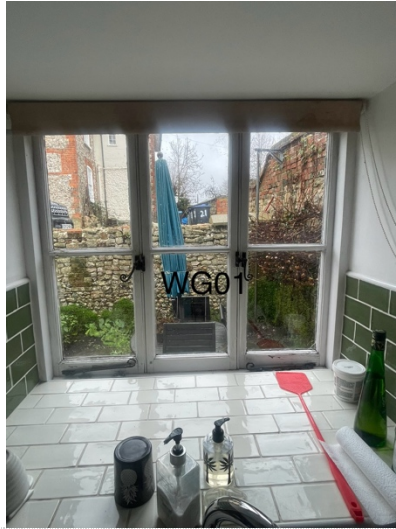
## **WG.01**

There is a general breakdown of paint and putty across these casement windows, together with extensive deterioration to each bottom rail.

In this context, repair would not provide a durable or effective long term solution.

Replacement on a like for like basis in timber is therefore considered justified and proportionate. The proposed replacement would replicate the existing configuration, proportions and detailing, with glazing improvements addressed separately to minimise visual change whilst improving performance.

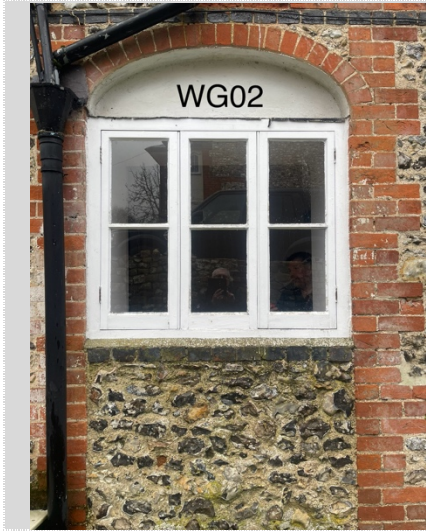
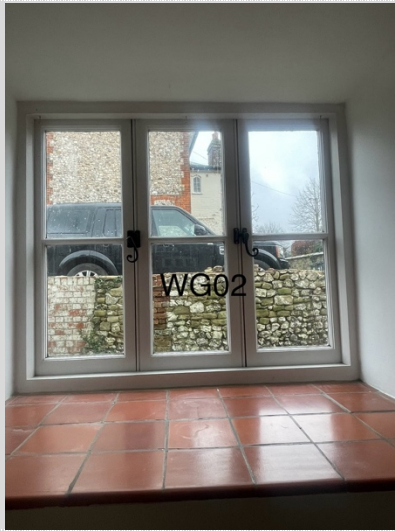
## WG.02

In this context, repair would not provide a durable or effective long term solution.

Replacement on a like for like basis in timber is therefore considered justified and proportionate. The proposed replacement would replicate the existing configuration, proportions and detailing, with glazing improvements addressed separately to minimise visual change whilst improving performance.

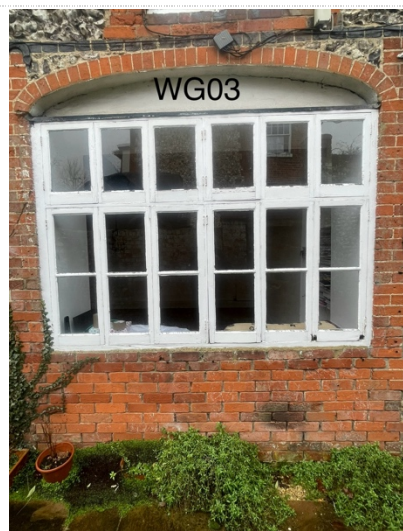
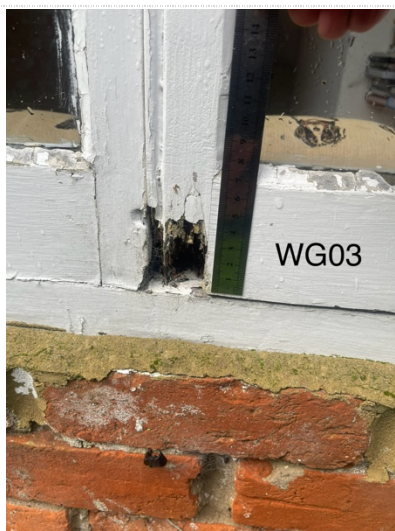
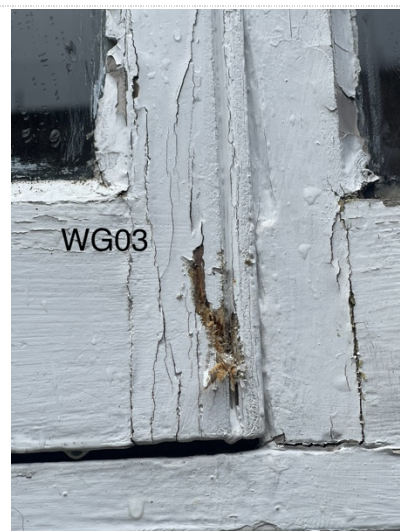
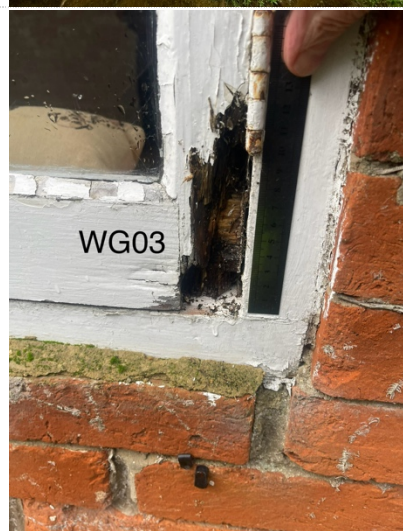
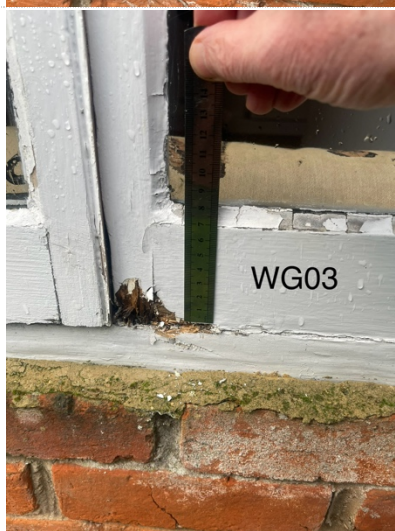
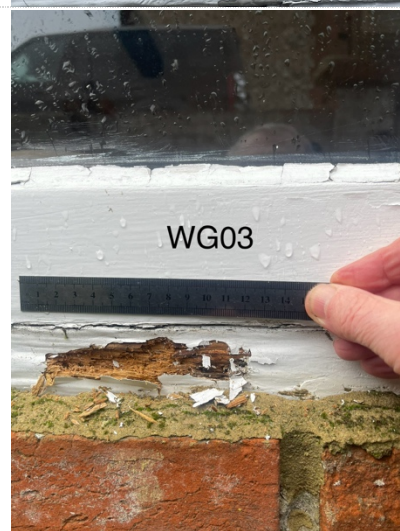
## WG.03

There is a general breakdown of paint and putty across the window, together with extensive deterioration to the bottom and top lights, in particular the bottom right hand casement and the bottom section of the frame in multiple areas.

More widespread deterioration to the timber elements is evident, suggesting a softwood construction with limited resistance to moisture ingress.

The extent and distribution of decay indicates that deterioration is not confined to isolated, readily repairable areas.

Any attempt at repair would require substantial replacement of decayed timber sections, particularly to the central elements, resulting in a level of intervention comparable to reconstruction rather than meaningful conservation.

In this context, repair would not provide a durable or effective long term solution.

Replacement on a like for like basis in timber is therefore considered justified and proportionate. The proposed replacement would replicate the existing configuration, proportions and detailing, with glazing improvements addressed separately to minimise visual change whilst improving performance.

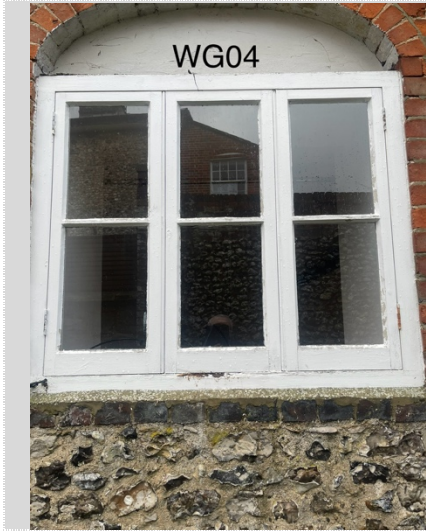
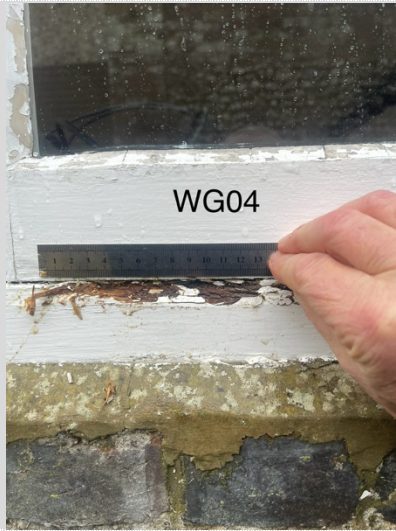
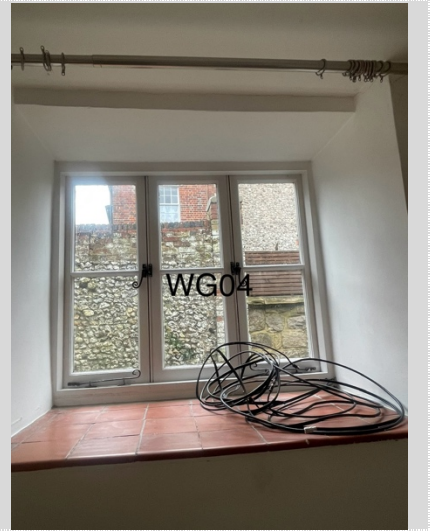
## WG.04

There is a general breakdown of paint and putty across these casement windows, together with extensive deterioration to the cill.

In this context, repair would not provide a durable or effective long term solution.

Replacement on a like for like basis in timber is therefore considered justified and proportionate. The proposed replacement would replicate the existing configuration, proportions and detailing, with glazing improvements addressed separately to minimise visual change whilst improving performance.

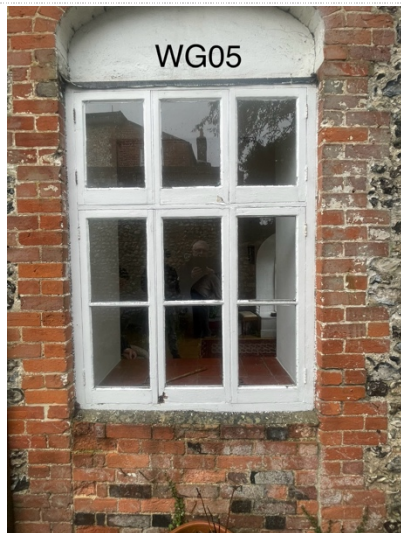
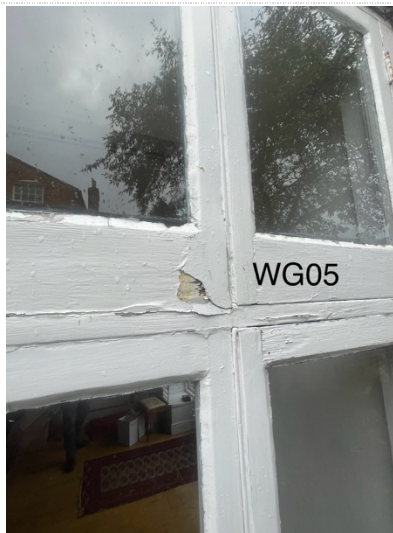
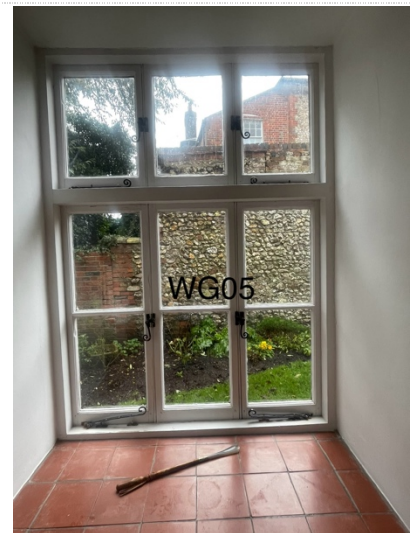
## WG.05

There is a general breakdown of paint and putty across the window, together with extensive deterioration to both the bottom centre casement and the top centre casement.

More widespread deterioration to the timber elements is evident, suggesting a softwood construction with limited resistance to moisture ingress.

The extent and distribution of decay indicates that deterioration is not confined to isolated, readily repairable areas.

Any attempt at repair would require substantial replacement of decayed timber sections, particularly to the central elements, resulting in a level of intervention comparable to reconstruction rather than meaningful conservation.

In this context, repair would not provide a durable or effective long term solution.

Replacement on a like for like basis in timber is therefore considered justified and proportionate. The proposed replacement would replicate the existing configuration, proportions and detailing, with glazing improvements addressed separately to minimise visual change whilst improving performance.

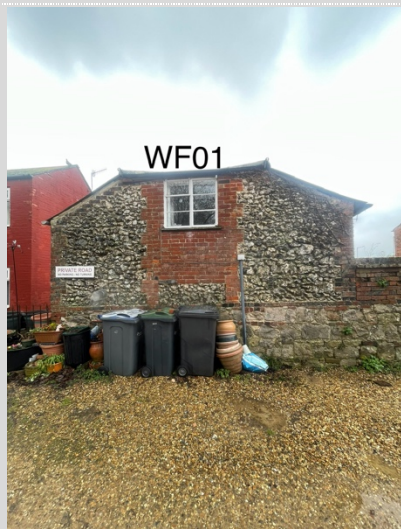
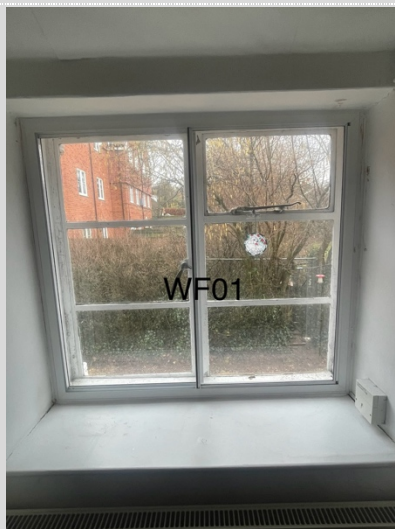
## WF.01

**Type:** Mid 20th century steel window (later insertion, 1930s to 1950s)

Repair has been considered in line with conservation best practice; however, due to the inherent limitations of mid 20th century steel windows, including susceptibility to corrosion, limited thermal performance and difficulty achieving long term weather tightness, continued repair would offer limited heritage or functional benefit.

Replacement with a new window of an appropriate historic pattern, replicating existing windows of similar proportions located within the building, carefully proportioned and detailed to reflect established local precedents, would not result in additional heritage harm and would provide an opportunity to enhance the significance of the building by reinstating a more historically legible opening.

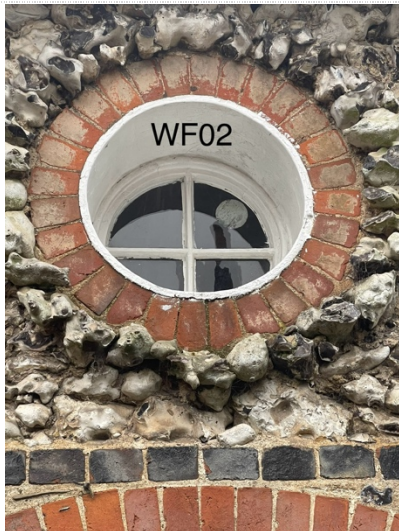
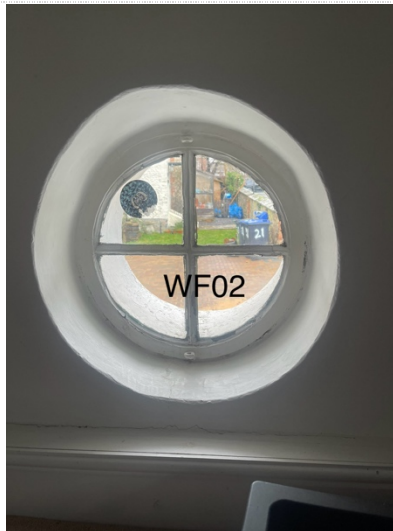
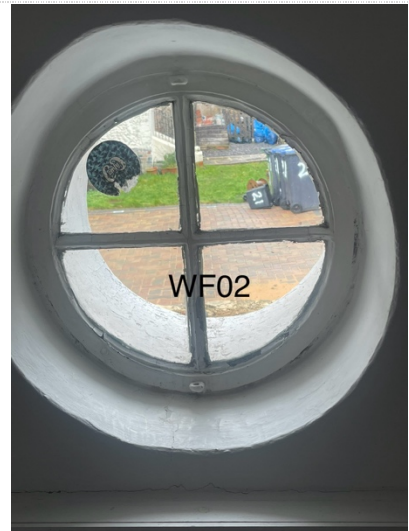
## WF.02

**Type:** Late C19 circular metal window set within a timber frame; currently sealed shut

Due to the heritage significance of this window and the survival of historic fabric, it is proposed that the window is retained in its existing form, with no replacement or glazing alteration, in order to avoid unnecessary intervention and potential harm to historic material.

Minor repair and maintenance works will be undertaken on a like for like basis, including localised repainting and re puttying where required, to ensure the continued weathertightness, functionality and long term preservation of the window.

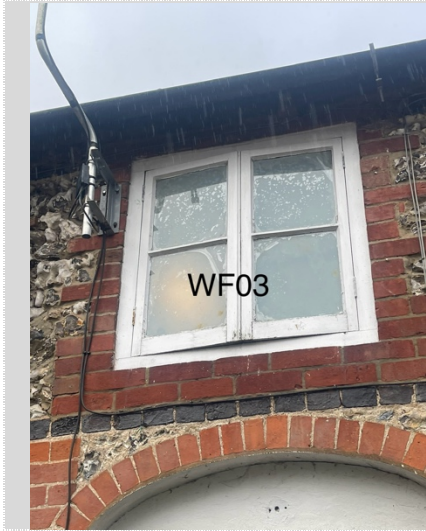
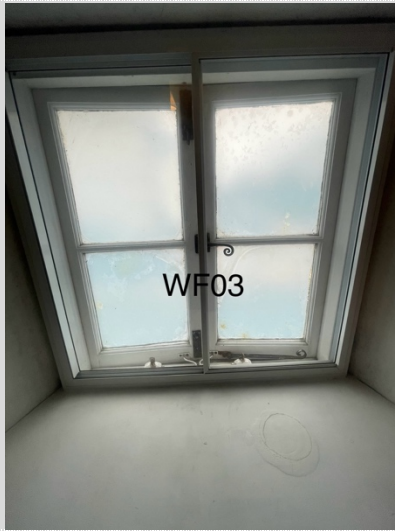
### WF.03

There is a general breakdown of paint and putty across these casement windows, with deterioration evident to the bottom rail area and tenon joints starting to open and fail.

In this context, repair would not provide a durable or effective long term solution.

Replacement on a like for like basis in timber is therefore considered justified and proportionate. The proposed replacement would replicate the existing configuration, proportions and detailing, with glazing improvements addressed separately to minimise visual change whilst improving performance.

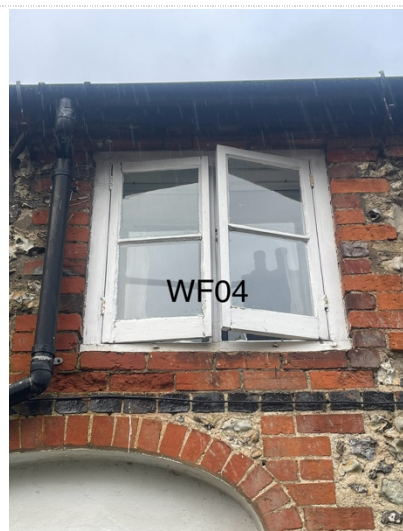
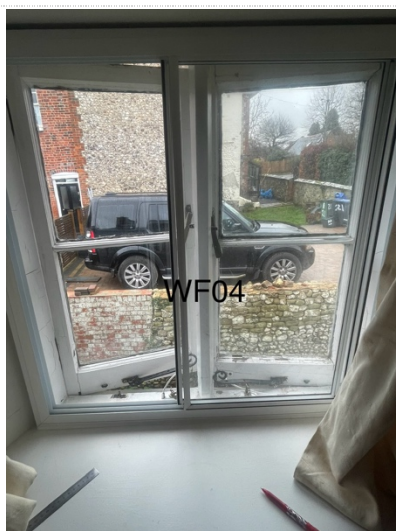
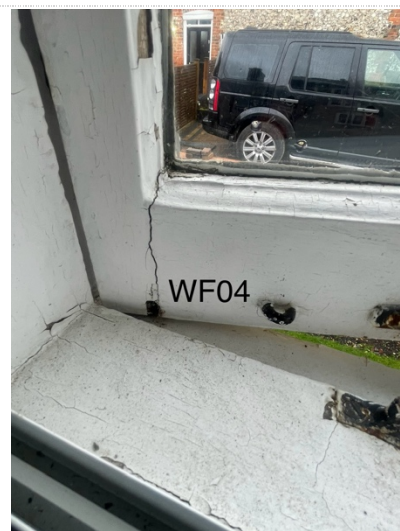
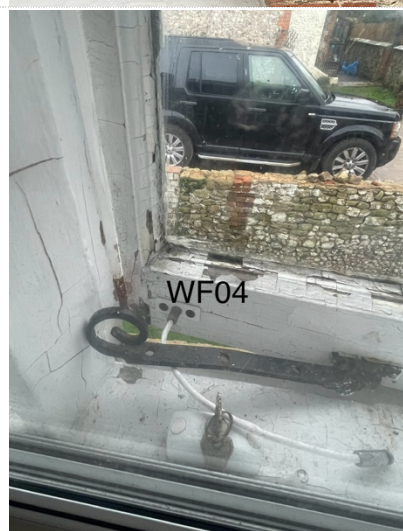
## WF.04

There is a general breakdown of paint and putty across these casement windows, together with extensive deterioration to each bottom rail, including tenon joints which have failed and are opening.

In this context, repair would not provide a durable or effective long term solution.

From its method of construction, the frame is considered likely to date from the early C19. It appears that a later, modern timber cill has been added to the front of the frame; this will need to be carefully removed to enable a full assessment of the condition of the lower section of the frame. As such, it is proposed that the frame is repaired using traditional methods, thereby extending the serviceable life of the historic frame.

As such, it is proposed that the frame is repaired using traditional methods, involving the careful removal of decayed timber to the lower sections of both jambs and the scarfing in of a compatible, durable timber such as Sapele, thereby extending the serviceable life of the historic frame.

Replacement on a like for like basis in timber is therefore considered justified and proportionate. The proposed replacement would replicate the existing configuration, proportions and detailing, with glazing improvements addressed separately to minimise visual change whilst improving performance.

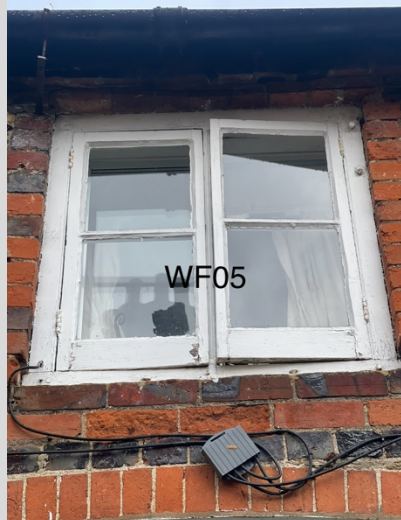
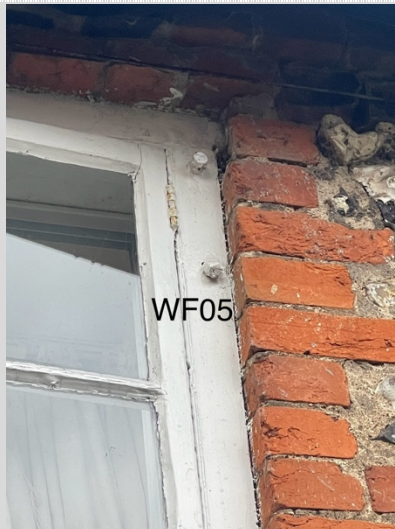
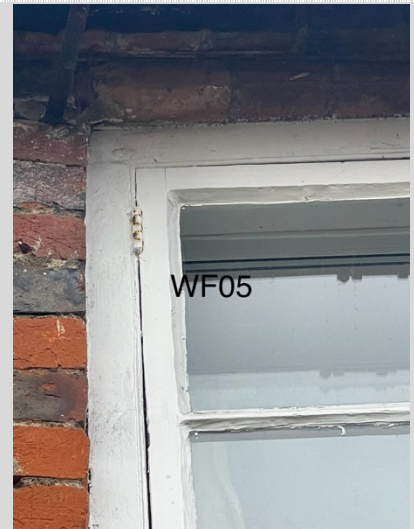
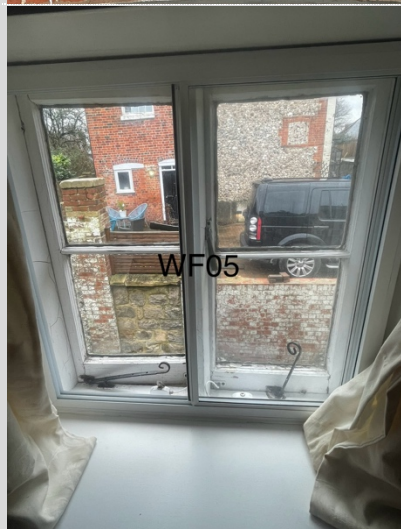
## WF.05

There is a general breakdown of paint and putty across these casement windows, together with extensive deterioration to each bottom rail, including tenon joints which have failed and are opening.

In this context, repair would not provide a durable or effective long term solution.

From its method of construction, the frame is considered likely to date from the early C19. As such, it is proposed that the frame is repaired using traditional methods, thereby extending the serviceable life of the historic frame.

As such, it is proposed that the frame is repaired using traditional methods, involving the careful removal of decayed timber to the lower sections of both jambs and the scarfing in of a compatible, durable timber such as Sapele, thereby extending the serviceable life of the historic frame.

Replacement on a like for like basis in timber is therefore considered justified and proportionate. The proposed replacement would replicate the existing configuration, proportions and detailing, with glazing improvements addressed separately to minimise visual change whilst improving performance.

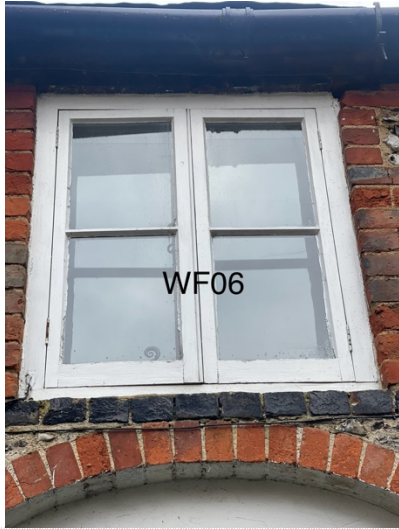
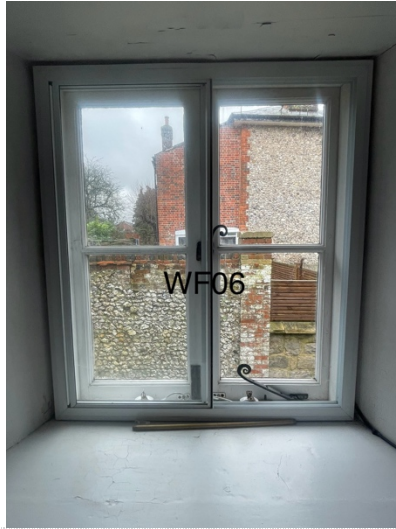
## WF.06

There is a general breakdown of paint and putty across these casement windows, with deterioration evident to the bottom rail area and tenon joints starting to open and fail.

In this context, repair would not provide a durable or effective long term solution.

Replacement on a like for like basis in timber is therefore considered justified and proportionate. The proposed replacement would replicate the existing configuration, proportions and detailing, with glazing improvements addressed separately to minimise visual change whilst improving performance.

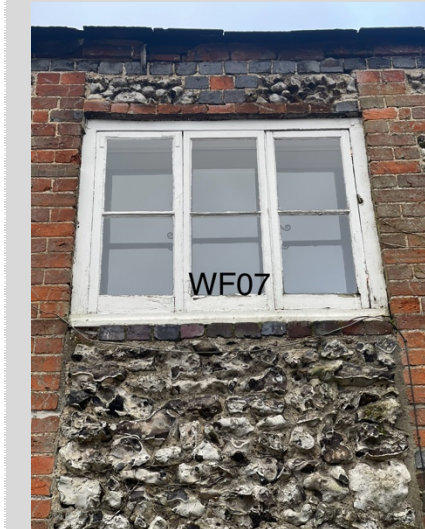
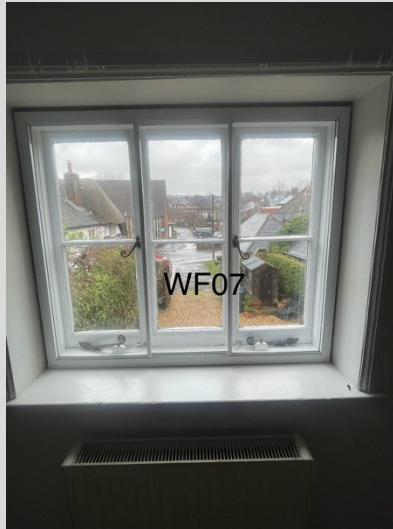
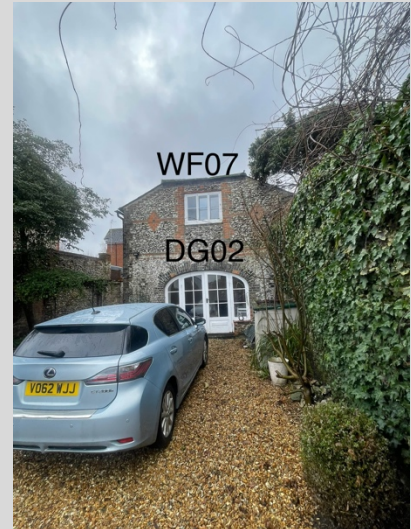
## WF.07

There is a general breakdown of paint and putty across these casement windows, together with extensive deterioration to each bottom rail, including tenon joints which are opening.

In this context, repair would not provide a durable or effective long term solution.

From its method of construction, the frame is considered likely to date from the early C19. It appears that a later, modern timber cill has been added to the front of the frame; this will need to be carefully removed to enable a full assessment of the condition of the lower section of the frame. As such, it is proposed that the frame is repaired using traditional methods, involving the careful removal of decayed timber to the lower sections of both jambs and the scarfing in of a compatible, durable timber such as Sapele, thereby extending the serviceable life of the historic frame.

As such, it is proposed that the frame is repaired using traditional methods, involving the careful removal of decayed timber to the lower sections of both jambs and the scarfing in of a compatible, durable timber such as Sapele, thereby extending the serviceable life of the historic frame.

Replacement on a like for like basis in timber is therefore considered justified and proportionate. The proposed replacement would replicate the existing configuration, proportions and detailing, with glazing improvements addressed separately to minimise visual change whilst improving performance.
