**Inspection to GALES COTTAGE, 56-58 HIGH STREET, STEEPLE ASHTON, BA14 6EU**

Following your instruction, I attended the site on Monday 26<sup>th</sup> January 2026 to review damage to the external stone wall forming part of Gales Cottage, located at 56–58 High Street, Steeple Ashton, BA14 6EU.

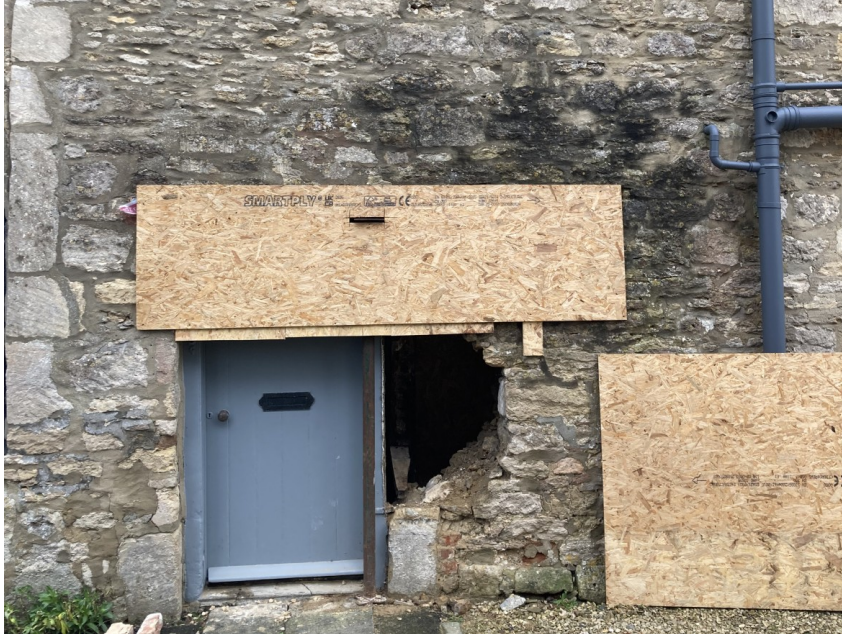
The damage has been caused by a point loading resulting from an impact by a passenger vehicle. The vehicle struck the side elevation of the building adjacent to the entrance door. As reported by the property owner, the initial damage was not clearly visible externally, other than localised cracking to the stonework. However, the damage was significantly more evident internally, where the inner skin of the stone wall collapsed into the room. Temporary propping was installed immediately following the incident to support the first-floor joists bearing onto the damaged wall. Over time, loose sections of masonry detached, resulting in the formation of a substantial opening and further cracking, as shown on the photographs provided.

It should also be noted that a large area of black mould growth and staining is present on the external face of the side wall, directly above the impact location. The mortar in this area appears to be heavily weathered and degraded, and several cracks have formed as a result of the impact. Notably, the cracking appears to terminate at the point where the black staining ceases, beyond which the stone and mortar return to their natural colour and are consistent with the remainder of the elevation.

*1. Collapsed section of the side wall with visible black mould and staining.*

We recommend that the damaged section of the external stone wall is demolished and reinstated. As noted above, cracking has developed extensively within the stonework affected by black mould and staining. Due to the extent of cracking and the overall poor condition of the mortar, we recommend that the entire section of wall affected by the black staining is demolished and rebuilt, rather than undertaking localised repairs.

Access to the affected area should be restricted immediately and maintained throughout the remedial works.

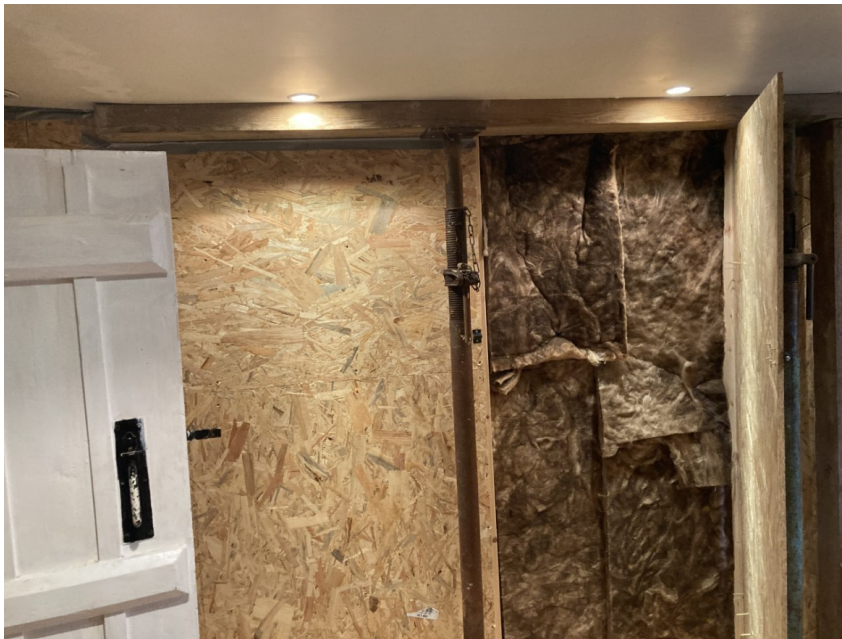
*2. Temporary propping installed internally.*

The crack to the internal face of the external front wall should be further inspected by the main contractor on site to confirm whether it is limited to surface finishes only or penetrates deeper into the stone wall construction. The findings should be reported back to MG Structures to allow an appropriate repair methodology to be advised. The new wall panel should be adequately tied back to the remaining section of the side wall. The lintel over the entrance door should be inspected and assessed for suitability for reuse; if found to be damaged or inadequate, it should be replaced on a like-for-like basis. Temporary propping must be provided to support the existing first-floor structure for the full duration of the construction works.

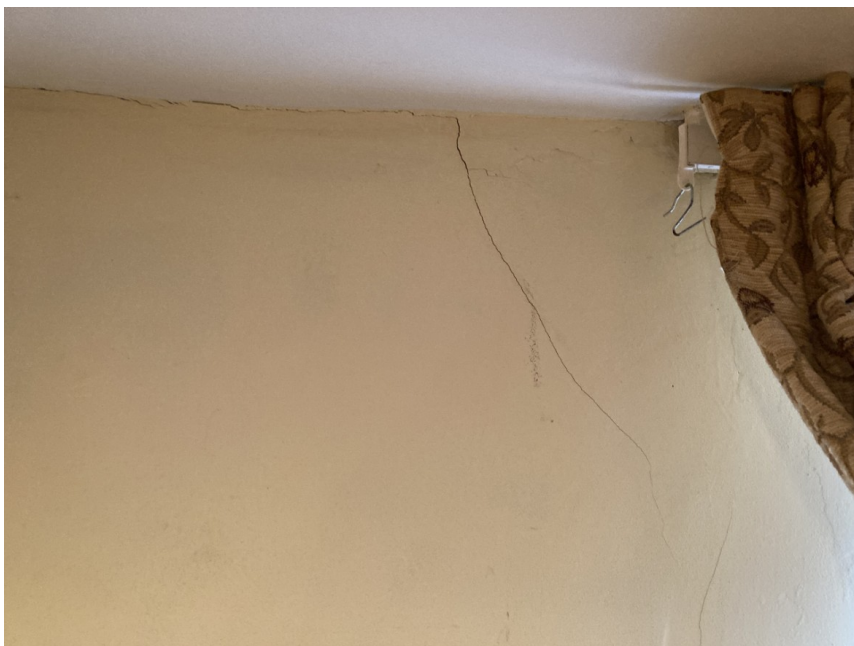
The adjacent external wall forming the front elevation exhibits a diagonal crack extending from the top corner of the window opening. In addition, a minor horizontal crack is visible internally along the ceiling line. We inspected the first-floor rooms located directly above the point of impact and found no visible cracks or signs of structural movement. All wall and ceiling finishes were intact, with no evidence of distress. It is noted that these rooms have been recently renovated, and therefore any cracking or movement would be clearly apparent.

*3. Diagonal crack on the internal face of the external front wall*

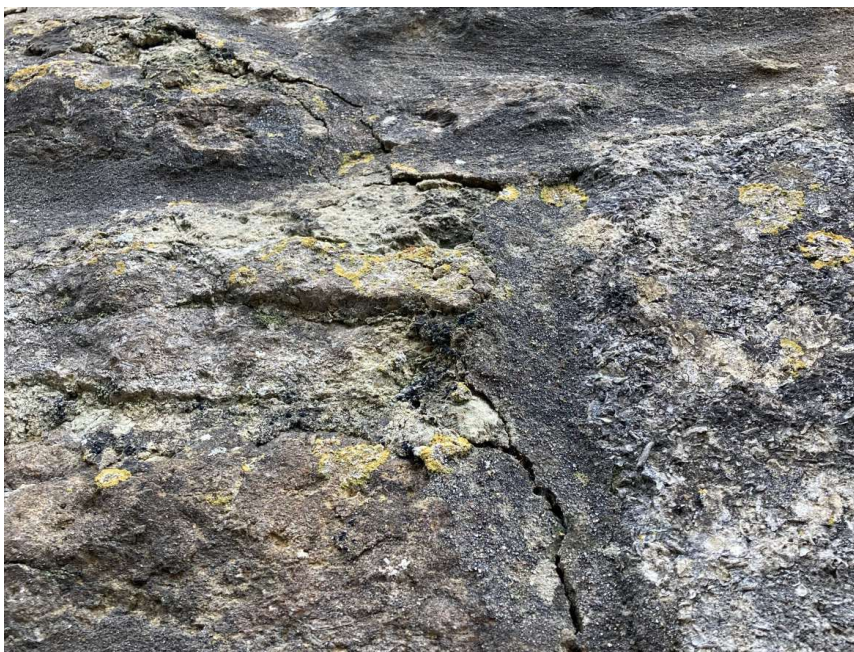
*4. Cracking at the section of wall affected by black mould and staining.*
